Hazardous Building Materials Assessment

Monsignor Paul Dwyer Catholic
School

700 Stevenson Road North,
Oshawa, Ontario

March 15, 2019

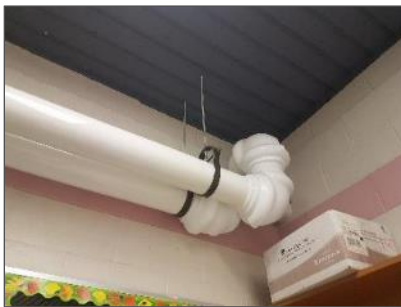
Photo 1 – View of non-asbestos fibreglass pipe insulation in classrooms.

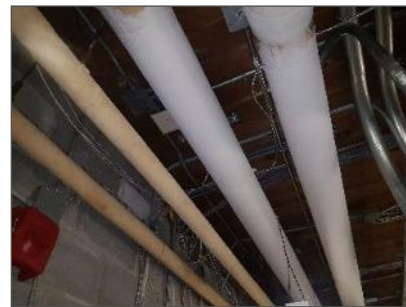
Photo 2 – Non-asbestos fibreglass pipe insulation in Electrical Room 124B.

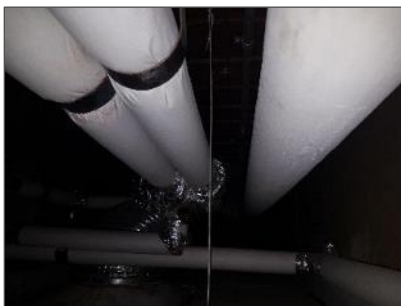
Photo 3 – Non-asbestos fibreglass pipe insulation above ceiling tiles in classrooms.

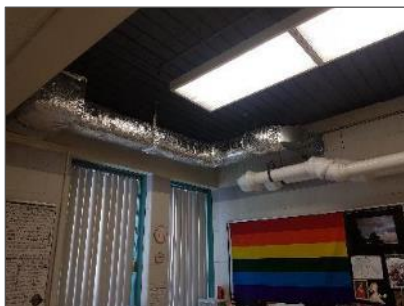
Photo 4 – View of foil-faced, non-asbestos fiberglass duct insulation.

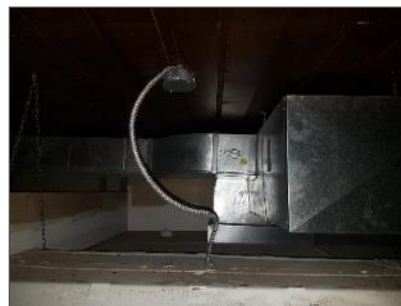
Photo 5 – Ducts above ceiling tile are uninsulated.

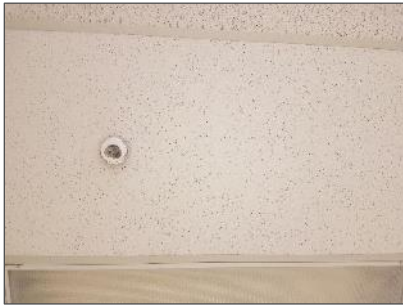
Photo 6 – Non-asbestos 24" x 48", lay-in ceiling tile with medium and large pinholes.

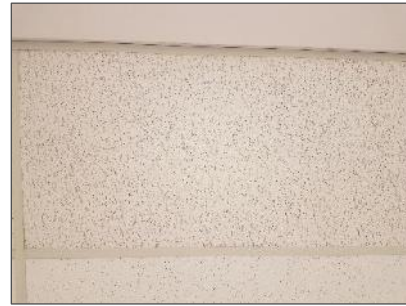
Photo 7 – Non-asbestos 24" x 48", lay-in ceiling tile with dense pinholes with fissure widthways.

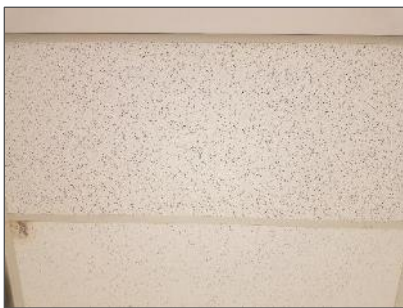
Photo 8 – Non-asbestos 24" x 48", lay-in ceiling tile with pinholes and random flecks.

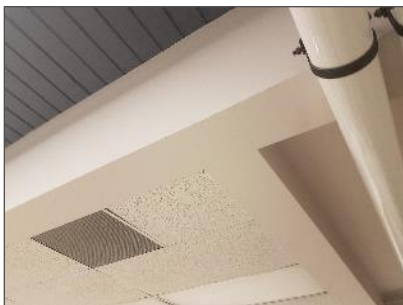
Drywall joint compound present on wall and ceiling finishes throughout the assessed area does not contain asbestos (samples 0032A-C).

Photo 9 – Drywall bulkheads are located in Classrooms 124, 126, 137 and 133.

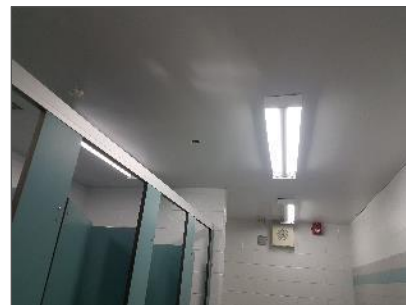
Photo 10 – Drywall ceiling in washroom 135.

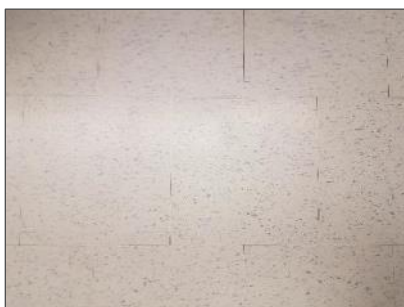
The vinyl floor tiles and mastic are non-friable and are in good condition.

Photo 11 – Non-asbestos 12" x 12" white vinyl floor tile with blue fleck.

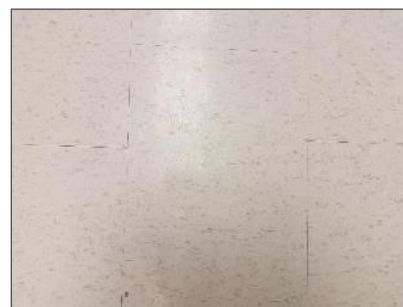
Photo 12 – Non-asbestos 12" x 12" white vinyl floor tile with grey streak.

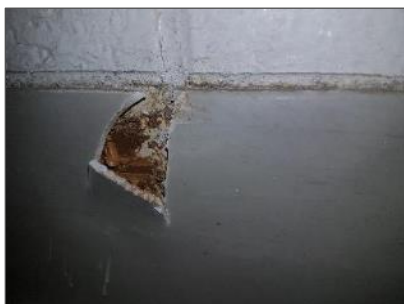
Vinyl baseboard adhesive present at bottom of walls throughout the assessed area does not contain asbestos (samples 0033A-C).

Photo 13 – Non-asbestos vinyl baseboard adhesive.

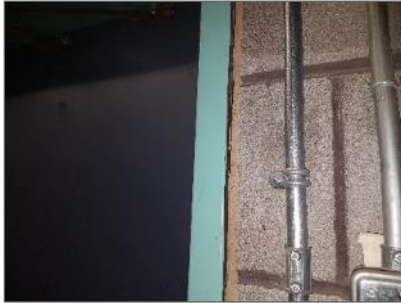
Material and Colour	Location	Quantity	Sample Number	Asbestos Type
Caulking, beige	Door frames of 124B	40 linear feet	0034A-C	Chrysotile

Caulking is a non-friable material and in good condition.

Photo 14 – Asbestos containing beige caulking around doorframe in Room 124B.

Remove asbestos-containing materials (ACM) prior to renovation, alteration, or maintenance if ACM may be disturbed by the work.

If the identified ACM will not be removed prior to commencement of the work, any potential disturbance of ACM must follow asbestos precautions appropriate for the type of work being performed.

Asbestos-containing materials must be disposed of at a landfill approved to accept asbestos waste.

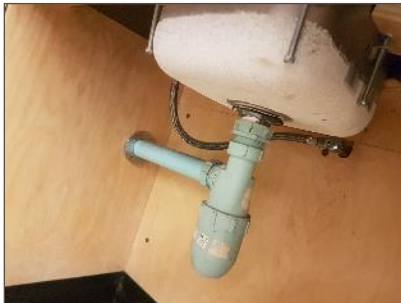
White sink mastic present on the underside of sinks in Rooms 124 and 124A does not contain asbestos (0035A-C)

Photo 15 – Non-asbestos white sink mastic in room 124.
