# Limited Designated Substances Survey

**Room Nos. 108, 109, 110,  
122, 123, 136, 137, 138, 150  
and 156**

**25 Laurelcrest Street,  
Brampton, Ontario**

June 3, 2020

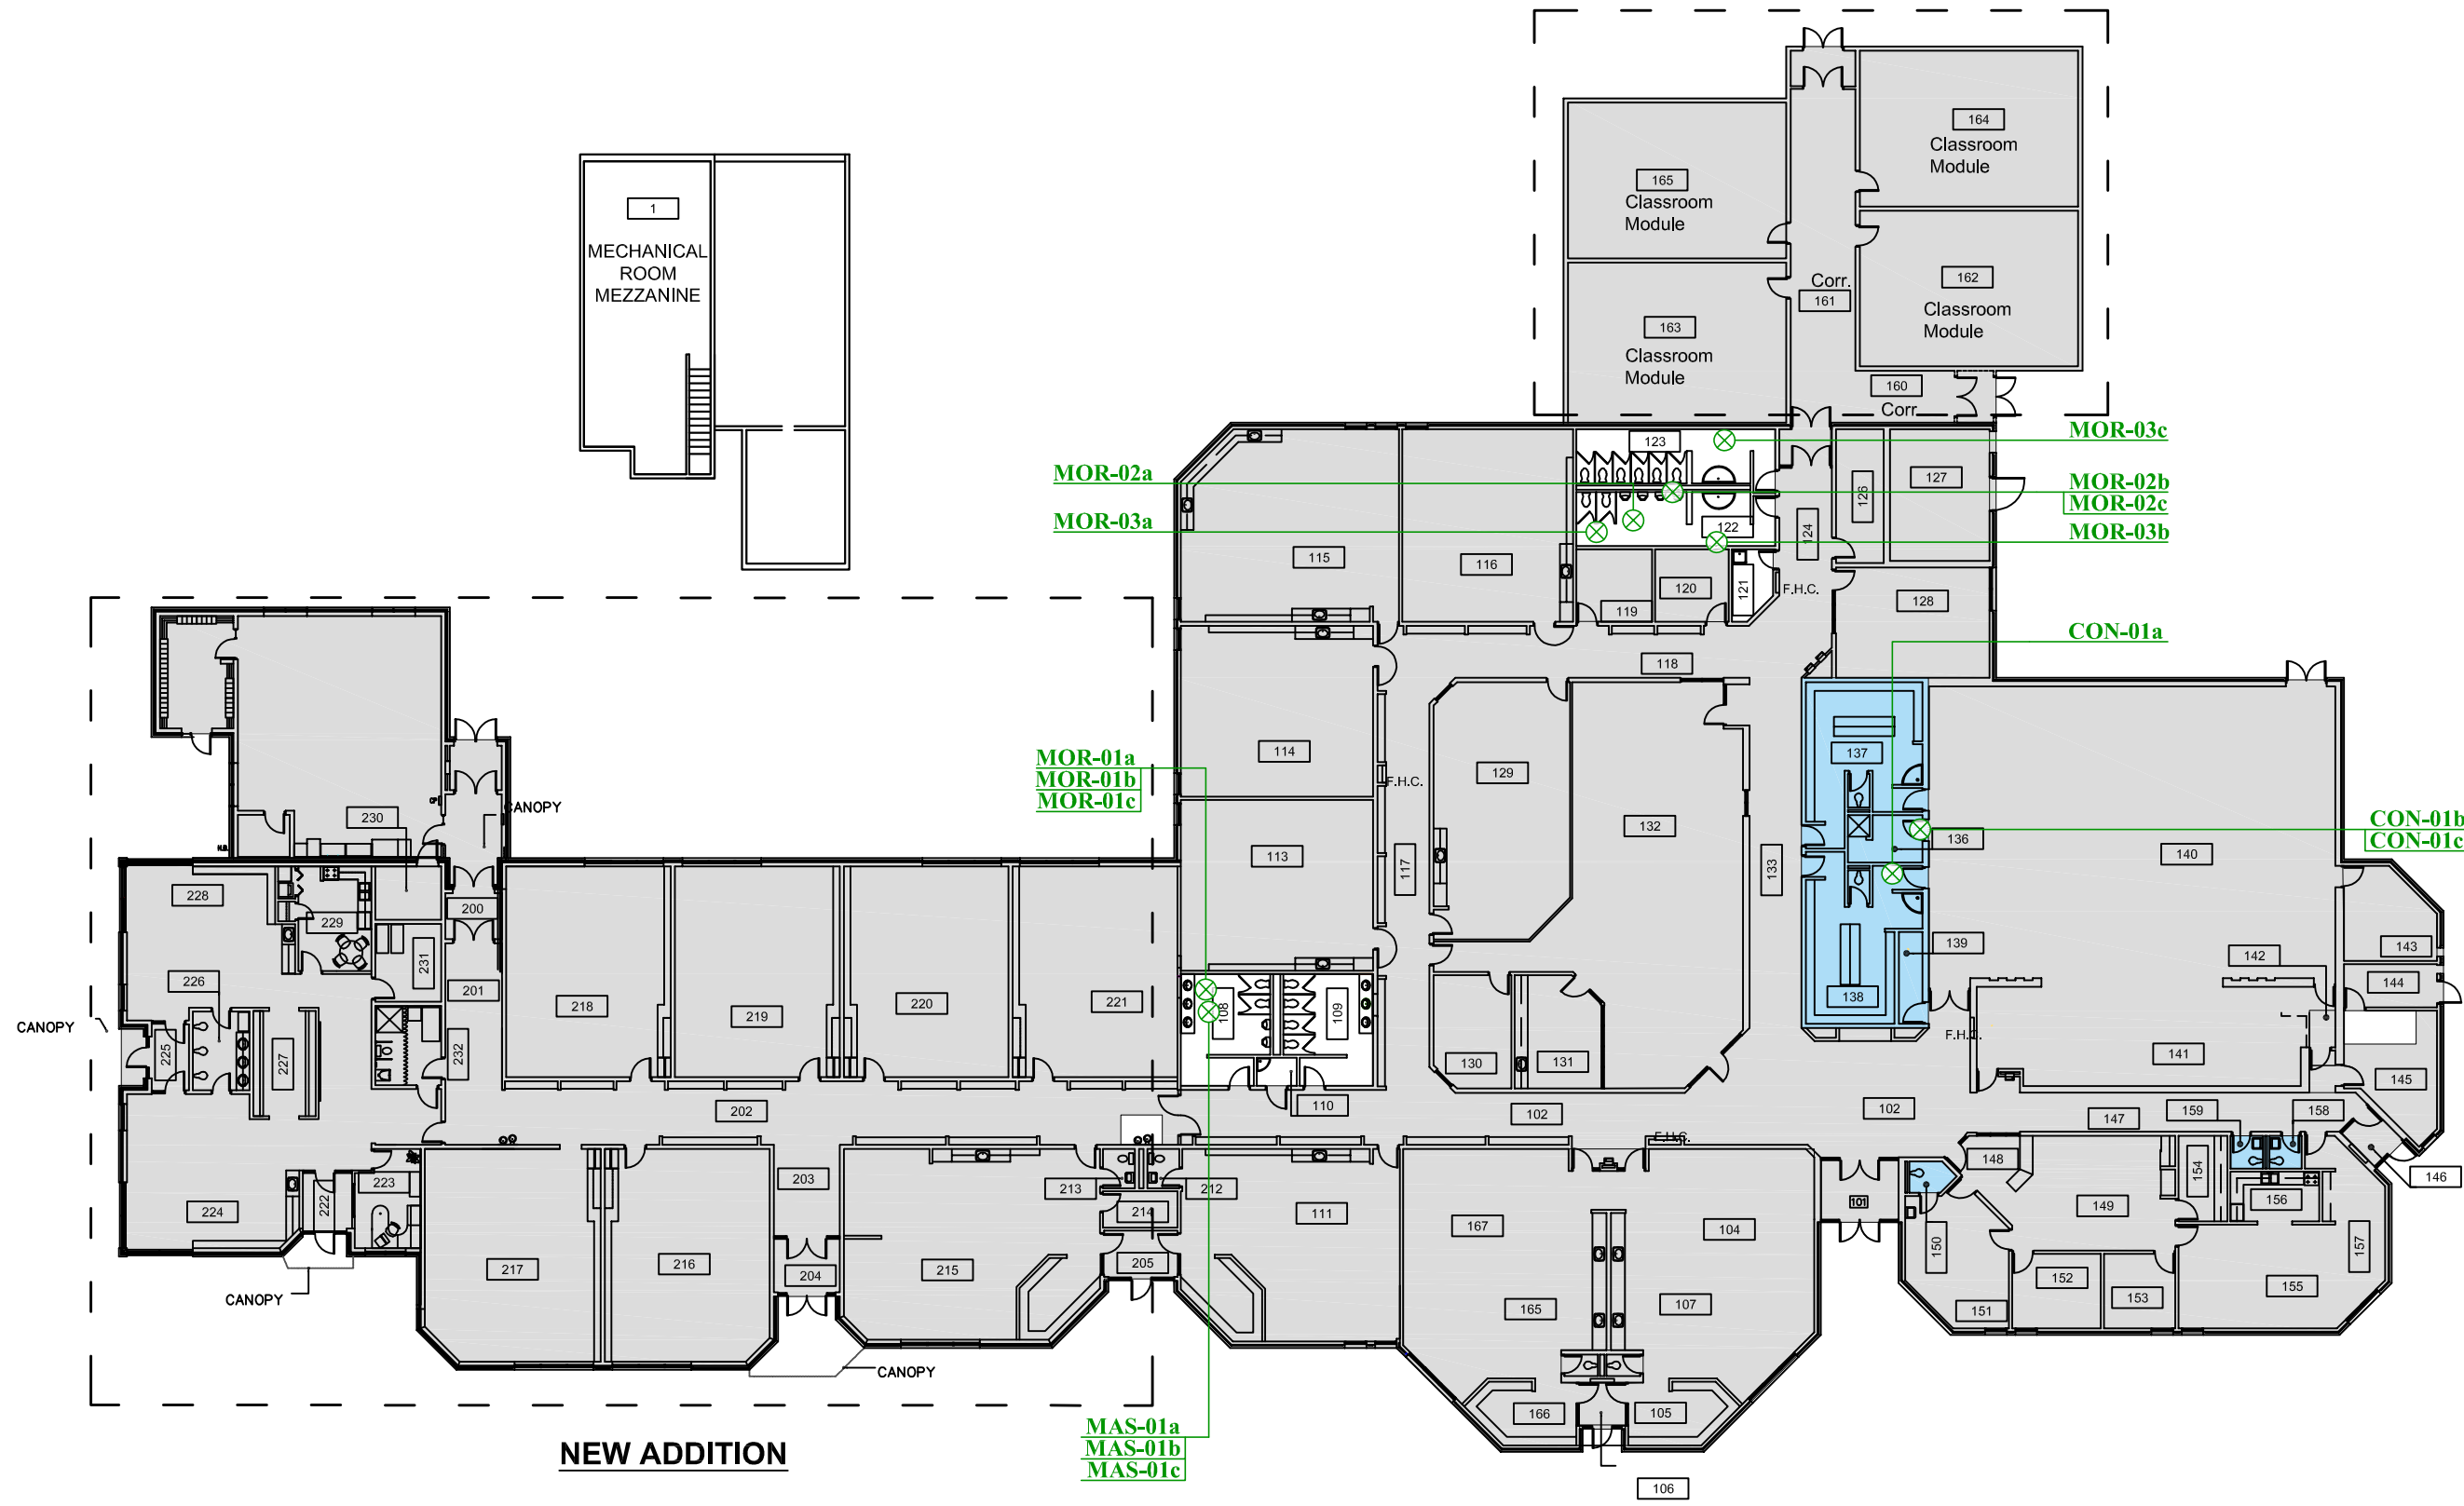
A site plan showing the approximate sample locations of suspect ACMs is provided in Appendix A as Drawing No. 1. Selected photographs of building materials submitted for laboratory analysis and confirmed designated substances are included in Appendix B. A Copy of the Laboratory Certificate of Analysis is included in Appendix C.

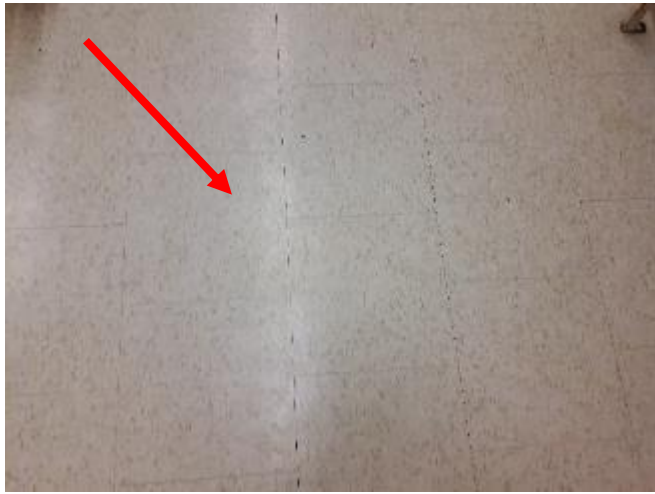
Designated Substances/ Hazardous Materials	Findings
Asbestos	<p>12"x12" light brown vinyl floor tiles observed in Rooms 136, 137, 138, 150 and 156 were previously determined to contain <b>2.4% Chrysotile</b> asbestos (Maple, 2007). The mastic associated with these vinyl floor tiles is also considered to be asbestos containing. At the time of the site visit, a total of approximately 1,600 ft<sup>2</sup> of the presumed asbestos containing vinyl floor tiles were observed to be in good condition within the Subject Areas.</p> <p>ACMs may be present behind or within materials in inaccessible areas as noted above within Sections 4.1 and 4.3 of this report.</p>
Lead	<p>Lead may be present in paints not sampled, electronic components (e.g., wiring connections, wire bundles, etc.), plumbing solder, roof flashing, noise baffles, emergency lighting batteries, and cast-iron piping gaskets (i.e., bell &amp; spigots). Where present within the Subject Areas, they are presumed to be lead-containing.</p>

**Photo 1: View of the asbestos containing 12"x12" light brown vinyl floor tiles (see arrow) observed in Room 138.**

- 1) S2S recommends that the following asbestos containing materials identified in Table 2 be managed in place or removed following Type 1 asbestos abatement procedures in accordance with O. Reg 278/05:
  - Vinyl floor tiles and associated mastic (if removed without power tools/power equipment)

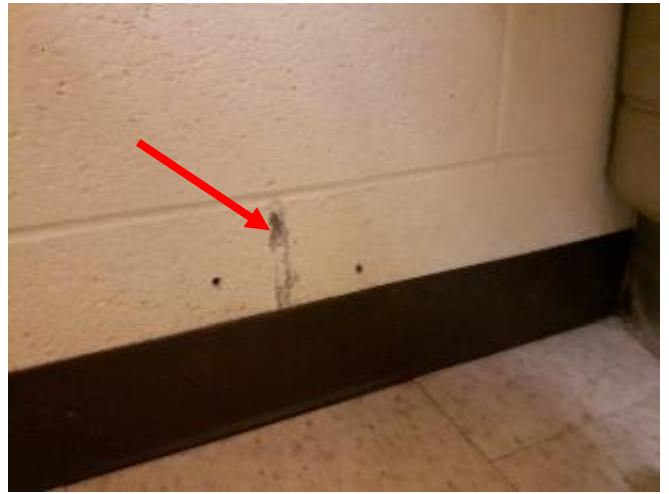
**Photo 2: View of the non-asbestos containing concrete block mortar (see arrow) observed in Room 138.**

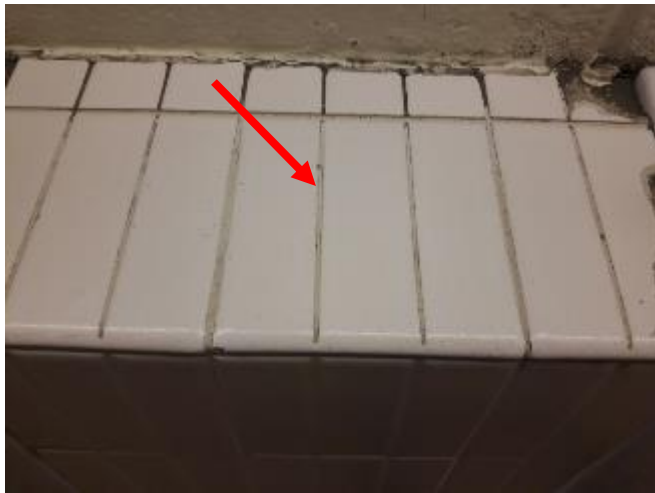
**Photo 3: View of the non-asbestos containing mortar (see arrow) observed on beige tiles within Room 122.**

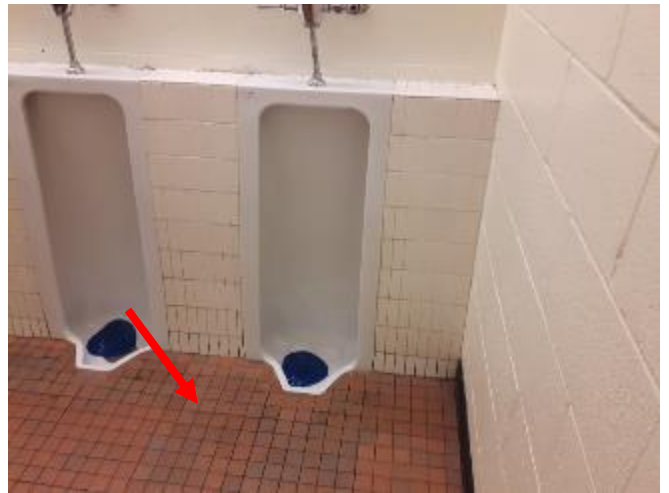
**Photo 4: View of the non-asbestos containing mortar (see arrow) observed on terracotta tiles within Room 122.**
