August 31, 2020

Project No. 20147153(2000)

**PRE-RENOVATION DESIGNATED SUBSTANCES AND HAZERDOUS MATERIALS ASSESSMENT SURVEY  
– 200 JOHN STREET WEST, UNIT 5C, OSHAWA, ONTARIO**

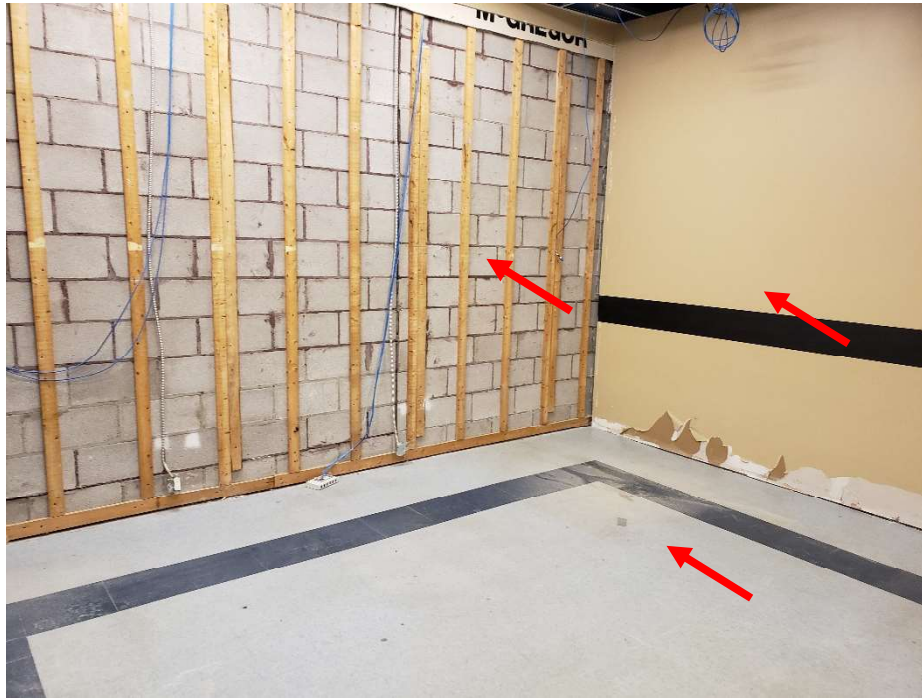
- Drywall joint compound throughout the Unit (Samples 01A-E);
- Joint compound on drywall ceilings in the Men's and Women's Washrooms (Samples 02A-C);
- Dark blue 12"x12" vinyl floor tiles with associated black mastic throughout the former Classrooms (Samples 03A-C, layer 1 and 2);

- Light blue 12"x12" vinyl floor tiles with associated black mastic found throughout former Classrooms (Samples 04A-C, layer 1 and 2);
- Light blue speckled 12"x12" vinyl floor tiles with associated black mastic found throughout the Boiler and Electrical Rooms (Samples 05A-C, layer 1 and 2);

- Purple tinted interior concrete brick mortar found on the south-east walls (Samples 06A-C);
- Interior concrete brick mortar found on the north-east walls (Samples 07A-C);

**Photograph 1: Non-asbestos various 12"x12" vinyl floor tiles, drywall joint compound, and concrete brick mortar within former Classrooms, throughout Unit.**

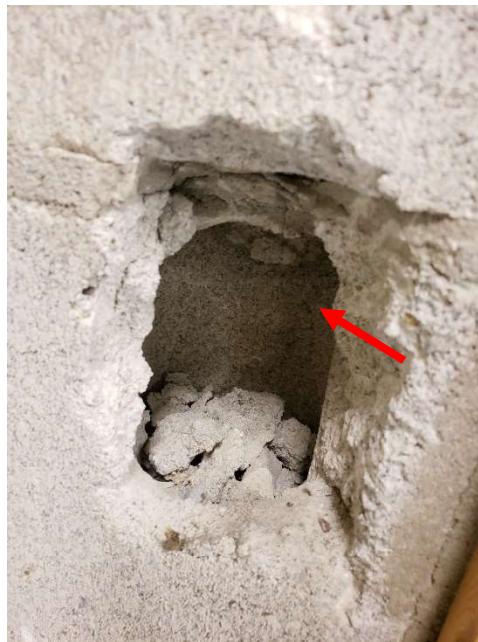
Bell and spigot cast iron pipe connections were not observed. In addition, no vermiculite insulation was observed in the north-east concrete block wall, however it may be present in concealed locations not investigated. Additionally, the rooftop and HVAC systems were not within the renovation scope of work and was not investigated.

**Photograph 2: Where observed, no vermiculite present within concrete block walls.**

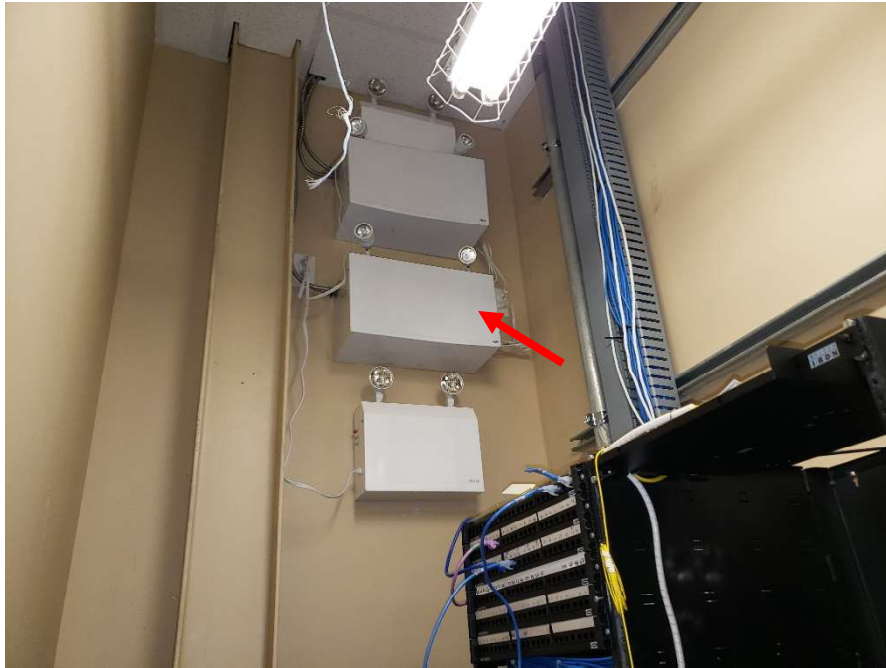
**Photograph 3: Presumed lead-containing batteries within emergency lighting.**

However, lead is suspected within solder in domestic water pipes and in the lead acid batteries of emergency lighting. Although not observed, lead may also be present as lead sheeting concealed behind finished surfaces throughout (i.e. flashing, brick tiles, etc.). If uncovered during renovation, all bulk lead-containing materials should be extracted and sent to a recycling facility. If recycling of the lead is not practicable then it must be disposed of in an approved landfill as lead waste.

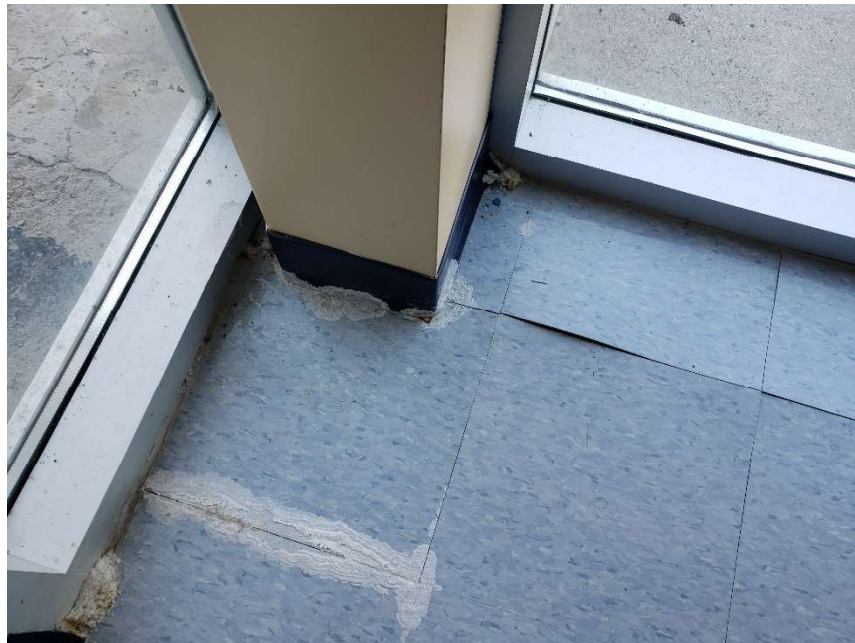
Approximately five square feet of water-damage was present on the west windowsills, drywall walls and non-asbestos vinyl floor tiles in former Classroom 5 and Classroom 6. Additionally, approximately 15 water-damaged acoustic ceiling tiles were observed throughout the Unit. Visible mould was not identified during the assessment; however the water damage could be an indication of concealed mould growth behind drywall surfaces. As a precautionary measure the ceiling tiles should be disposed of following Level 1 procedures as defined under the Environmental Abatement Council of Ontario (EACO) *Mould Abatement Guidelines, Edition 3 (2015)* (the EACO Guidelines). It is also recommended that a building science engineer determine the water sources with the goal of providing suitable repair options.

**Photograph 4: Water-damaged non-asbestos vinyl floor tiles and drywall.**

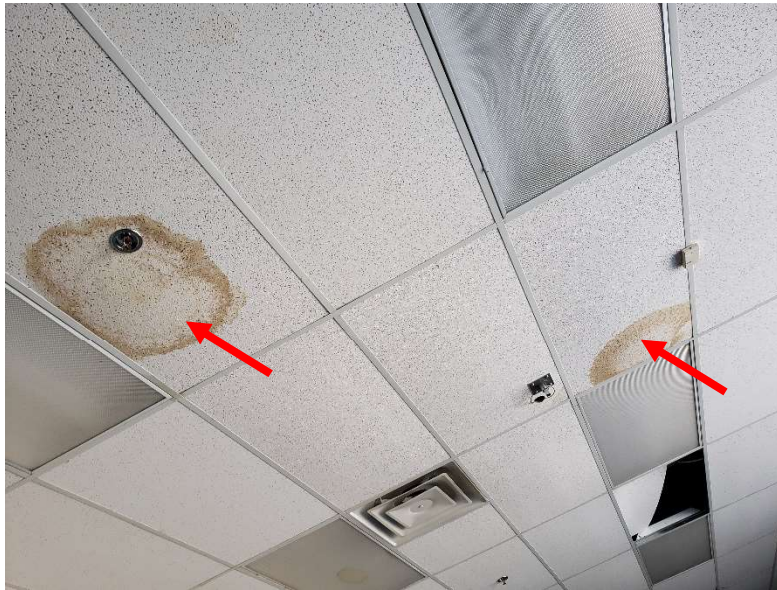
**Photograph 5: Water-damaged acoustic ceilings tiles, present throughout Unit.**

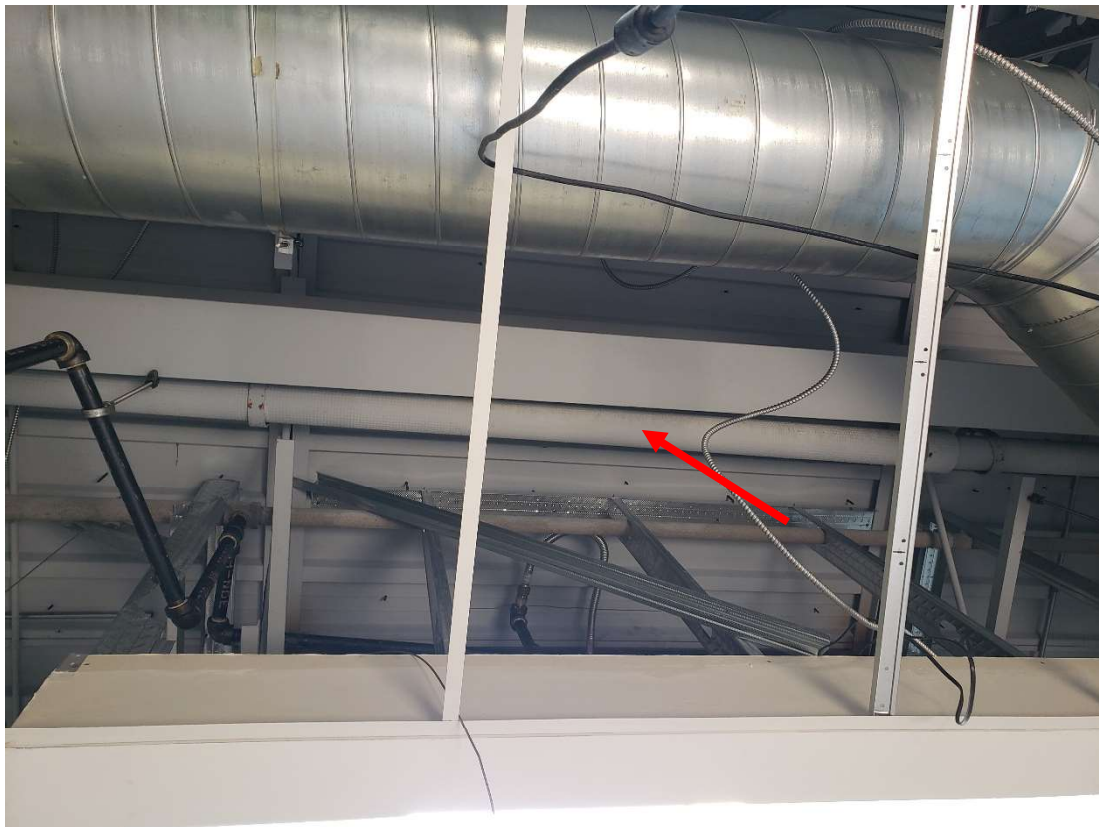
**Photograph 6: Asbestos-cement (also known by the tradename Transite™) observed in the traversing ceiling space throughout the Unit.**

- Approximately 100 linear feet of presumed asbestos-cement (also known by the tradename Transite™) pipe was observed in the traversing ceiling space throughout the Unit. If the non-friable asbestos-cement pipe is to be impacted during future renovation or maintenance activities, the piping should be removed following Type 1 asbestos procedures, as prescribed under O. Reg. 278/05, provided the pipe remains wetted throughout the removal process and only non-powered hand tools are used. If powered tools are used to remove the pipe, then Type 2 or 3 asbestos procedures are required, dependant on the tools used.
