CRESTWOOD SECONDARY SCHOOL MECHANICAL UPGRADES - 2021

Hazardous Building Materials Assessment (Pre-construction)

HVAC Update Program and
Walk-in Cooler Replacement
Crestwood Secondary School
1885 Sherbrooke Street West,
Peterborough, Ontario

May 11, 2021

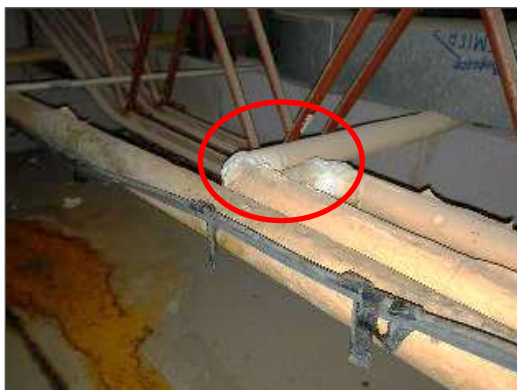
Asbestos-containing parging cement above walk-in cooler.

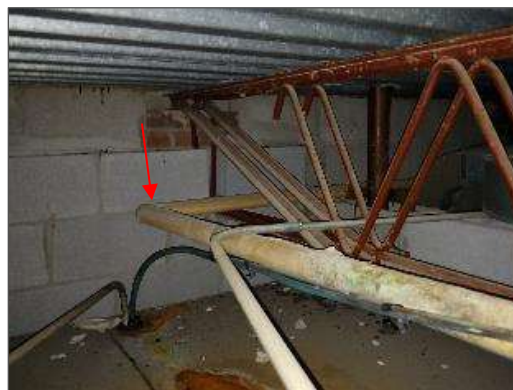
Asbestos-containing parging cement above walk-in cooler.

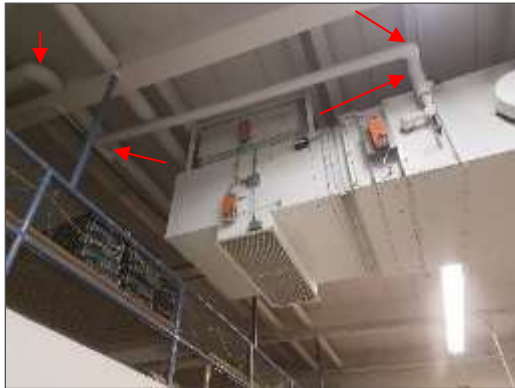
Asbestos-containing parging around AHU in Electrical Shop B107 (Location 92).

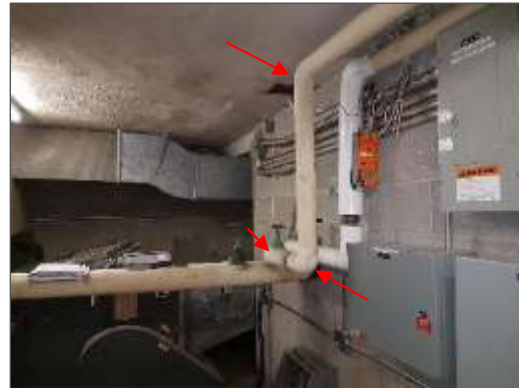
Asbestos-containing parging Fan Room 124 (Location 49).

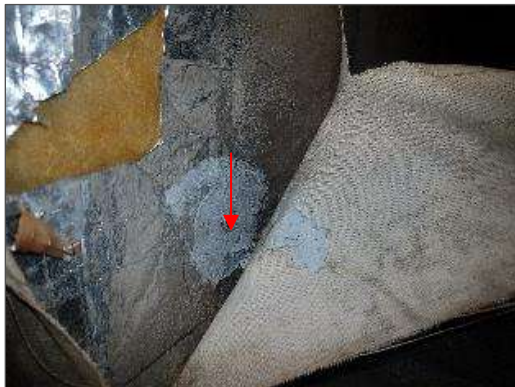
Asbestos-containing parging cement on pins of fibreglass ducts in Fan Room 124 (Location 49).

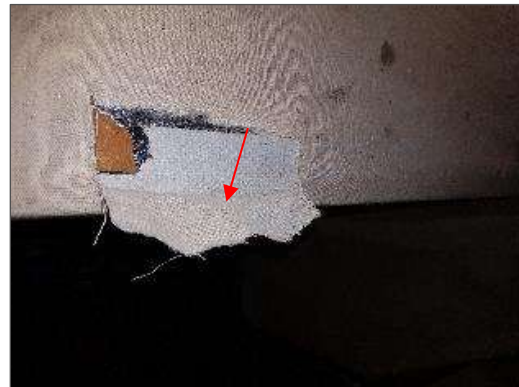
Glued-on paper, containing chrysotile asbestos, is present on joints and edges of ducts of Fan Room 124 (Location 49) and Fan Room 124A (Location 50) (samples 0061A-C). All paper on ducts is non-friable.

Asbestos-containing glued-on paper of fibreglass duct in Fan Room 124 (Location 49).

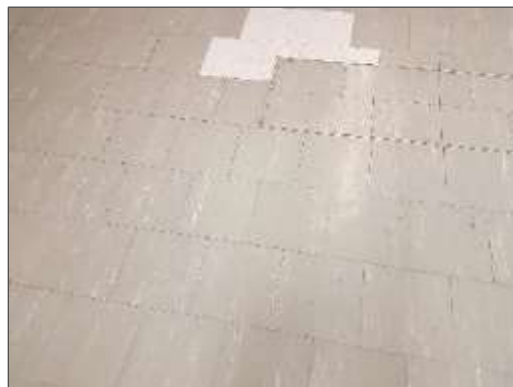
The 9" x 9" grey with white streaks vinyl floor tiles are present within Electrical Shop B107 (Location 92), but not in the assessed area.

Asbestos-containing 9" x 9" grey with white streak vinyl floor tiles.

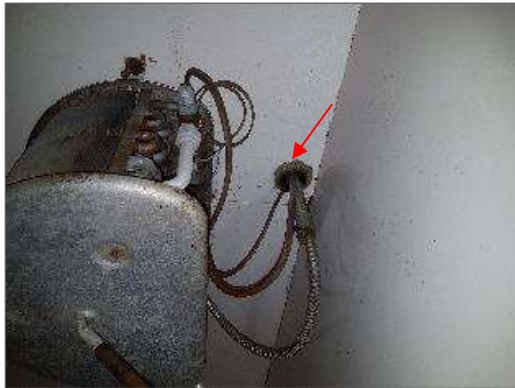
Material and Colour	Location (Location #)	Quantity	Sample Number	Asbestos Type
Caulking, grey	Penetrations in walk-in coolers of Kitchen 126 (Location 26)	5 linear feet	0058A-C	Chrysotile

Caulking is a non-friable material and in good condition.

Asbestos-containing grey caulking in walk-in cooler at wall penetration.

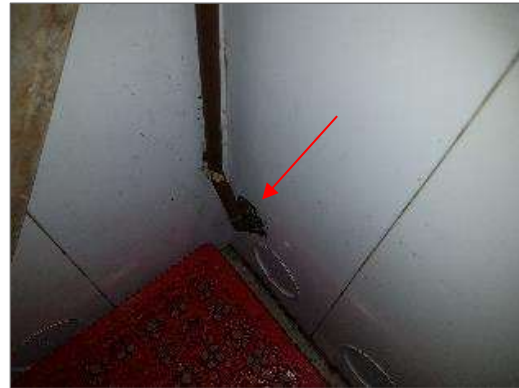
Asbestos-containing grey caulking in walk-in cooler at wall penetration.

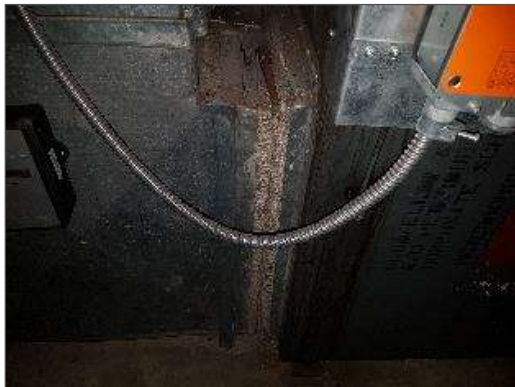
Textile vibration dampers, presumed to contain asbestos, are present as duct connectors throughout the assessed area. Vibration dampers are non-friable.

Presumed asbestos textile vibration dampers on AHU in Fan Room 124A (Location 50).

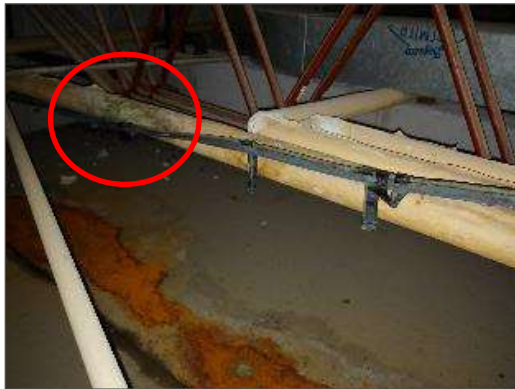
Mould and Water Damage: Approximately five linear feet of mould is present on jacketing of fibreglass pipe insulation above the walk-in cooler.

Visible mould growth and water staining is present on fibreglass pipe insulation wrapped in canvas above the walk-in cooler. There is approximately five linear feet of pipe insulation with visible mould growth.

Visible water damage and mould observed on fiberglass pipe insulation above walk-in cooler.
