Asbestos Assessment

Chemong Public School
1029 Gore Street, Bridgenorth,
Ontario

Kawartha Pine Ridge District School Board

June 4, 2018

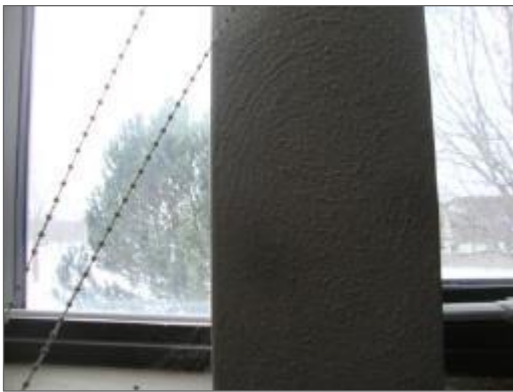
Texture finish is present on steel columns in the building. Texture coat was sampled, and determined to be non-asbestos (b95237.0017A-C).

Photo 1 – Non-asbestos texture finish present on steel columns
in Classroom 102 and 104.

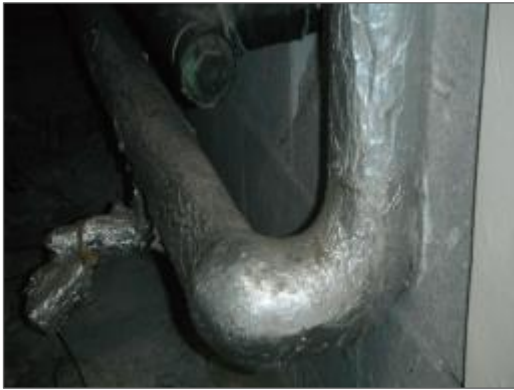
Parging cement, containing chrysotile asbestos, is present on pipe fittings (elbows, valves, tees, etc.) on hot water heating, rain water leader, and domestic water systems (Sample 1101401.S006A-C). Parging cement is a friable material and is in fair to good condition.

Photo 2 – Asbestos-containing parging cement on hot water heating pipe systems with foil jacketing.

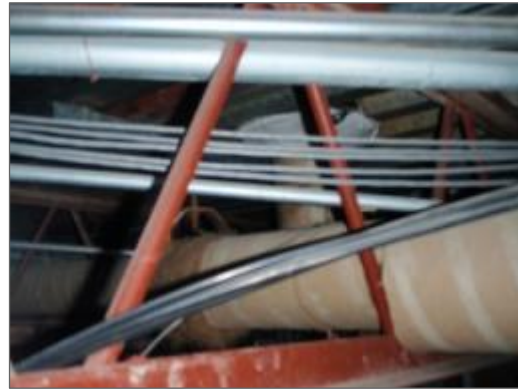
Photo 3 – Non-asbestos sweatwrap present on rain water leader pipe systems.

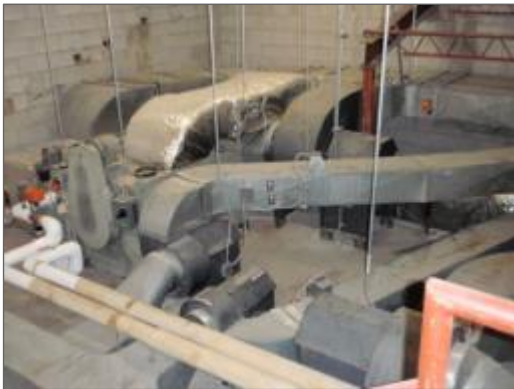
Photo 4 – Ducts in the upper Mechanical Room (Location 5) insulated with non-asbestos fibreglass.

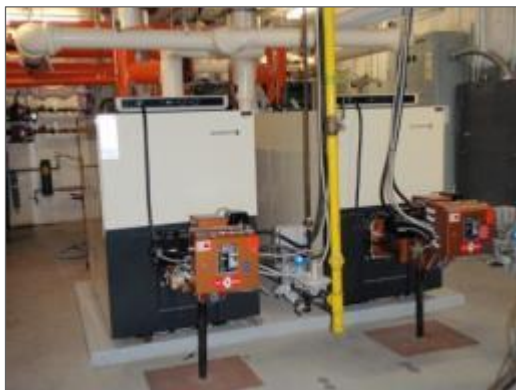
Photo 5 – New gas powered boilers present in the Boiler Room
BR1 (Location 3).

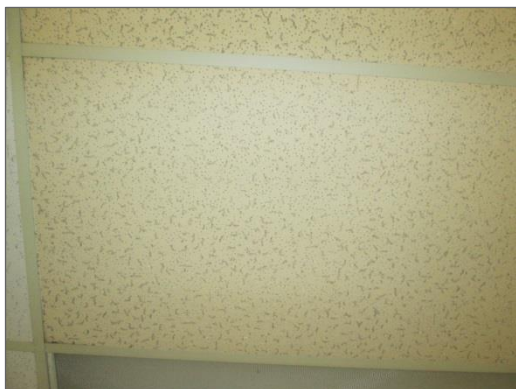
Photo 6 – Non-asbestos 24" x 48", lay-in, random fissure and medium pinhole.

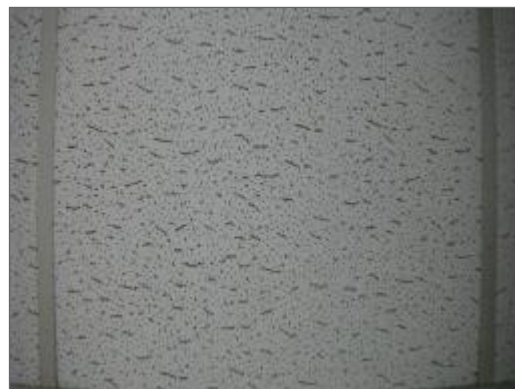
Photo 7 – Non-asbestos 24" x 48", width wise fissure and hole ceiling tile.

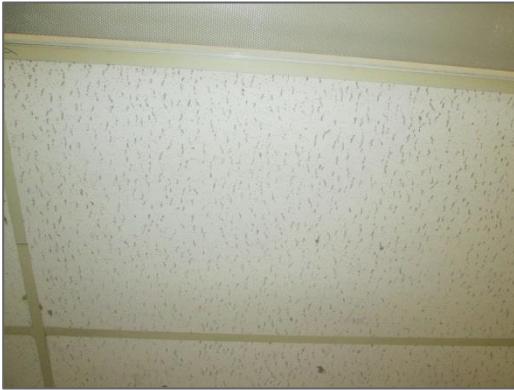
Photo 8 – Non-asbestos 24" x 48", multi directional ridges with pinhole.

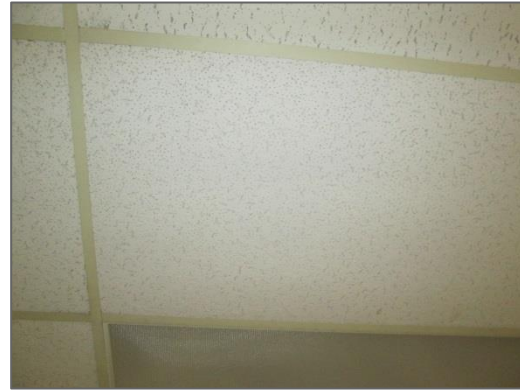
Photo 9 – Non-asbestos 24" x 48", lay-in, white depressed fissure with pinhole.

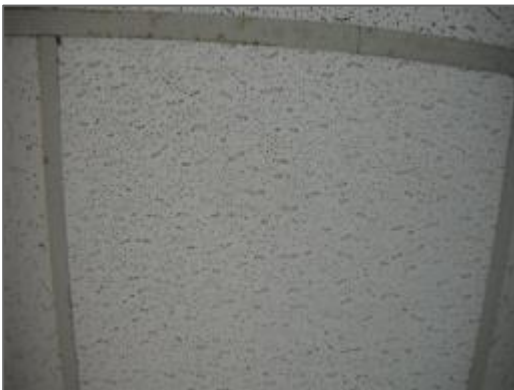
Photo 10 – Non-asbestos 24" x 48", lay-in, large width-wise fissure and large pinhole ceiling tile.

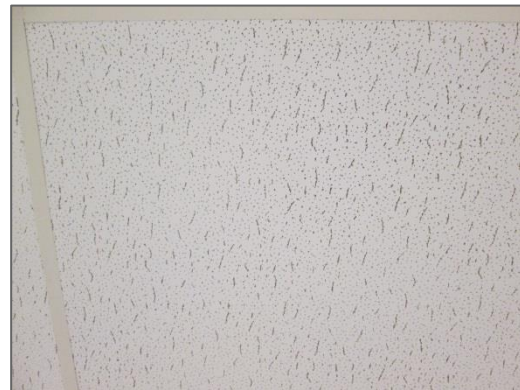
Photo 11 – Non-asbestos 24" x 48", ceiling tile fissure with tight pinhole bundle.

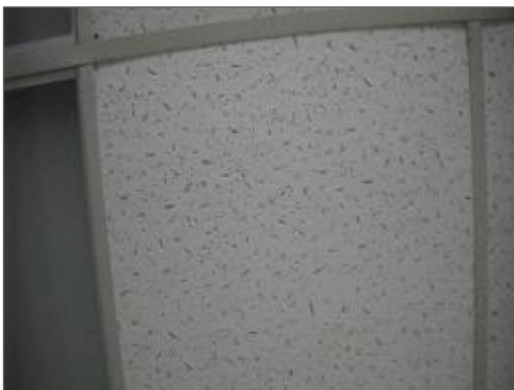
Photo 12 – Non-asbestos 24" x 48", lay-in, fissure, dimples and pinhole.

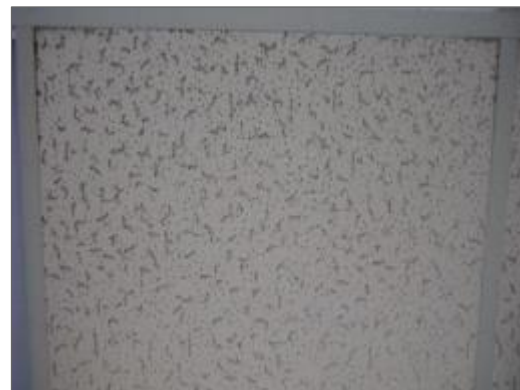
Photo 13 – Non-asbestos 24" x 48", lay-in, multi-directional ridges with large pinhole.

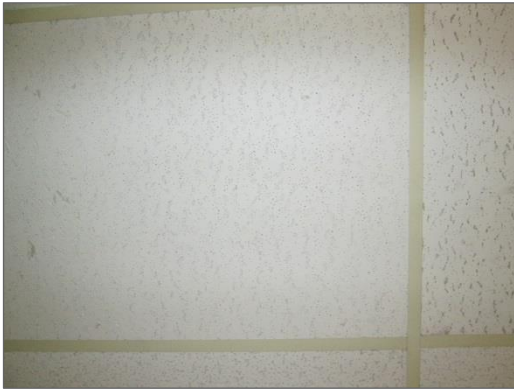
Photo 14 – Non-asbestos 24" x 48", lay-in acoustic ceiling tile present in the Corridors.

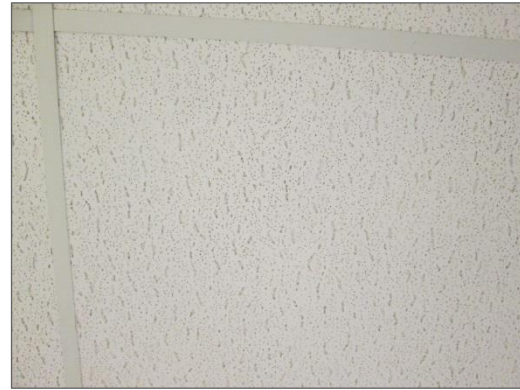
Photo 15 – Non-asbestos 24" x 48", lay in, ridges and pinhole ceiling tile.

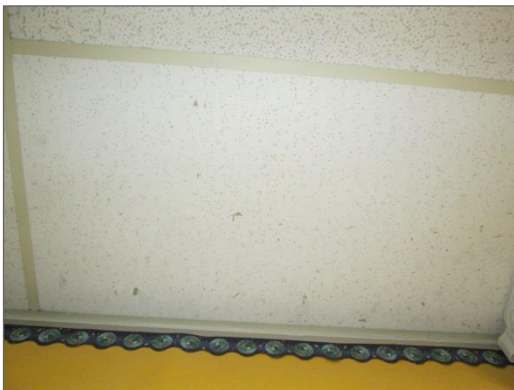
Photo 16 – Non-asbestos 24" x 48", lay-in, rough ridges and pinhole ceiling tile.

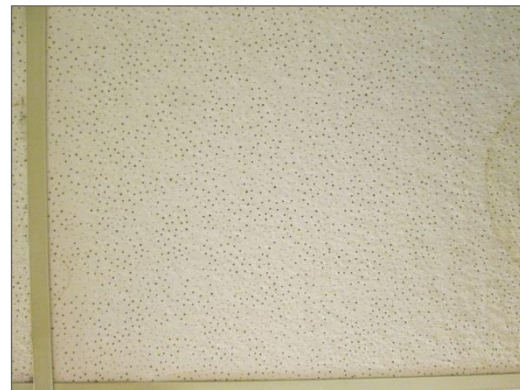
Photo 17 – Non-asbestos 24" x 48", lay-in, pinhole and swirl pattern ceiling tile.

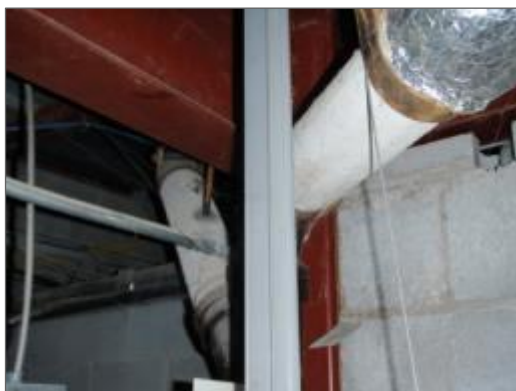
Transite is a non-friable material. All transite is in good condition.

Photo 18 – Transite pipe present as a rain water leader above ceilings in the corridors.

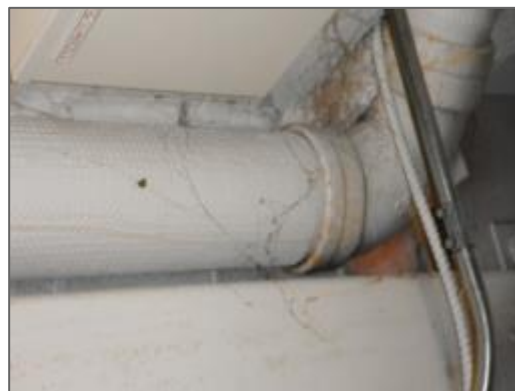
Photo 19 – Transite rain water leader; Storage Room (Location 44).

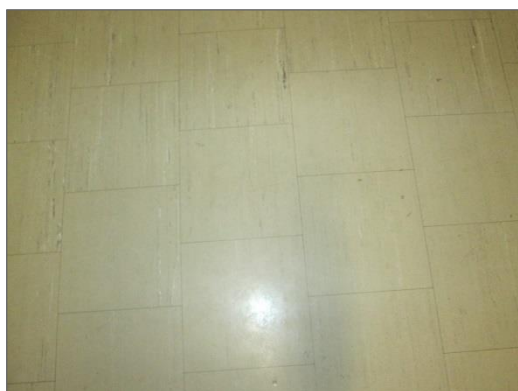
The vinyl floor tiles and mastic are non-friable and are in good condition.

Photo 20 – Asbestos-containing 9" x 9" brown with black and white streak floor tile.

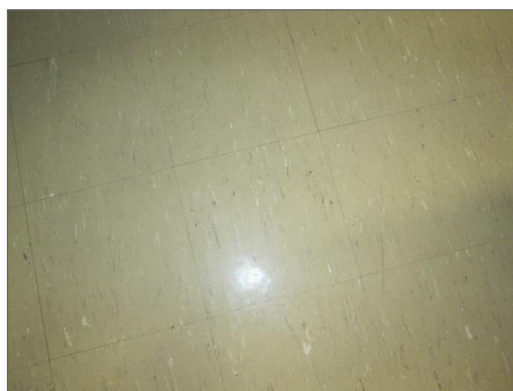
Photo 21 – Asbestos-containing 12" x 12" beige with brown and white streak floor tile.

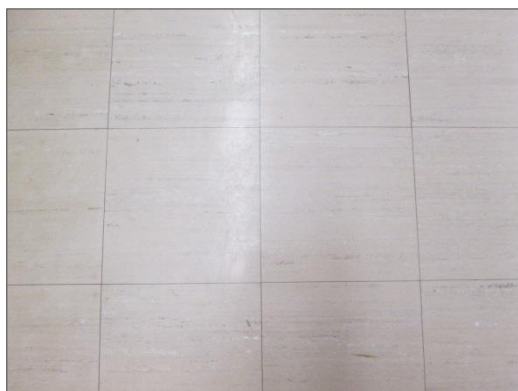
Photo 22 – Asbestos-containing brown with brown and white striations 12" x 12: vinyl floor tile.

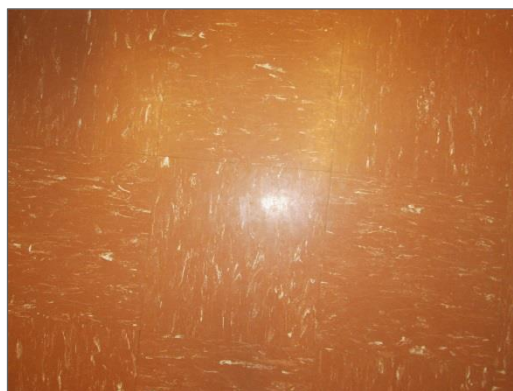
Photo 23 – Asbestos-containing 12" x 12" red and white streak floor tile.

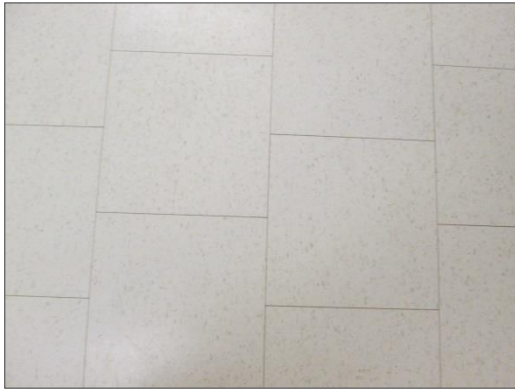
Photo 24 – Non-asbestos 12" x12" white with grey replacement tiles.

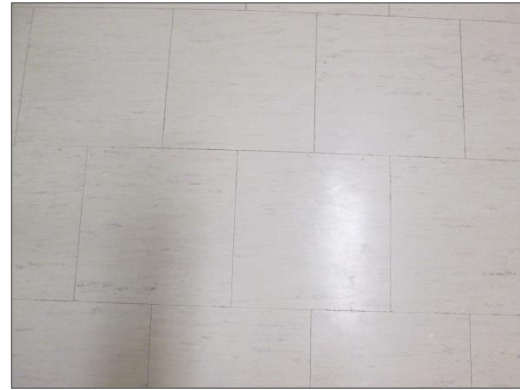
Photo 25 – Non-asbestos 12" x 12" vinyl floor tile white with blue streak with asbestos-containing mastic beneath.

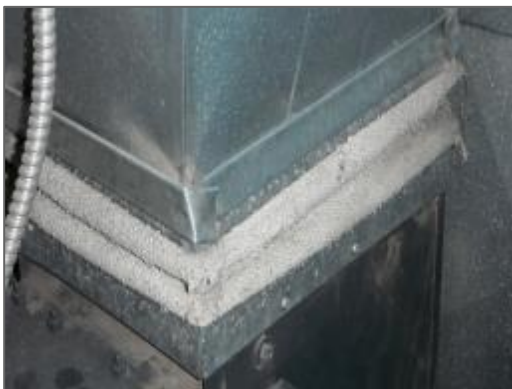
Vibration dampers at duct connections present in the Upper Mechanical Room 2 (Location 6) were determined to contain chrysotile asbestos (Sample 1101401.S002A). Vibration dampers are non-friable materials which were in good condition.

Photo 26 – Asbestos-containing duct vibration damper Upper Mechanical Room 2.

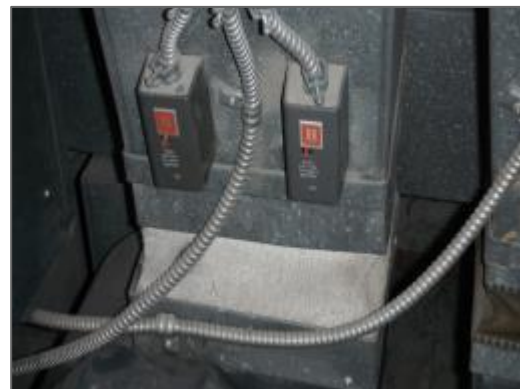
Photo 27 – Asbestos-containing vibration damper present in Upper Mechanical Room 2.
