ASBESTOS-CONTAINING BUILDING MATERIALS RE-ASSESSMENT REPORT

Bobcaygeon Public School

30 Balaclava Street
Bobcaygeon, Ontario

Maple Project No. 18736-29

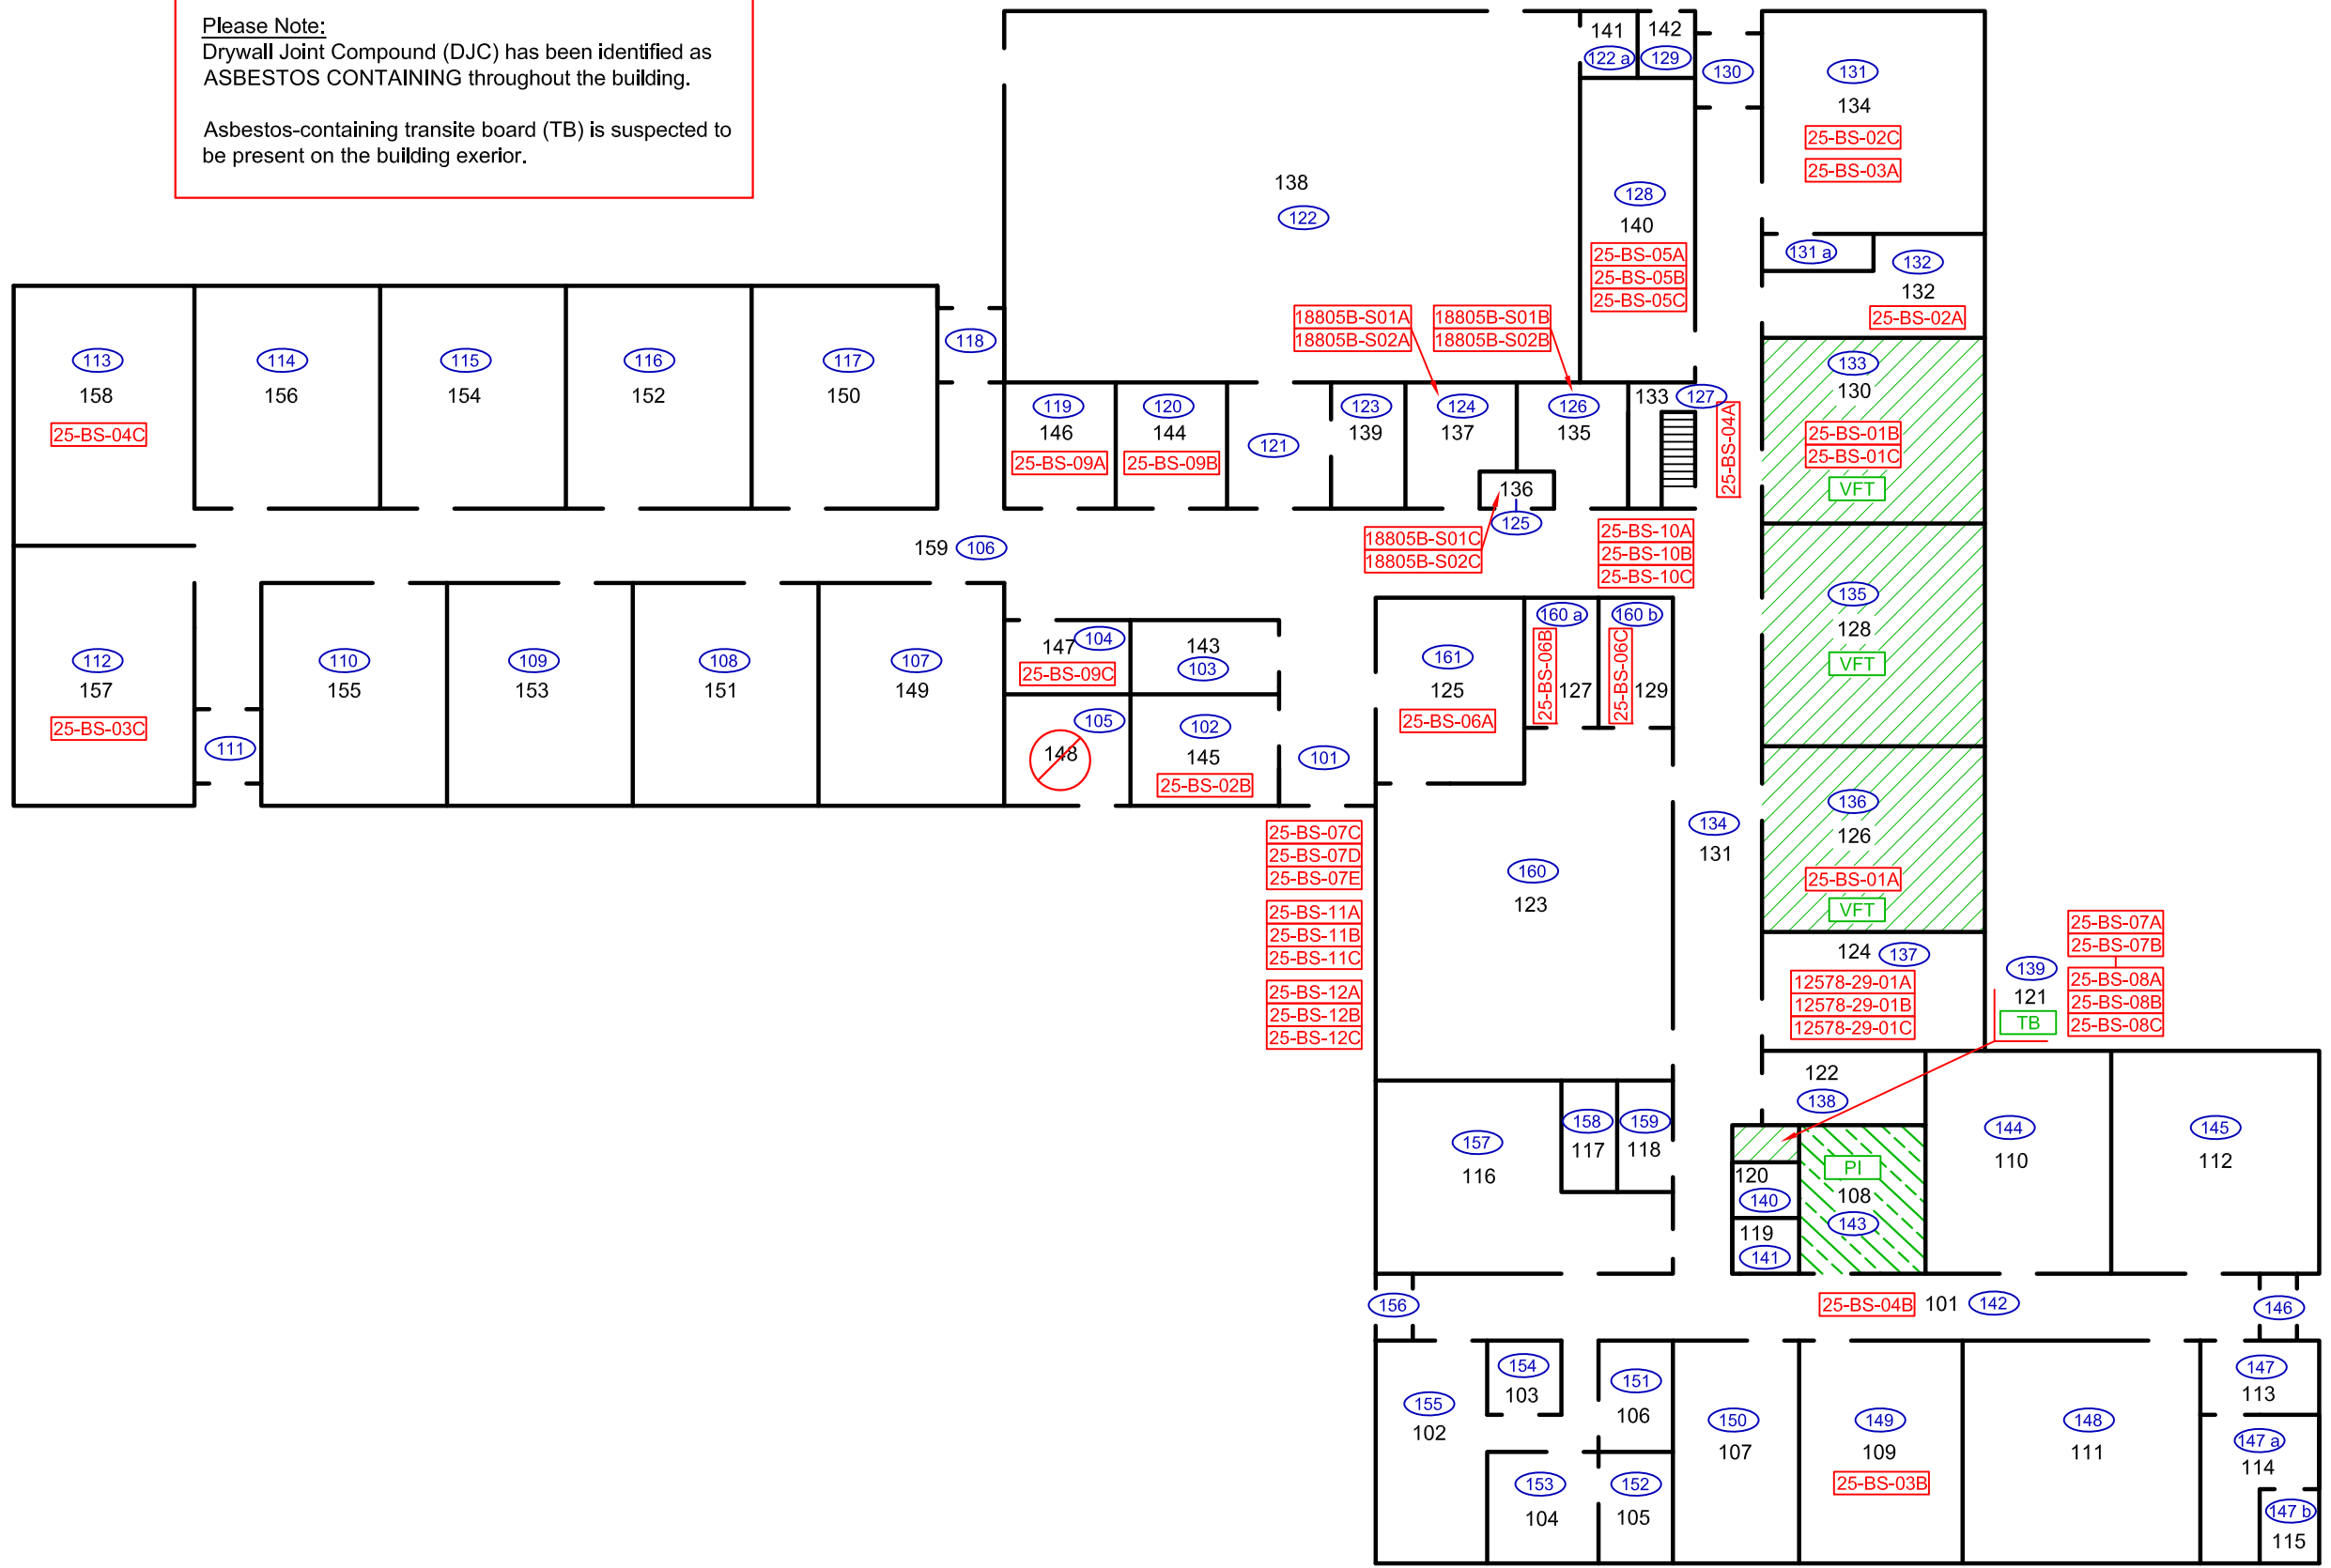
First Floor Plan

Please Note:
 Drywall Joint Compound (DJC) has been identified as ASBESTOS CONTAINING throughout the building.

Asbestos-containing transite board (TB) is suspected to be present on the building exterior.
