ASBESTOS-CONTAINING BUILDING MATERIALS RE-ASSESSMENT REPORT

Mariposa Elementary School

755 Eldon Road
Oakwood, Ontario

Maple Project No. 18736-38

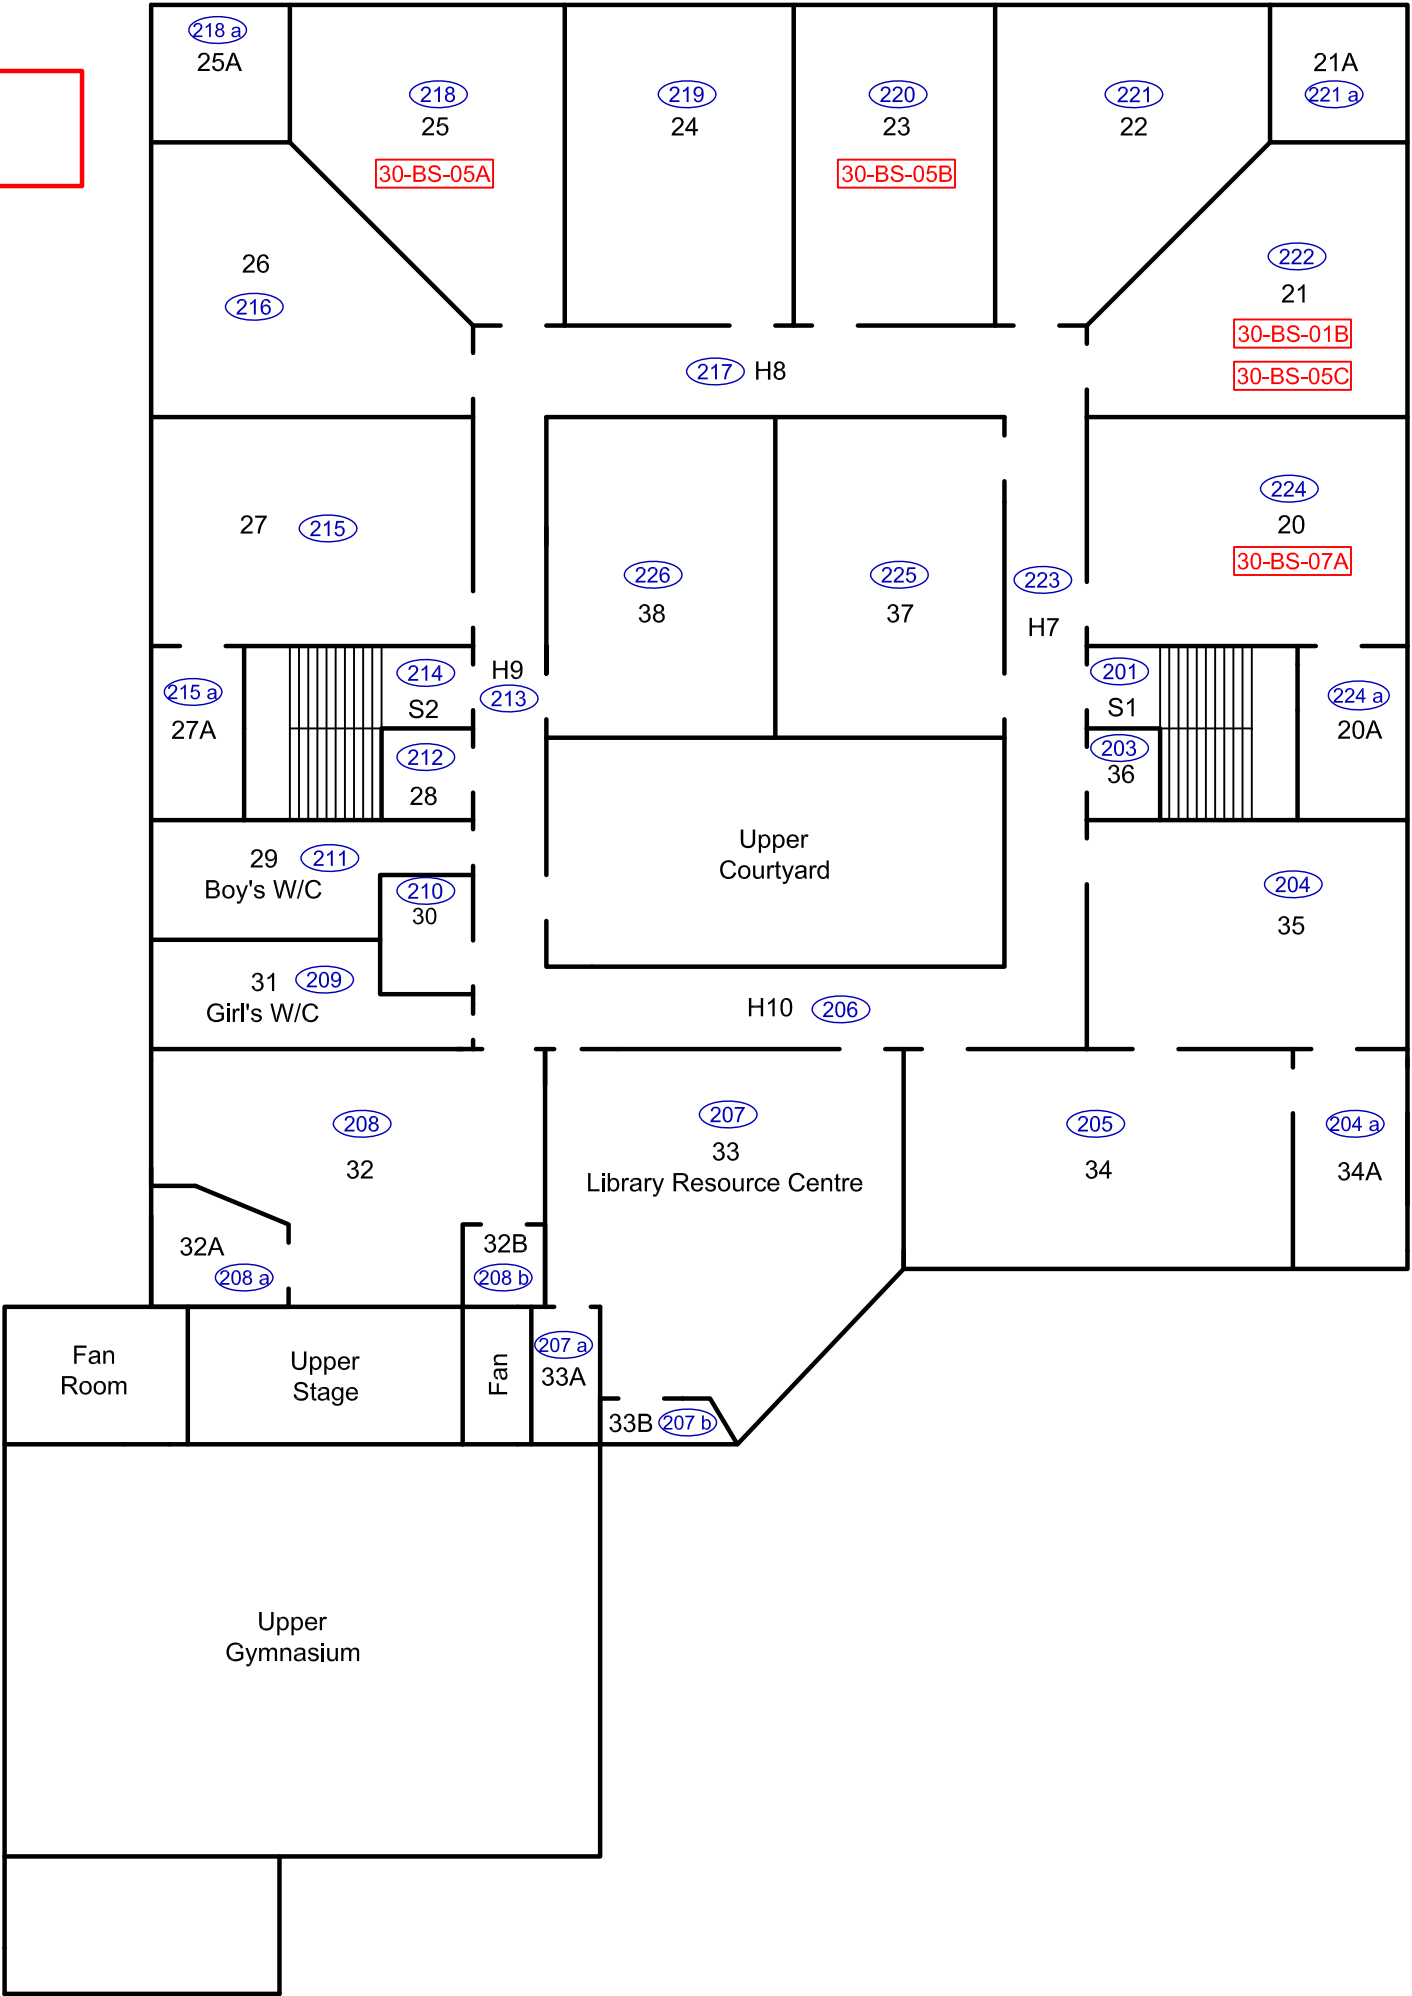
12578-38-01A

Please Note:
Asbestos-containing transite board (TB) is
suspected to be present on the building exterior
