ASBESTOS-CONTAINING BUILDING MATERIALS RE-ASSESSMENT REPORT

Leslie Frost Public School

51 Angeline Street South
Lindsay, Ontario

Maple Project No. 18736-37

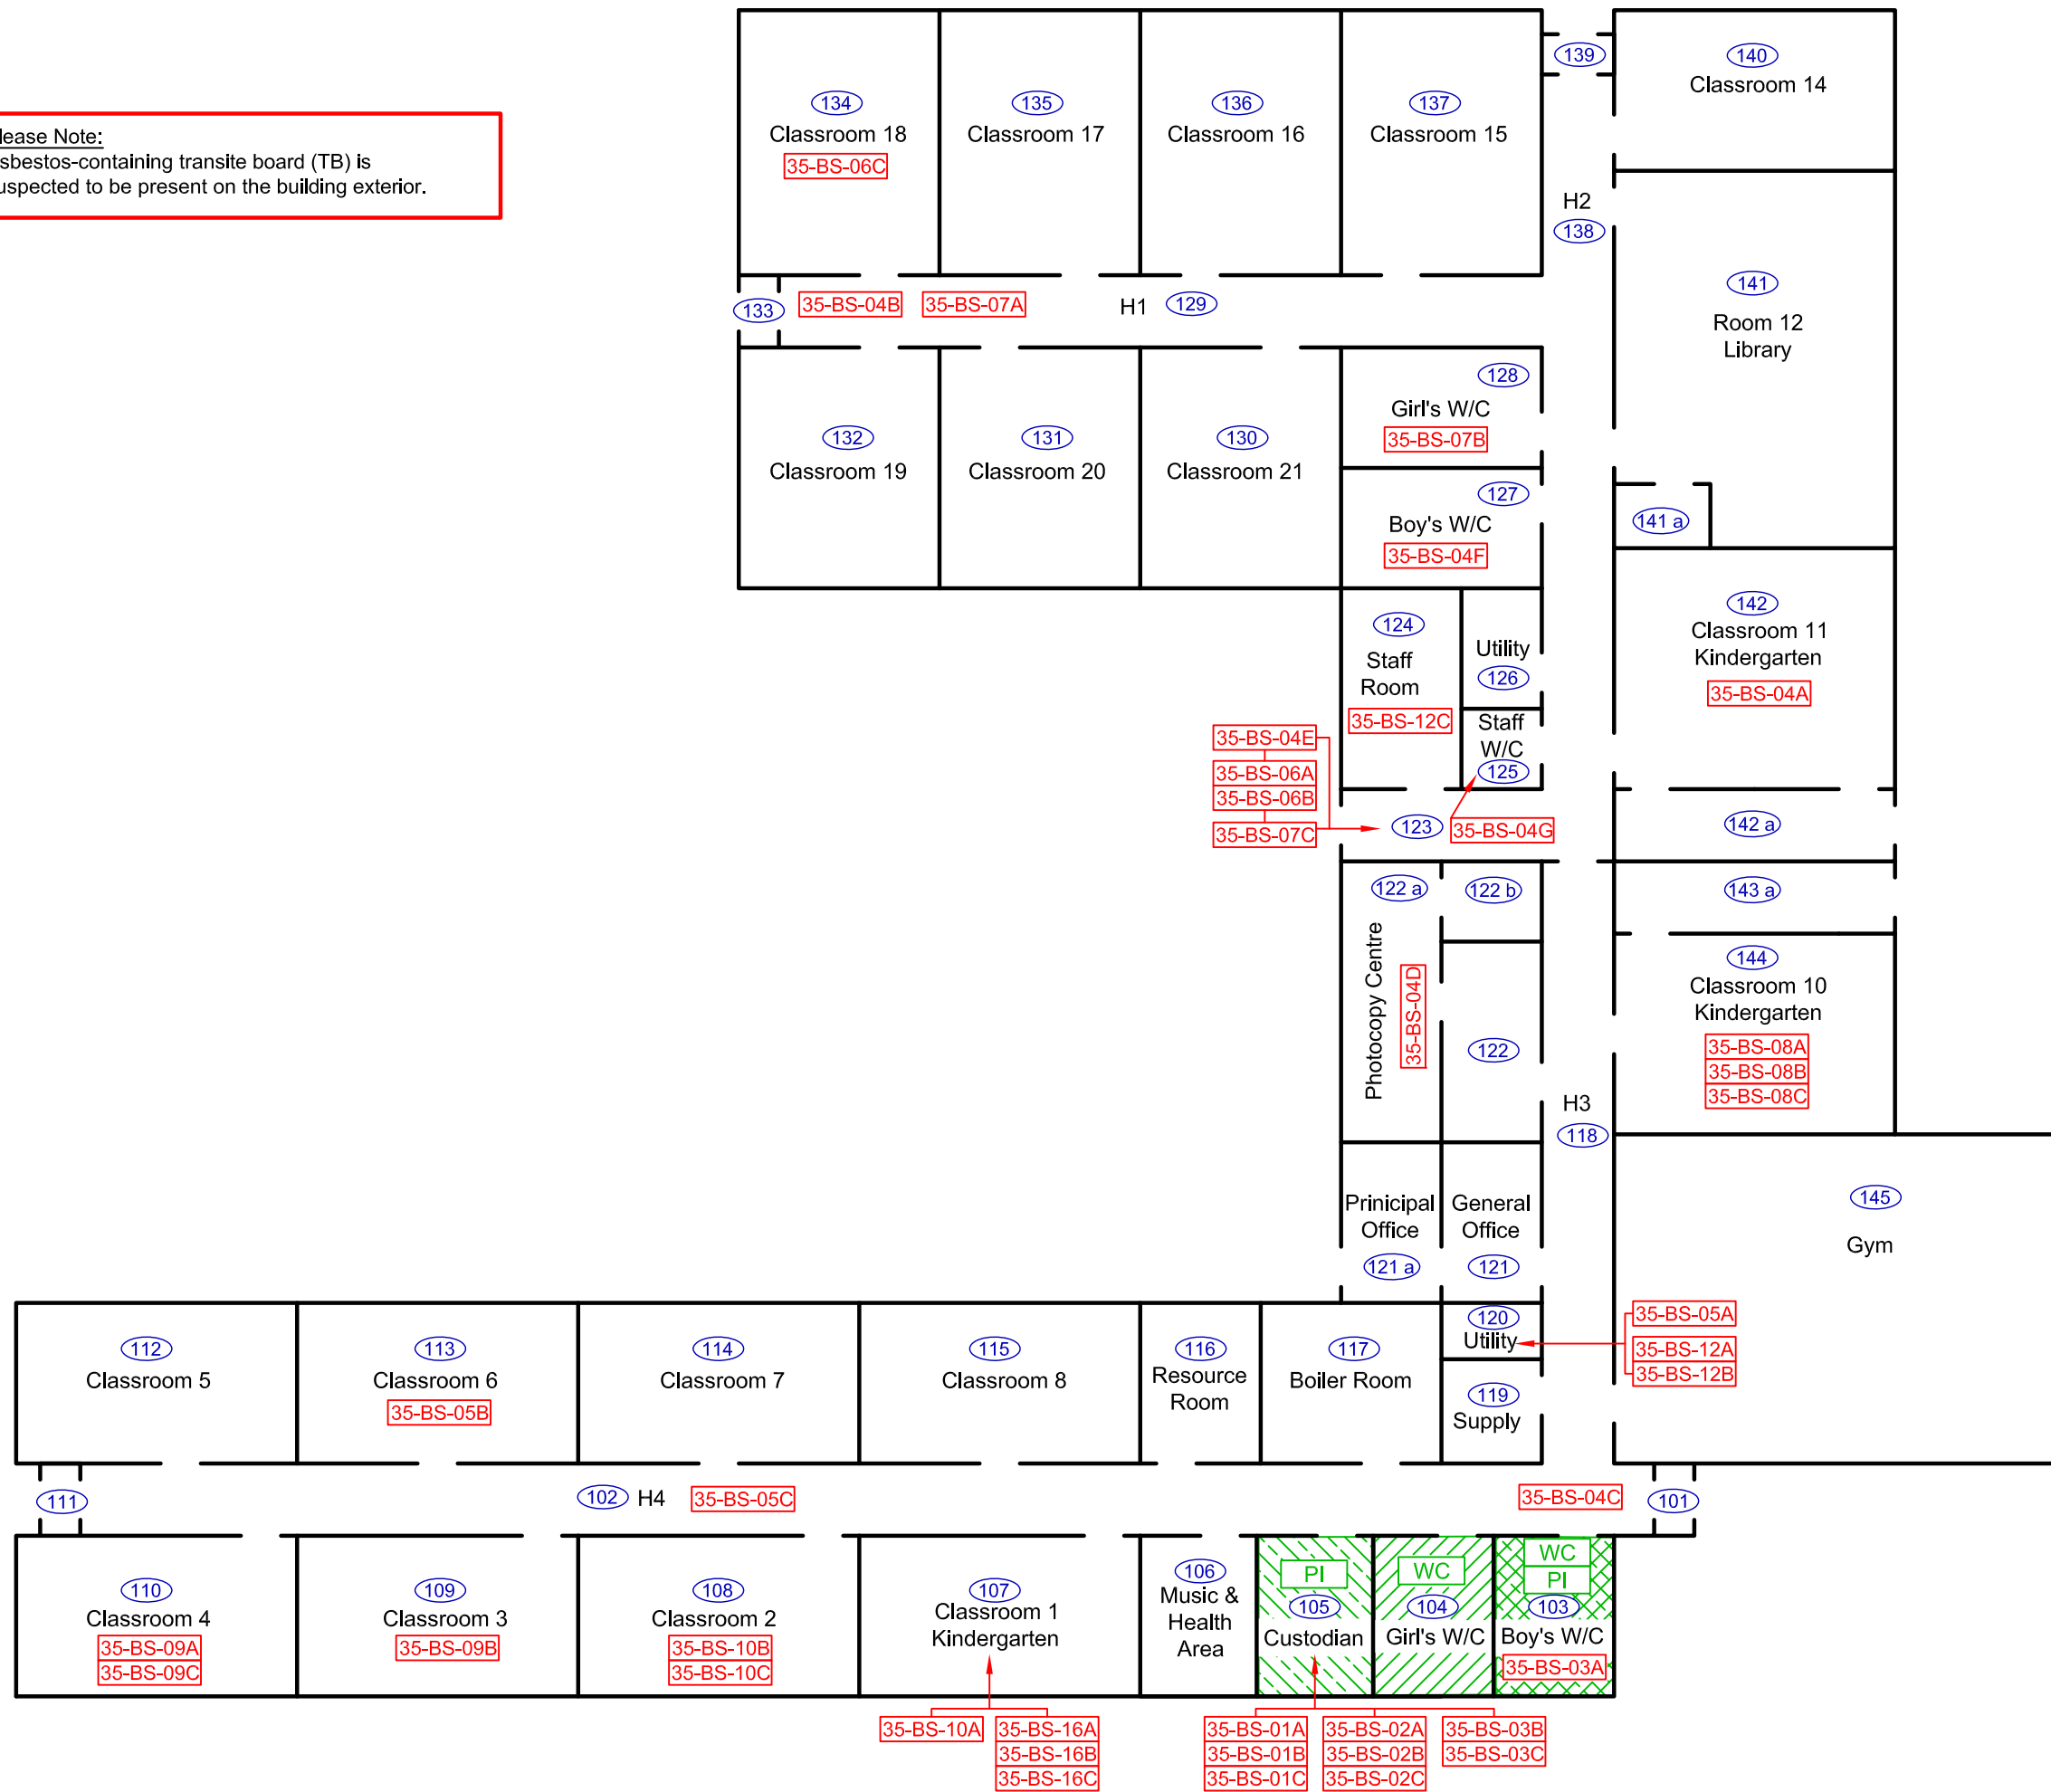
Please Note:
Asbestos-containing transite board (TB) is suspected to be present on the building exterior.
