## **ASBESTOS-CONTAINING BUILDING MATERIALS RE-ASSESSMENT REPORT**

### **Fenelon Township Public School**

September 2020

**Maple Project No. 18736-32**

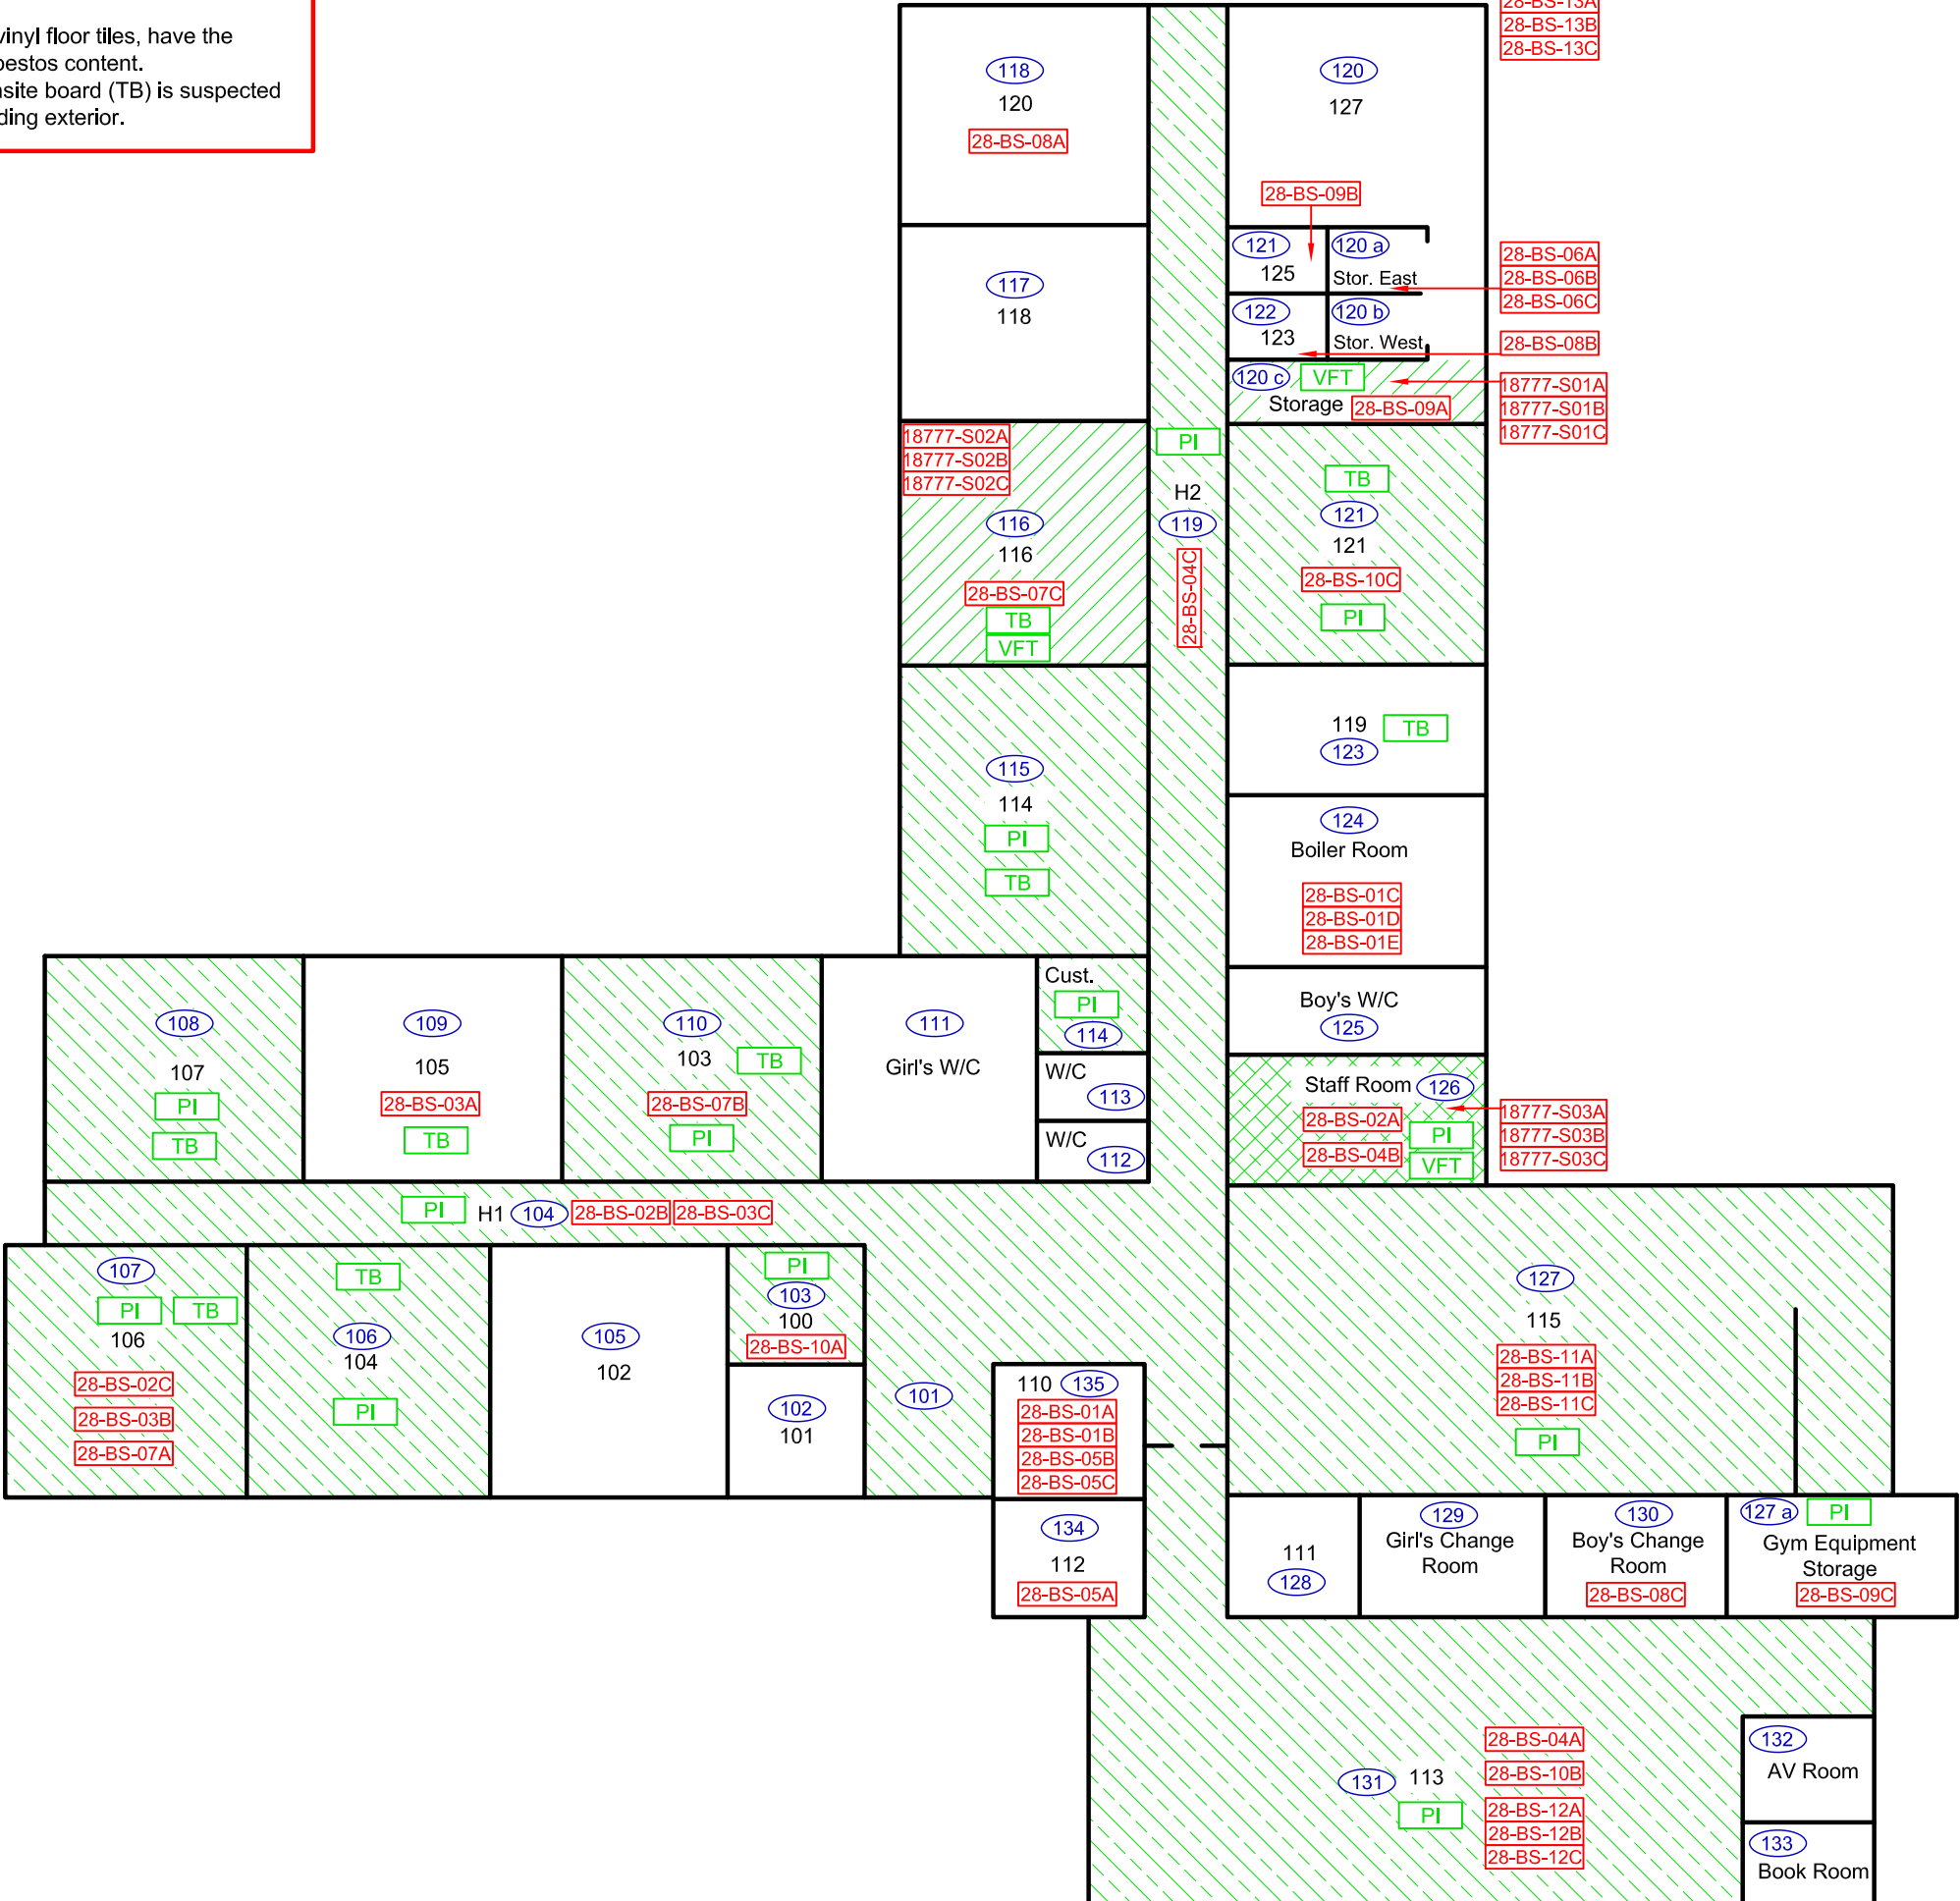
**Please Note:**  
Prior to disturbing 9"x9" vinyl floor tiles, have the material analyzed for asbestos content.  
Asbestos-containing transite board (TB) is suspected to be present on the building exterior.
