DESIGNATED SUBSTANCES AND HAZARDOUS BUILDING MATERIALS ASSESSMENT REPORT

**Door Upgrade Project (Buildings A, B, D, E, F, G)
Seneca College's Newnham Campus
1750 Finch Avenue East
North York, Ontario
M2J 2X5**

Safetech Project Number: 3210562

**Date of Site Work: July 22, 2021
Date of Issue: August 10, 2021**

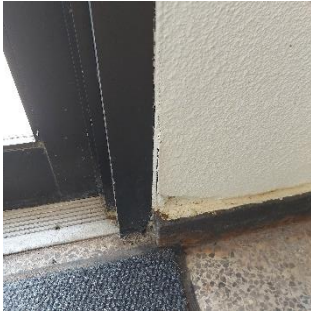
Architectural Finishes & Finishing Materials	Location/Description	
Sprayed Texture / Stucco Finishes	Texture coat finishes on wall were observed in the subject building. Bulk samples were collected during the assessment and results of analysis confirmed that this building material is not asbestos-containing. Refer to sample set 6 in Table 2.

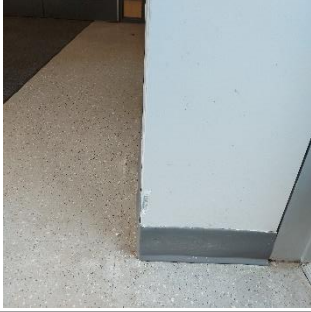
Plaster Finishes	None identified in subject building.	
Drywall Joint Compound	Drywall joint compound (drywall wall finishes) was observed in the subject building. Bulk samples were collected during the assessment and results of analysis confirmed that this building material is not asbestos-containing. Refer to sample set 3 in Table 2.

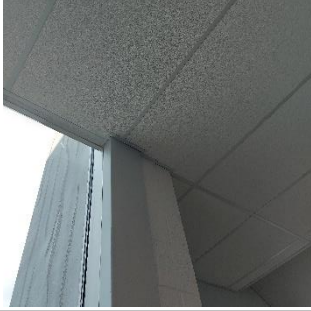
Ceiling Tiles	Location/Description	
Lay-in Acoustic Ceiling Tiles	Lay-in ceiling tiles were observed in the subject building. Bulk samples were not collected as the ceiling tiles were built with non-asbestos fiberglass with paper backing.

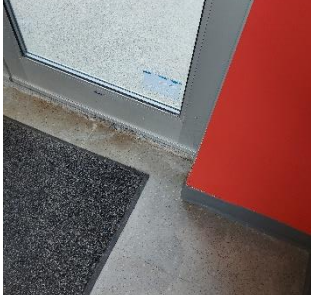
Glued-on Acoustic Ceiling Tiles	None identified in subject building.	
Cement Ceiling Panels	None identified in subject building.	
Flooring	Location/Description	
Vinyl Floor Tiles	Vinyl floor tiles (1.5'x1.5' Grey Vinyl Floor Tiles with White and Black Flecks) were observed in the subject building. Bulk samples were collected during the assessment and results of analysis confirmed that this building material is not asbestos-containing. Refer to sample set 2 in Table 2.

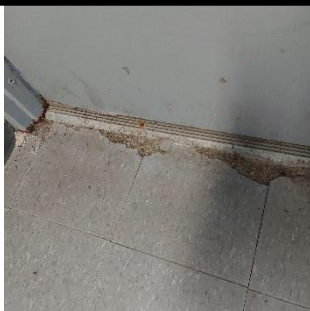
Vinyl Floor Tiles (continued)	Vinyl floor tiles (1'x1' Vinyl Floor Tiles Grey with White and dark grey flecks) were observed in the subject building. Bulk samples were collected during the assessment and results of analysis confirmed that this building material is not asbestos-containing. Refer to sample set 7 in Table 2.

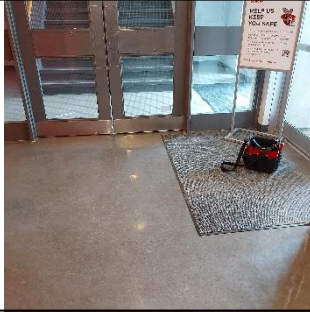
Vinyl Sheet Flooring	Vinyl sheet flooring (Dark Grey) was observed in the subject building. Bulk samples were collected during the assessment and results of analysis confirmed that this building material is not asbestos-containing. Refer to sample set 4 in Table 2.

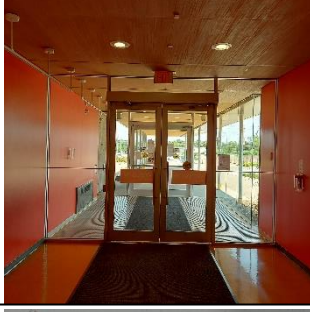
Vinyl sheet flooring (Yellow) was observed in the subject building. Bulk samples were collected during the assessment and results of analysis confirmed that this building material is not asbestos-containing. Refer to sample set 5 in Table 2.

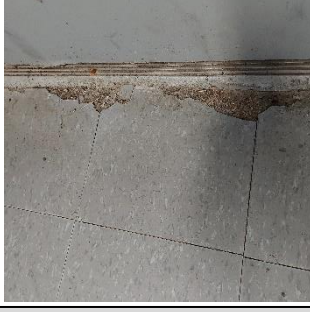
Mastic	Mastic associated with vinyl floor tiles and sheet was observed in the subject building. Bulk samples were collected during the assessment and results of analysis confirmed that this building material is not asbestos-containing. Refer to sample set 2, 4 & 7 in Table 2.

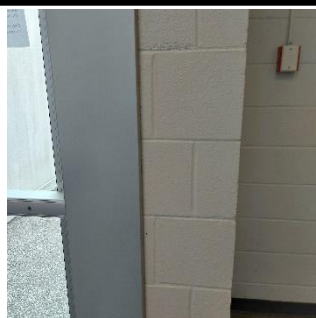
Other Cement Products	Interior Concrete Block Mortar was observed in the subject building. Bulk samples were collected during the assessment and results of analysis confirmed that this building material is not asbestos-containing. Refer to sample set 8 in Table 2.

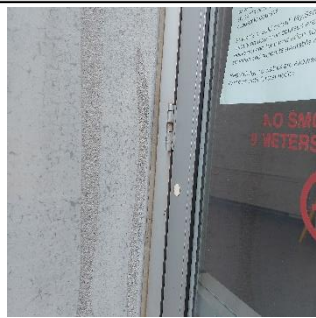
Exterior Building Materials	Location/Description	
Caulking	Exterior Door Frame Caulking was observed in the subject building. Bulk samples were collected during the assessment and results of analysis confirmed that this building material is not asbestos-containing. Refer to sample set 1 in Table 2.
