STRUCTURAL ENGINEERING REPORT

FOUNDATION AND FRAME PHOTO PRESENTATION

Roar File #18R05058

48 WELLINGTON STREET
PORT HOPE, ONTARIO

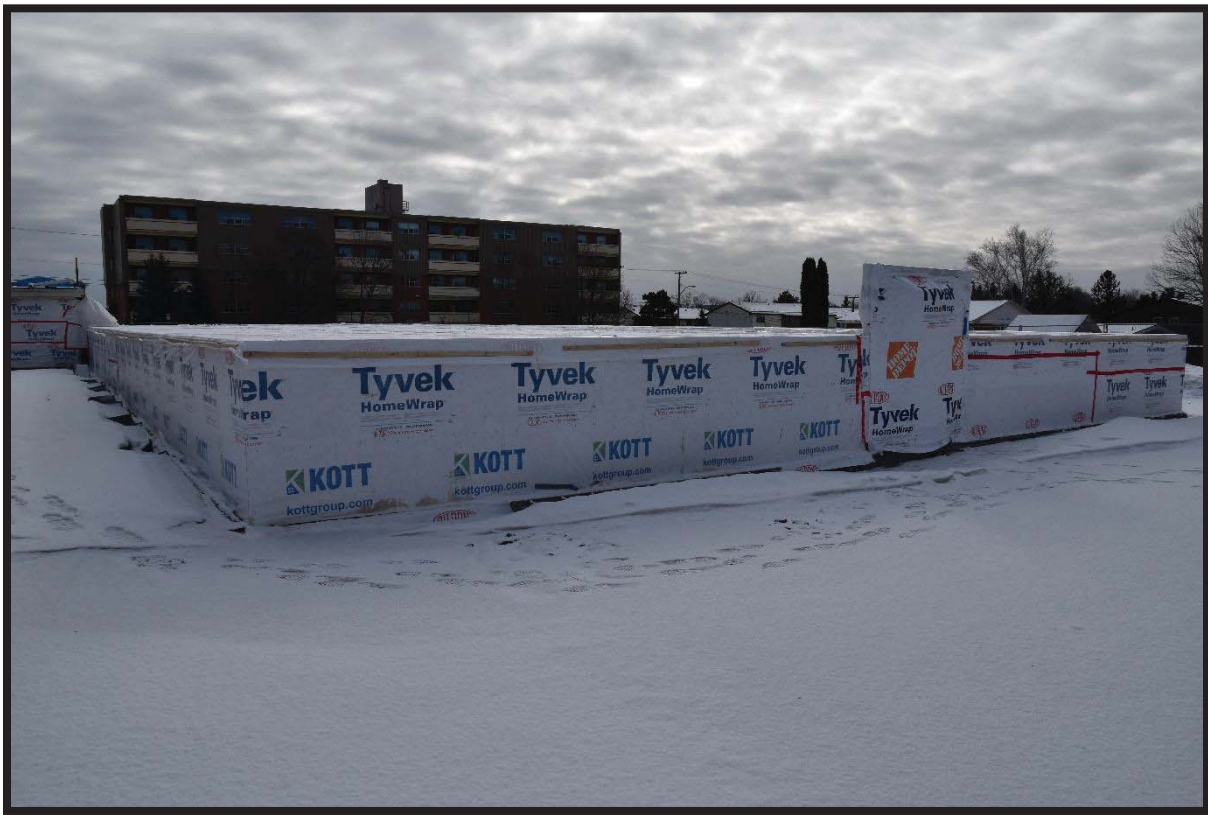
1. Remaining portion of building following demolition.

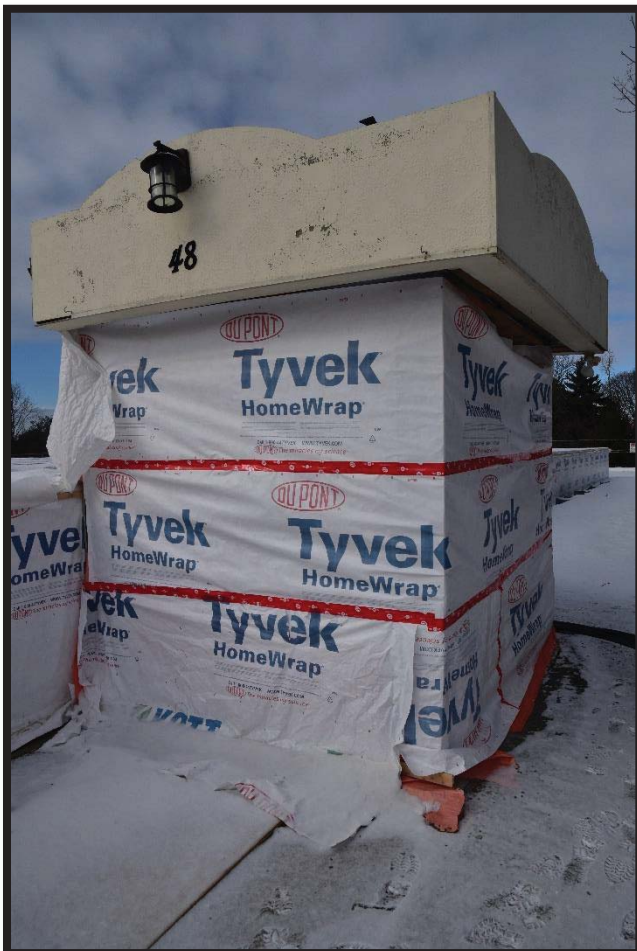
2. Building access.

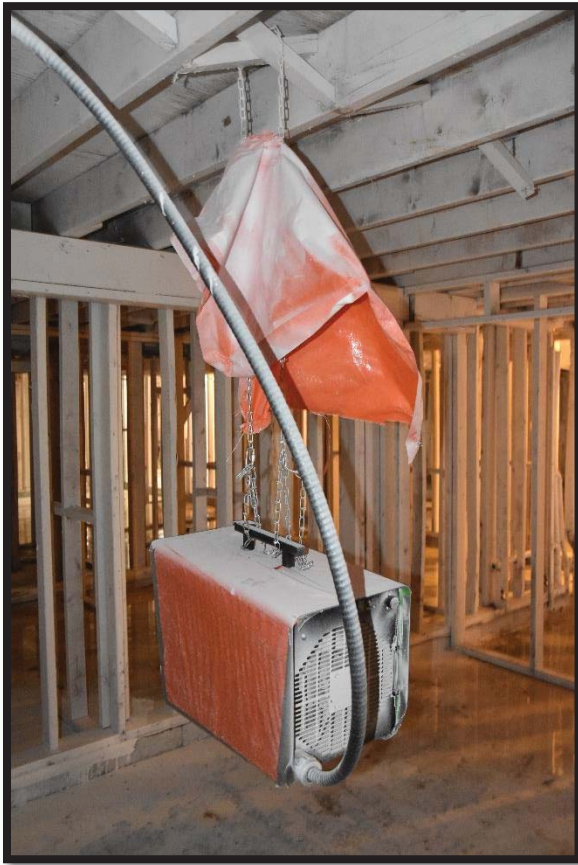
3. Temporary heat in building.

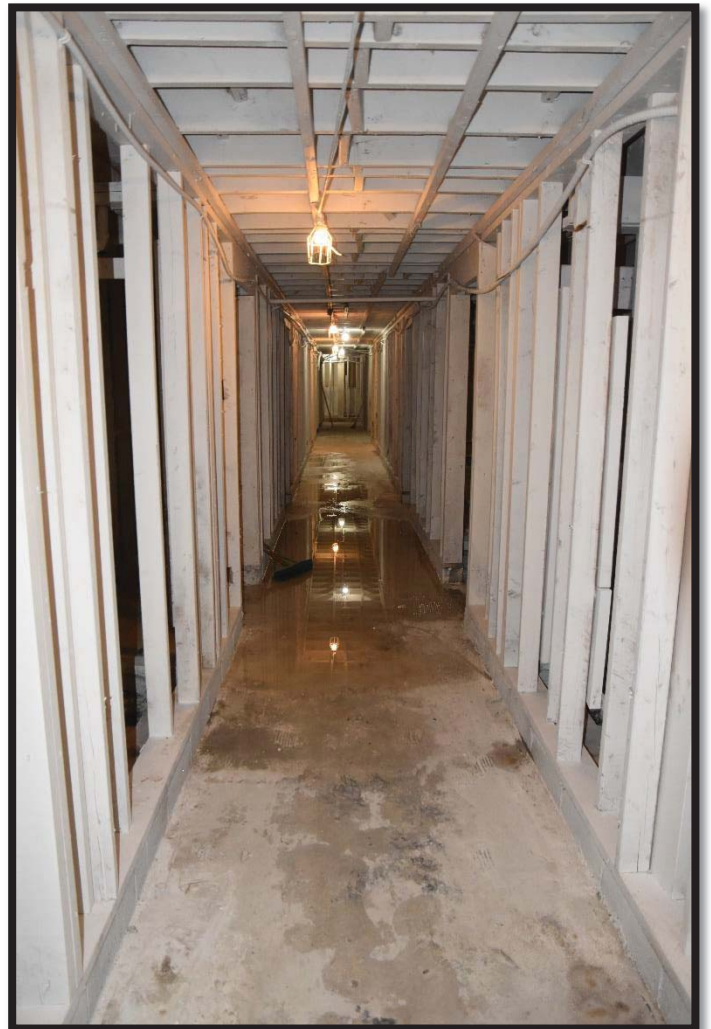
4. Remediated framing.

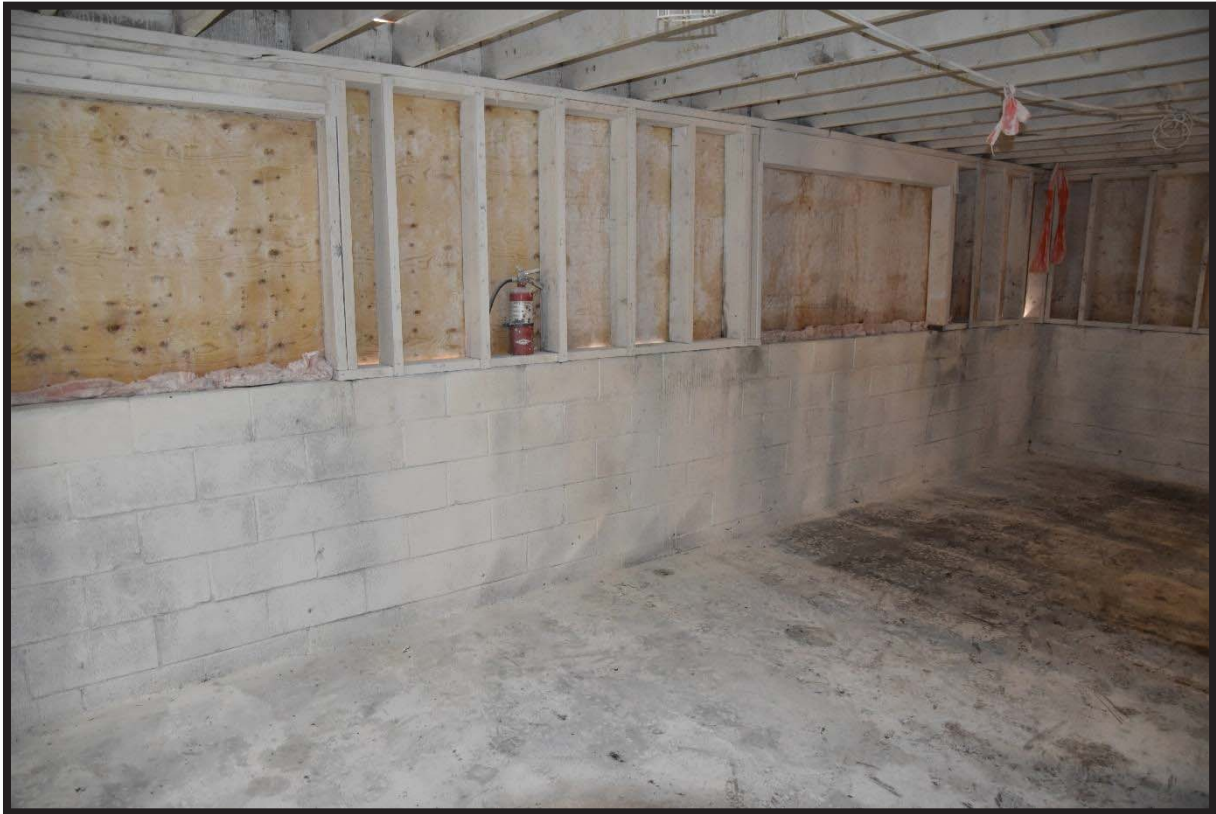
Completed remediation of water damage and smoke contamination to the structural framing elements, as well as removal of hazardous materials, was evident.

5. Structural elements remediated for smoke contamination and water damage.

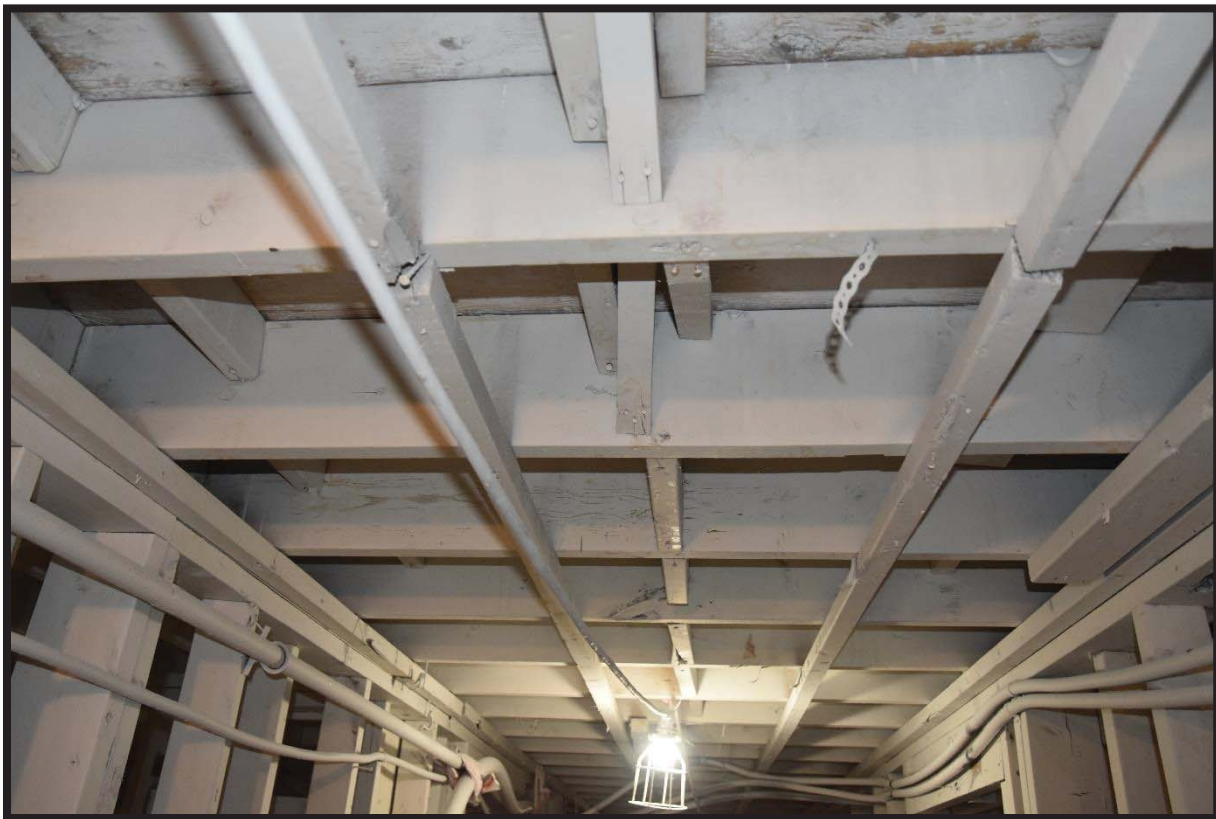
6. Remediated wood framing.

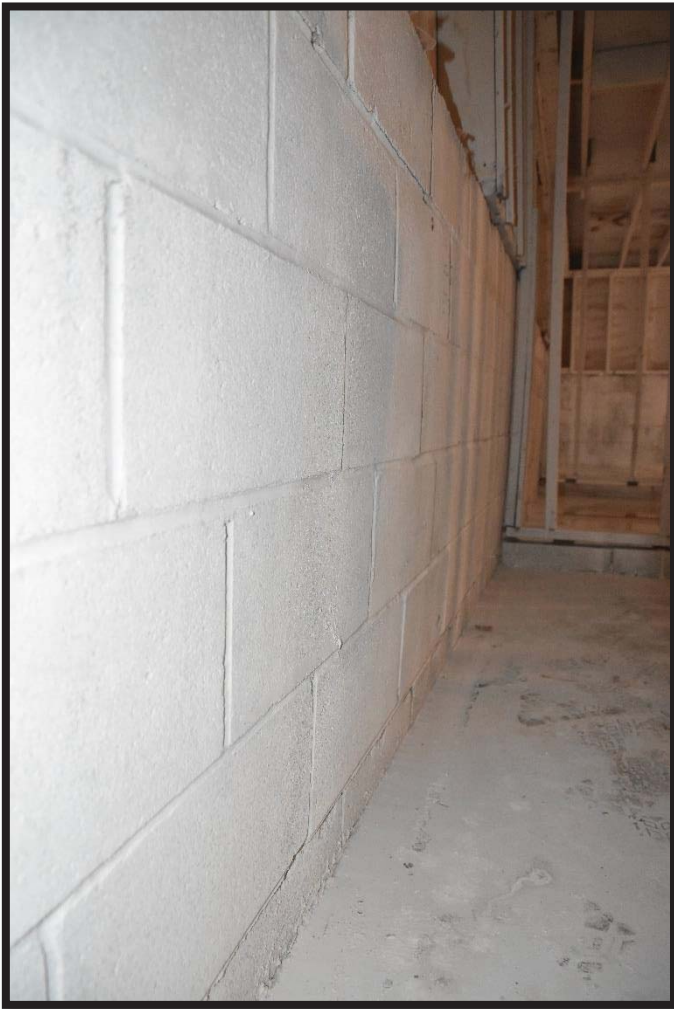
- Inward deflection of top of wall at various locations
- Horizontal and stepped cracks at several locations

The above-noted damage was considered to be related to frost exposure since the loss occurrence. The above-noted items would require localized repair to accommodate building reconstruction. Impact tests indicated the concrete blocks were generally in sound condition. Regularly spaced anchor bolts were present in the top of the foundation walls. The concrete slab-on-grade was in satisfactory condition. Minor cracks were noted in the concrete slab-on-grade at isolated locations.

7. Foundation wall out of plumb.

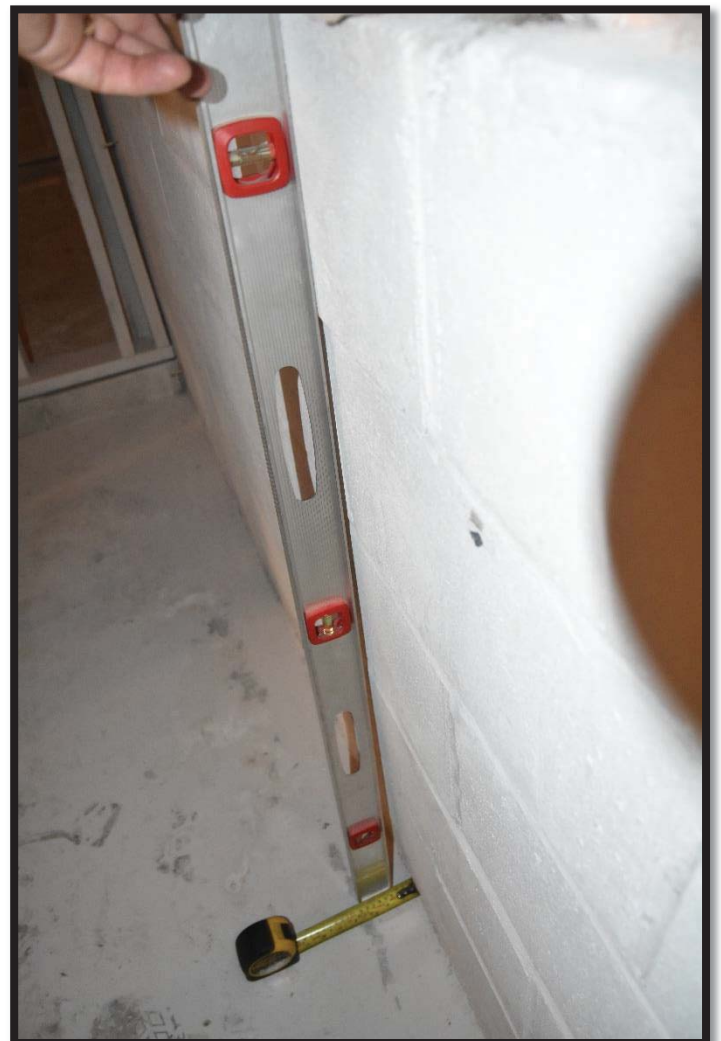
8. Foundation wall out of plumb.

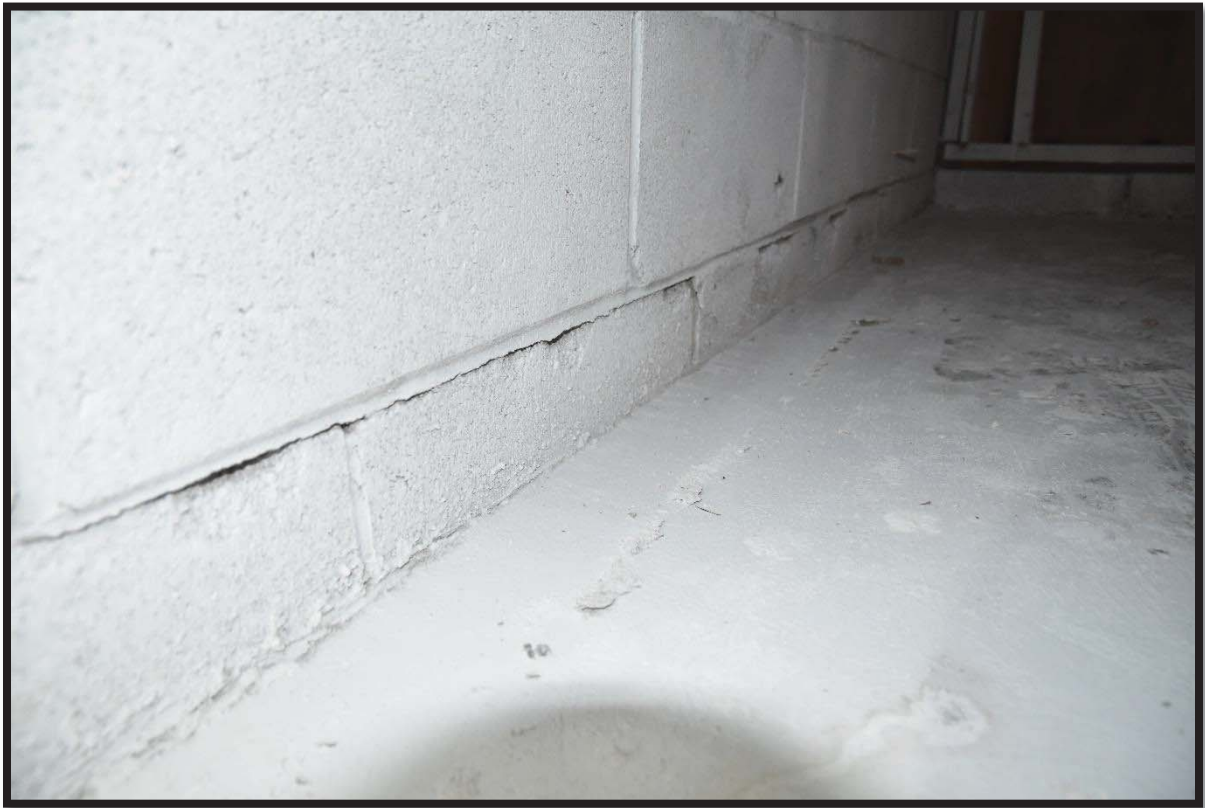
9. Horizontal crack in foundation wall.

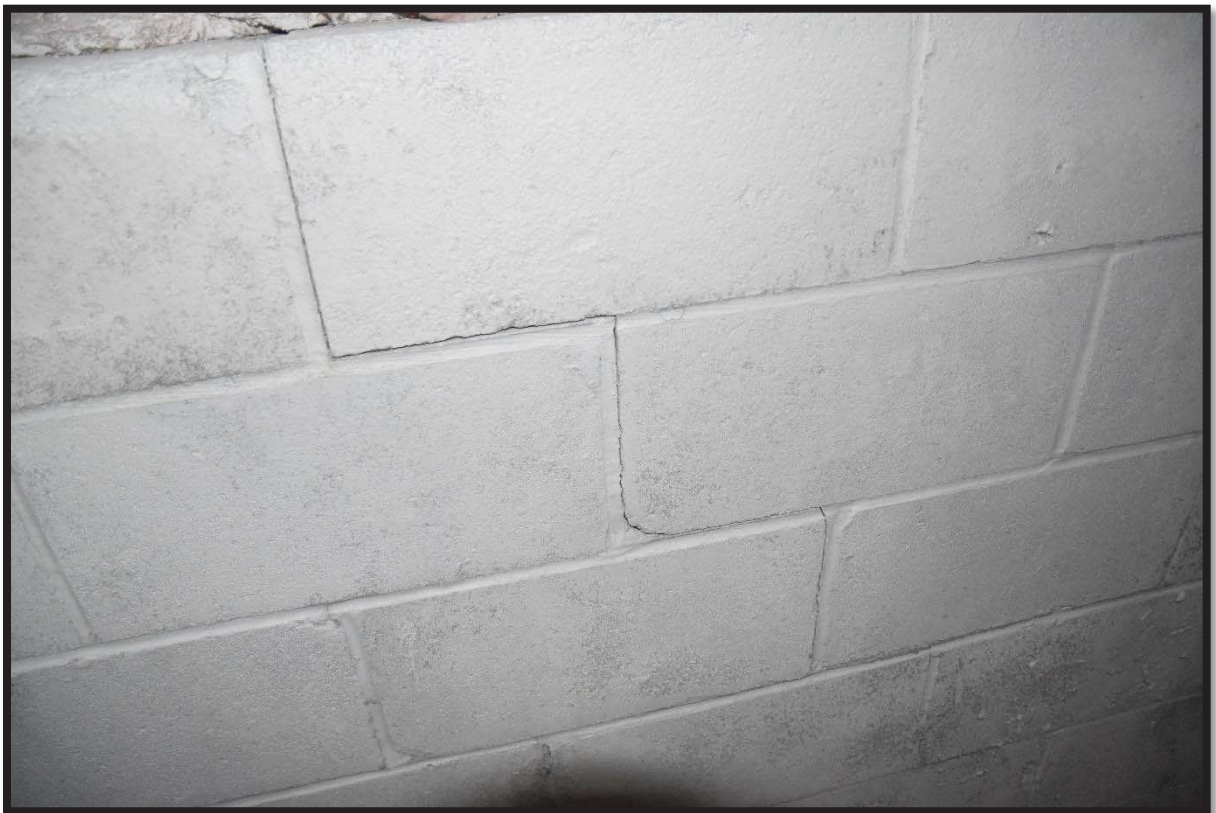
10. Stepped crack in foundation wall.

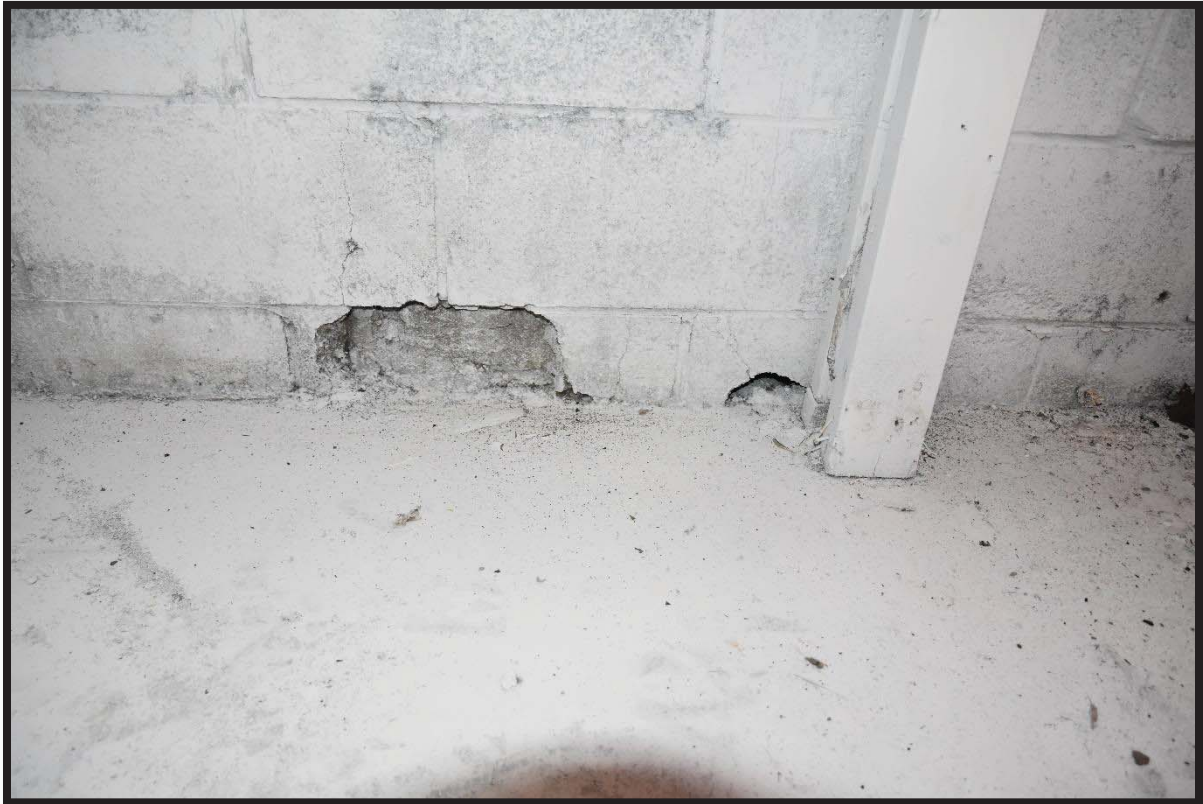
11. Cavity at base of foundation wall.

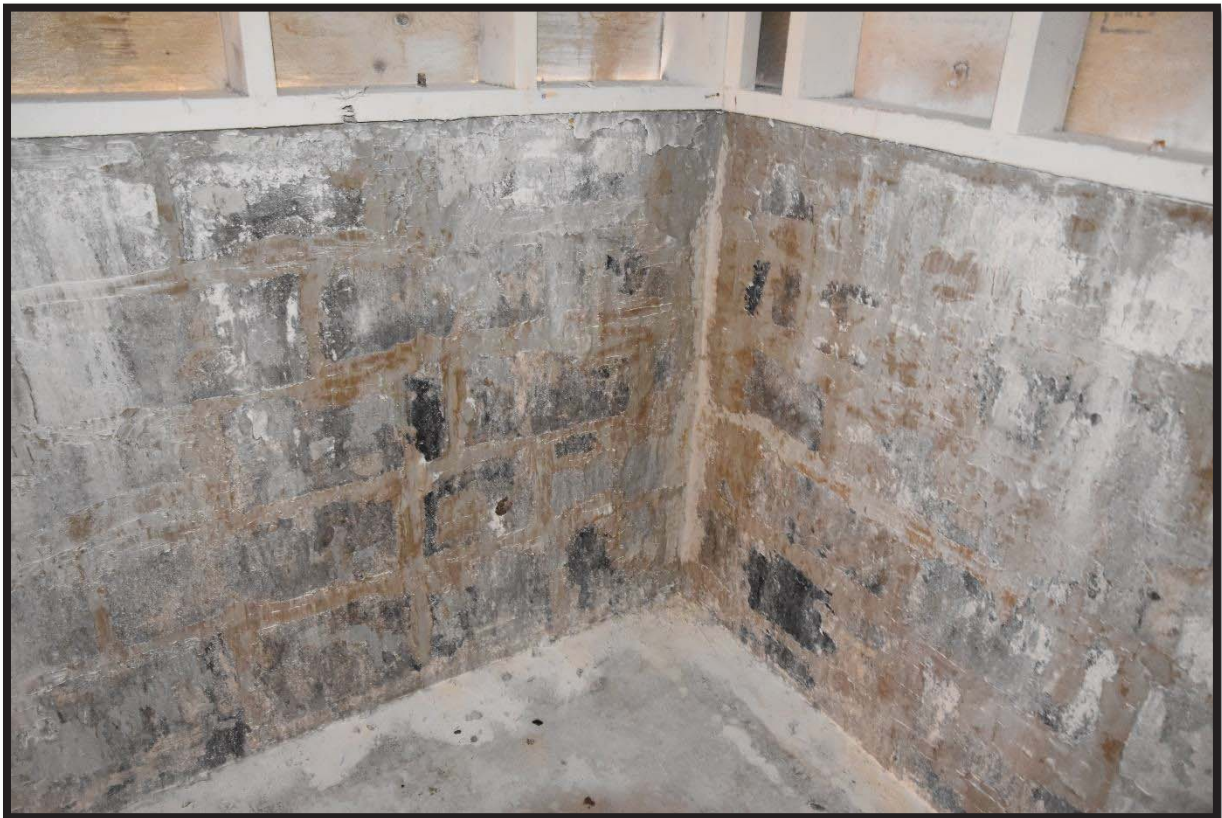
12. Aged moisture damage to foundation wall.

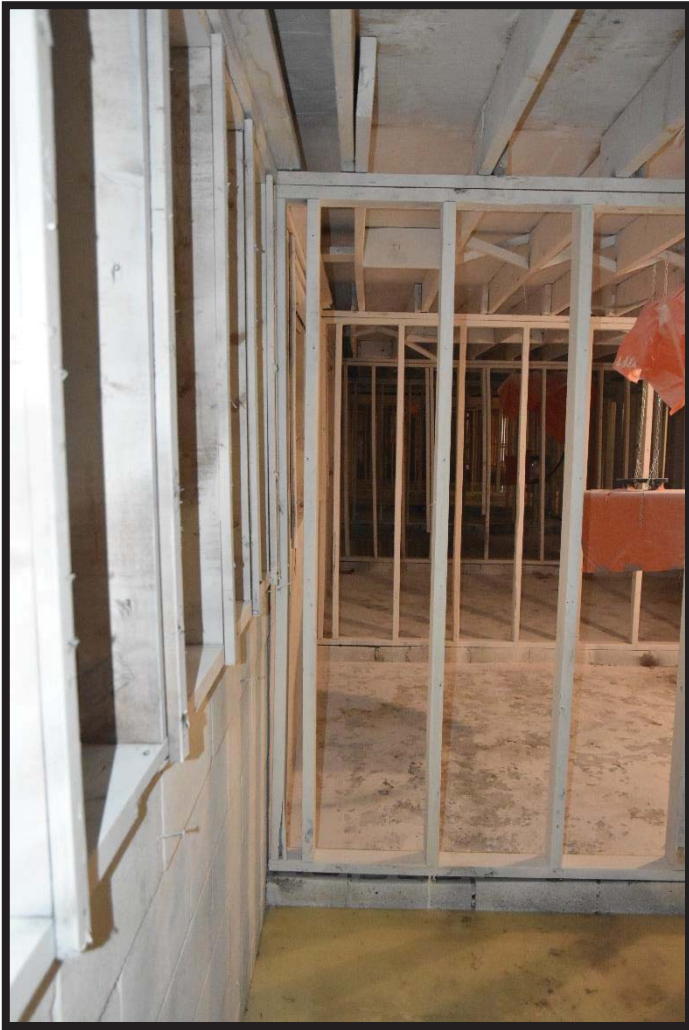
13. Misalignment in exterior wall framing.

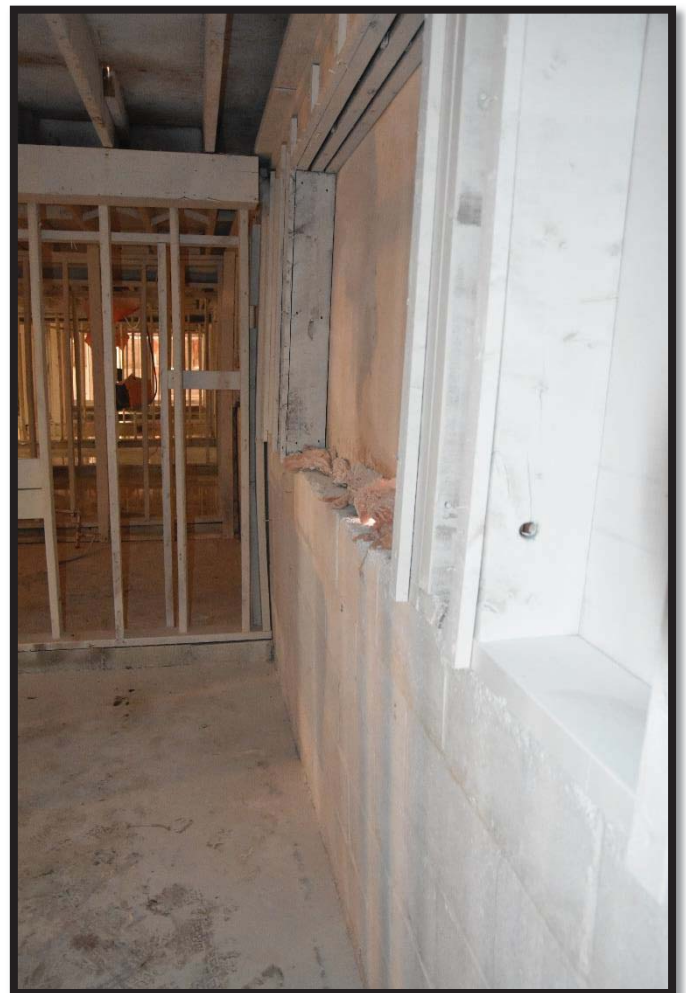
The 1.22 metre high wood-framed exterior walls on top of the concrete block foundation walls were notably out of plumb. The top of the walls were leaning out relative to the bottom of the walls. The anchor bolts projecting from the foundation walls passed through the bottom plates of the wood-framed walls but no bolts were present. A direct connection was not present between the wood-framed wall and the foundation wall. Based on the aged appearance of the anchor bolts and the holes in the wall bottom plates, the above-noted condition was considered to be a deficiency in the original construction of the building. The exterior walls would require re-setting to plumb alignment in order to accommodate building reconstruction.

14. Exterior wall frame out of plumb.

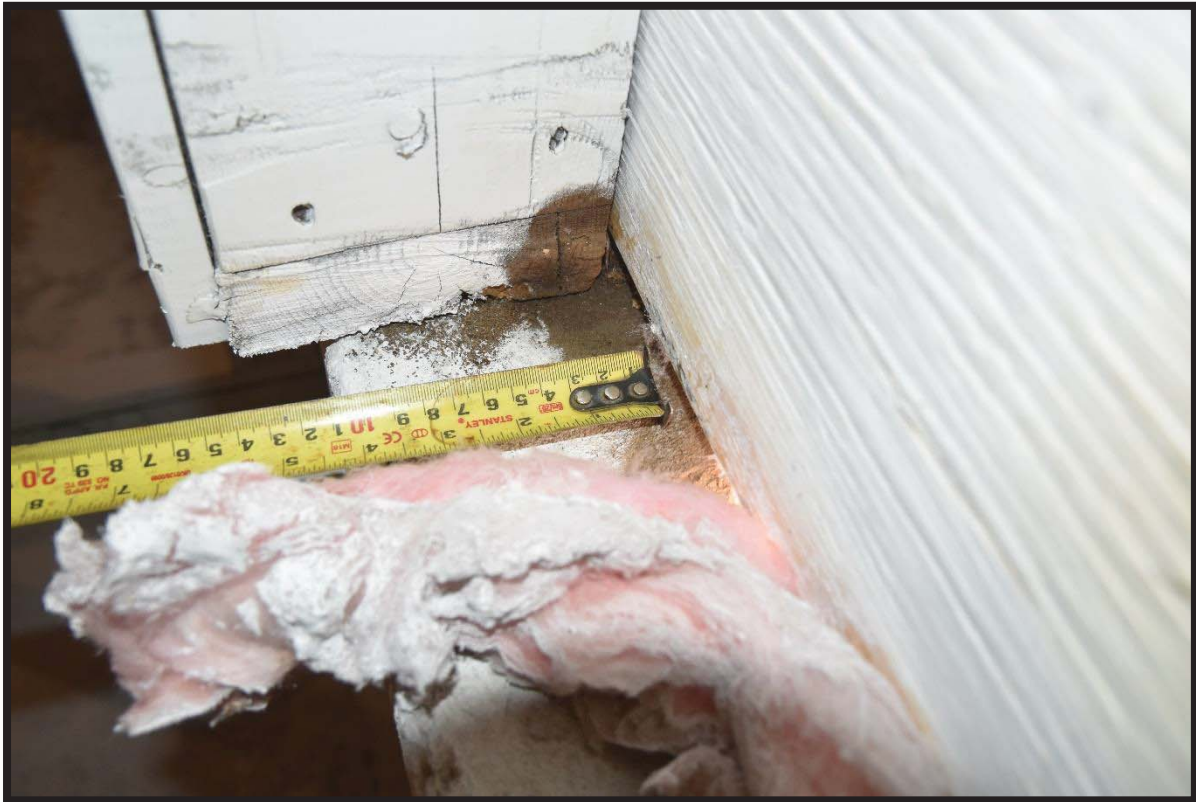
15. Wall frame offset from concrete block foundation wall.

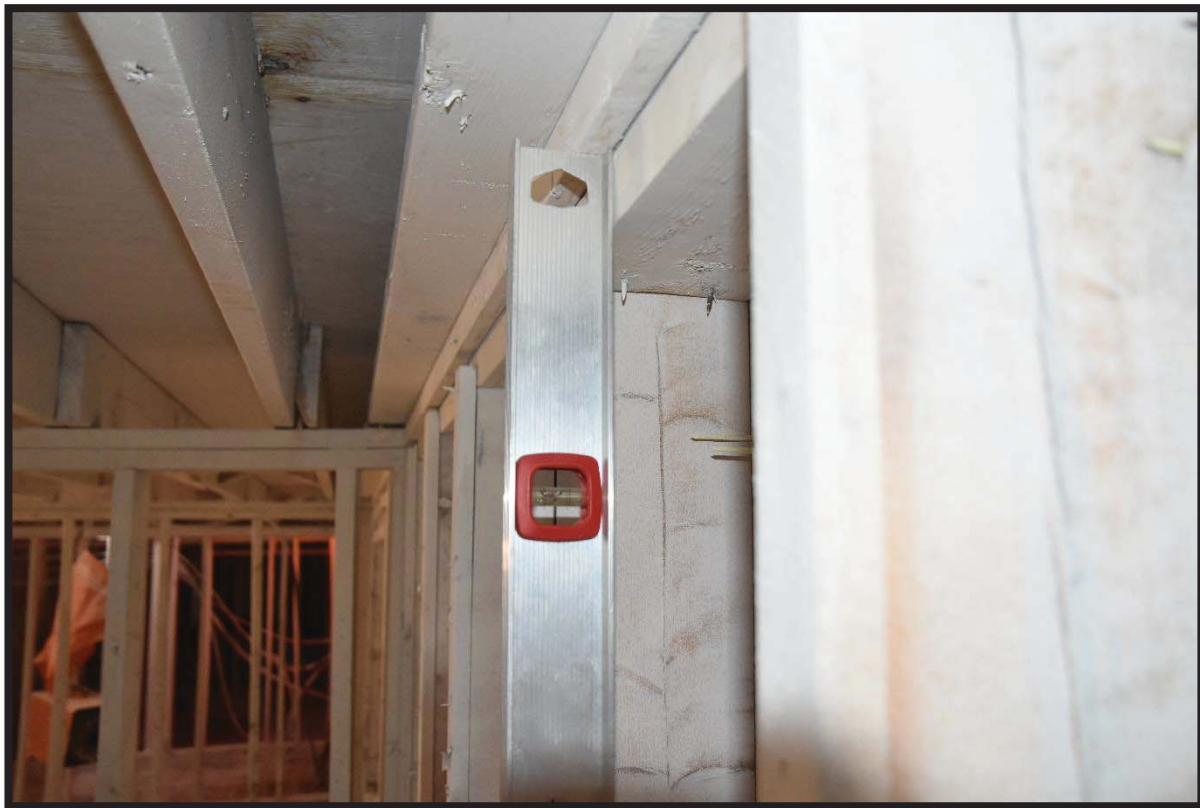
16. Exterior wall framing out of plumb.

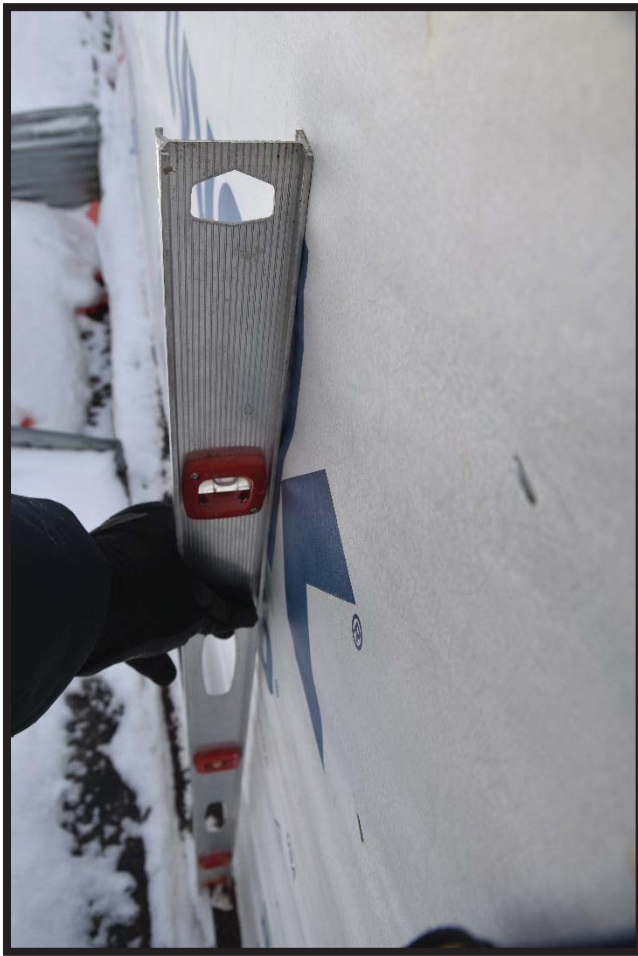
17. Top of exterior wall leaning out relative to bottom of wall.

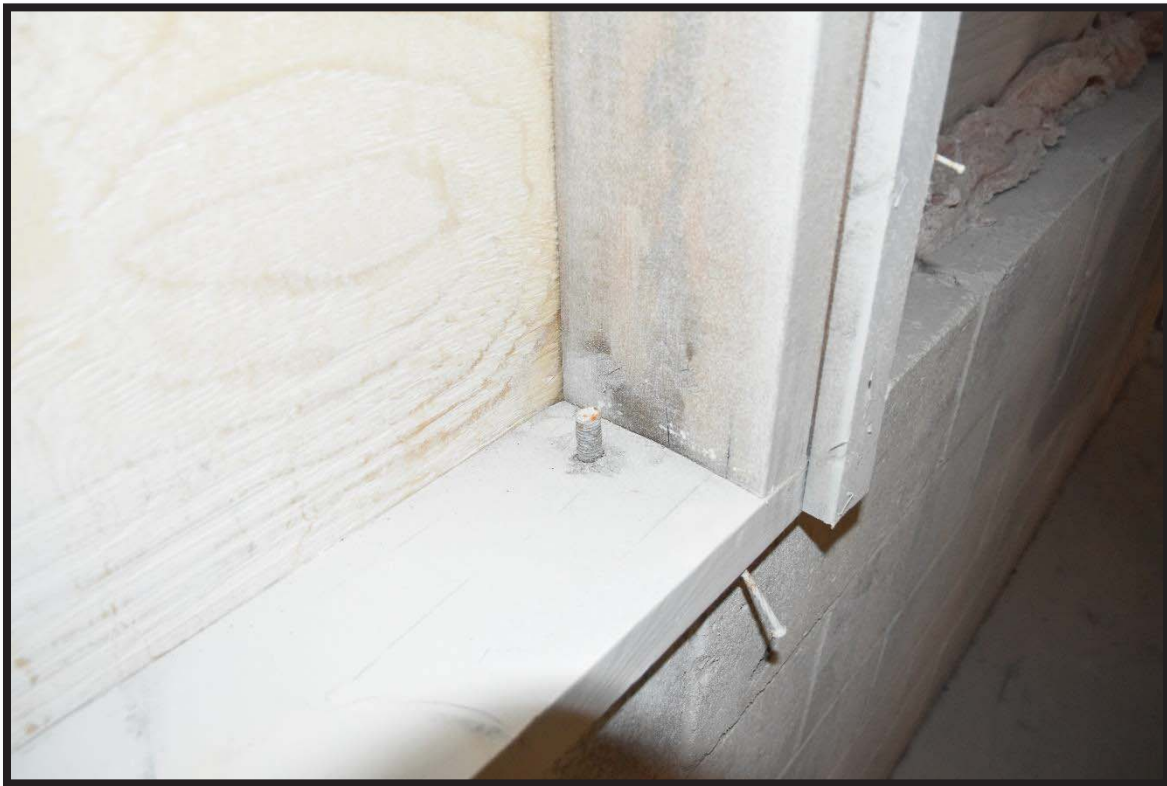
18. Unsecured anchor bolt (typical condition).

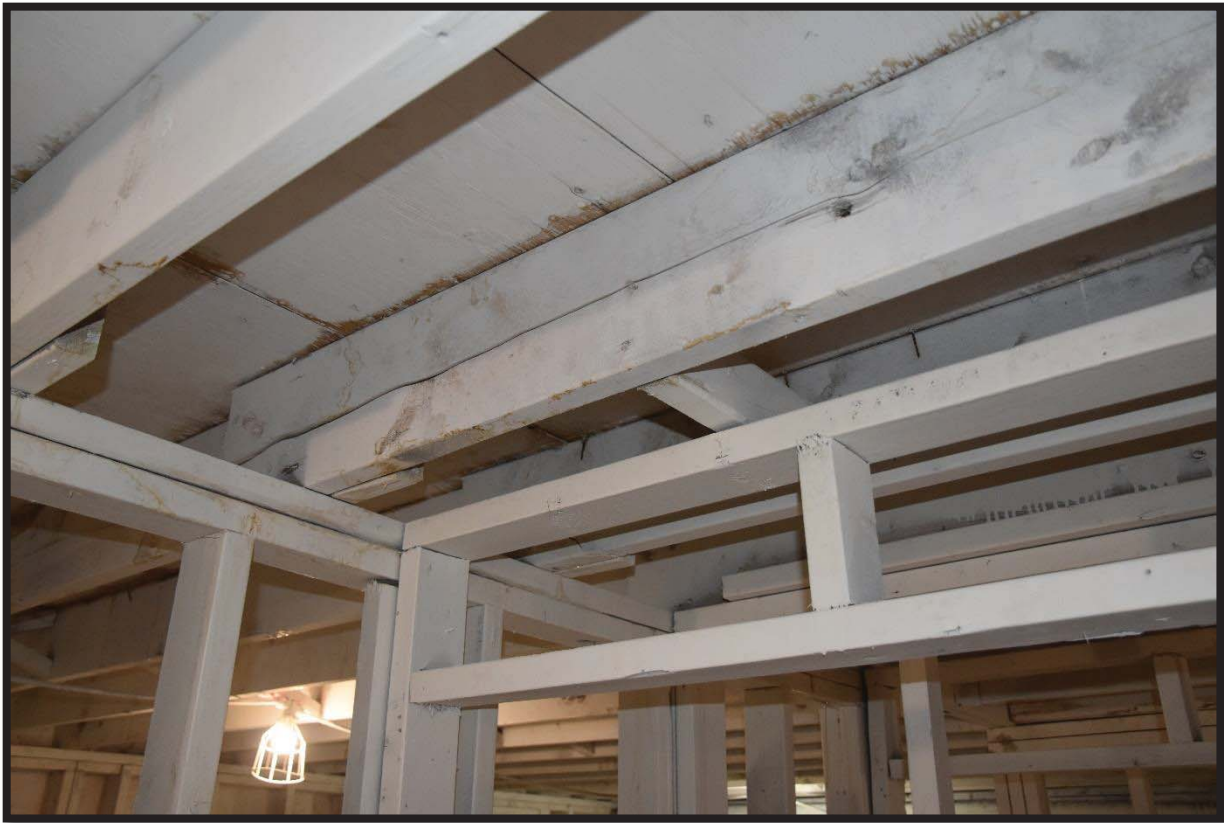
The floor frame was generally in satisfactory condition. The floor frame was slightly crowned along the east-west centreline. Minor damage was noted to floor joists at various locations. The damage included cracks and holes for services. Based on its aged appearance, the aforementioned damage was considered to have pre-existed the loss occurrence. The damage may be addressed in conjunction with building reconstruction.

19. Cracked floor joist.

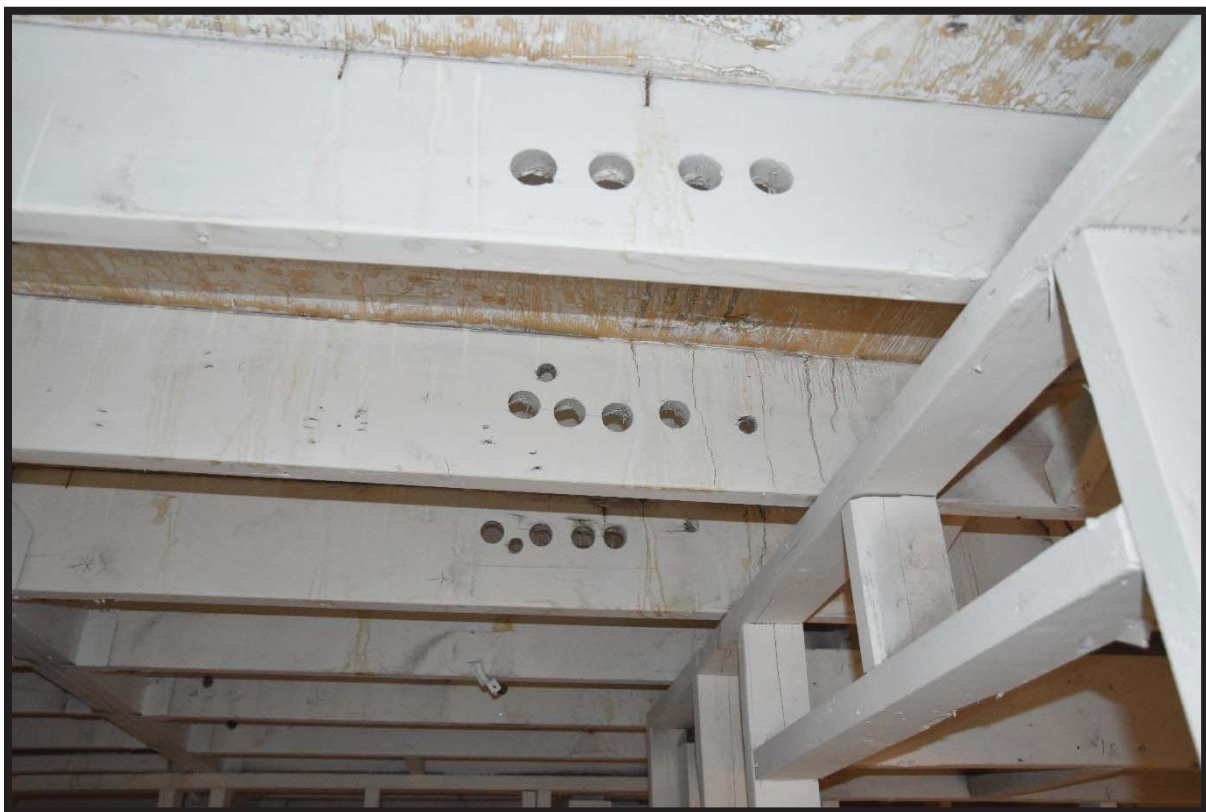
20. Holes in floor joists (for services).

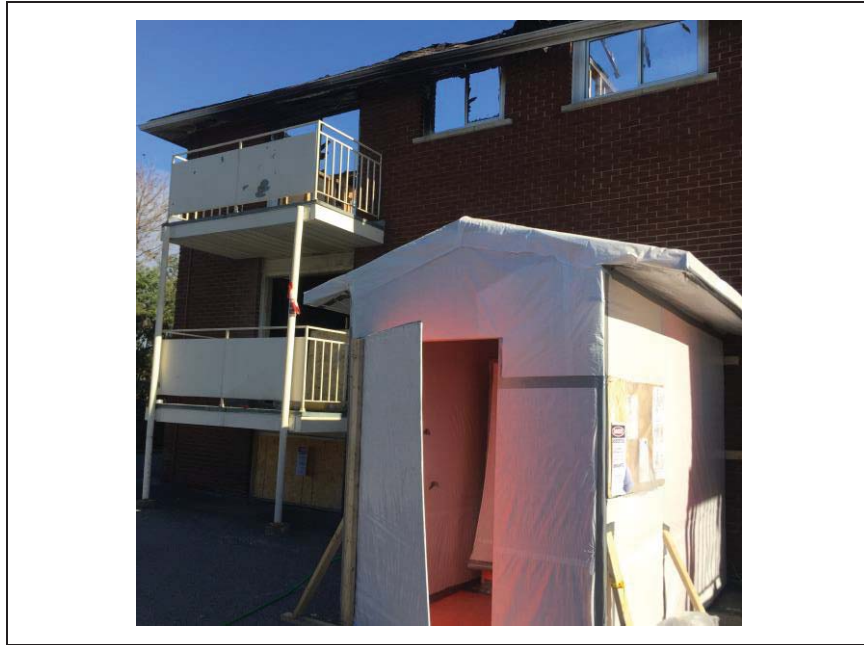
P1 – Enclosure Entrance

View of enclosure entrance to the work area.

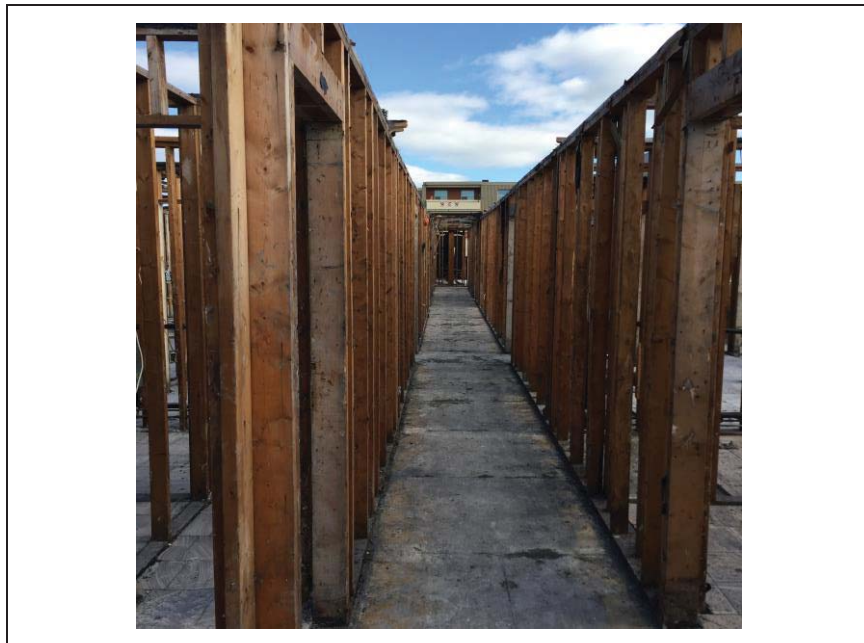
P2 – Second Floor

Our post-abatement visual inspection confirmed that all asbestos-containing textured coat, and joint compound outlined in the scope of work and had been removed. However, minor drywall finish debris and associated asbestos-containing joint compound was identified to remain on the floor of the porch. The abatement contractor was informed of these deficiencies at the time of our site visit.

View of work area during our post abatement inspection visit on November 14, 2018.

Upon correction of these deficiencies the work area was deemed to be acceptably clean and permission was granted to apply a slow-drying sealant to all surfaces within the Type 3 work area.

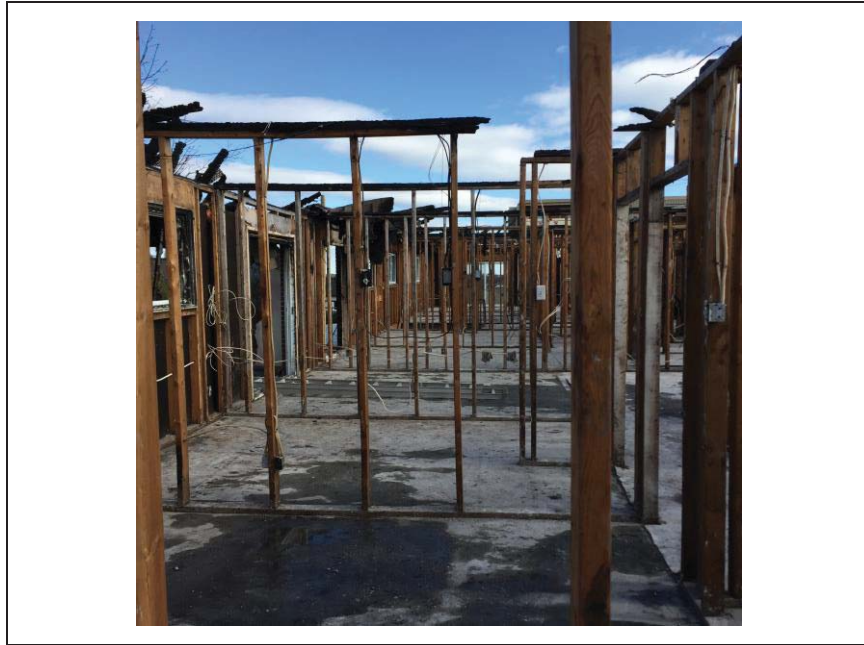
P3 – Second Floor

Alternative view of work area during our post abatement inspection visit on November 14, 2018.

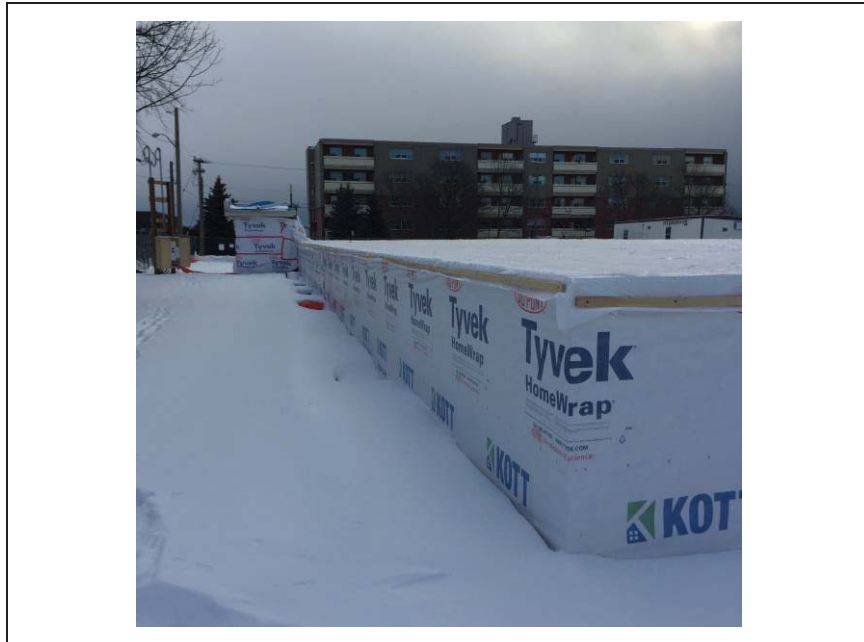
P4 – Exterior View

Typical view of the building during our site inspection on January 30, 2019.
