## **Hazardous Building Materials Assessment (Pre-construction)**

HVAC Ventilation and Accessible  
Washroom

Monsignor Philip Coffey Catholic School  
1324 Oxford Street, Oshawa, Ontario

April 25, 2022

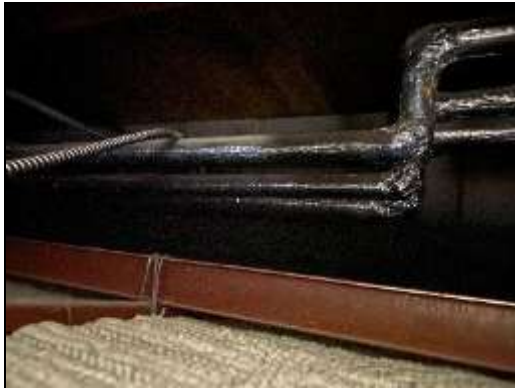
Pipes are insulated with non-asbestos fiberglass above ceiling.

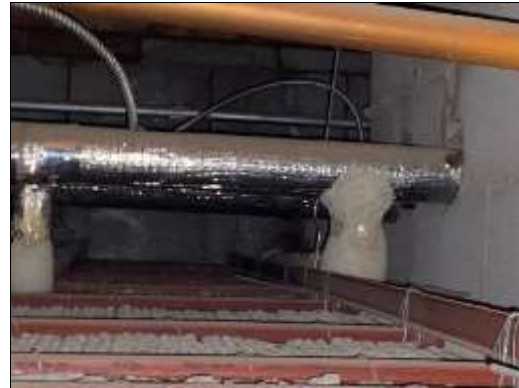
Since the presumed asbestos parging cement is adjacent to the plaster ceiling, disturbance of plaster ceiling is considered an asbestos procedure and asbestos precautions should be followed.

Presumed asbestos containing parging cement above ceiling.

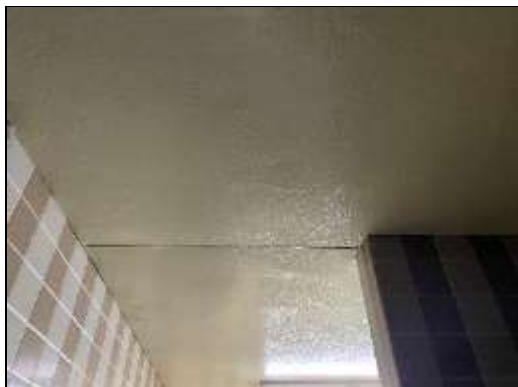
Plaster present on ceilings within Girls Washroom/Change room/Shower (Location 8) does not contain asbestos (samples S0027A-C). Previous sampling throughout the school were also found to be non-asbestos (samples S0002, S0004, S0005A-C, S0006).

Since the presumed asbestos parging cement is adjacent to the plaster ceiling, disturbance of plaster ceiling is considered an asbestos procedure and asbestos precautions should be followed.

Plaster present on ceilings within Girls Washroom/Change room/Shower (Location 8).

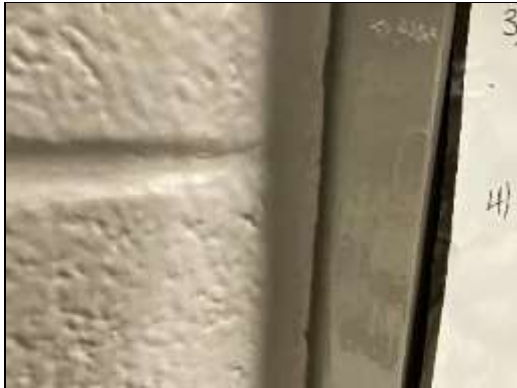
Material, Colour	Application	Sample Locations	Sample Number	Asbestos Type
Caulking, Brown	Door Frames	Women's Changeroom (Location 8)	S0026A-C	Chrysotile

Asbestos containing brown caulking present on interior door frames.

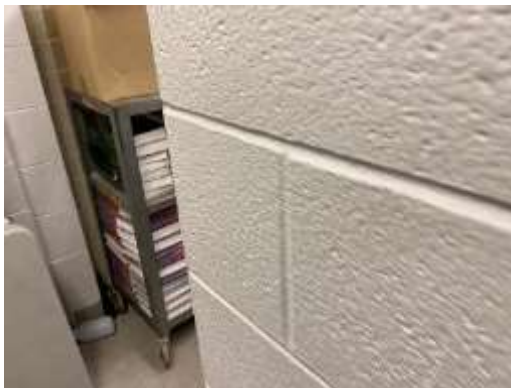
Non-asbestos white paint on concrete within Girls Washroom/Change room/Shower (Location 8).

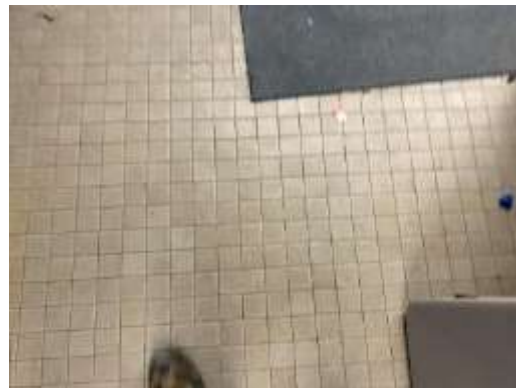
Non-asbestos thin set within Girls Washroom/Change room/Shower (Location 8).

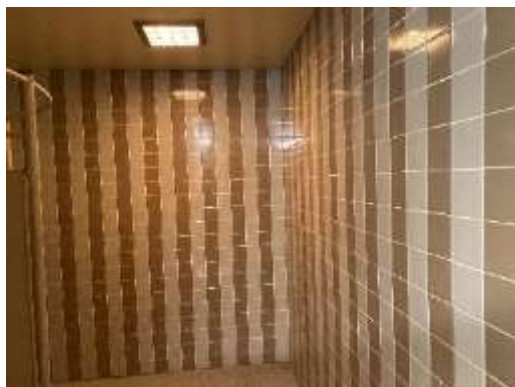
Non-asbestos thin set on walls within Girls Washroom/Change room/Shower (Location 8).
