# **EXTERIOR OPENING REPAIRS AT MULTIPLE SCHOOL SITES**

**Tender No. T22-15**

## **SUPPLEMENTARY INFORMATION PROJECT MANUAL VOLUME 2**

**Re: Asbestos-Containing Materials Reassessment**

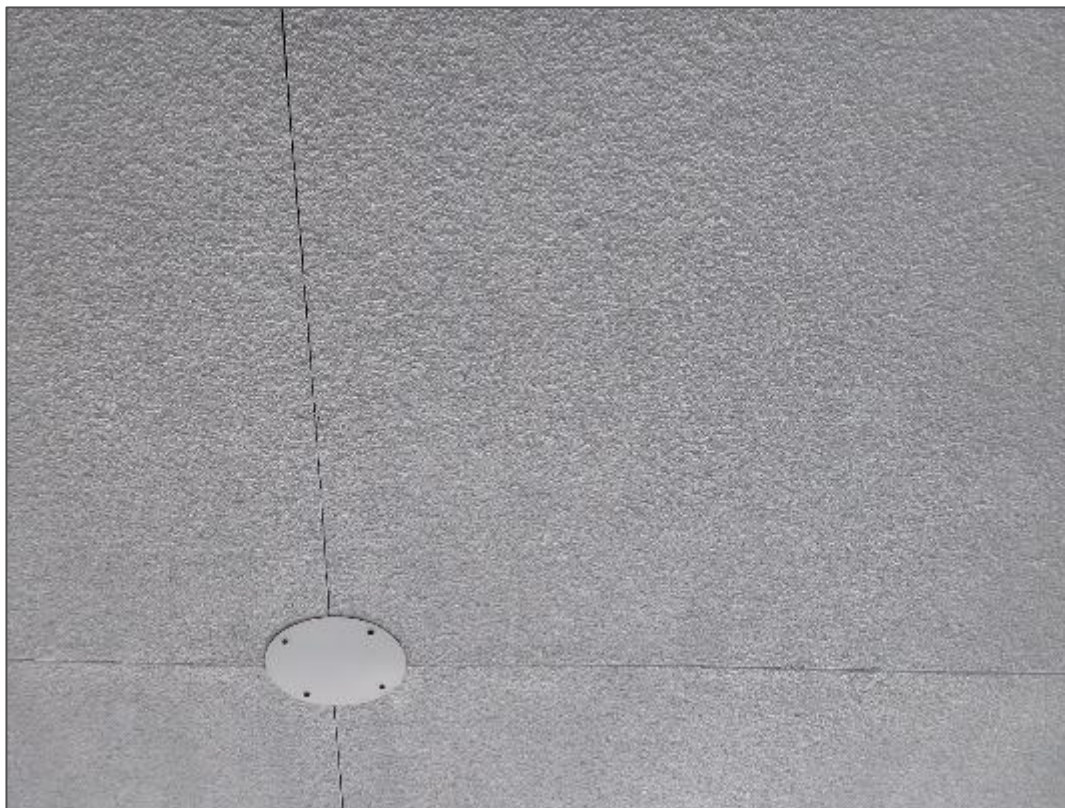
S0010 (Confirmed Asbestos), Other, Soffit, Texture Coat, Main Entrance Foyer & Exterior (Loc. 25).

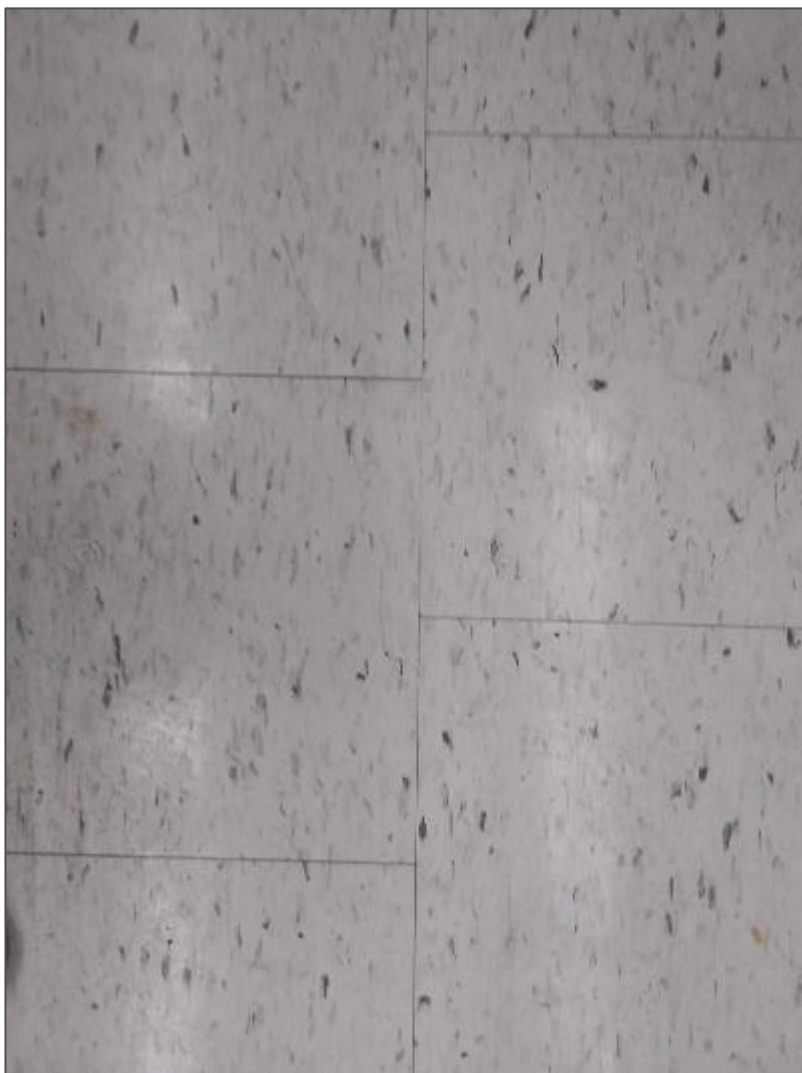
S0016 (Confirmed Asbestos), Floor, Vinyl Floor Tile and Mastic, Science Rm (Loc. 28).

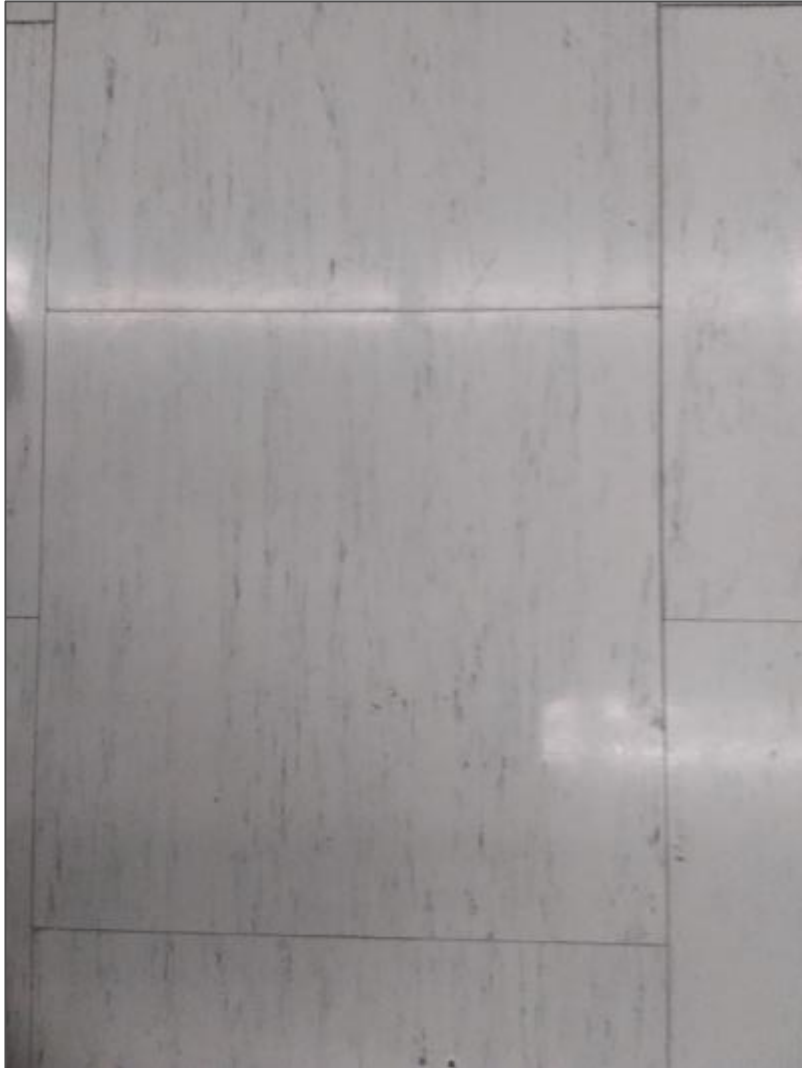
S0016 (Confirmed Asbestos), Floor, Vinyl Floor Tile and Mastic, Classroom # 10 (Loc. 40).

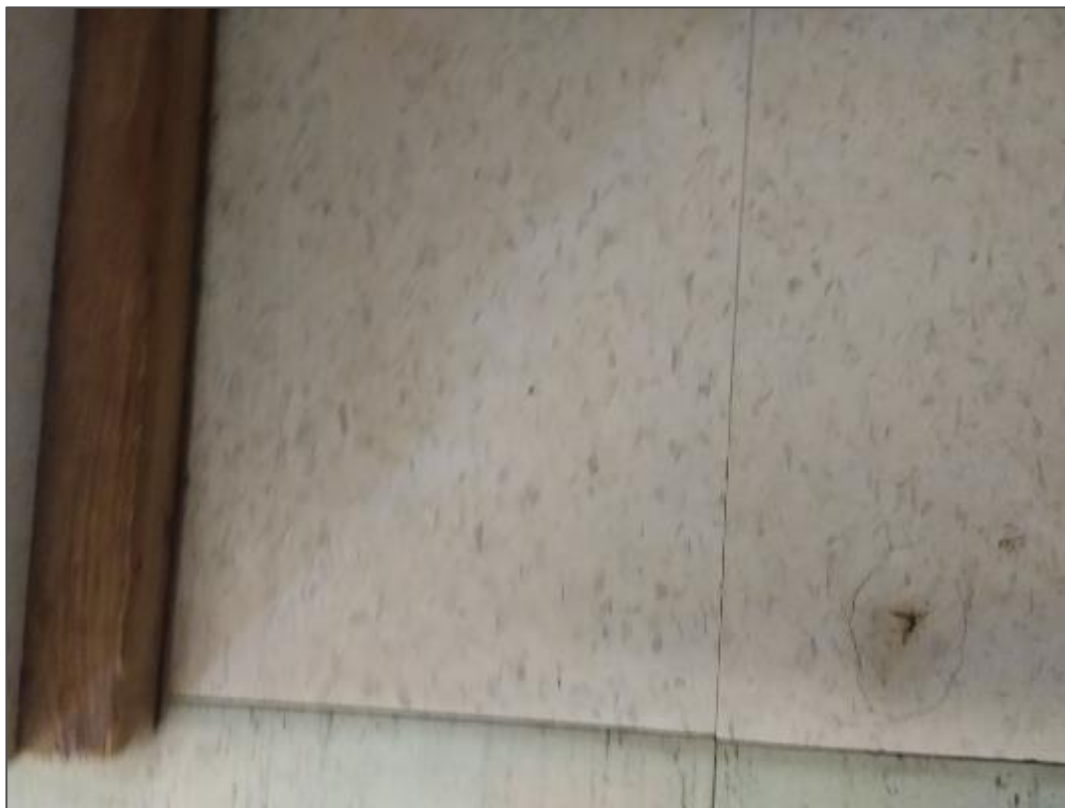
S0017 (Confirmed Asbestos), Floor, Vinyl Floor Tile and Mastic, Classroom # 10 (Loc. 40).

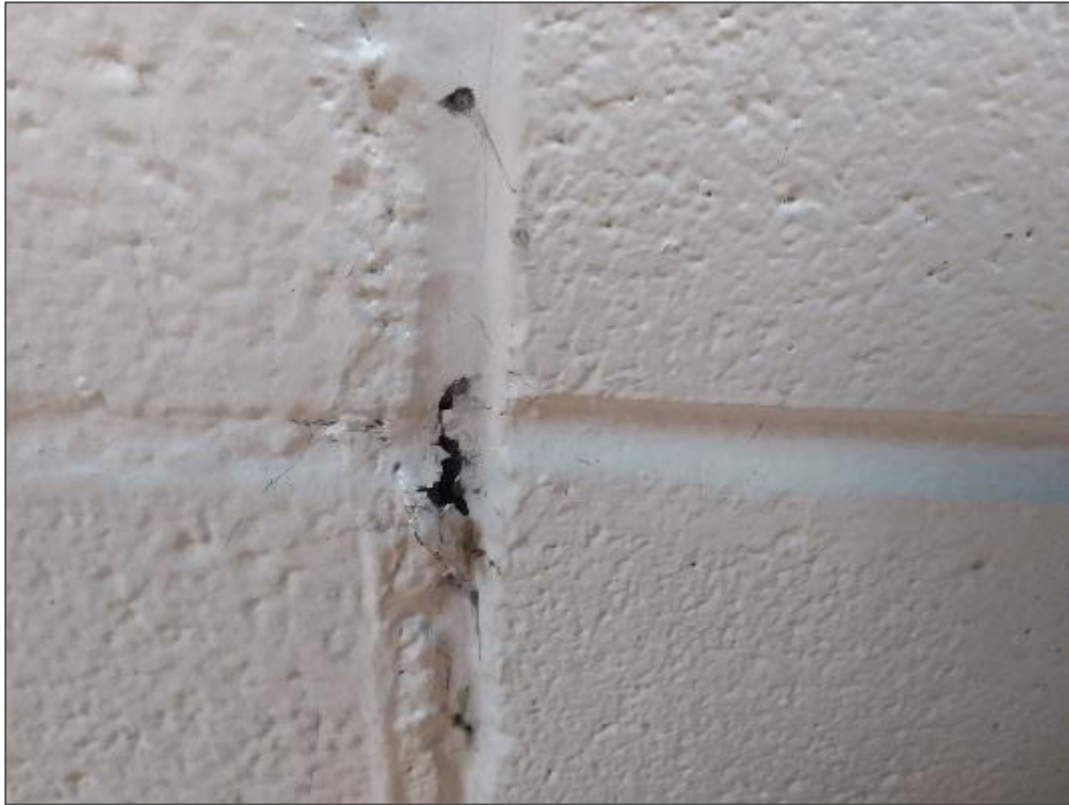
S0028 (Confirmed Asbestos), Other, Caulking, Library (Loc. 31).

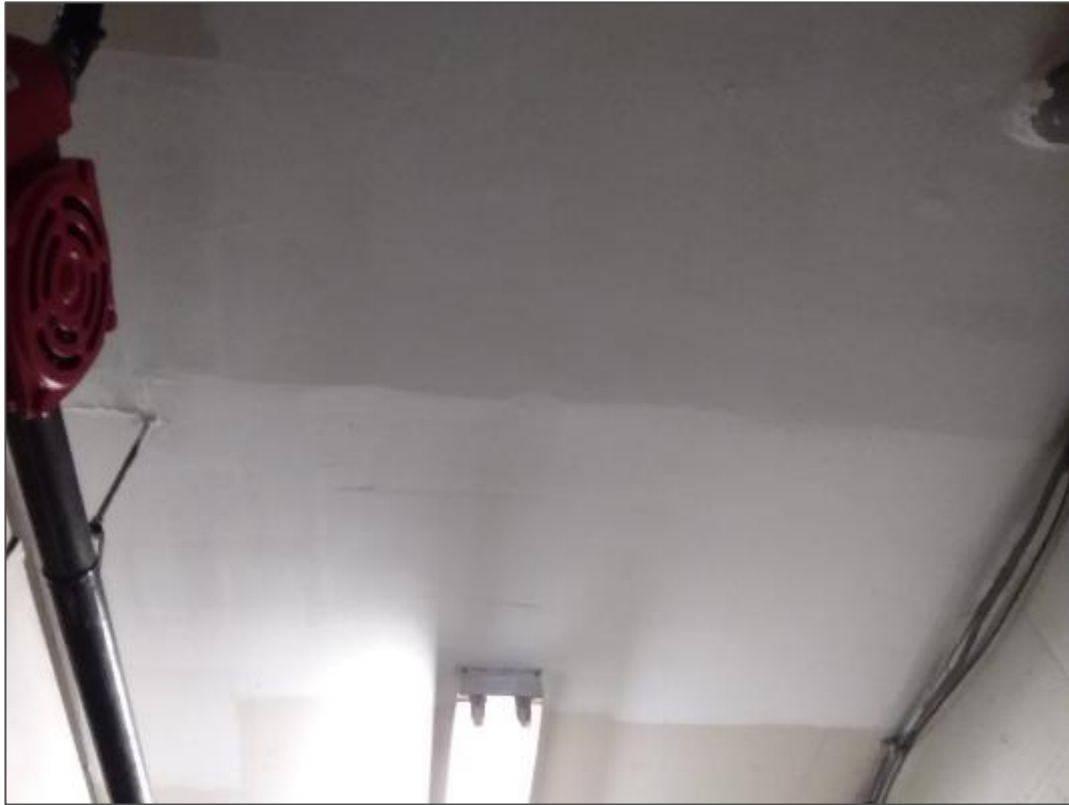
V9500 (Presumed Asbestos), Ceiling, Plaster, Boiler Room (Loc. 17).

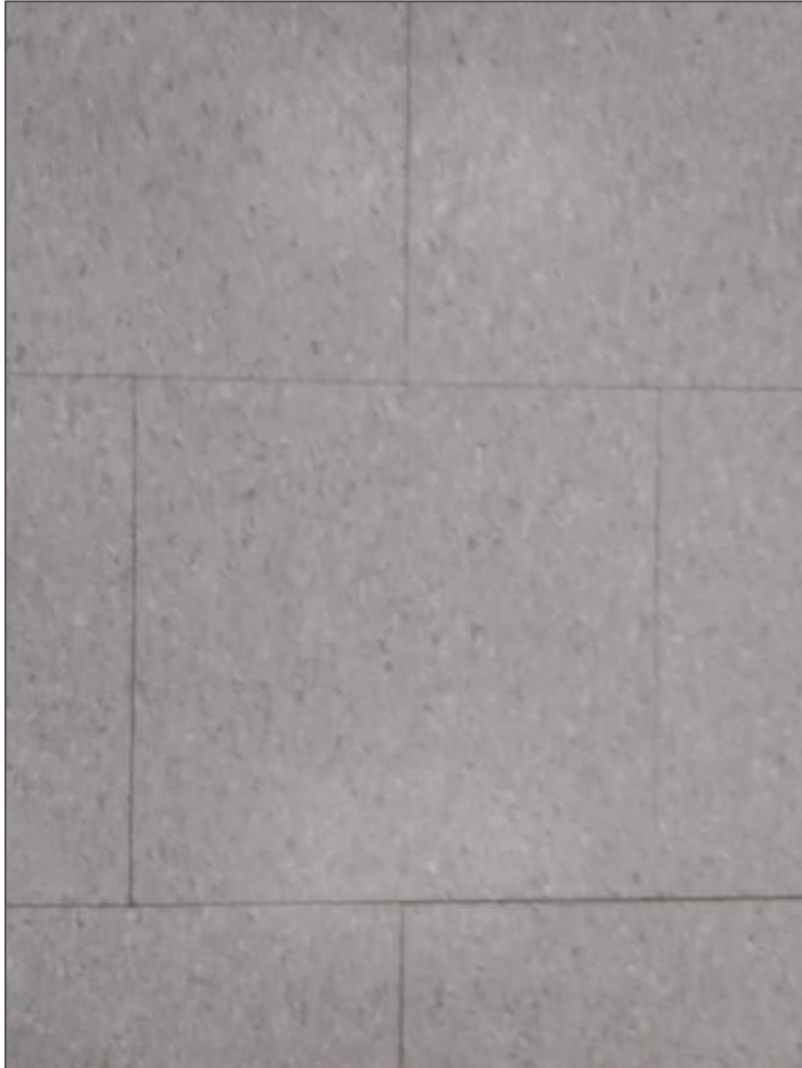
V9500 (Presumed Asbestos), Floor, Vinyl Floor Tile and Mastic, Classroom 9 (Loc. 4).

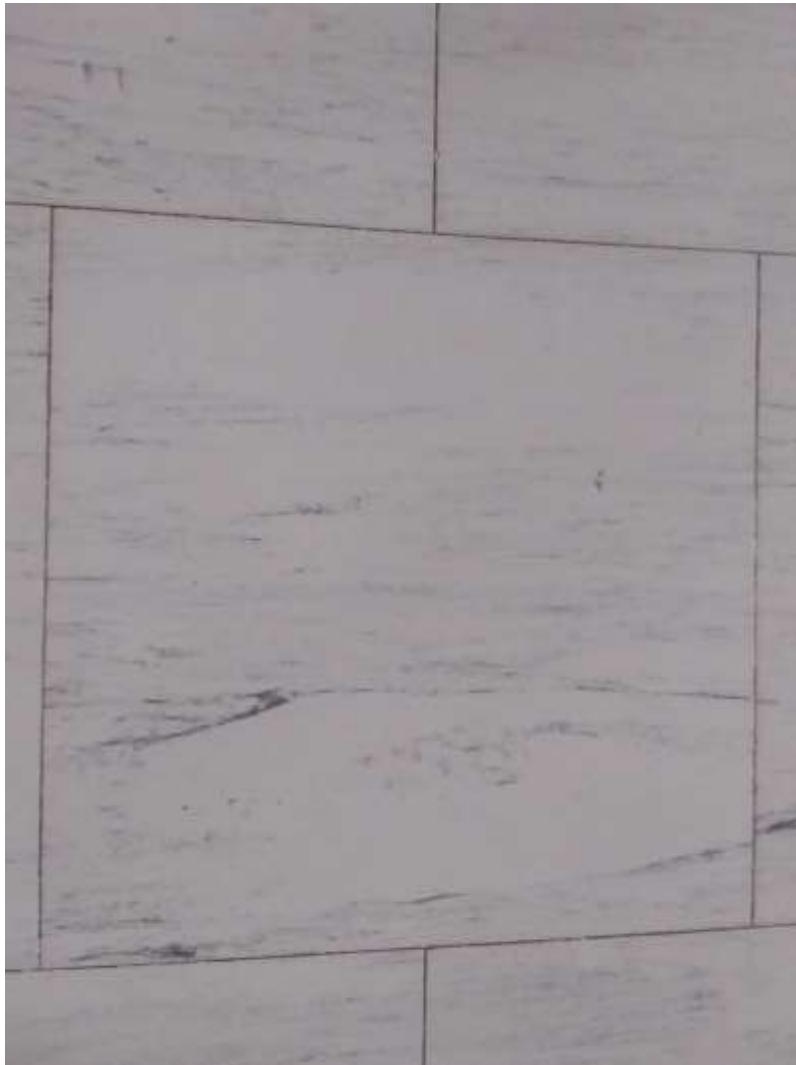
S0001 (Confirmed Asbestos), Floor, N/A, Vinyl Floor Tile and Mastic, Classroom 12 (Loc. 1)

12 x 12 green with streaks

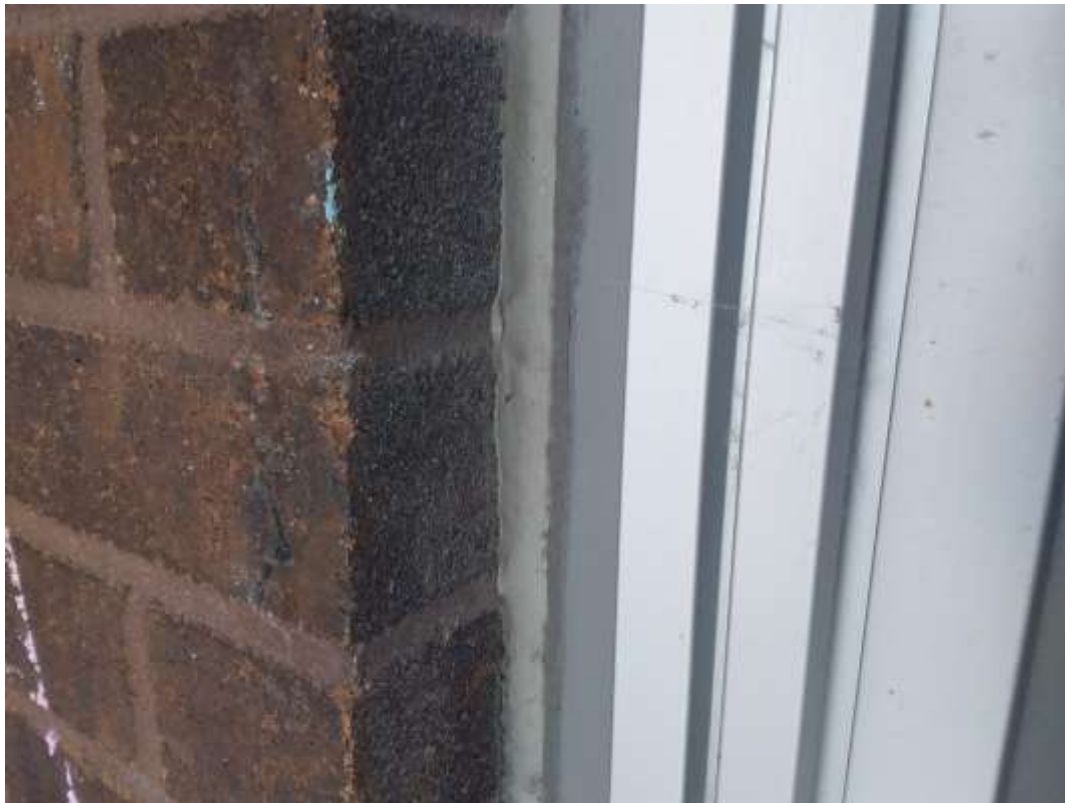
V9500 (Presumed Asbestos), Other, Caulking, Vestibule (Loc. 2)

off white

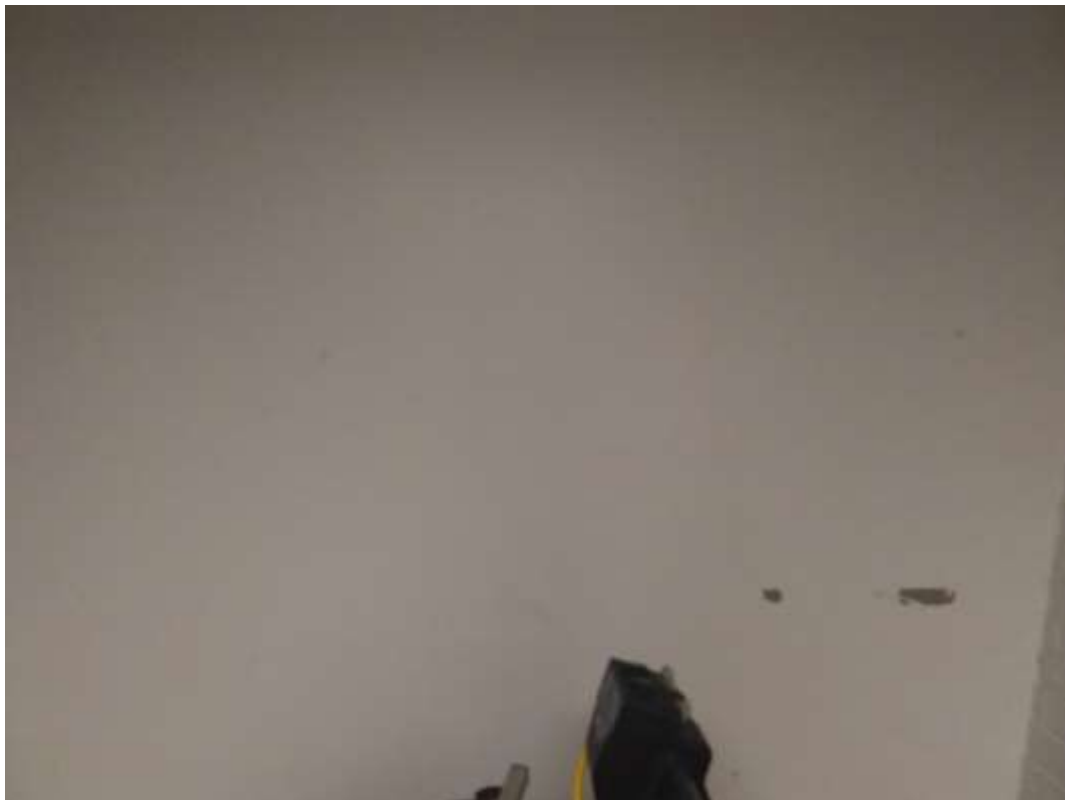
V9500 (Presumed Asbestos), Wall, Drywall and joint compound, Corridor (Loc. 21)

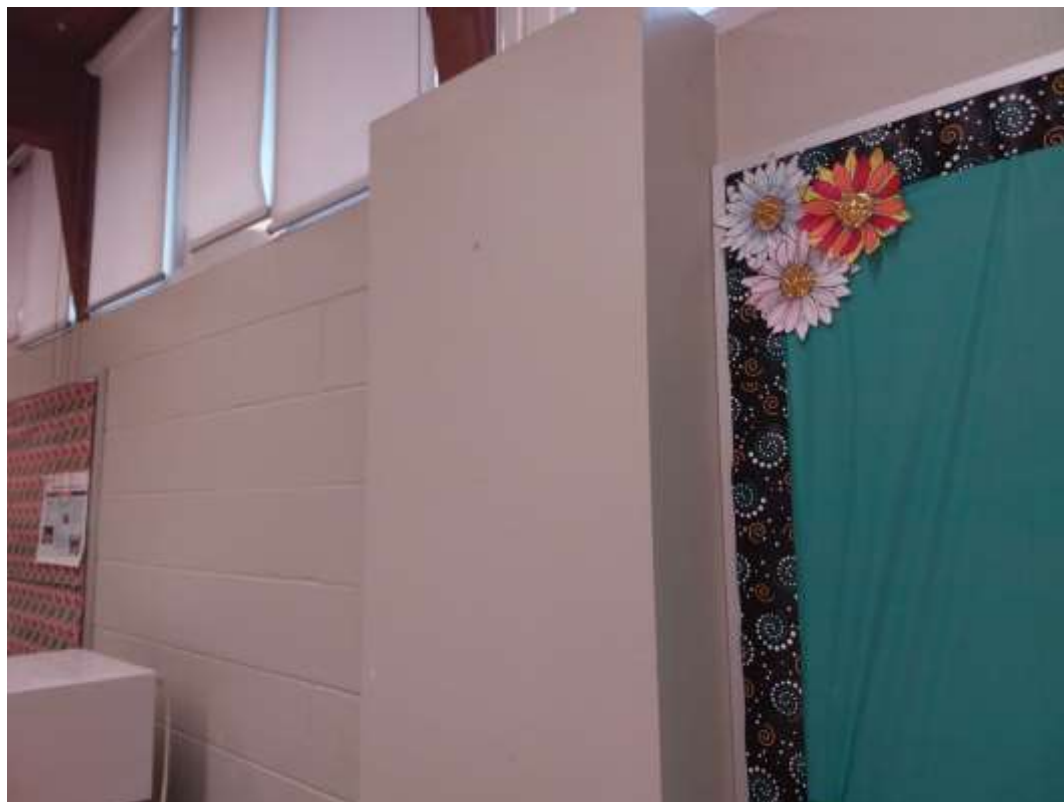
V9500 (Presumed Asbestos), Wall, Drywall and joint compound, Staff Room (Loc. 24)

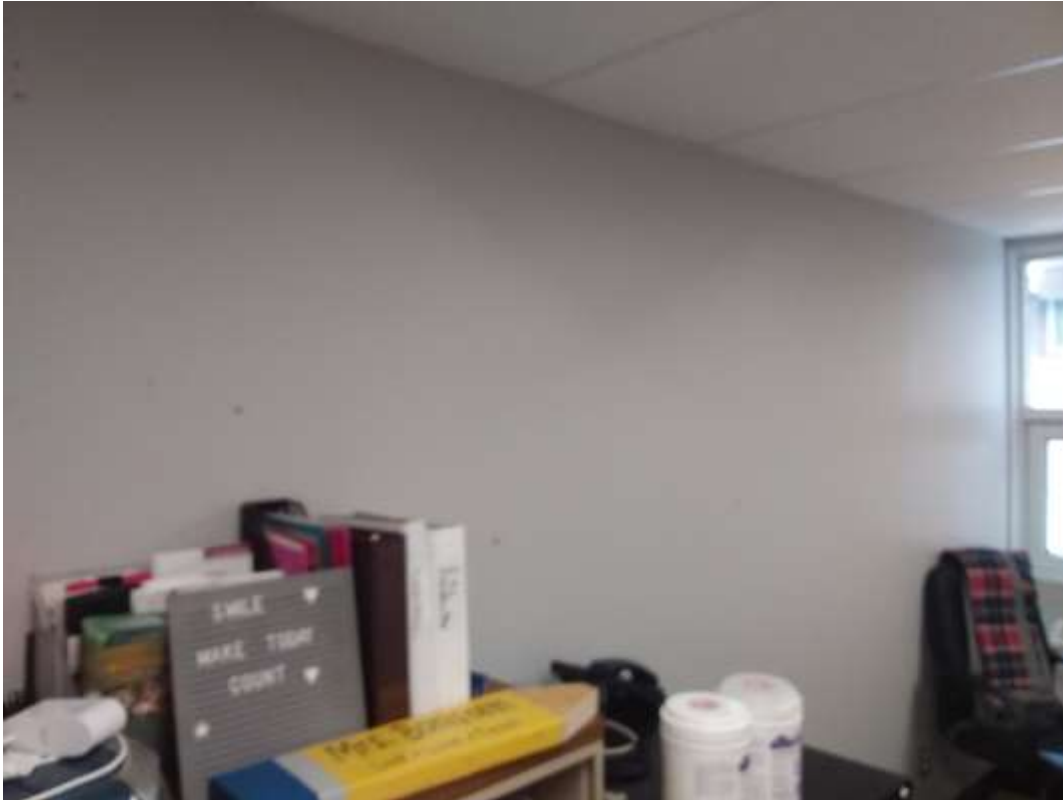
V9500 (Presumed Asbestos), Wall, N/A, Drywall and joint compound, Principal's Office (Loc. 26)

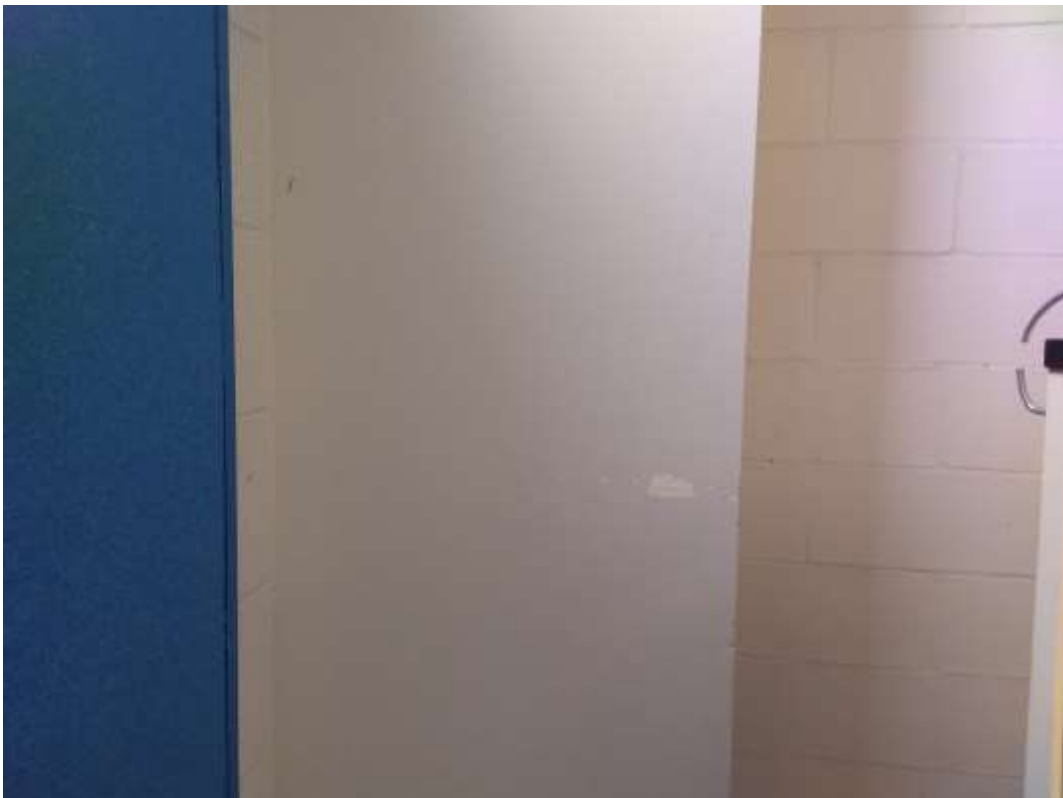
V9500 (Presumed Asbestos), Wall, N/A, Drywall and joint compound, Classroom 2 (Loc. 28)

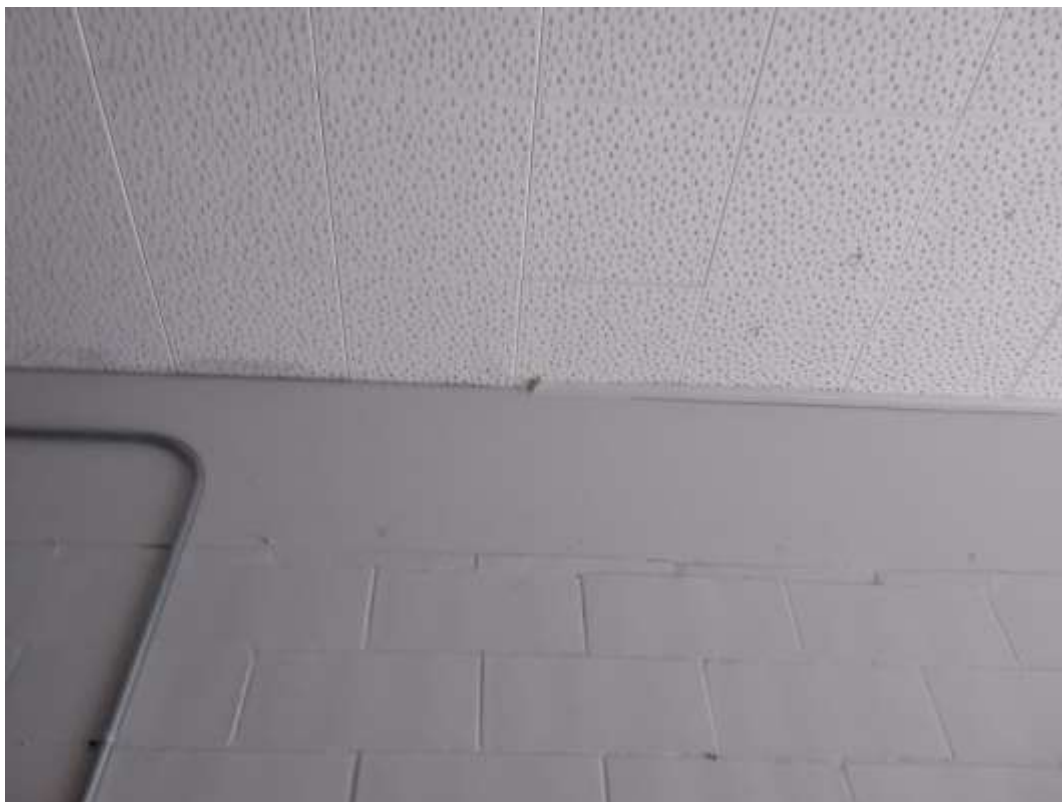
V9500 (Presumed Asbestos), Wall, N/A, Drywall and joint compound, Custodian Office (Loc. 36)

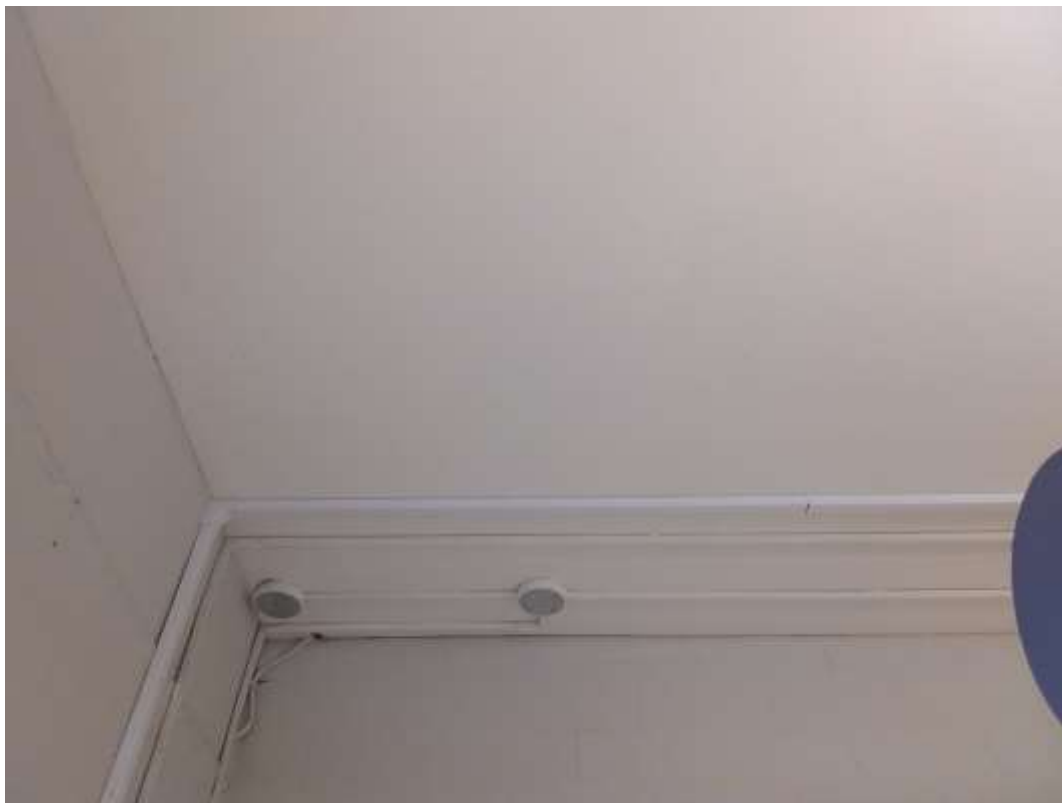
V9500 (Presumed Asbestos), Wall, N/A, Drywall and joint compound, Classroom 5 (Loc. 39)

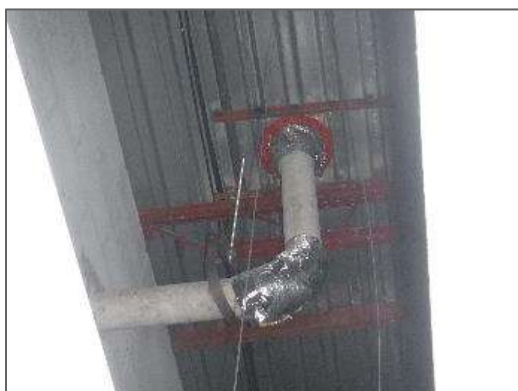
Transite is a non-friable material that was visually determined to contain asbestos. All Transite is in good condition.

Transite pipe is present in the assessed area.

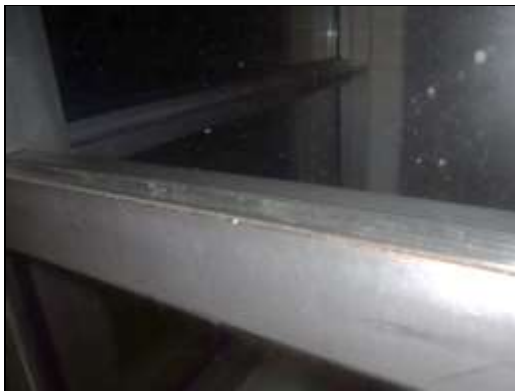
Asbestos-containing black putty on exterior windows and doors of the 1990 phase of construction.

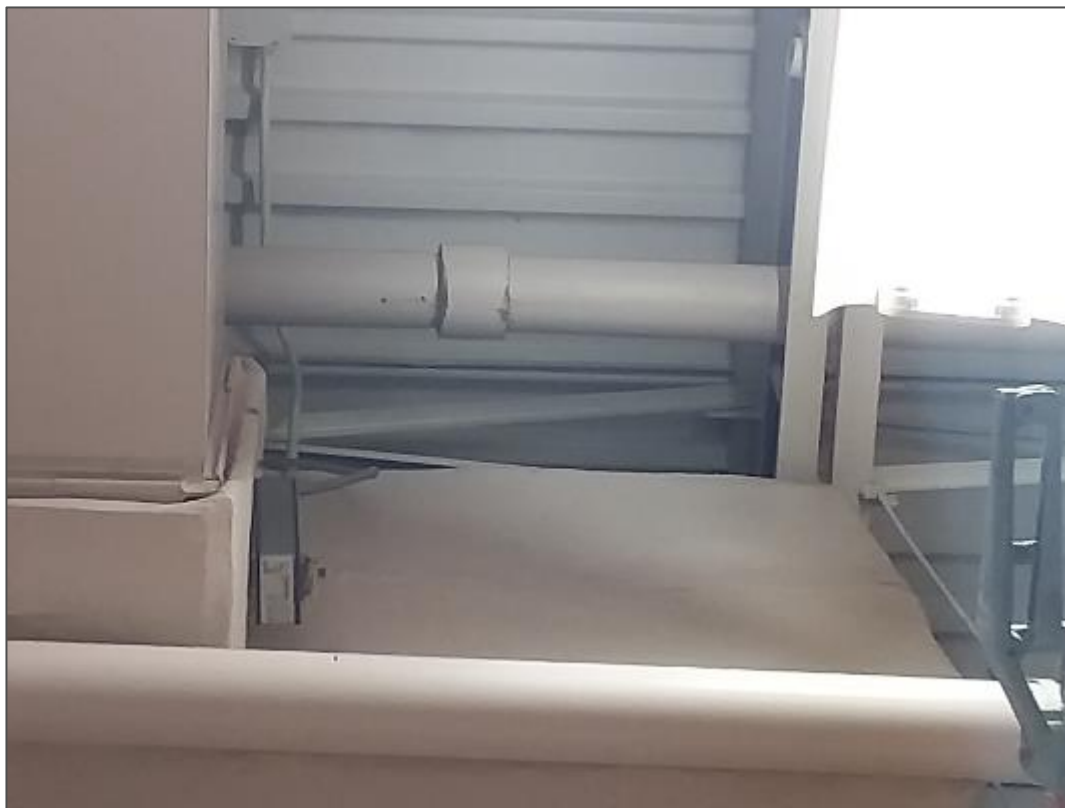
V9000 (Confirmed Asbestos), Piping, Cement Product, MEC1 (Loc. 52).

Transite pipe.

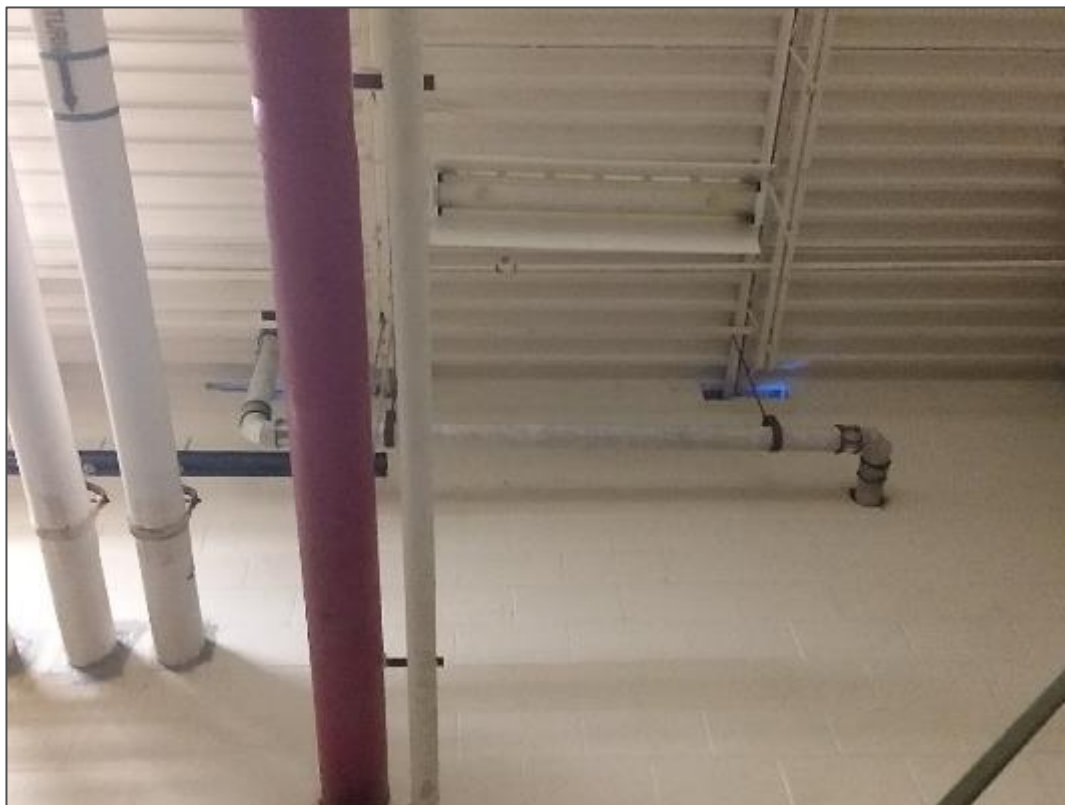
V9000 (Confirmed Asbestos), Piping, Cement Product, BR01 (Loc. 53).

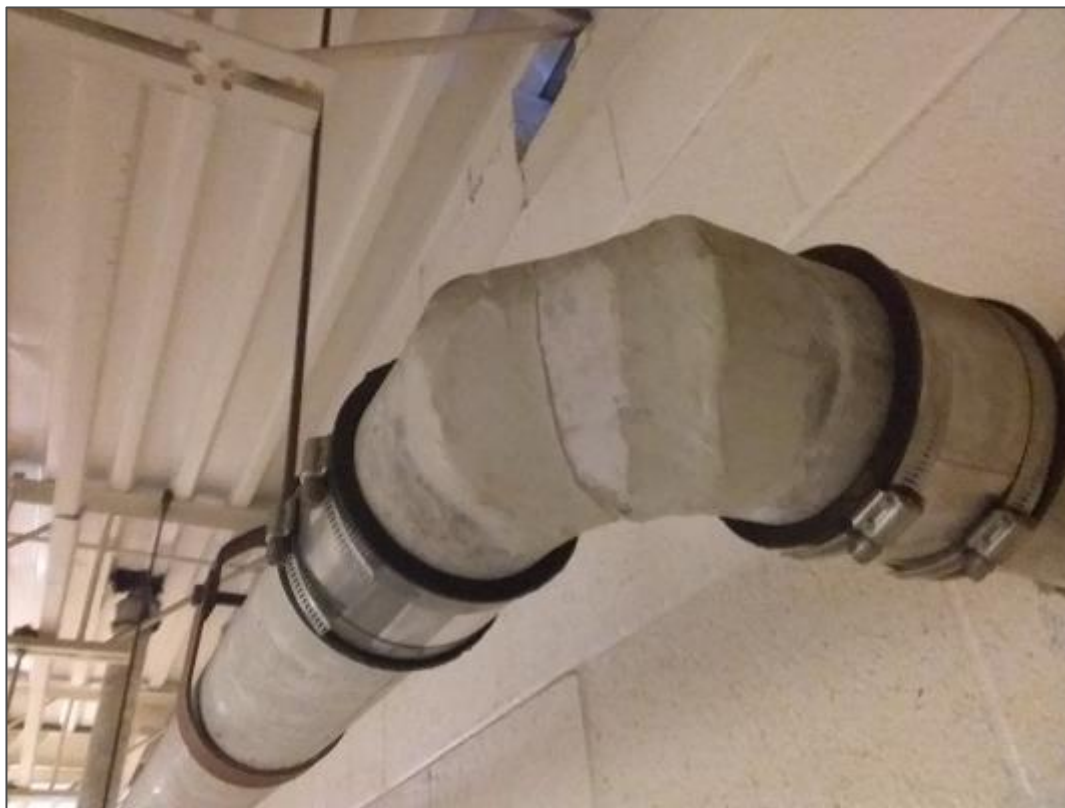
V9000 (Confirmed Asbestos), Other, Adhesive/mastic, BR01 (Loc. 53).

Cement product adhesive.

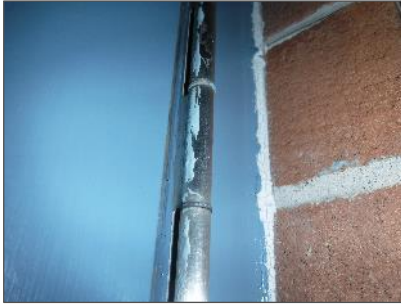
Caulking is non-friable and is in good condition.

Photo 1 – Asbestos-containing white caulk is present on the west Exit 107 doors.

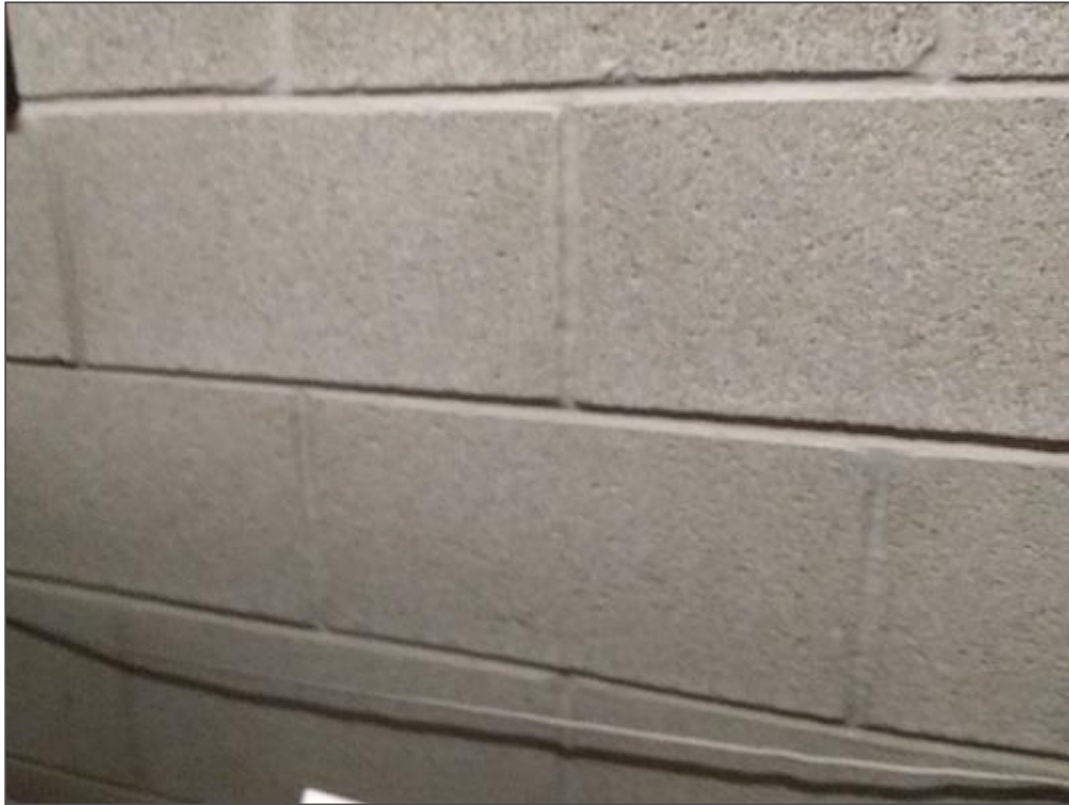
V9500 (Presumed Asbestos), Wall, All, Vermiculite/concrete block walls, Meter Room (Loc. 3).

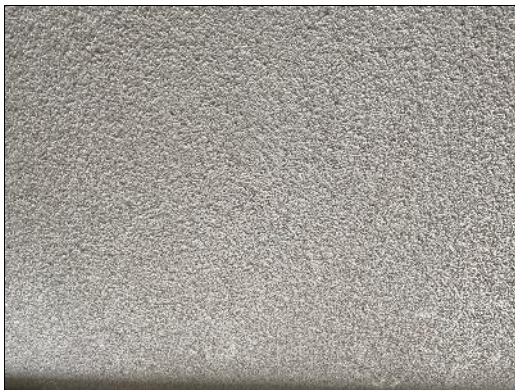
Texture finish, containing chrysotile asbestos, is present on the concrete exterior entrance soffits (previously sampled S0010A-C).

Texture finish, containing chrysotile asbestos, is present on the concrete soffit on the exterior (Location 25)

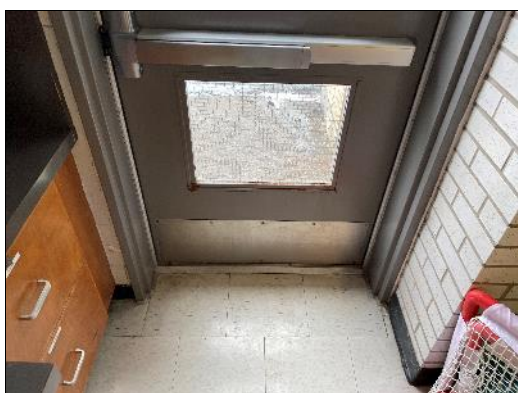
Presumed asbestos-containing white caulking on 1970 phase interior door frame

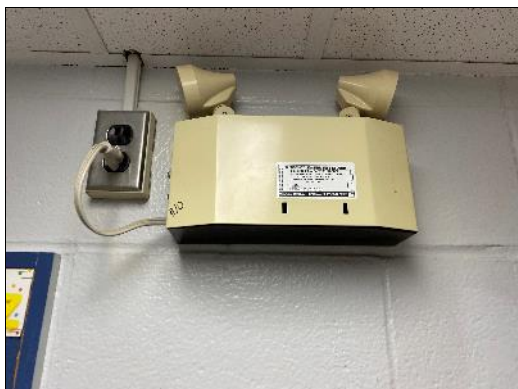
Lead-containing batteries are present in emergency lighting.

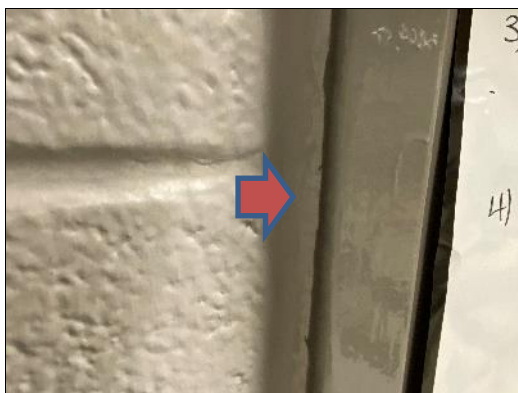
Asbestos-containing brown caulking present on interior door frames

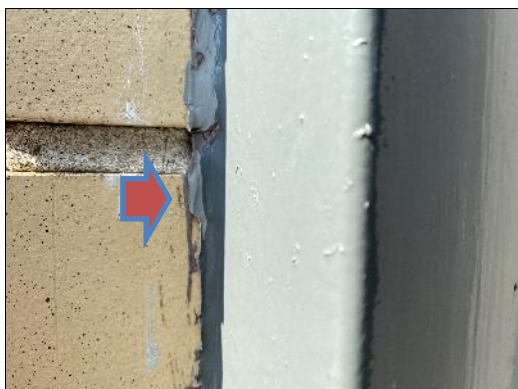
Material, Colour	Application	Sample Locations	Sample Number	Asbestos Type
Caulking, Brown	Door Frames	Exterior (Location 43)	S0030A-C	Chrysotile

Asbestos-containing brown caulking present on exterior door frames
