Designated Substances Survey -12 Queen Street, Lakefield, Ontario

June 6, 2022

Prepared for:
Township of Selwyn

Cambium Reference: 15392-001

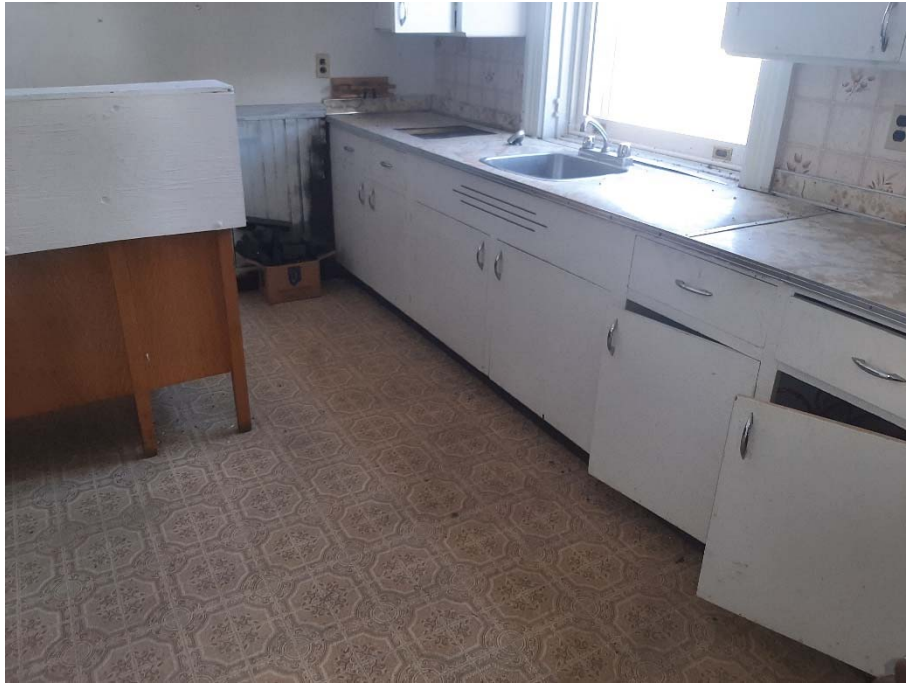
- Beige pattern vinyl sheet flooring, containing chrysotile asbestos, is present in the second floor kitchen and basement stairwell of the building. If affected by planned renovations, remove beige pattern vinyl sheet flooring using Type 2 procedures as outlined in O. Reg. 278/05.

Photo 1 – Asbestos-containing beige square pattern vinyl sheet flooring.

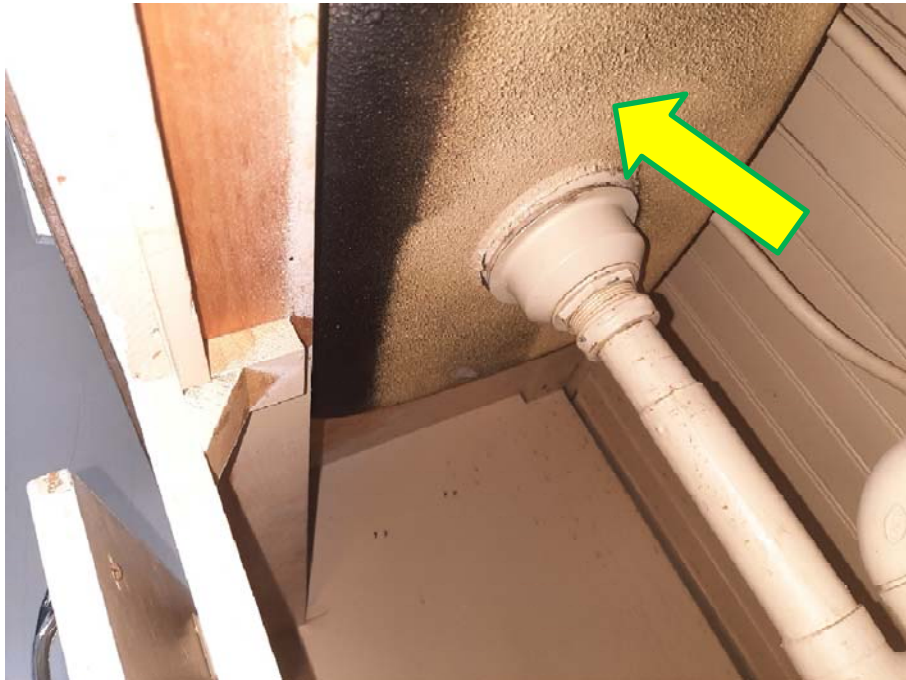
- Black sink coating, containing chrysotile asbestos, is present on the bottom of the sink in the kitchen of the second floor and on the sink in the basement of the building. If affected by planned renovations, remove sink coating using Type 1 procedures as outlined in O. Reg. 278/05.

Black sink coating, containing chrysotile asbestos, is present on the bottom of the sink in the kitchen of the second floor and the sink in the basement of the building. There is approximately 10 square feet of black sink coating in each location and was observed in good condition.

Photo 2 – Asbestos-containing sink coating.

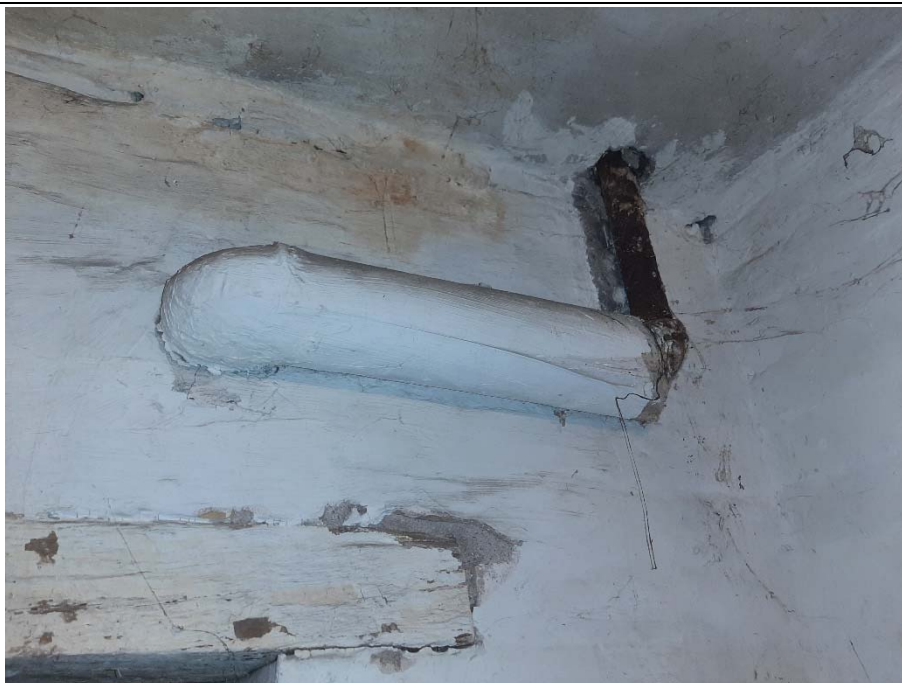
- Aircell pipe insulation, containing chrysotile asbestos, is present on select hot water heating pipes and is present in residual amounts on piping in the basement of the building. Remove residual Aircell pipe insulation using Type 2 glovebag procedures as outlined in O. Reg. 278/05. If affected by planned renovation activities, remove remaining Aircell pipe insulation on piping using Type 2 glovebag procedures as outlined in O. Reg. 278/05.

- Parging cement pipe insulation, containing chrysotile asbestos, is present on select hot water heating pipes and is present in residual amounts on piping in the basement of the building. Remove residual parging cement pipe insulation using Type 2 glovebag procedures as outlined in O. Reg. 278/05. If affected by planned renovation activities, remove remaining parging cement pipe insulation on piping using Type 2 glovebag procedures as outlined in O. Reg. 278/05.

Aircell pipe insulation, containing chrysotile asbestos, is present on one straight section of piping in the storage room of the basement (sample ASB-110.1). There is approximately four linear feet of Aircell pipe insulation and it was observed in poor condition.

Parging cement pipe insulation, containing chrysotile asbestos, is present on one pipe fitting in the storage room of the basement (sample ASB-111.1). There is one pipe fitting and it was observed in good condition.

Photo 3 – Asbestos-containing parging cement and Aircell pipe insulation.

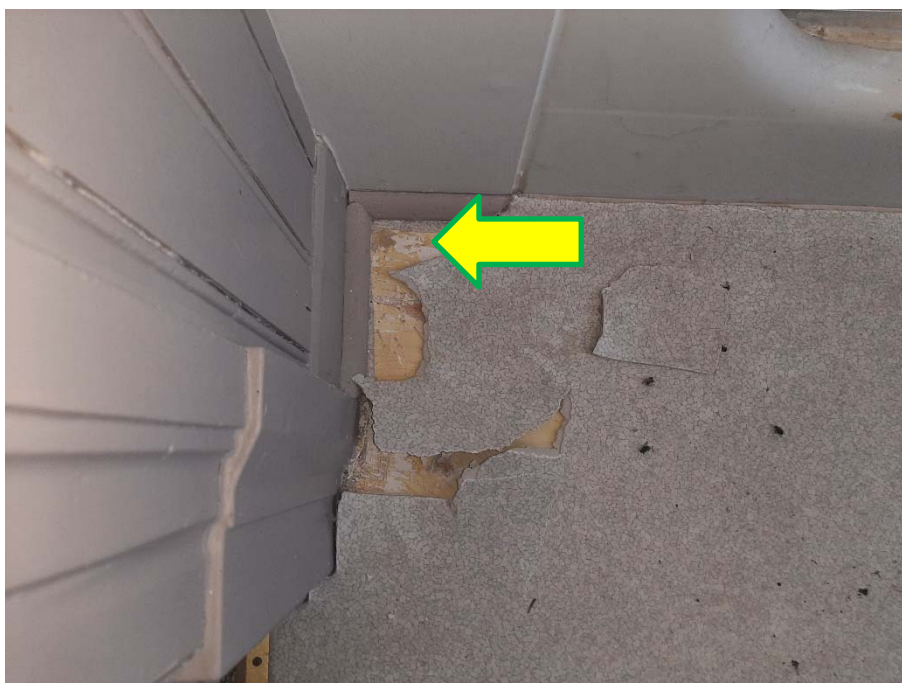
- White vinyl sheet flooring, containing chrysotile asbestos, is present (concealed beneath non-asbestos grey vinyl sheet flooring) in the second floor washroom of the building. If

affected by planned renovations, remove white vinyl sheet flooring using Type 2 procedures as outlined in O. Reg. 278/05.

Photo 4 – Asbestos-containing white vinyl sheet flooring concealed beneath non-asbestos grey vinyl sheet flooring.

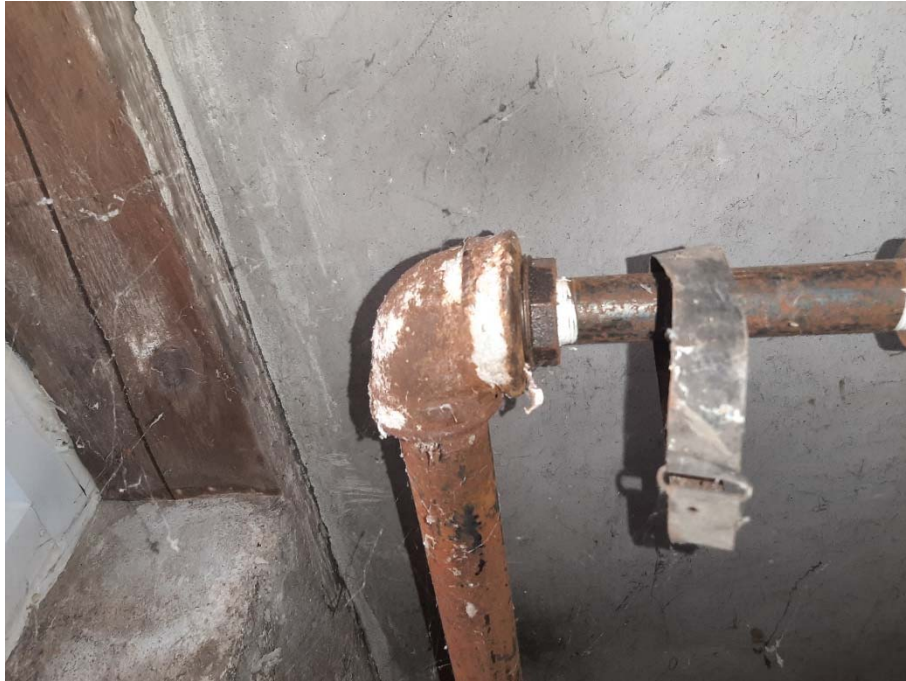
Residual parging cement is present on pipe fittings on hot water heating pipes throughout the basement. There is approximately 75 pipe fittings with residual parging cement and it was observed to be in poor condition.

Photo 5 – Asbestos-containing residual parging cement pipe insulation.

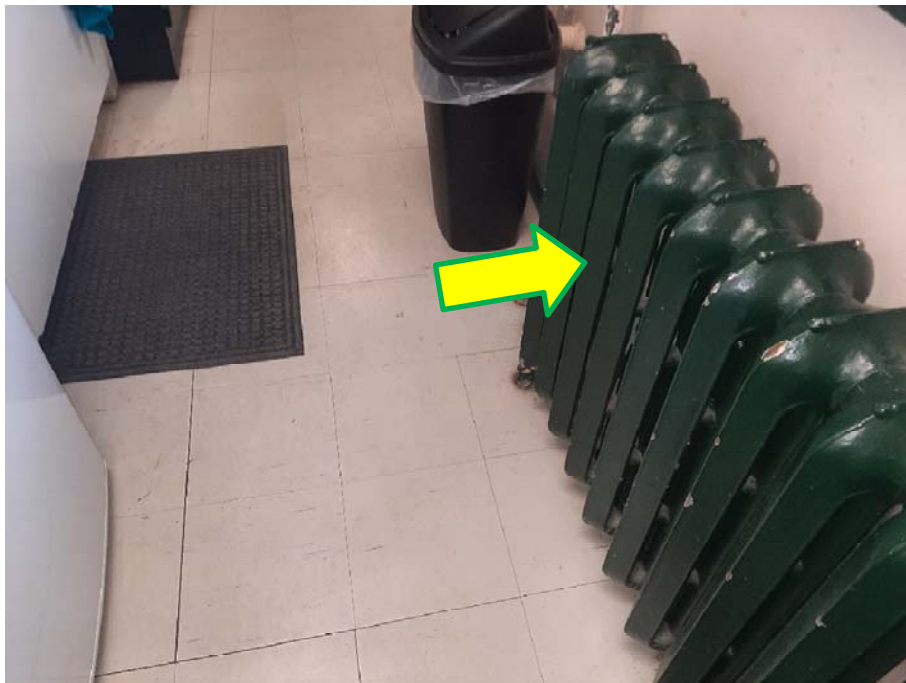
The results of laboratory analysis indicated that grey paint on wood and green paint on wood, light grey paint on plaster, beige paint on metal, pink paint on wood, green paint on wood, white paint on wood, and white paint on plaster is lead-based. All remaining painted finishes contain low levels of lead and are not considered to be lead-based. Painted finishes were found to be in good condition.

Photo 6 – Lead-based green paint.

- Remove lead-based painted finishes using Class 1 procedures as outlined in the guideline, "Lead Guideline For Construction, Renovation, Maintenance or Repair" issued by Environmental Abatement Council of Canada, dated October 2014.
- If affected by planned renovations, leachate samples should be performed on lead-based paints to determine the appropriate waste stream and disposed of in accordance with O. Reg. 347.
- Any paints discovered during the course of renovation activities that are not mentioned in this report shall be considered to be lead-based until sampling and analysis indicates otherwise.

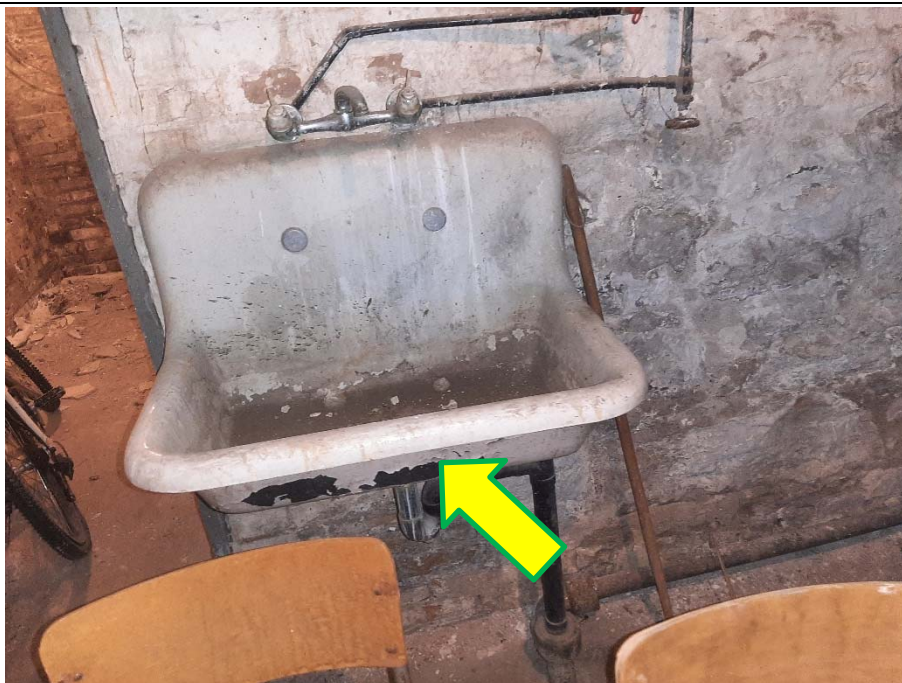
Photo 7 – Asbestos-containing sink coating in the basement.
