# **Asbestos Building Materials Survey and Assessment Report**

## **The Regional Municipality of Durham**

### **Harmony Creek WPCP 785 Colonel Sam Oshawa, Ontario**

February 04, 2011

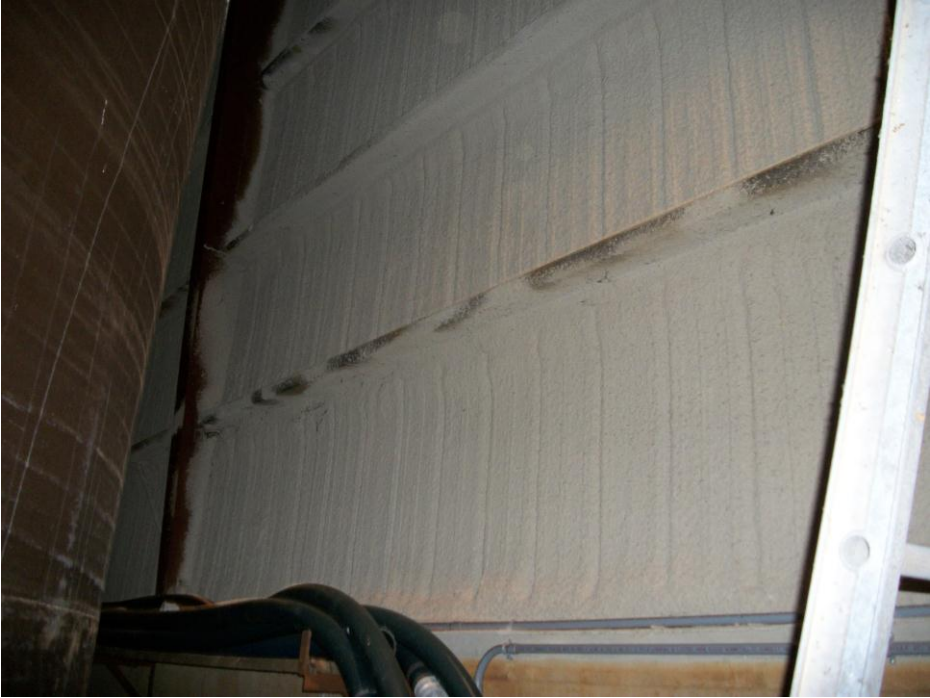
<b>Photo No. 1</b>

Sprayed fireproofing is present in this facility. This material was sampled (Sample #13069-O4-04A through 13069-O4-04C) and laboratory analysis confirms that Sprayed fireproofing does not contain asbestos.

<b>Date:</b> September 21, 2011	
<b>Description:</b>  Non-asbestos sprayed fire proofing in Building I
