St. Elizabeth Seton CS Child Care Expansion

ADDENDUM #1

Hazardous Building Materials Assessment

St. Elizabeth Seton Catholic School
490 Stroud's Lane, Pickering, Ontario

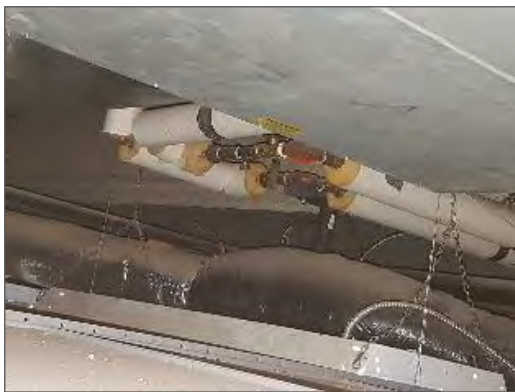
Pipes are either uninsulated or insulated with non-asbestos fibreglass or elastomeric insulation (Armaflex).

Photo 1 – Non-asbestos fibreglass pipe insulation on heating system pipes above lay-in ceiling tiles in room 104.

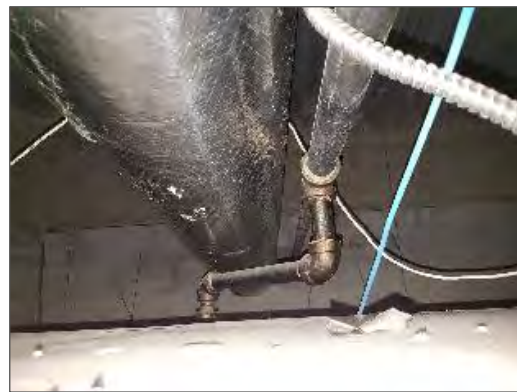
Photo 2 – Uninsulated pipe above lay-in ceiling tiles in room 104.

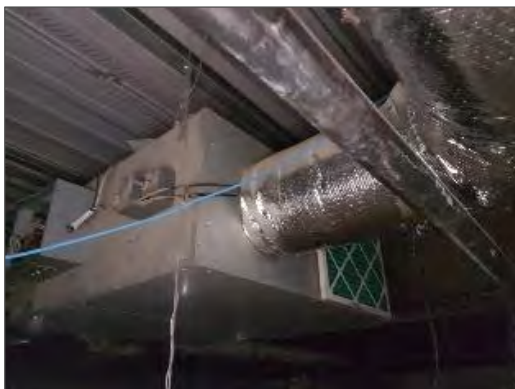
Ducts are either uninsulated or insulated with non-asbestos fibreglass (foil-faced or canvas).

Photo 3 – Fiberglass insulated flex duct above lay-in ceiling tiles in room 104.

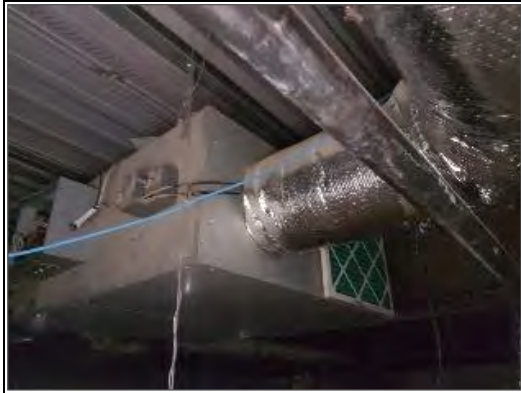
Mechanical equipment was not insulated in the assessed area.

Photo 4 – Uninsulated heating equipment above lay-in ceiling tiles in room 104.

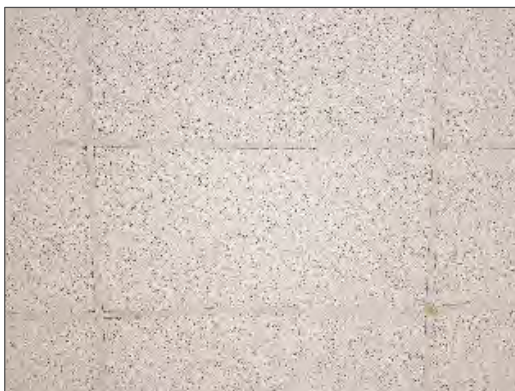
Ceiling tiles without date stamps were sampled for asbestos. Samples a0001A-C taken from ceiling tiles do not contain asbestos.

Photo 5 – Non-asbestos lay-in acoustic ceiling tile present within the assessed area.

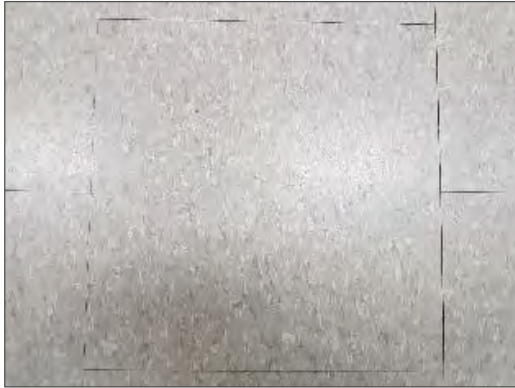
Vinyl floor tiles were presumed to be non-asbestos based on historical knowledge of the date of installation.

Photo 6 – Grey with white and dark-grey speckled floor tile present throughout the assessed area.

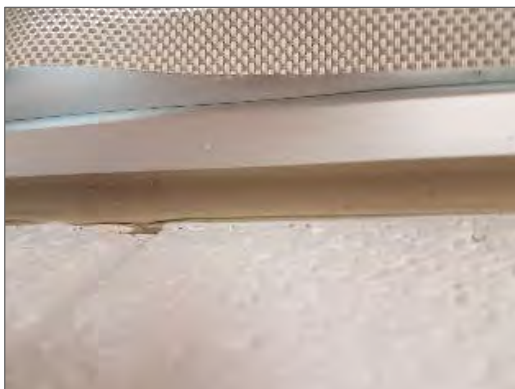
Tan caulking at interior window frames does not contain asbestos (samples a0002A-C).

Photo 7 – Tan coloured caulking in Room 104 on window frame. Does not contain asbestos.

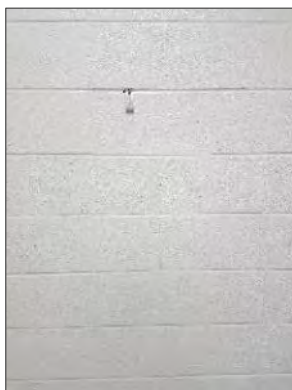
Photo 8 – Pale blue paint on wall.

Analytical results indicate that all of the paints from the Site Building contain low levels of lead (i.e., less than the EACO guideline of 0.1% for lead-containing paints). Special precautions are not recommended unless aggressive disturbance (grinding, blasting, torching) is planned.

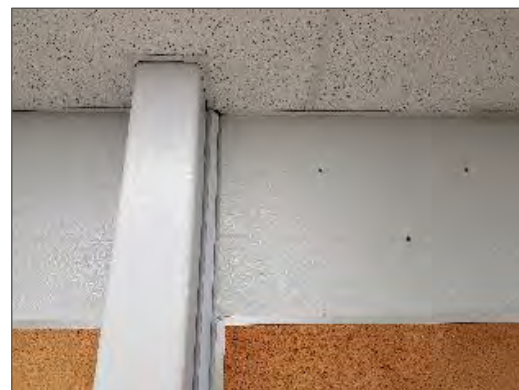
Photo 9 – Pale blue paint on metal beam.

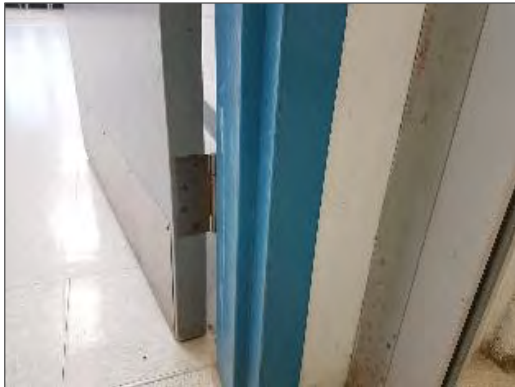
Photo 10 – Blue on metal door frame.

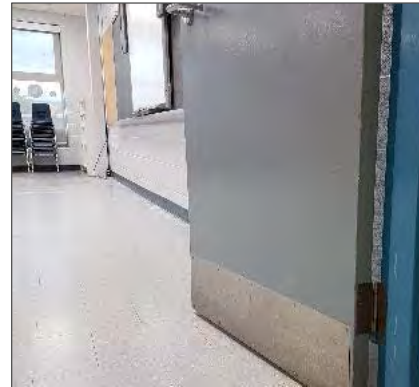
Photo 11 – Blue-grey on wood door.

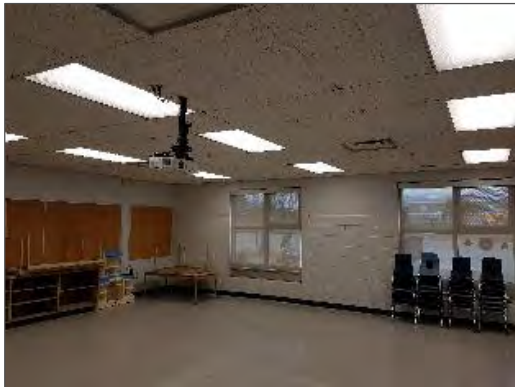
Mercury vapour is present in fluorescent lamps where present in the assessed area.

Photo 12 – Fluorescent lamps present in the assessed area.

Do not break lamps or separate liquid mercury from components. Recycle and reclaim mercury from fluorescent lamps when taken out of service. Liquid mercury is classified as a hazardous waste and must be disposed of in accordance with local regulations.

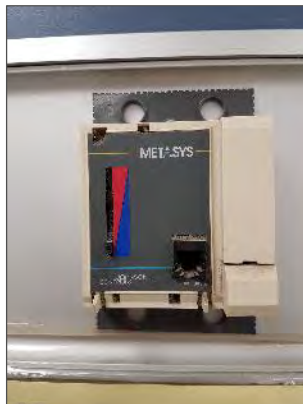
Thermostat inspected did not contain liquid mercury ampules.

Photo 13 – Non-mercury thermostat present in assessed room.
