# UPDATED SURVEY OF ASBESTOS- CONTAINING MATERIALS

École secondaire Étienne-Brûlé

August 25, 2022

École secondaire Étienne-Brûlé  
300 Banbury Road, North York, ON

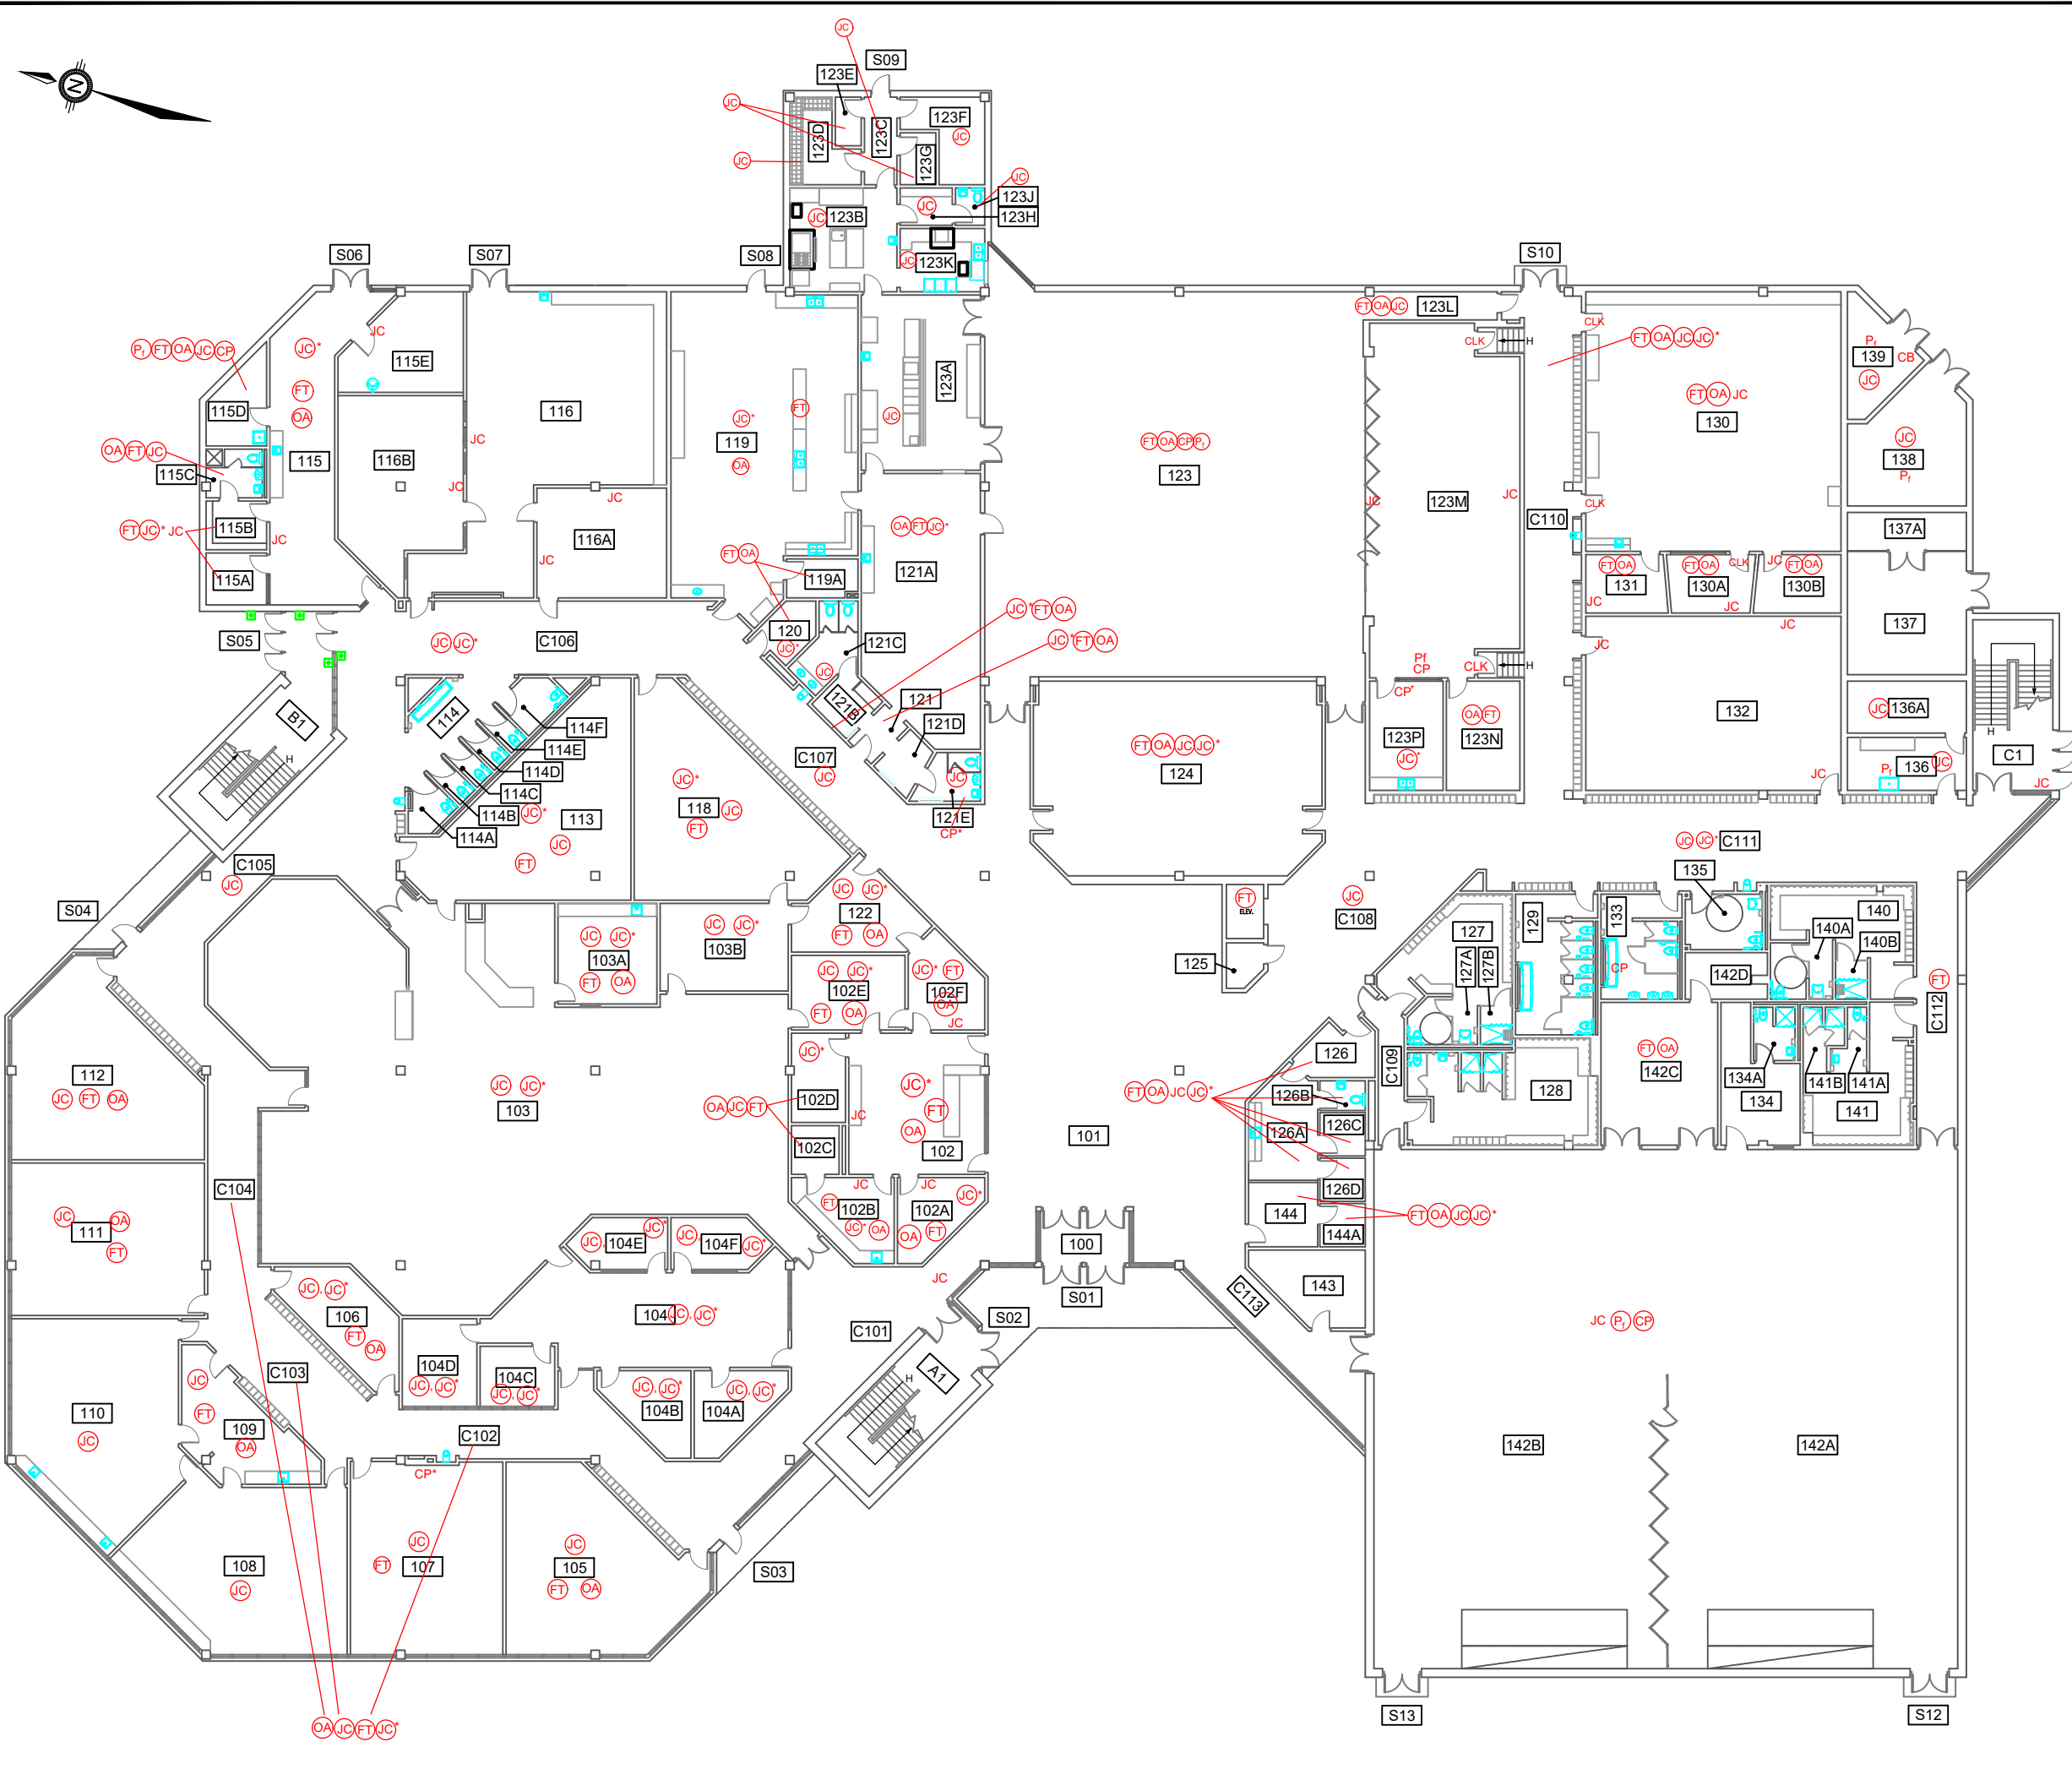
Drawn By: B.R.	Approved By: D.K.	Project No: 30075628
Date: AUG 2022	Scale: N.T.S	Drawing No: 30075628-1

A room-by-room summary of the locations and conditions of asbestos-containing materials identified is presented in Table 3.2. The locations of accessible asbestos containing materials are identified on the floor plans provided in Appendix A.
