# Designated Substances Survey

**St. Mary Catholic  
Elementary School**

**103B Lyle Street South,  
Grafton, Ontario**

January 26, 2024

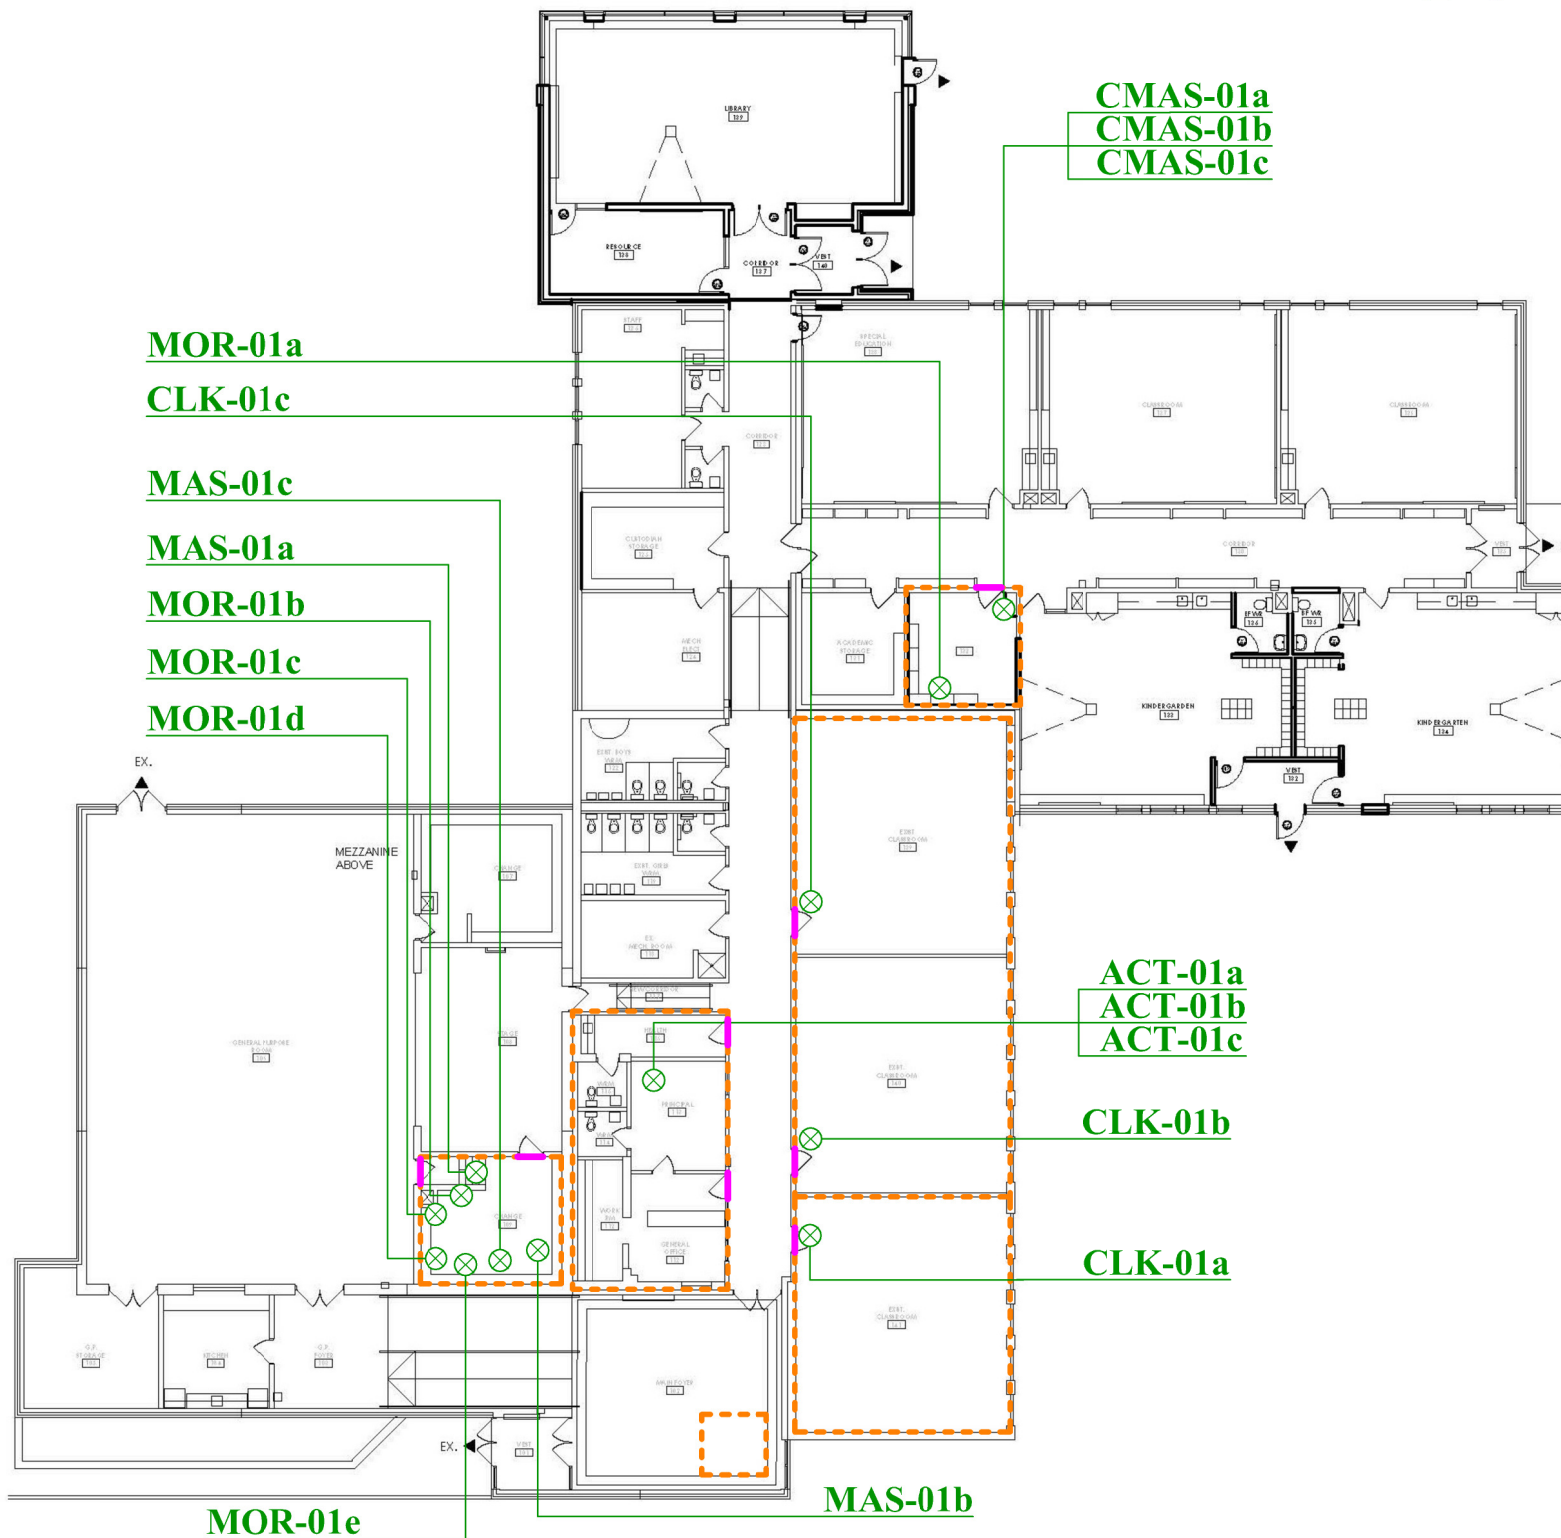
**DESIGNATED SUBSTANCES SURVEY**

Designated Substances/ Hazardous Materials	Findings
Asbestos	Approximately 54 ln ft of Brown caulking (Sample Nos: CLK-01a to CLK-01c) observed around the metal door frames within Classroom 101, 102 and 103 was identified to contain <b>1% Chrysotile</b> asbestos. Based on the homogeneous grouping of this material, all visually similar brown caulking in the Subject Building is to be considered as asbestos containing. The asbestos containing brown caulking within Classroom 101, 102 and 103 was observed to be in good condition at the time of the site visit.
	Yellow caulking observed on the lining of concrete block walls and concrete block ceiling in the Hallway parallel to the General Office (above ceiling tiles) on the Ground Floor of the Subject building was previously identified to contain <b>4% Chrysotile</b> asbestos (S2S, 2021). The asbestos containing yellow caulking on the lining of concrete block walls and concrete block ceiling in the Hallway parallel to the General Office (above ceiling tiles) was observed to be in good condition at the time of the site visit.

- 1) S2S recommends that the following asbestos containing materials identified in Table 2 above be managed in place and/or removed following Type 1 asbestos abatement procedures in accordance with O. Reg. 275/05:
  - a. Brown caulking observed around the doors in the Subject Areas;
  - b. Yellow caulking observed on the lining of concrete block walls and concrete block ceiling (above ceiling tiles) in the Hallway parallel to the General Office;

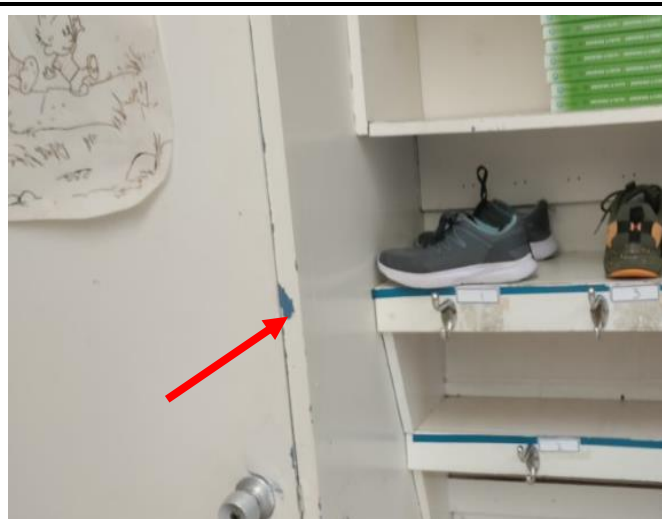
ACMs may be present behind or within materials in inaccessible areas as noted above within Sections 4.1 and 4.3 of this report.
Lead	Blue paint (Layer 2) observed behind the non-lead containing beige paint on the closet and storage cupboard within Classroom 101 was previously identified to contain <b>0.0084% lead</b> by dry weight (S2S, 2023). The paint was observed to be in fair condition at the time of site visit.
	White paint present on concrete ceiling of Classroom 101 was previously identified to contain <b>150 ppm (0.015%)</b> lead content by dry weight (S2S, 2021). The paint was observed to be in good condition at the time of site visit.
	Dark blue paint present on wooden closet built-ins of Classroom 101 was previously identified to contain <b>960 ppm (0.096%)</b> lead content by dry weight (S2S, 2021). The paint was observed to be in good condition at the time of site visit.
	Lead may be present in paints of limited application not sampled, electronic components (e.g., wiring connections, wire bundles, etc.), plumbing solder, roof flashing, noise baffles, emergency lighting batteries, and cast-iron piping gaskets

**Photo 1: View of lead containing blue paint (layer 2) (see arrow) observed behind the non-lead containing beige paint on the closet and storage cupboard within Classroom 101 of the Subject Building.**

- 2) Paints identified in Table 2 were found to contain detectable concentrations of lead. Paints with similar texture and appearance that are present in other areas of the Subject Building should be presumed to contain similar concentrations of lead. During any planned renovation, these materials should be regarded as lead containing.

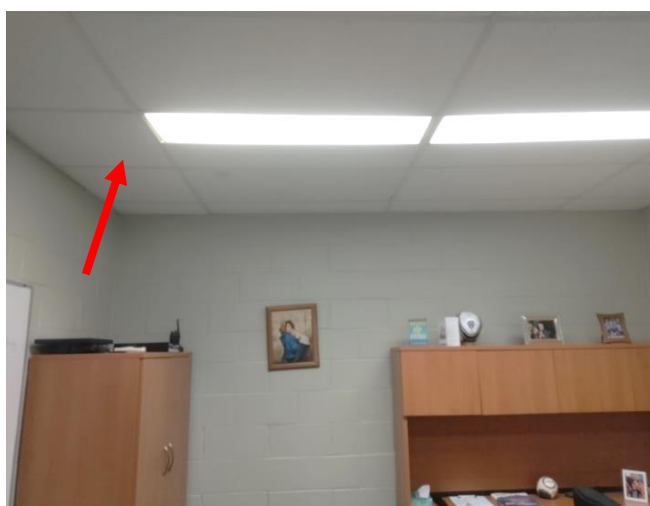
**Photo 2: View of non asbestos containing grey acoustic ceiling tiles (see arrow) observed within Principal Room 123 of the Subject Building.**
