# **LIMITED DESIGNATED SUBSTANCE SURVEY REPORT (NEW CUSTODIAL ROOM PROJECT)**

**King Albert Public School  
49 Glenelg Street West,  
Lindsay, Ontario**

**December 20, 2023**

**Maple Project No. 21402**

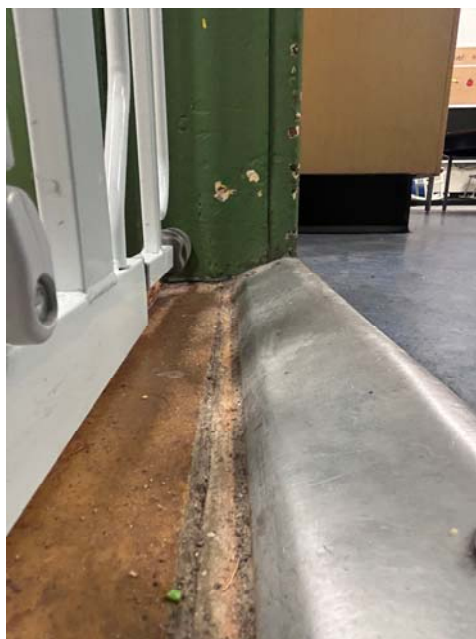
However, Maple has concerns with the built-up profile of the flooring in Room 109 as compared to the Corridor as it may be concealing additional layers of flooring.

Maple did not do any intrusive investigation of the flooring as it would destroy the integrity of the flooring and cause a tripping hazard.

Maple recommends destructive testing of the raised flooring in Classroom 109 to confirm the presence or absence of potential asbestos-containing flooring that maybe concealed.
