ASBESTOS-CONTAINING BUILDING MATERIALS RE-ASSESSMENT REPORT

Fenelon Township Public School

50 Cameron Road
Cameron, Ontario

September 2024

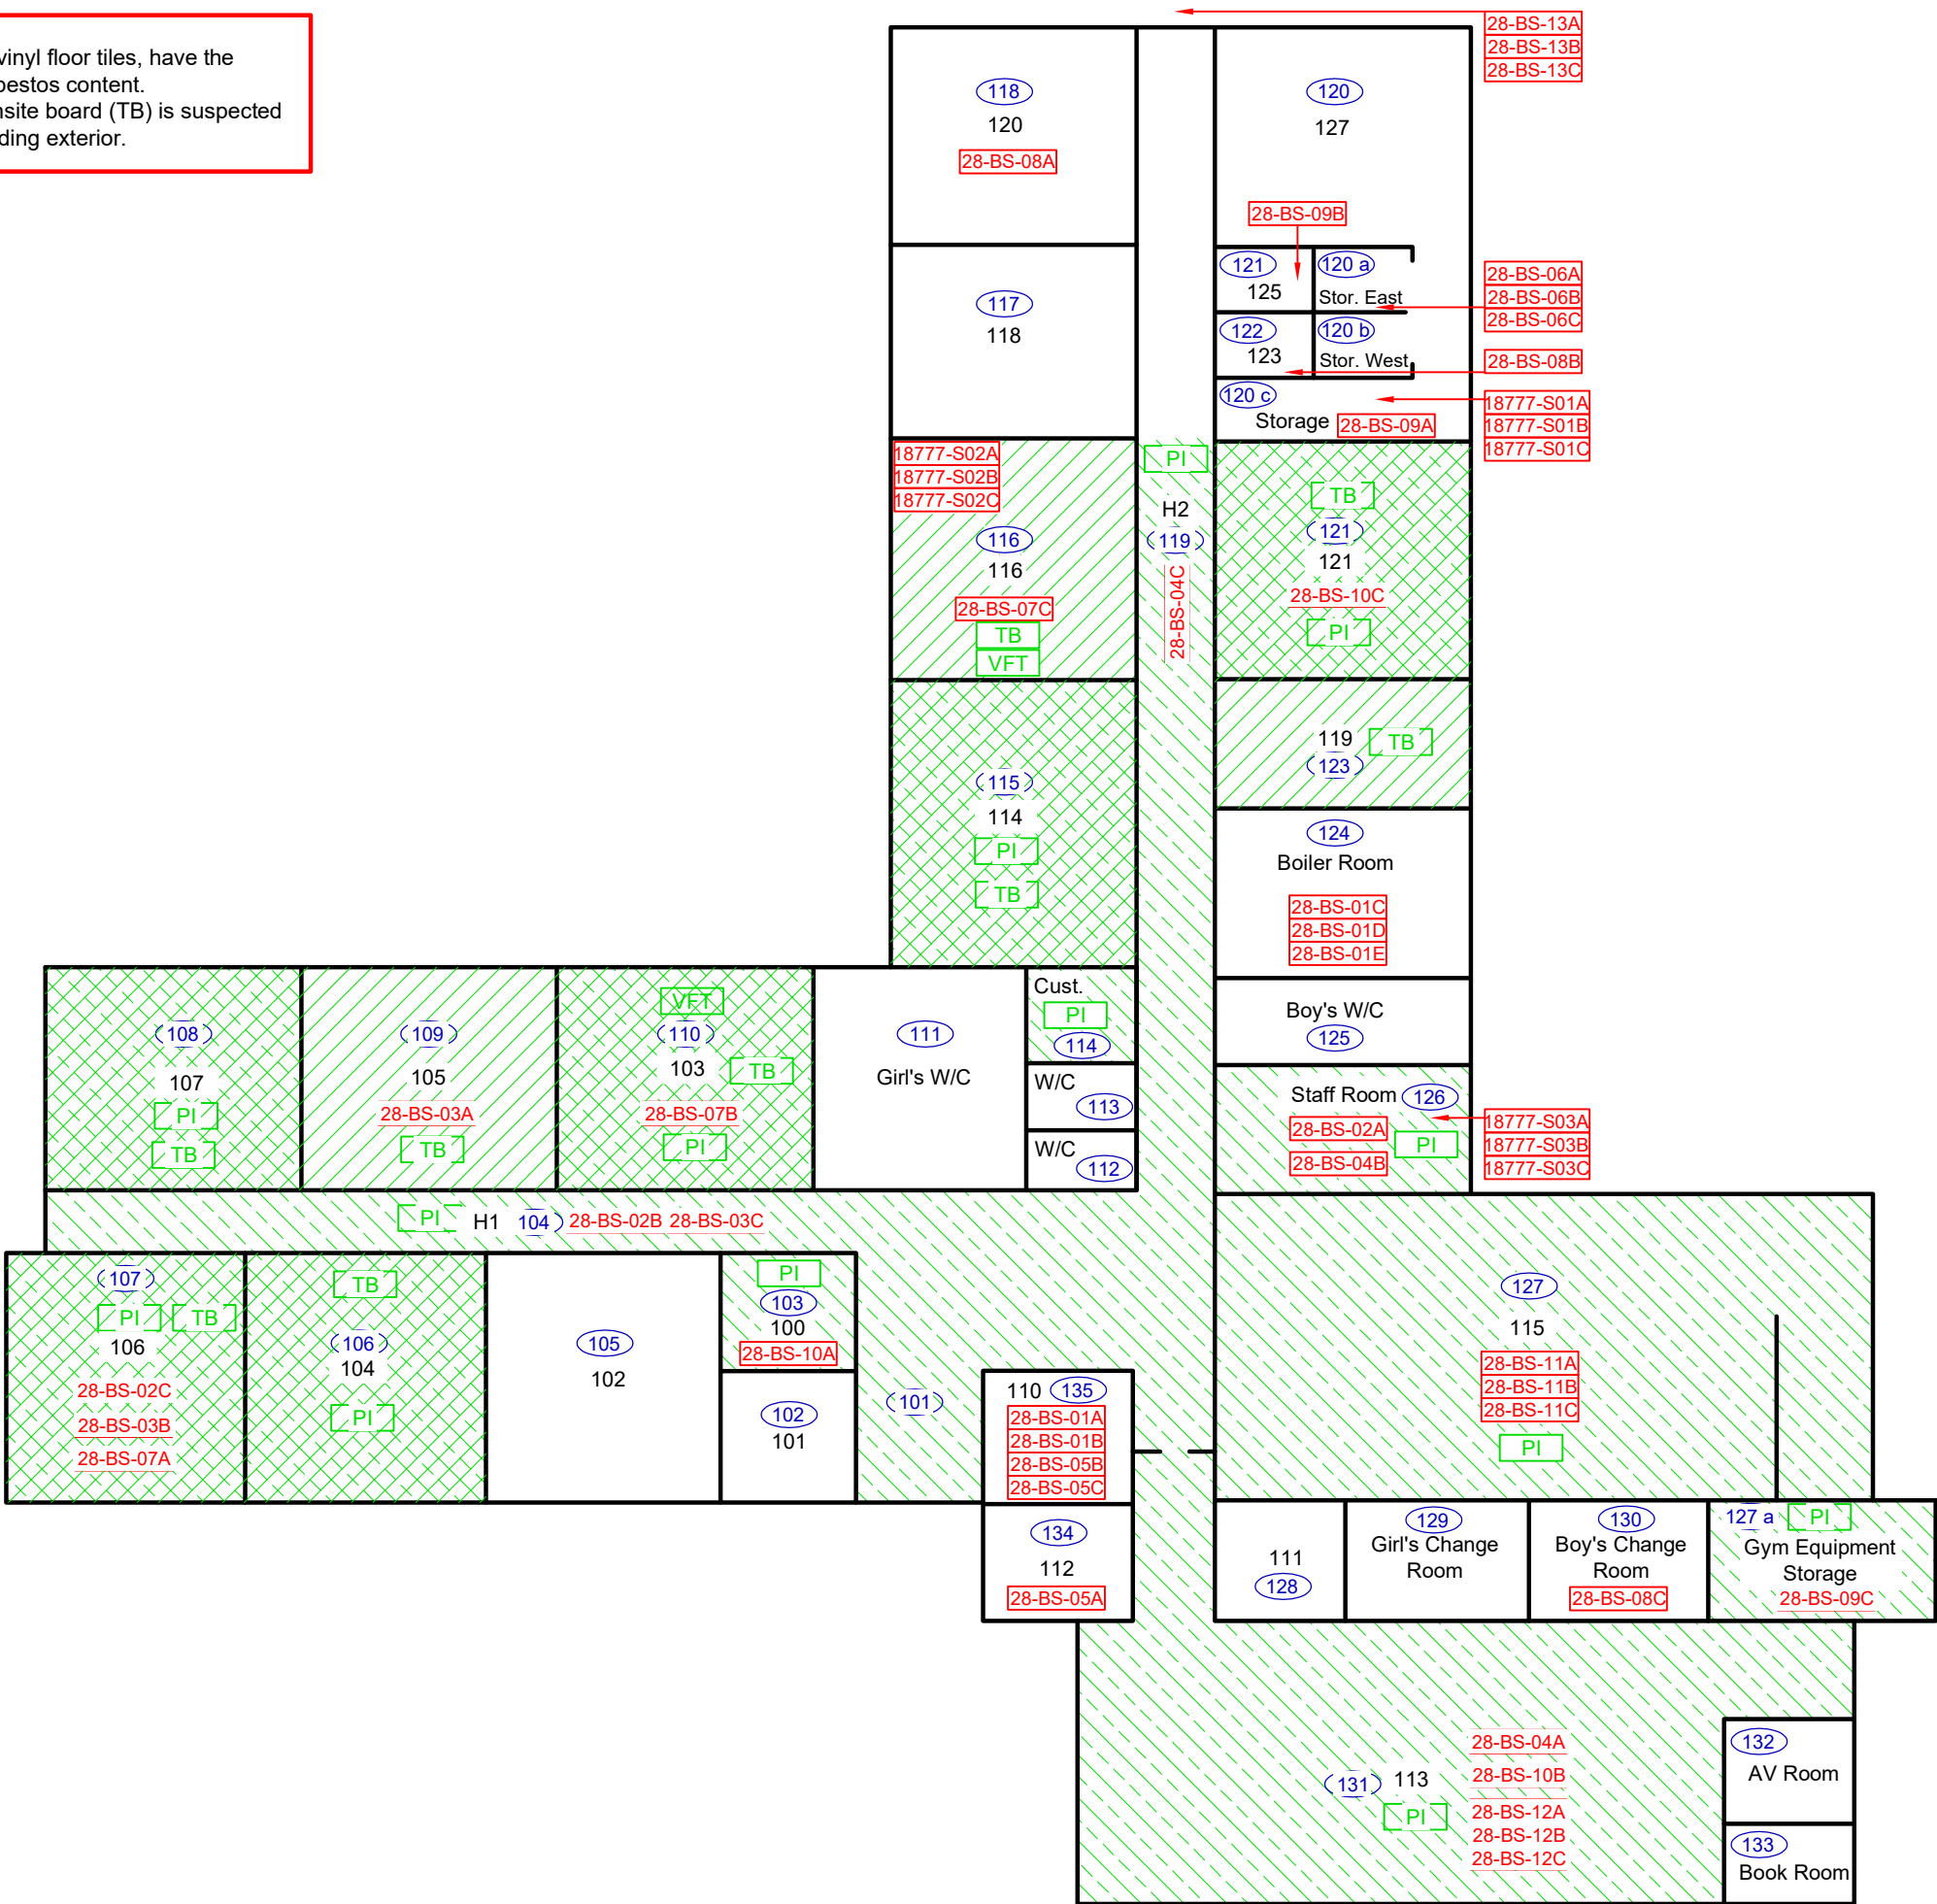
Please Note:
Prior to disturbing 9"x9" vinyl floor tiles, have the material analyzed for asbestos content. Asbestos-containing transite board (TB) is suspected to be present on the building exterior.
