Re: Hazardous Building Materials Assessment (Preconstruction)
Electrical Labs, Progress Campus, Centennial College
941 Progress Avenue, Toronto, Ontario
Pinchin File: 355286.000

Centennial College (Client) retained Pinchin Ltd. (Pinchin) to conduct a hazardous building materials assessment in the Electrical Lab B1-16 (HMIS Location 347), Electronics Lab E1-12 (HMIS Location 259) and Hydraulics Lab E1-15 (HMIS Location 261) of Block B and Block E areas in the Centennial College Progress Campus located at 941 Progress Avenue, Toronto, Ontario.

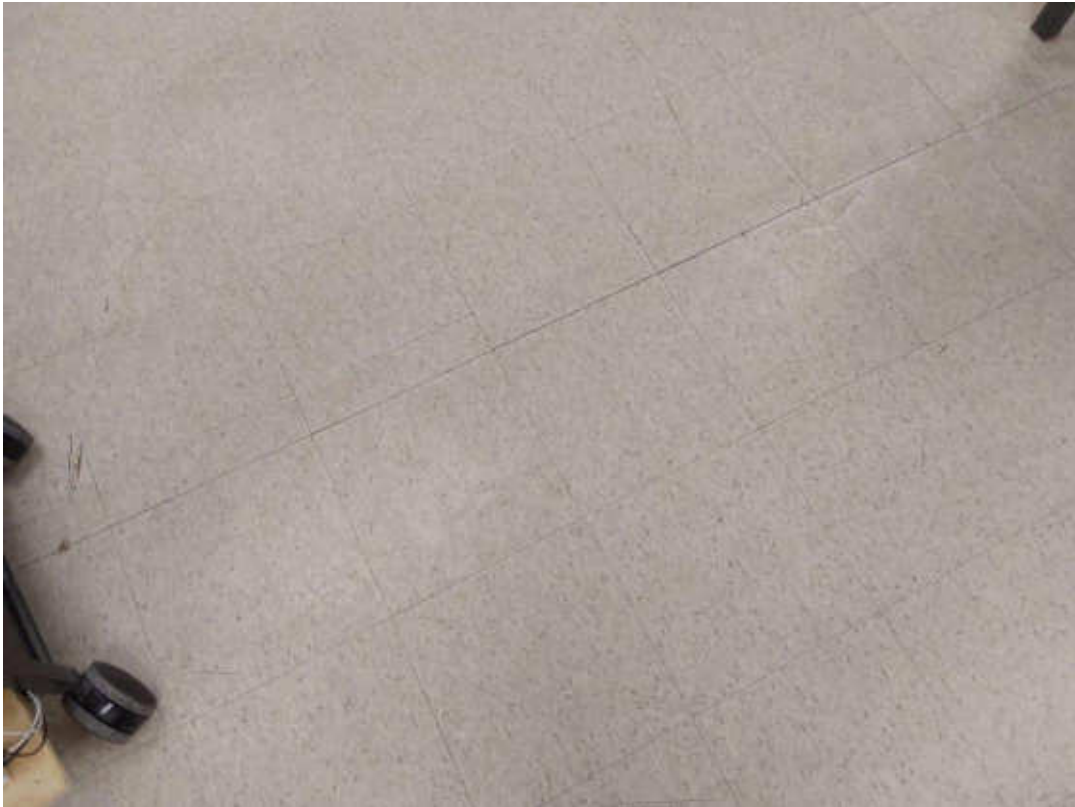
S0016A (None), 12" x 12" grey mottled, Floor, All, Vinyl Floor Tile and Mastic, Classroom (Location #: 259)

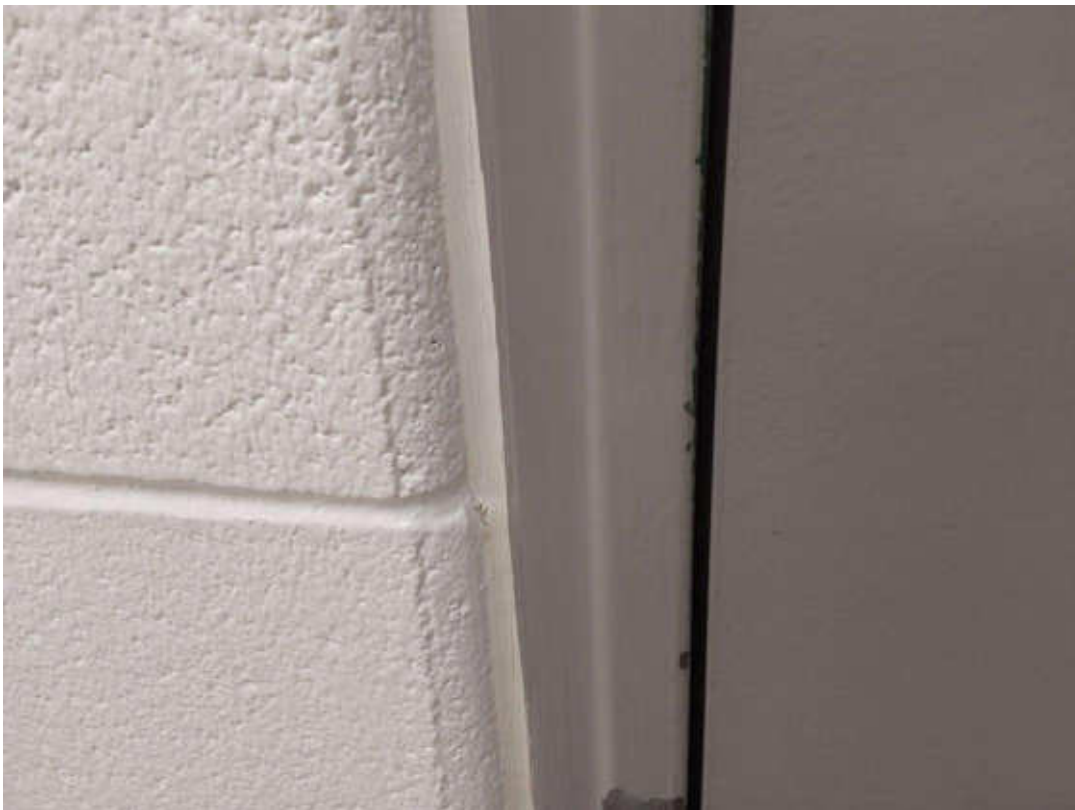
S0044C (None), Beige door caulking, Other, Caulking, Classroom (Location #: 259)

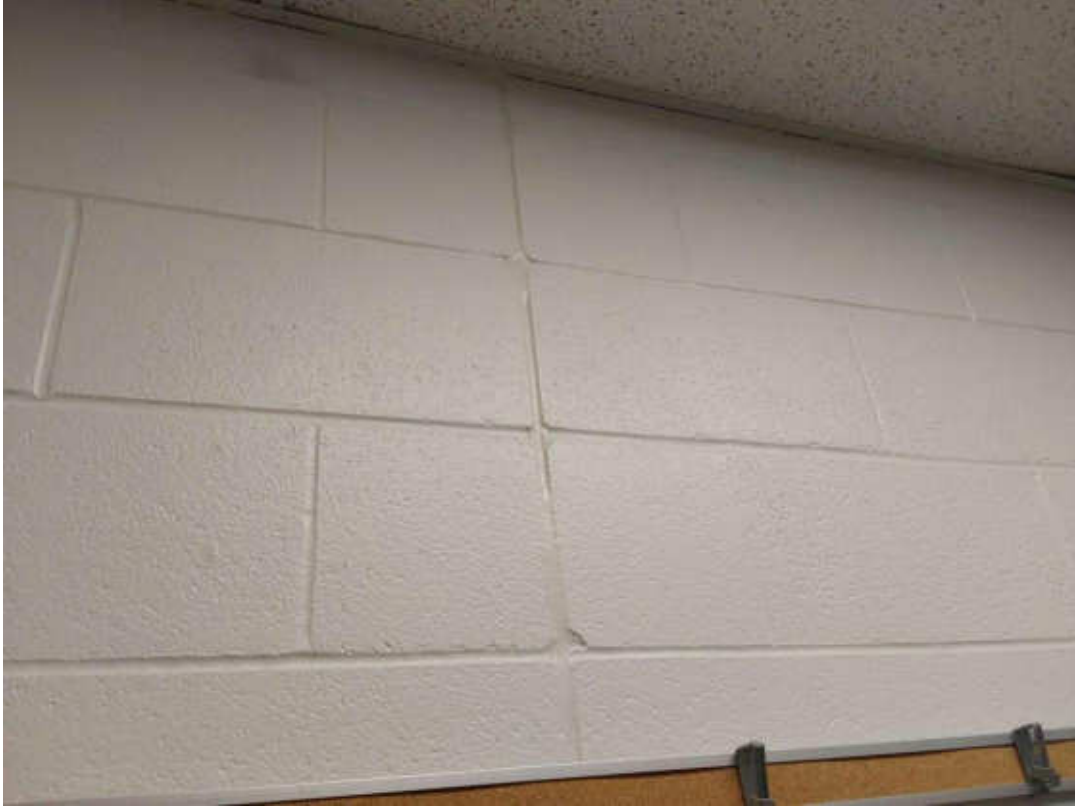
S0045C (None), Beige expansion joint caulking, Wall, Expansion Joint, Caulking, Classroom (Location #: 259)

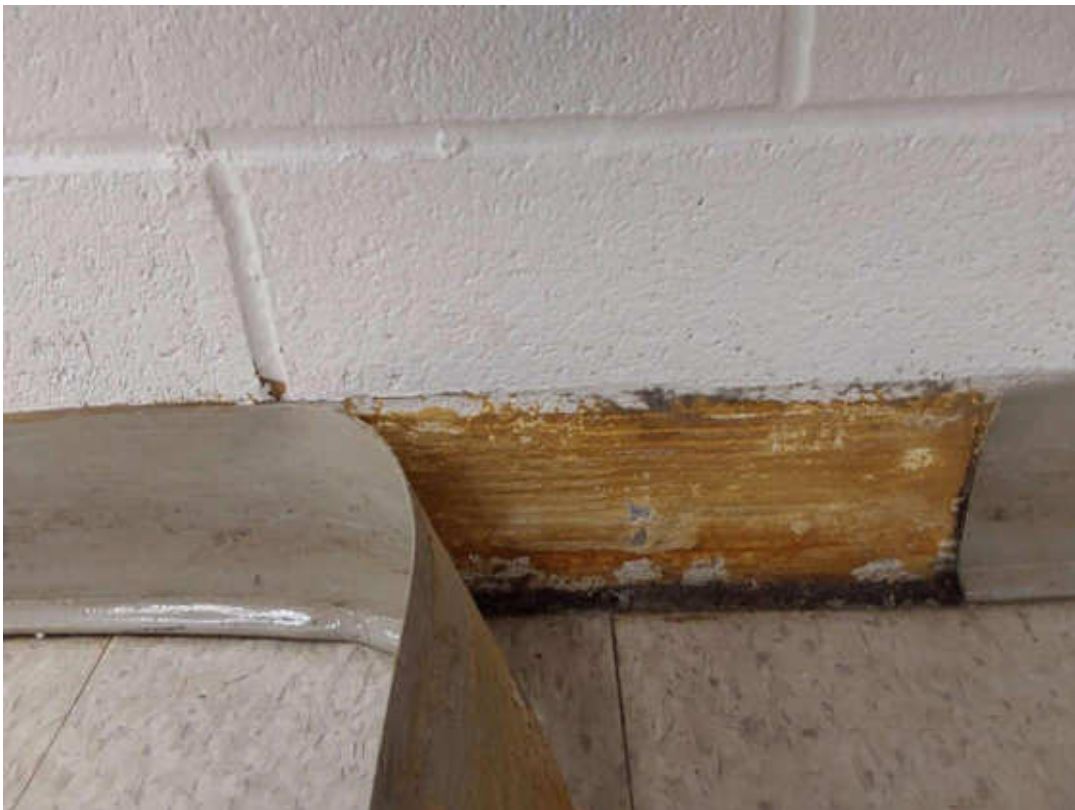
S0046C (None), Yellow baseboard mastic, Wall, Base, Adhesive/mastic, Classroom (Location #: 259)

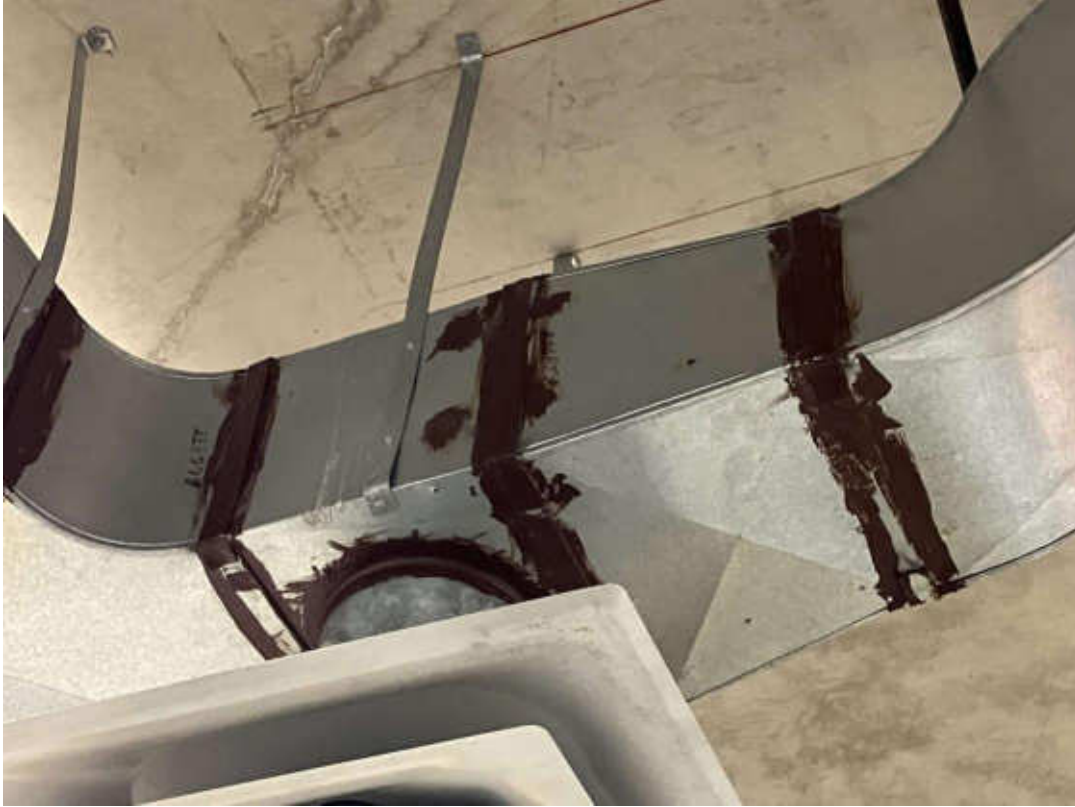
S0053C (None), Brown duct mastic, Duct, Mastic, Hydraulics Lab (Location #: 261)

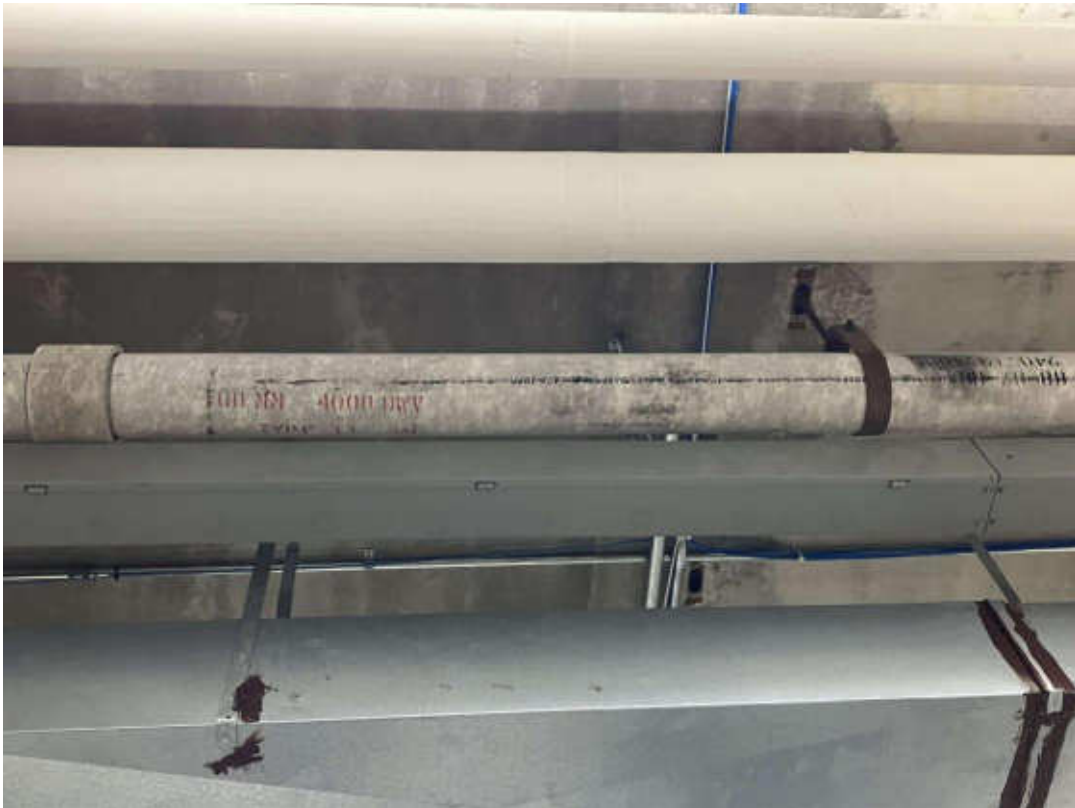
Materials identified as Sample Number V9000 were observed to be present and were determined to contain asbestos based on previous analytical results, or labelling (e.g., Transite clearly labelled by the manufacturer).

V9000 (Confirmed Asbestos), Piping, Cement Product, Hydraulics Lab (Location #: 261)

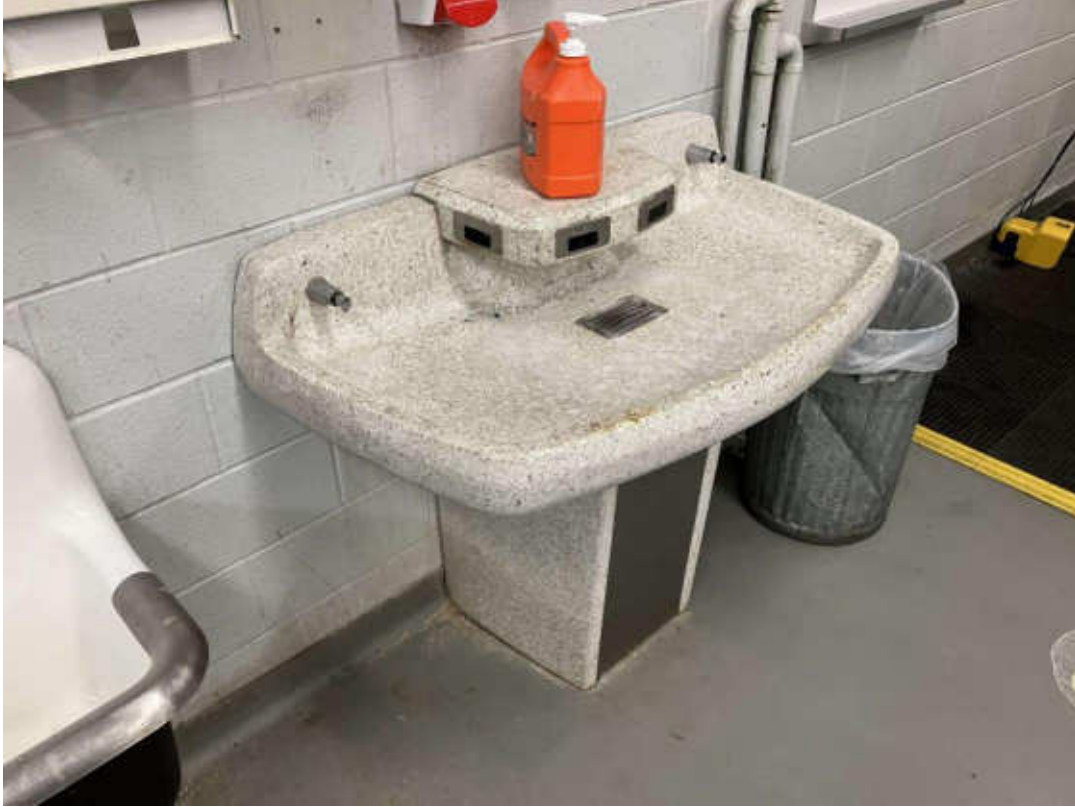
Materials identified as Sample Number V9500 were either observed to be present or based on the construction of the building/equipment are likely present in concealed locations. These materials have not been sampled and are presumed to contain asbestos based on historical known use of asbestos. Sampling of these materials may be completed prior to disturbance. Materials identified as Sample Number V0000 were determined to be non-asbestos based on the manufacture date and known end of use of asbestos in these products.

V9500 (Presumed Asbestos), Other, Sink, Terrazzo, Hydraulics Lab (Location #: 261)
Bradley sink

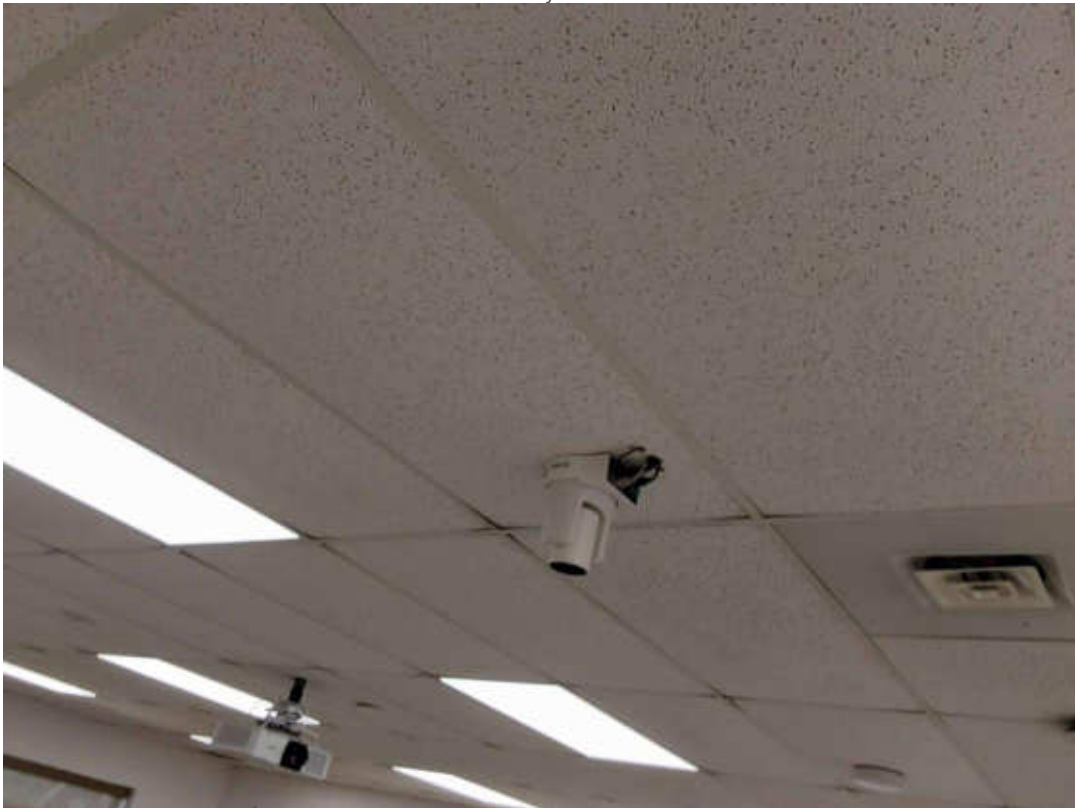
V0000 (None), 2ft by 4ft pinhole and small fissure, Ceiling, All, Ceiling Tiles (lay-in), Classroom (Location #: 259)
No date present

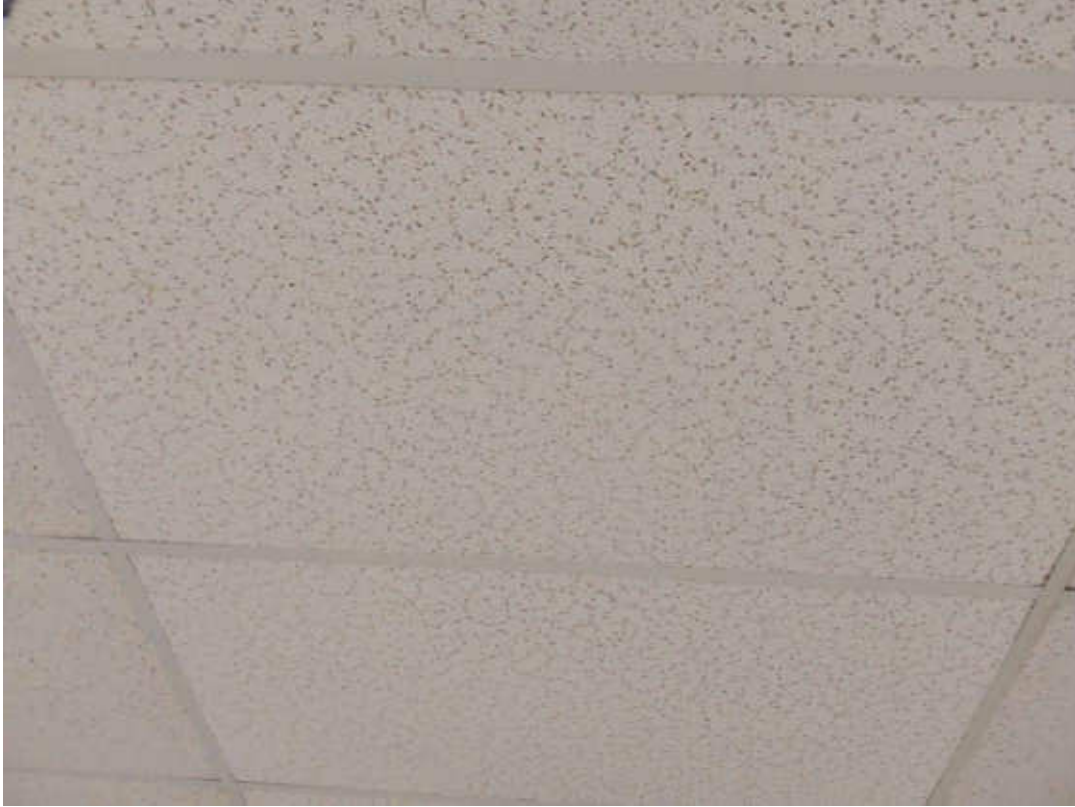
V0000 (None), 2ft by 4ft pinhole and fissure, Ceiling, All, Ceiling Tiles (lay-in), Classroom (Location #: 259)
Date stamped 07/08/02

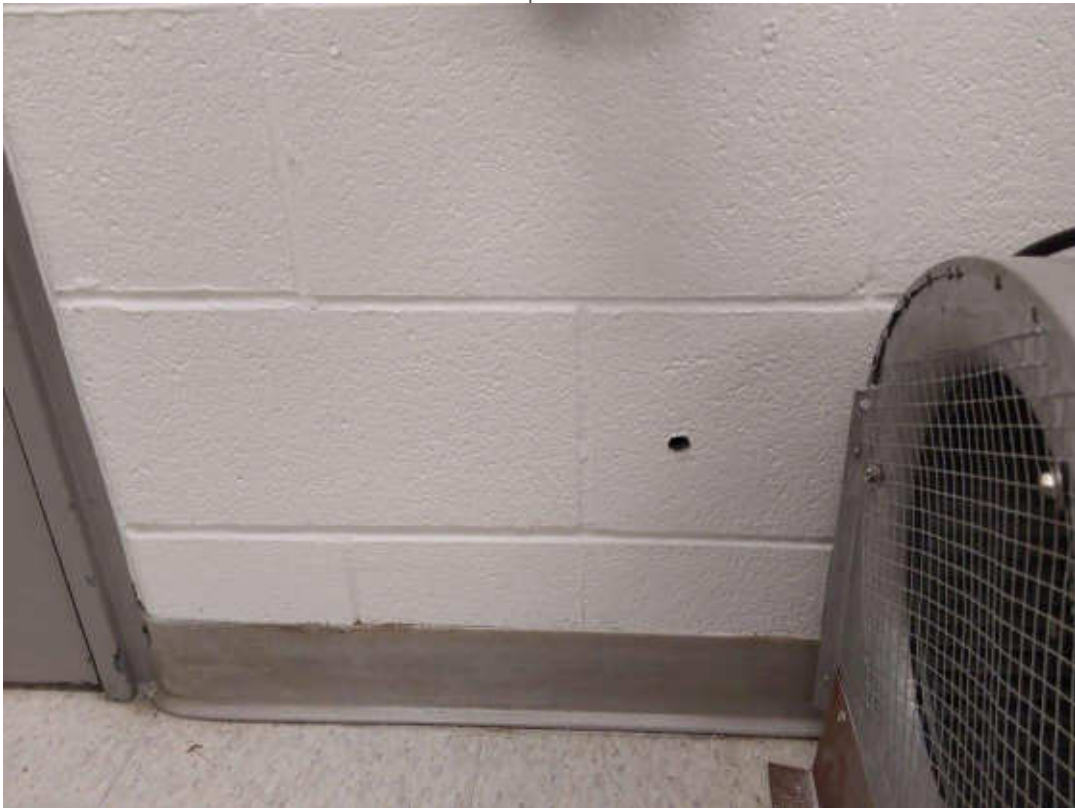
V0000 (None), Wall, Vermiculite Investigation, Classroom (Location #: 259)

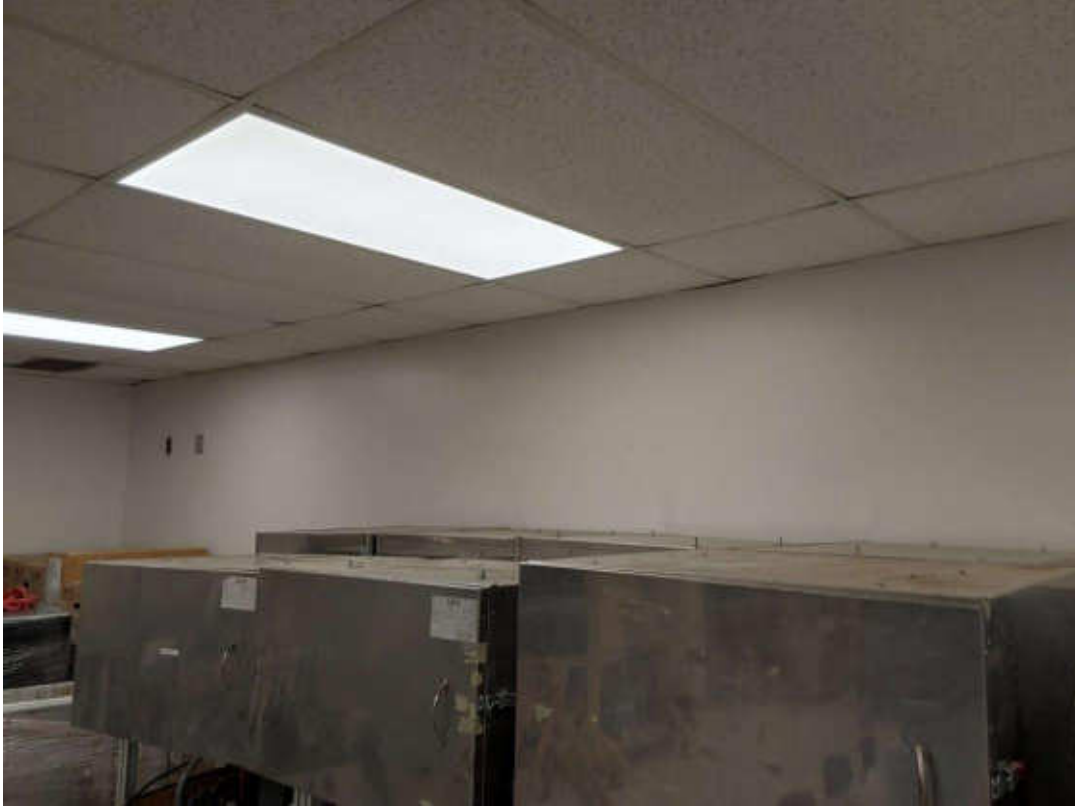
V0000 (None), Wall, Drywall and joint compound, Classroom (Location #: 259)

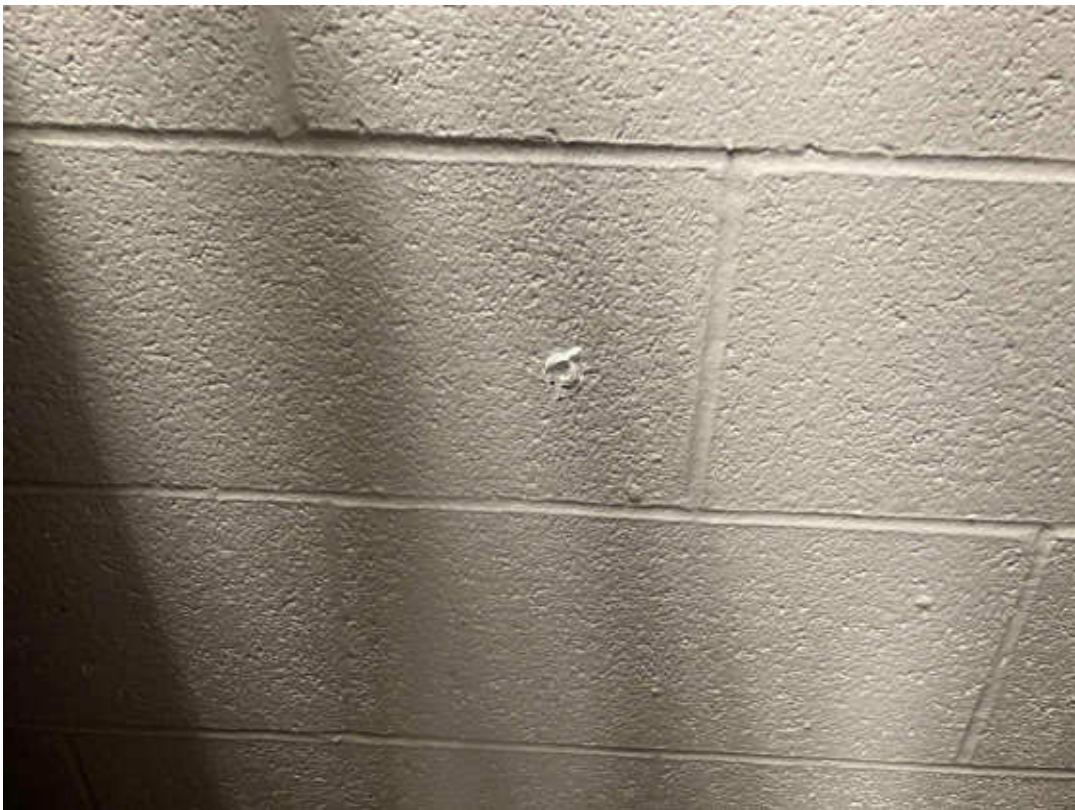
V0000 (None), Wall, Vermiculite Investigation, Hydraulics Lab (Location #: 261)

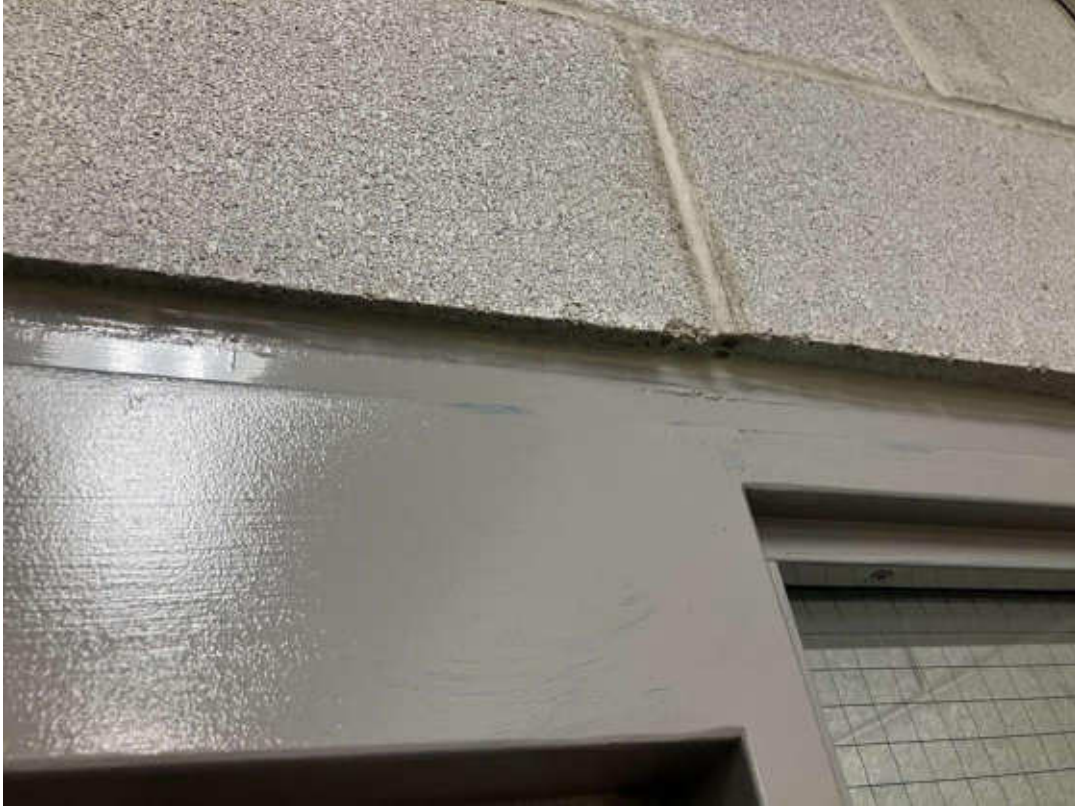
V0000 (None), Other, Silicone, Hydraulics Lab (Location #: 261)
Silicone caulking on door

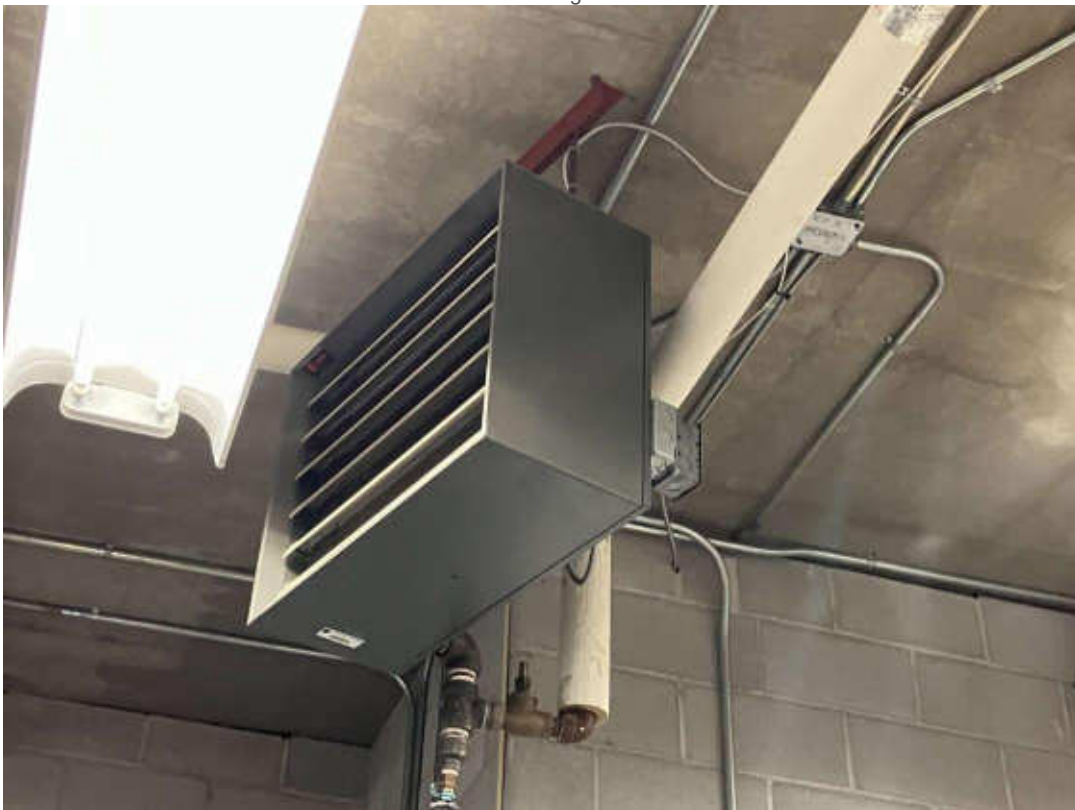
Mechanical Equipment, Unit Heater, Not Insulated, Hydraulics Lab (Location #: 261)

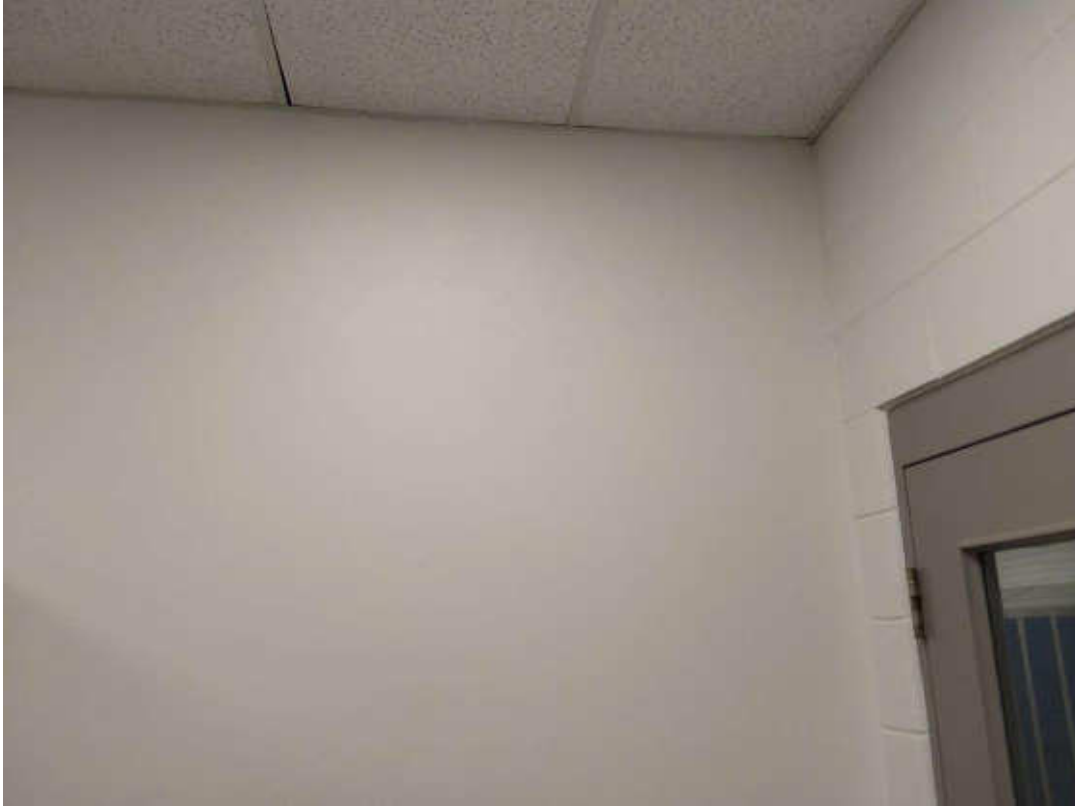
V0005(Lead, None), White paint on drywall, Wall, Classroom (Location #: 259)

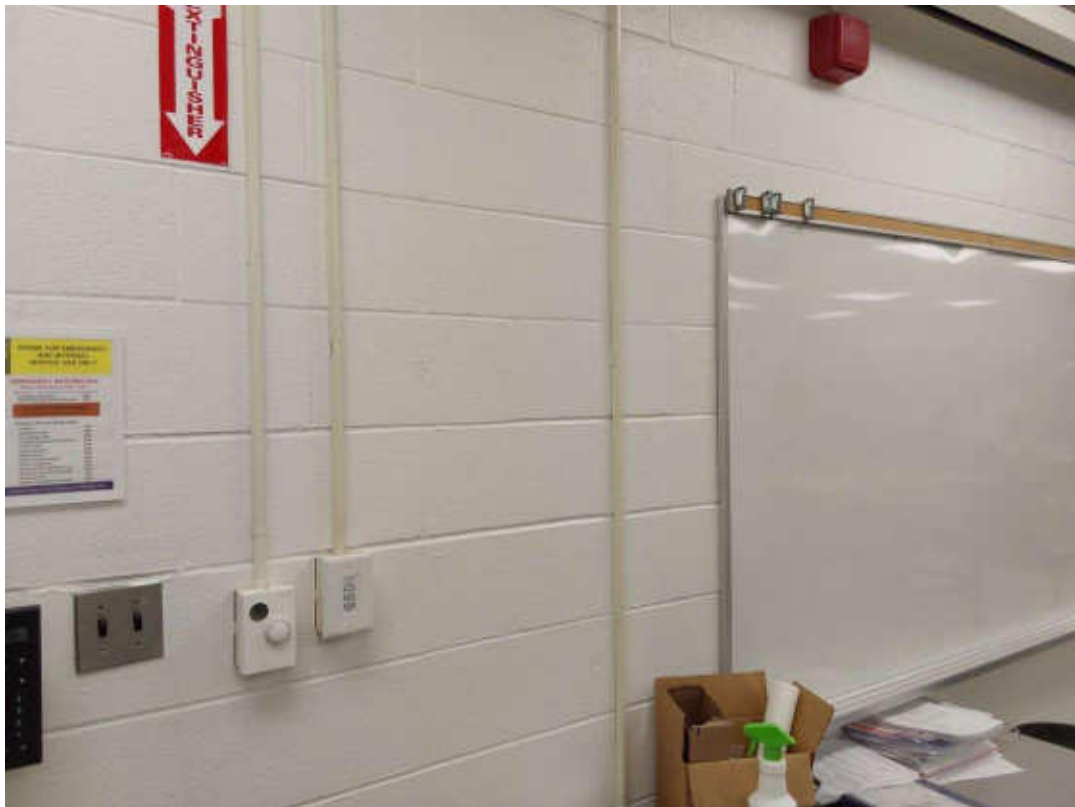
V0006(Lead, None), White paint on block walls, Wall, Classroom (Location #: 259)

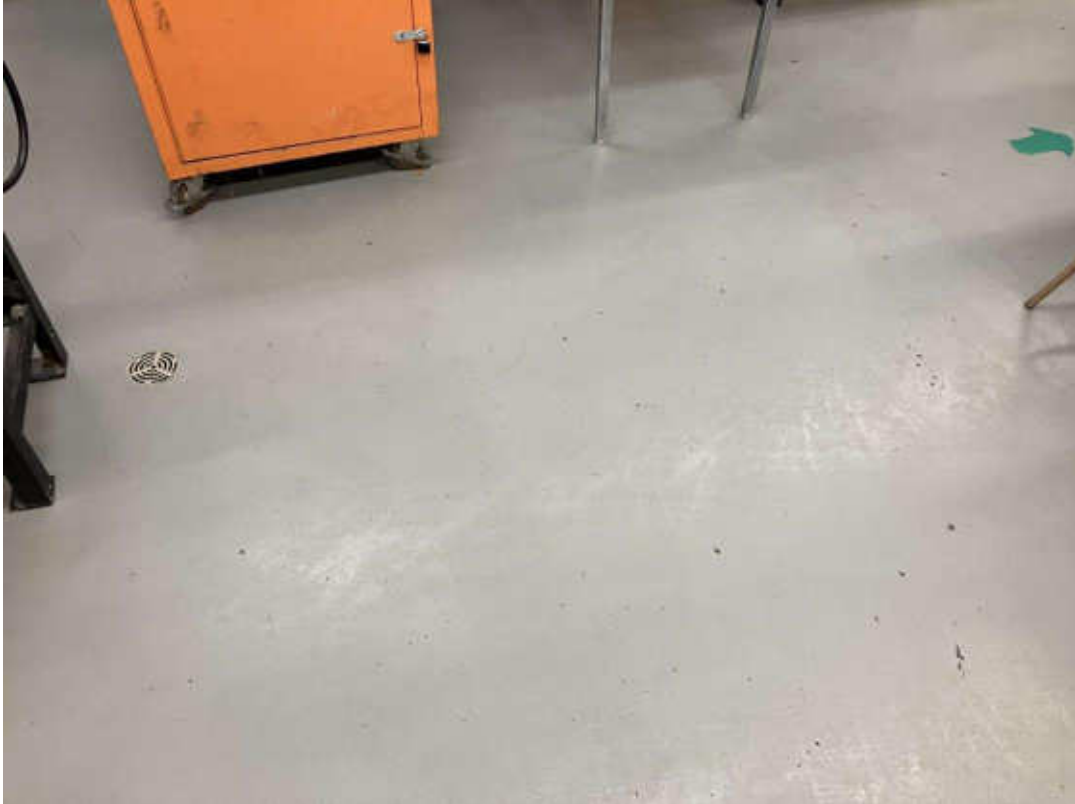
L0008(Lead, None), Grey paint on floor, Floor, Hydraulics Lab (Location #: 261)

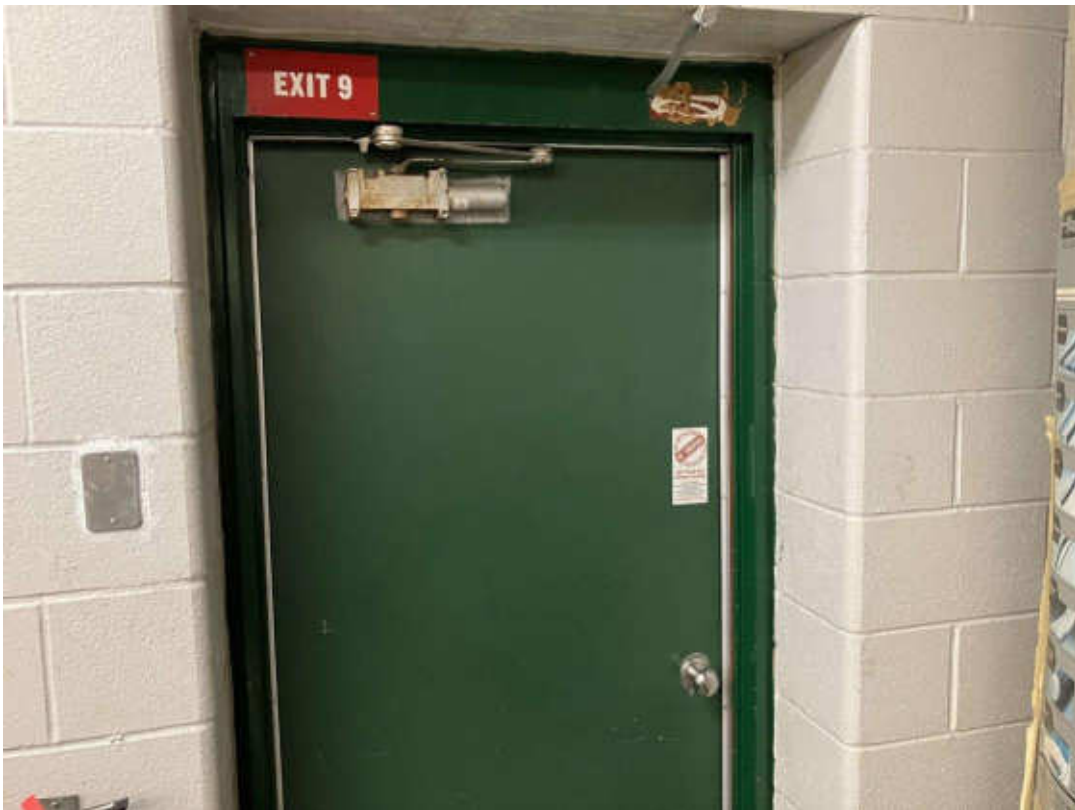
L0009(Lead, Low), Green paint on door frame, Wall, Hydraulics Lab (Location #: 261)

For paints identified as having low levels of lead (i.e., equal to or above 0.009% (90 mg/kg) but less than or equal to the EACC guideline of 0.1% (1,000 mg/kg) for lead-containing paints) special precautions are not recommended unless aggressive disturbance (grinding, blasting, torching) is planned.

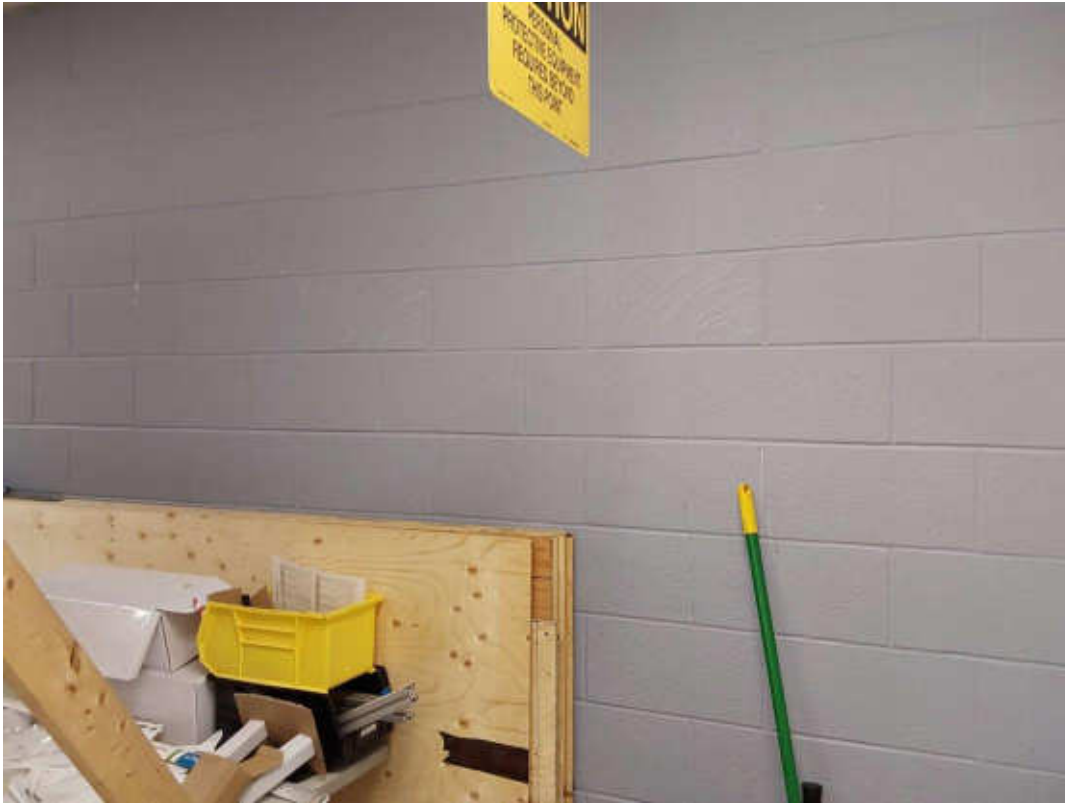
V0014(Lead, None), Blue paint on concrete block wall, Wall, Electrical Lab (Location #: 347)

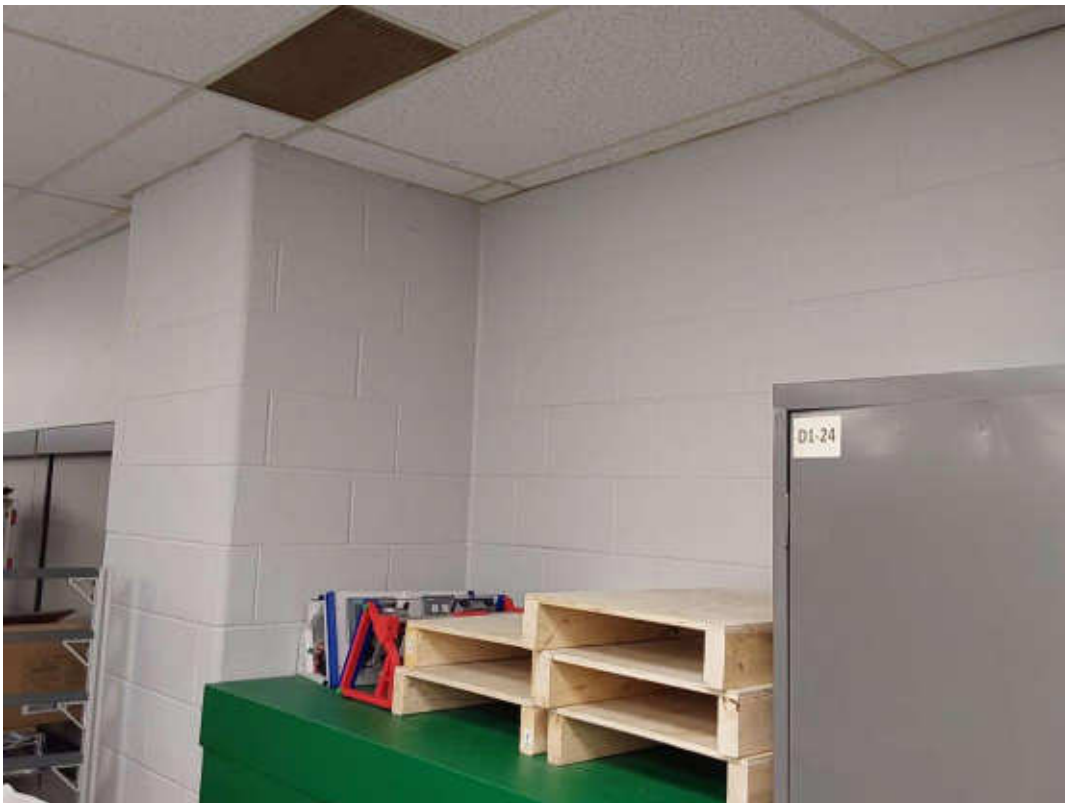
V0015(Lead, None), Grey paint on concrete block walls, Wall, Electrical Lab (Location #: 347)

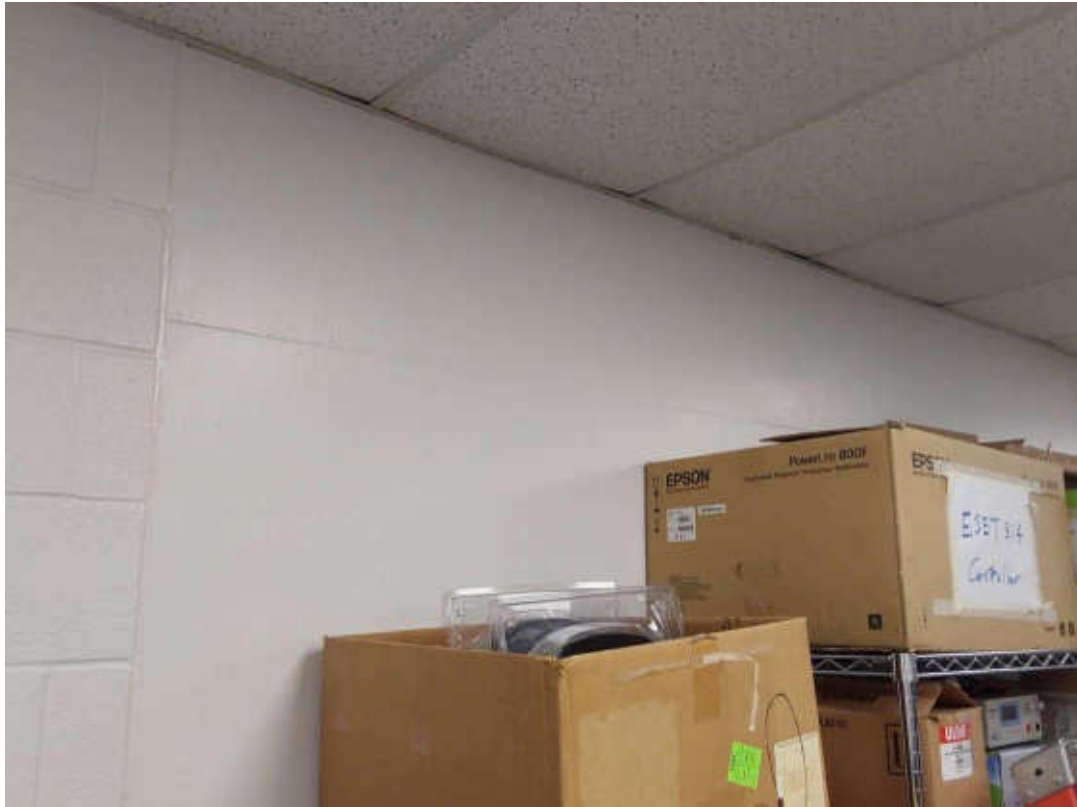
L0020(Lead, None), White paint on concrete wall, Wall, Classroom (Location #: 259)

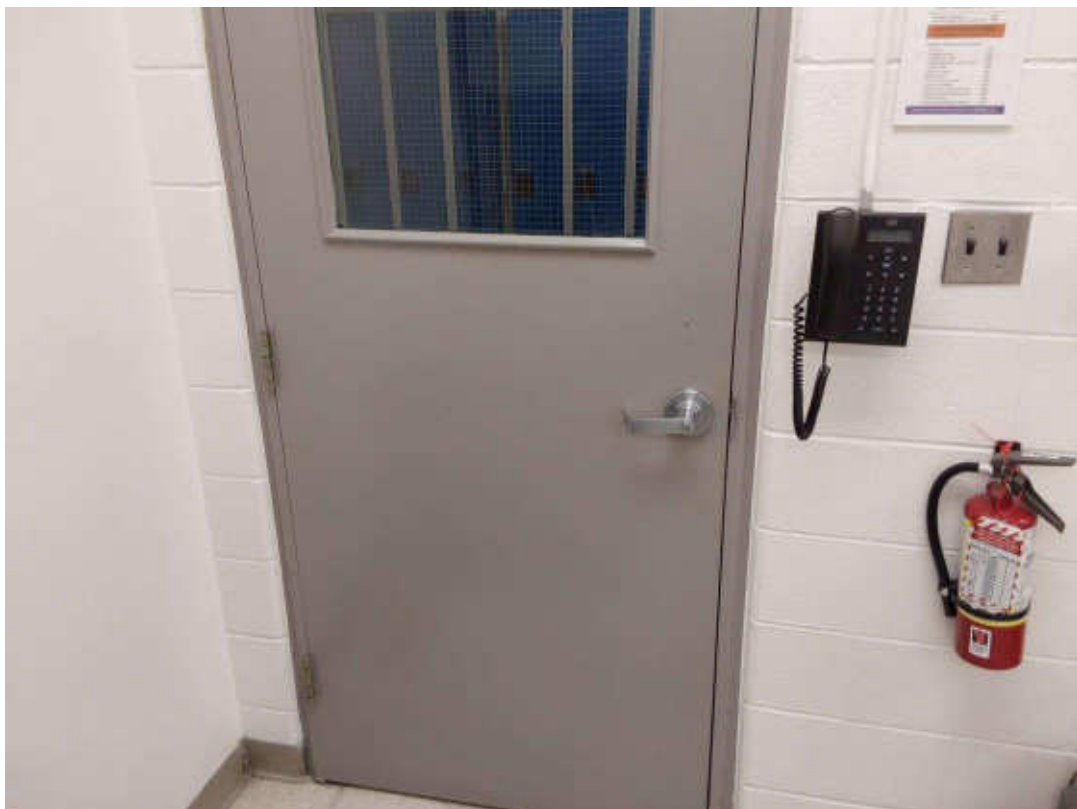
L0021(Lead, None), Grey paint on metal door frames, Other, Classroom (Location #: 259)

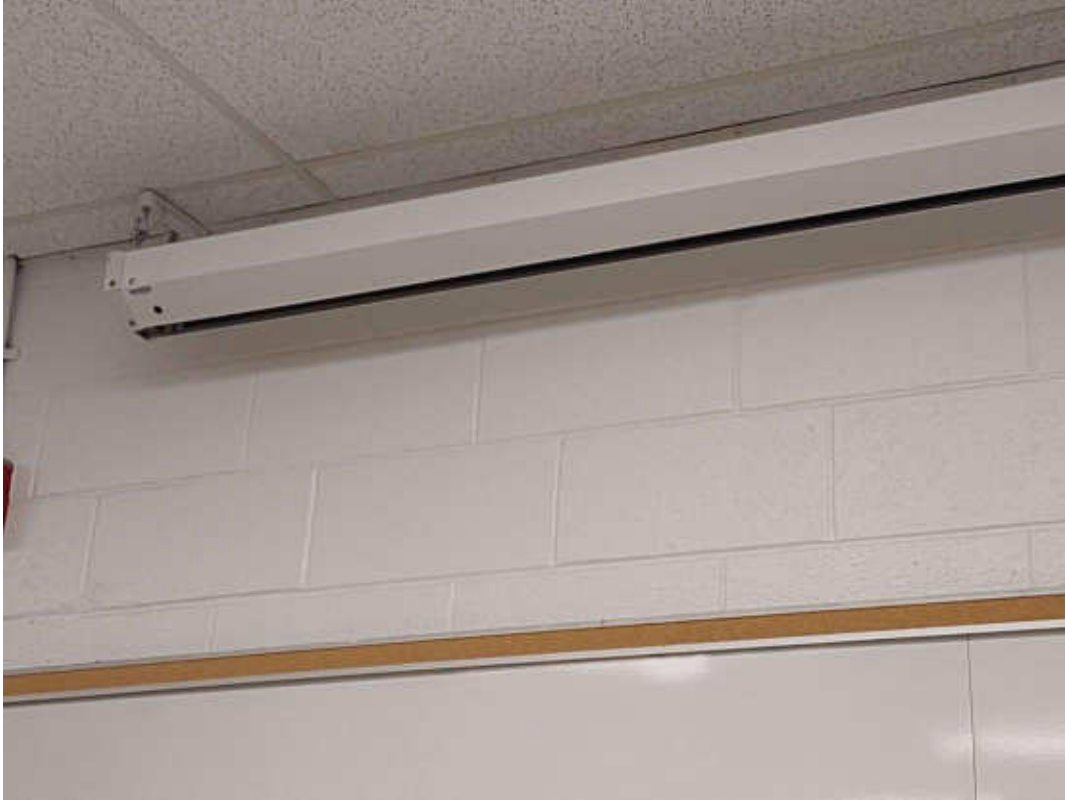
L0022(Lead, Low), White paint on concrete block wall, Wall, Electrical Lab (Location #: 347)

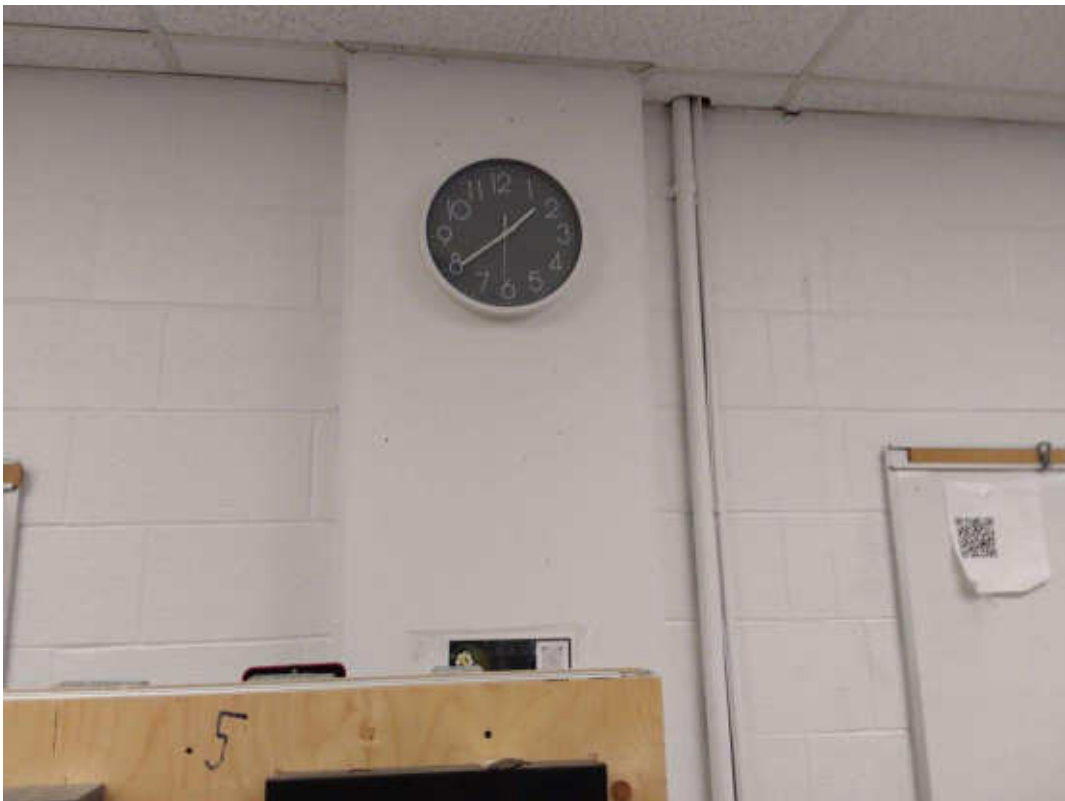
L0023(Lead, None), White paint on concrete, Wall, Electrical Lab (Location #: 347)

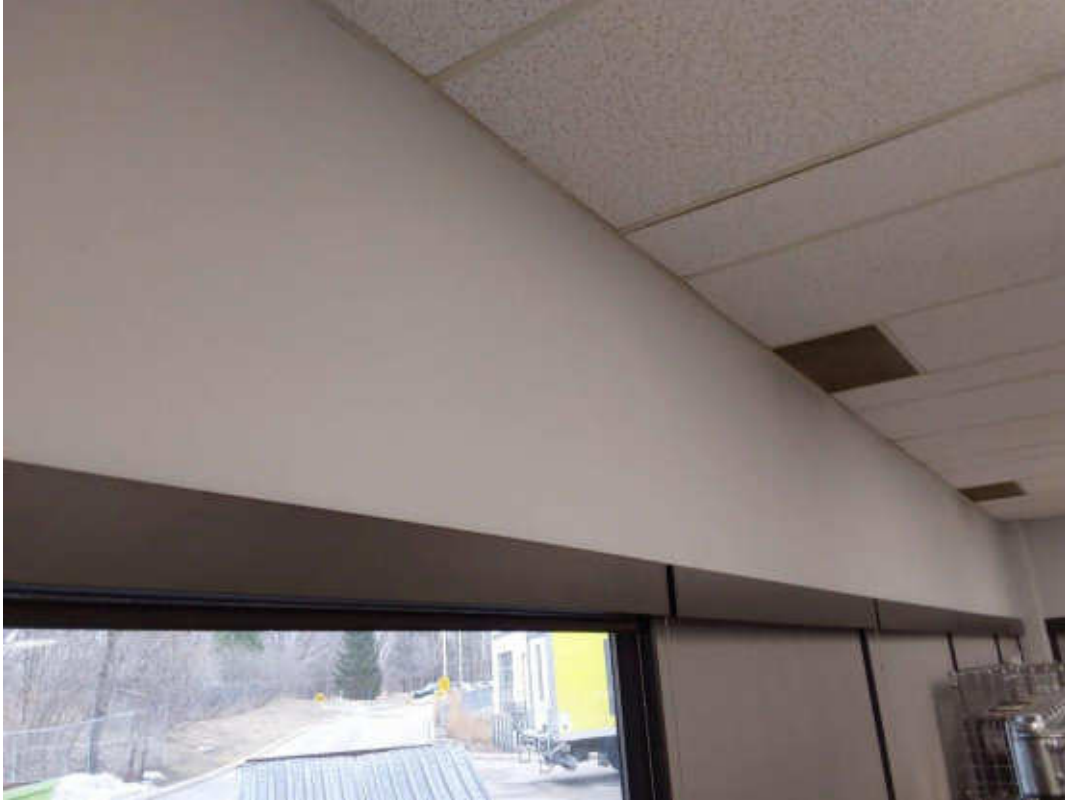
L0024(Lead, None), Grey paint on drywall walls, Wall, Electrical Lab (Location #: 347)
