Re: Hazardous Building Materials Assessment (Preconstruction)
Electrical Labs, Progress Campus, Centennial College
941 Progress Avenue, Toronto, Ontario
Pinchin File: 355286.000

Centennial College (Client) retained Pinchin Ltd. (Pinchin) to conduct a hazardous building materials assessment in the Electrical Lab B1-16 (HMIS Location 347), Electronics Lab E1-12 (HMIS Location 259) and Hydraulics Lab E1-15 (HMIS Location 261) of Block B and Block E areas in the Centennial College Progress Campus located at 941 Progress Avenue, Toronto, Ontario.

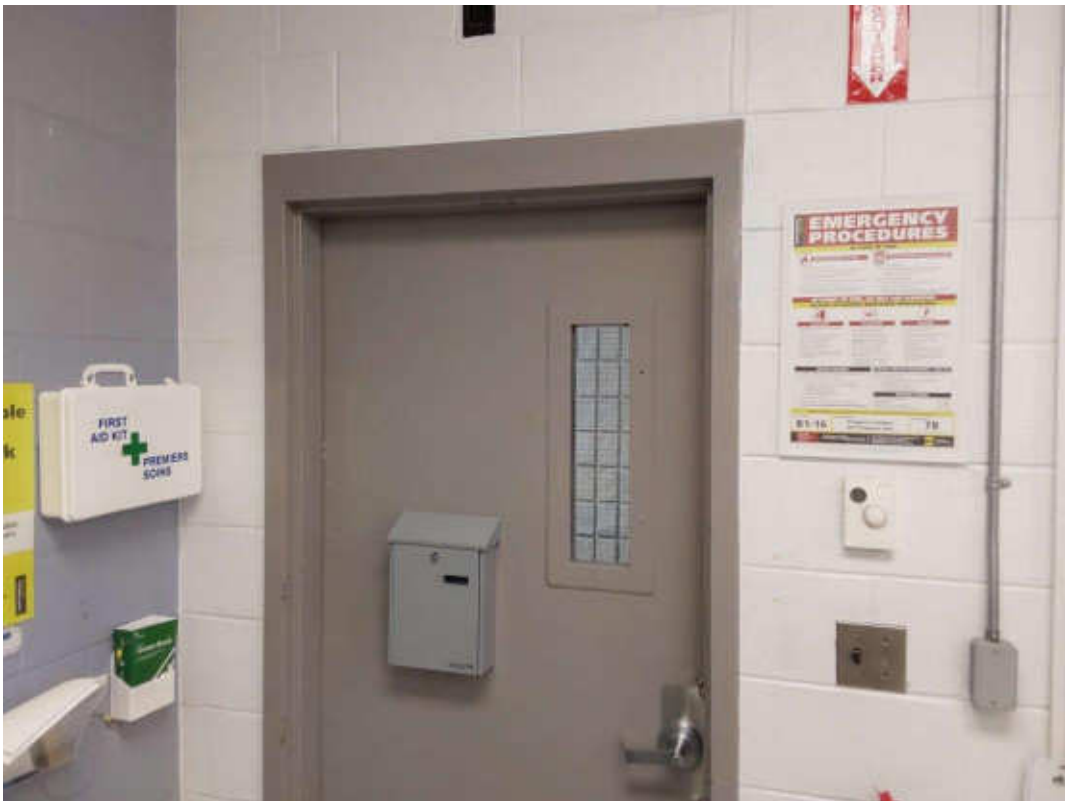
L0025(Lead, Low), Grey paint on metal door frames, Other, Electrical Lab (Location #: 347)

For paints identified as having low levels of lead (i.e., equal to or above 0.009% (90 mg/kg) but less than or equal to the EACC guideline of 0.1% (1,000 mg/kg) for lead-containing paints) special precautions are not recommended unless aggressive disturbance (grinding, blasting, torching) is planned.

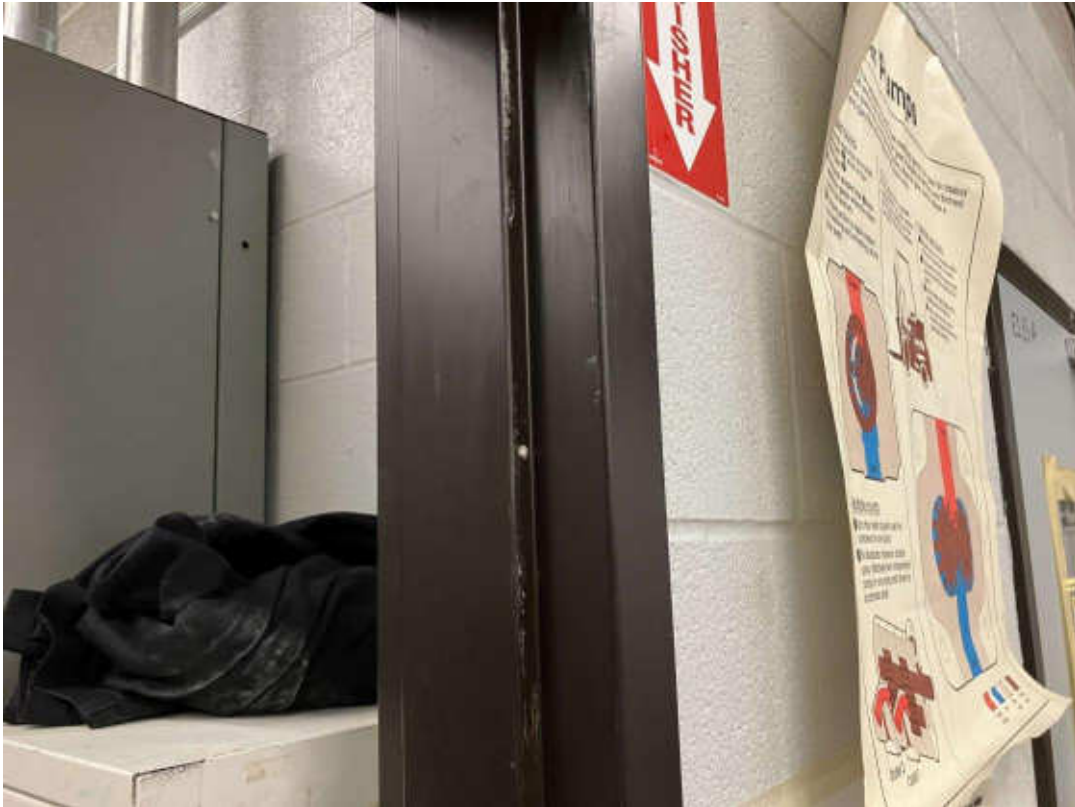
L0026(Lead, None), Dark brown paint on metal door frames, Wall, Hydraulics Lab (Location #: 261)

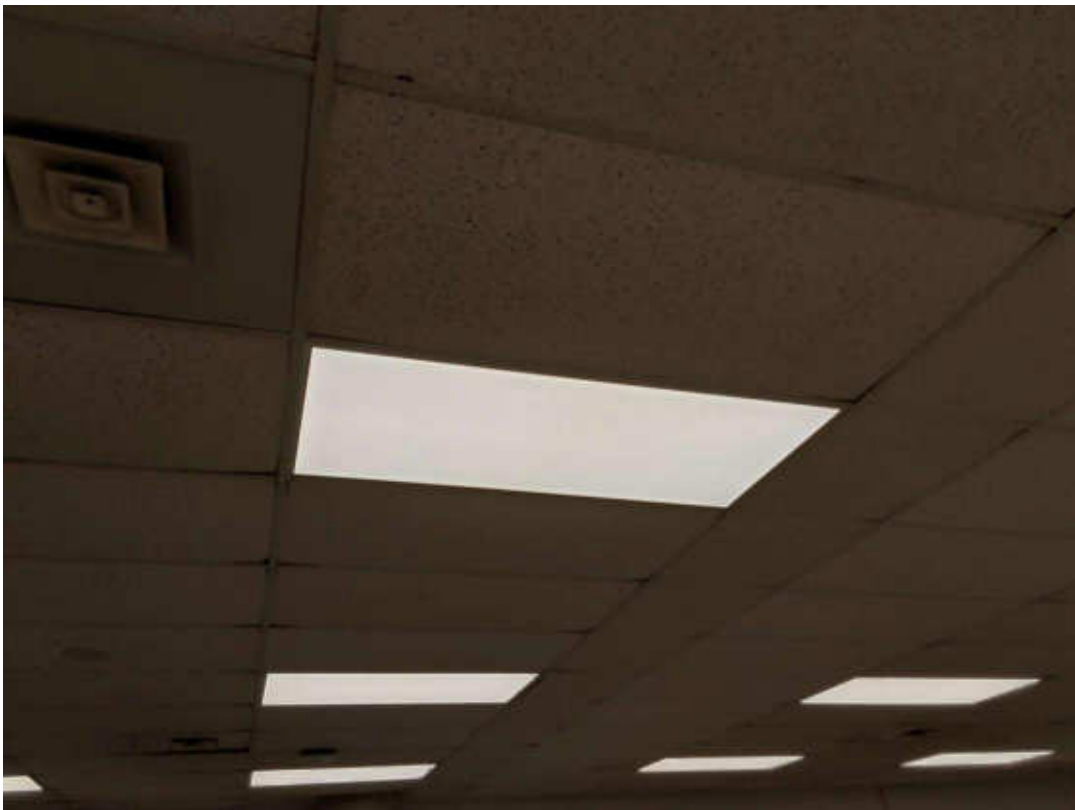
Mercury, V0000(No), LIGHT FIXTURE, LED, Classroom (Location #: 259)

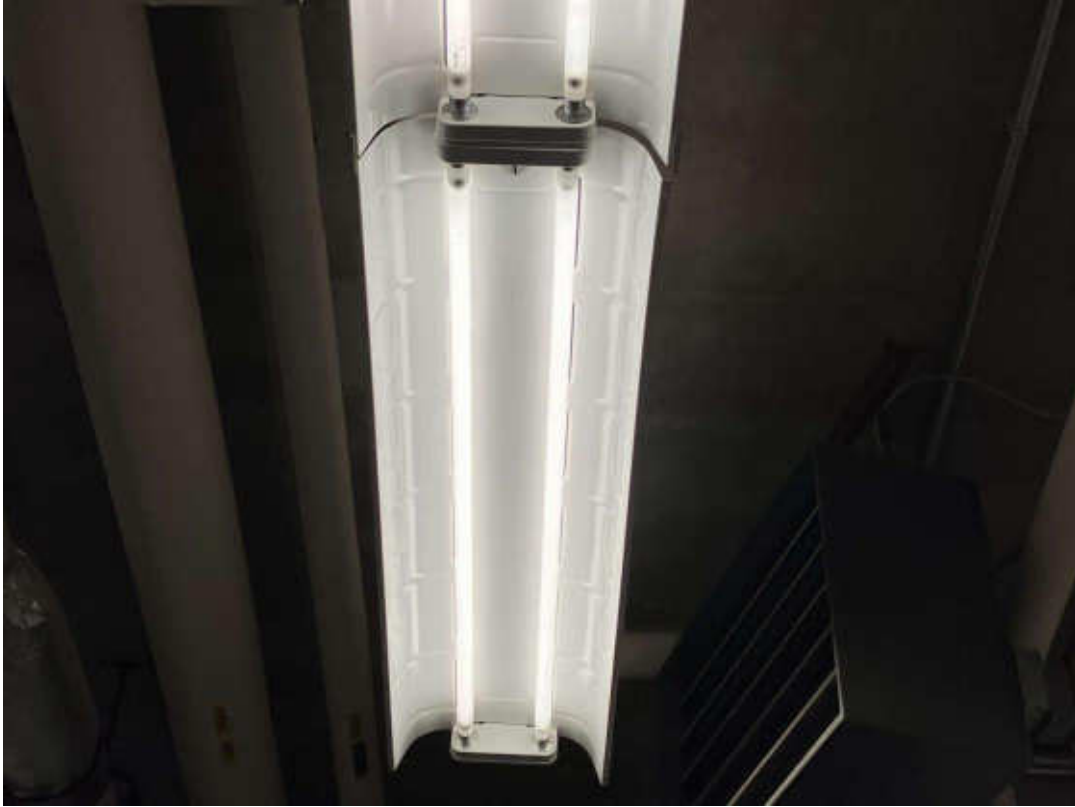
Items identified as Sample Number V9000 were observed to be present and were determined to contain mercury based on visual observation (e.g., labelled lamps and ampules in thermostats).

Mercury, V9000(Yes), LIGHT FIXTURE, Hydraulics Lab (Location #: 261)

Do not break lamps. Recycle and reclaim mercury from fluorescent lamps when taken out of service. Mercury is classified as a hazardous waste and must be disposed of in accordance with applicable regulations.

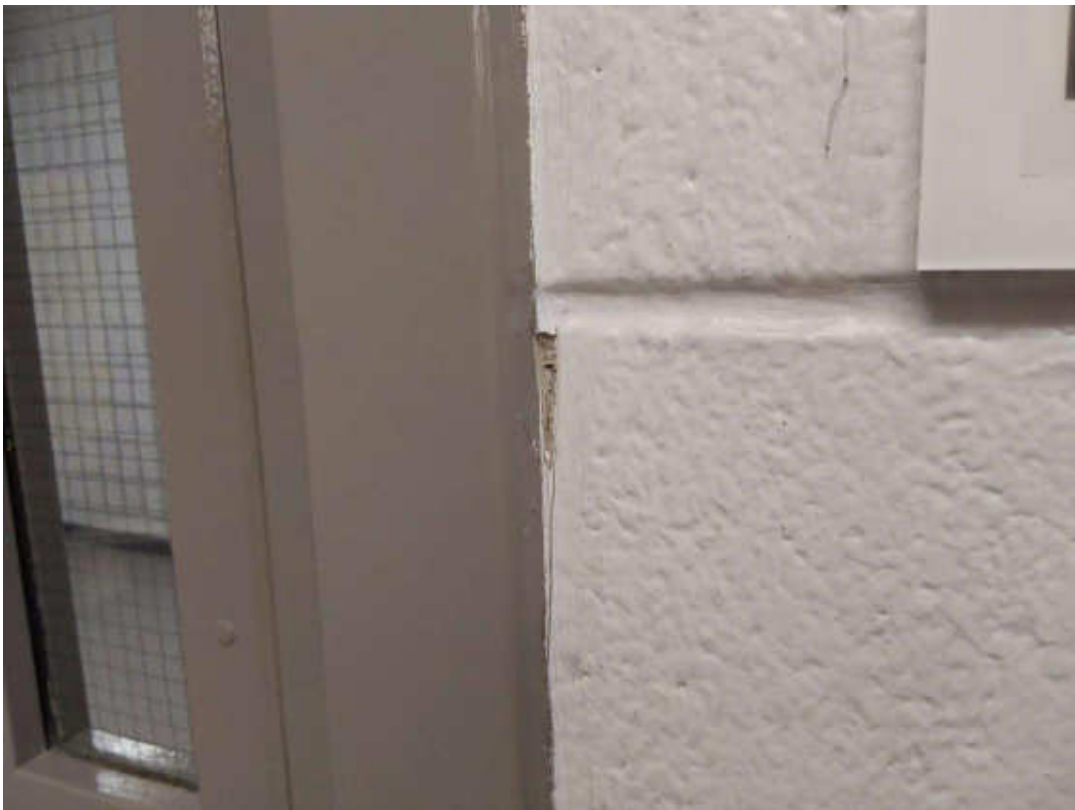
PCB, P0006(No), CAULKING, Caulking on door frames, Electrical Lab (Location #: 347)

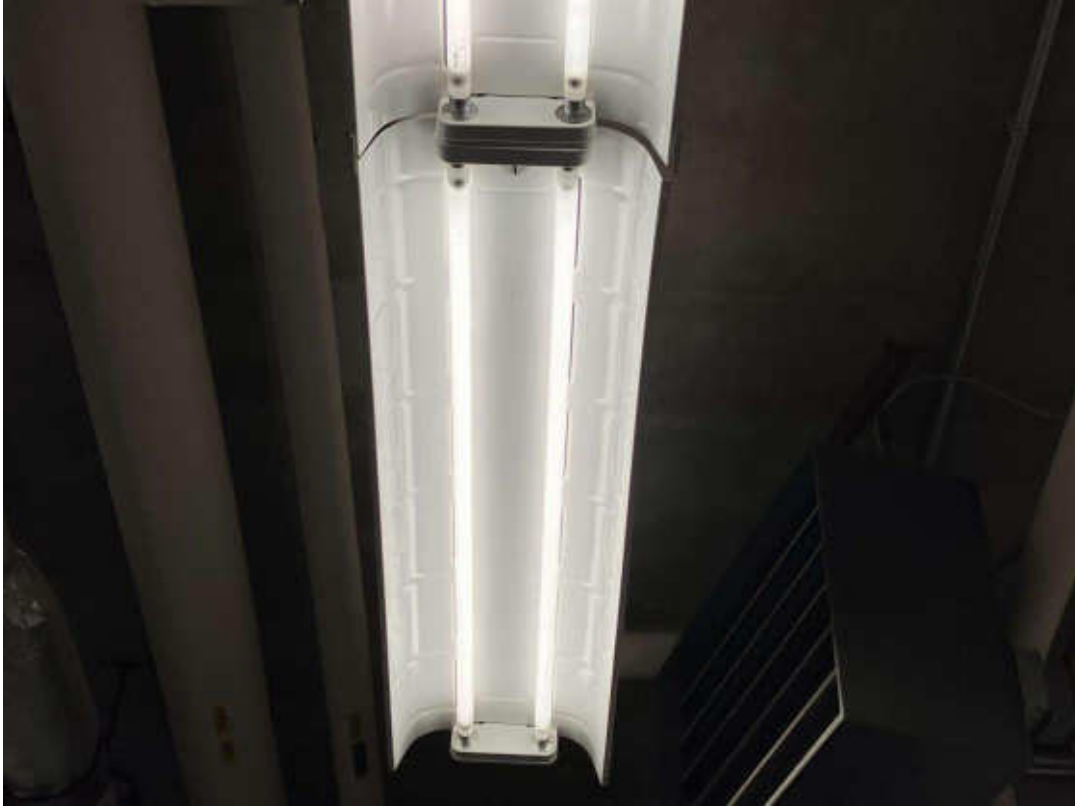
PCB, V0000(No), LIGHT BALLASTS, T8, Hydraulics Lab (Location #: 261)
