DESIGNATED SUBSTANCES AND HAZARDOUS BUILDING MATERIALS ASSESSMENT REPORT

**P00801 Window Replacements and Hollow Doors Repainting
St. Mary's Catholic School
340 Leacock Drive
Barrie, Ontario**

Safetech Project Number: 4-4250091

Date of Issue: April 22, 2025

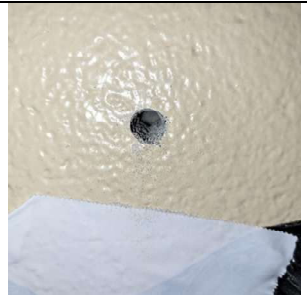
Sprayed and Loose Fill Insulating Materials	Location/Description	
Sprayed Fireproofing	None identified in subject areas.	
Sprayed Insulation	None identified in subject areas.	
Loose Fill / Vermiculite Insulation	None identified in subject areas. Inspections were performed via existing openings along the exterior stone block walls and representative inspections of interior block walls were performed via drilling. No loose fill / vermiculite insulation was discovered during these inspections. Should loose fill / vermiculite insulation be identified during the course of upcoming works, sampling should be performed prior to the recommencement of work.

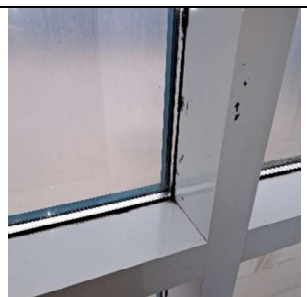
Thermal System Insulation	Location/Description	
Mechanical Pipe Insulation – Straights	None identified in subject areas.	
HVAC Duct Insulation	None identified in subject areas.	
HVAC Flex-Duct Connection	None identified in subject areas.	
Boiler Insulation	None identified in subject areas.	
Tank Insulation	None identified in subject areas.	
Window Glazing	Putty-like window glazing was observed in the subject areas. Bulk samples were collected during the assessment and results of analysis confirmed that this building material is between <0.25% and 0.32% <i>chrysotile asbestos</i> , and as such is not considered to be an asbestos containing material. Refer to sample set S11 in Table 2.

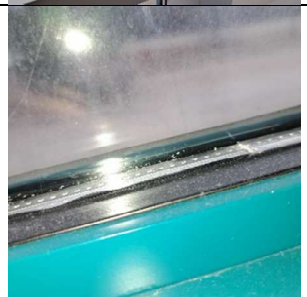
Window Glazing	Manufactured strip-like window glazing was observed in the subject areas. Bulk samples were collected during the assessment and results of analysis confirmed that this building material is not asbestos-containing. Refer to sample set S04 in Table 2.

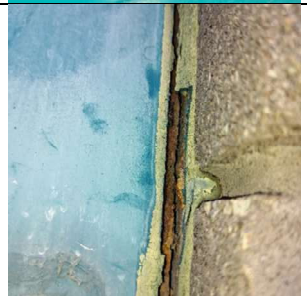
Casement Caulking	Window casement caulking was observed in the subject areas. Bulk samples were collected during the assessment and results of analysis confirmed that this building material is not asbestos-containing. Refer to sample sets S05-S08 in Table 2.

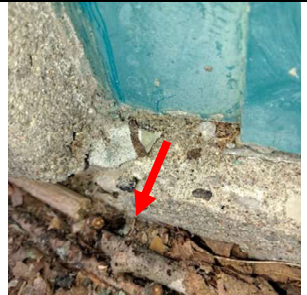
Vinyl Sheet Flooring	
Asbestos Cement Products	Location/Description
Piping	None identified in subject area.
Roofing, Siding, Wallboard	None identified in subject areas.
Ceramic Tile Grout	None identified in subject areas.
Ceramic Tile Thinset	None identified in subject areas.
Parging Cement	
Door Caulking	<p>Door threshold / vestibule casement caulking was observed in the subject areas. Bulk samples were collected during the assessment and results of analysis confirmed that this building material contains 1% chrysotile-asbestos and as such is to be considered an asbestos containing material. Refer to sample set S14 in Table 2</p>

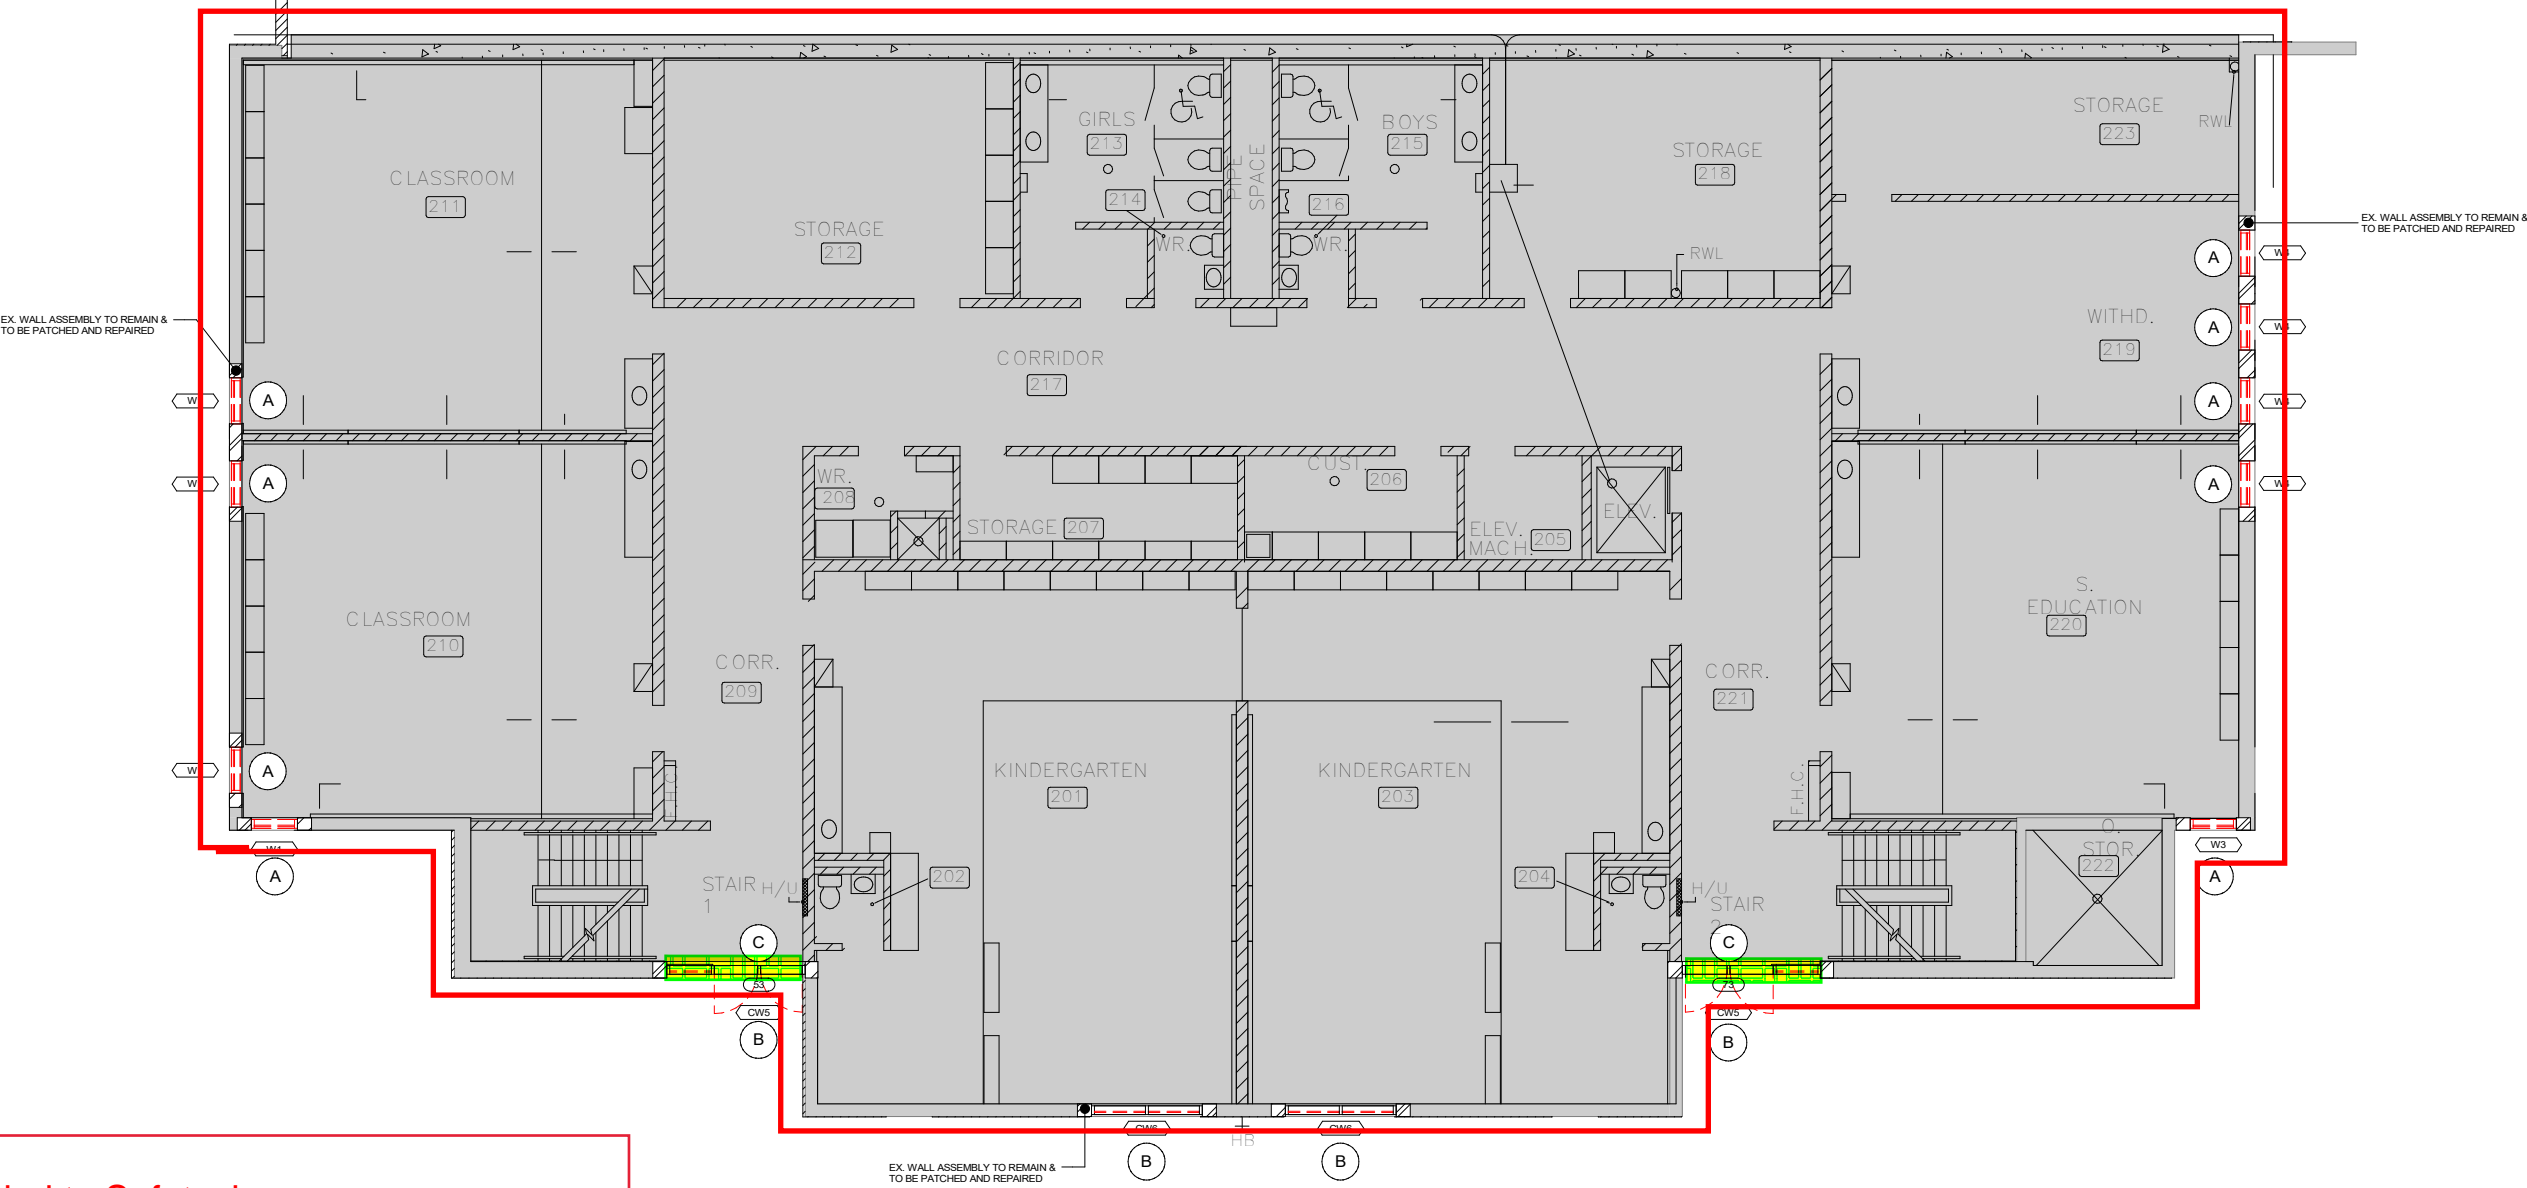
LOWER LEVEL	DRAWING NO.
WINDOW REPLACEMENT	WD-1
340 LEACOCK DRIVE BARRIE, ON	DATE: APRIL 21, 2025
	SAFETECH PROJECT NO. 4-4250091

- AREA(S) ASSESSED
- THRESHOLD DOOR CAULKING (ACM)

Door threshold caulking (Vestibule(s)): is considered to be a non-friable ACM. As per O. Reg. 278/05, removal of non-friable ACM can be conducted following Type 1 operations; as long as the material can be removed without being broken, cut, drilled or

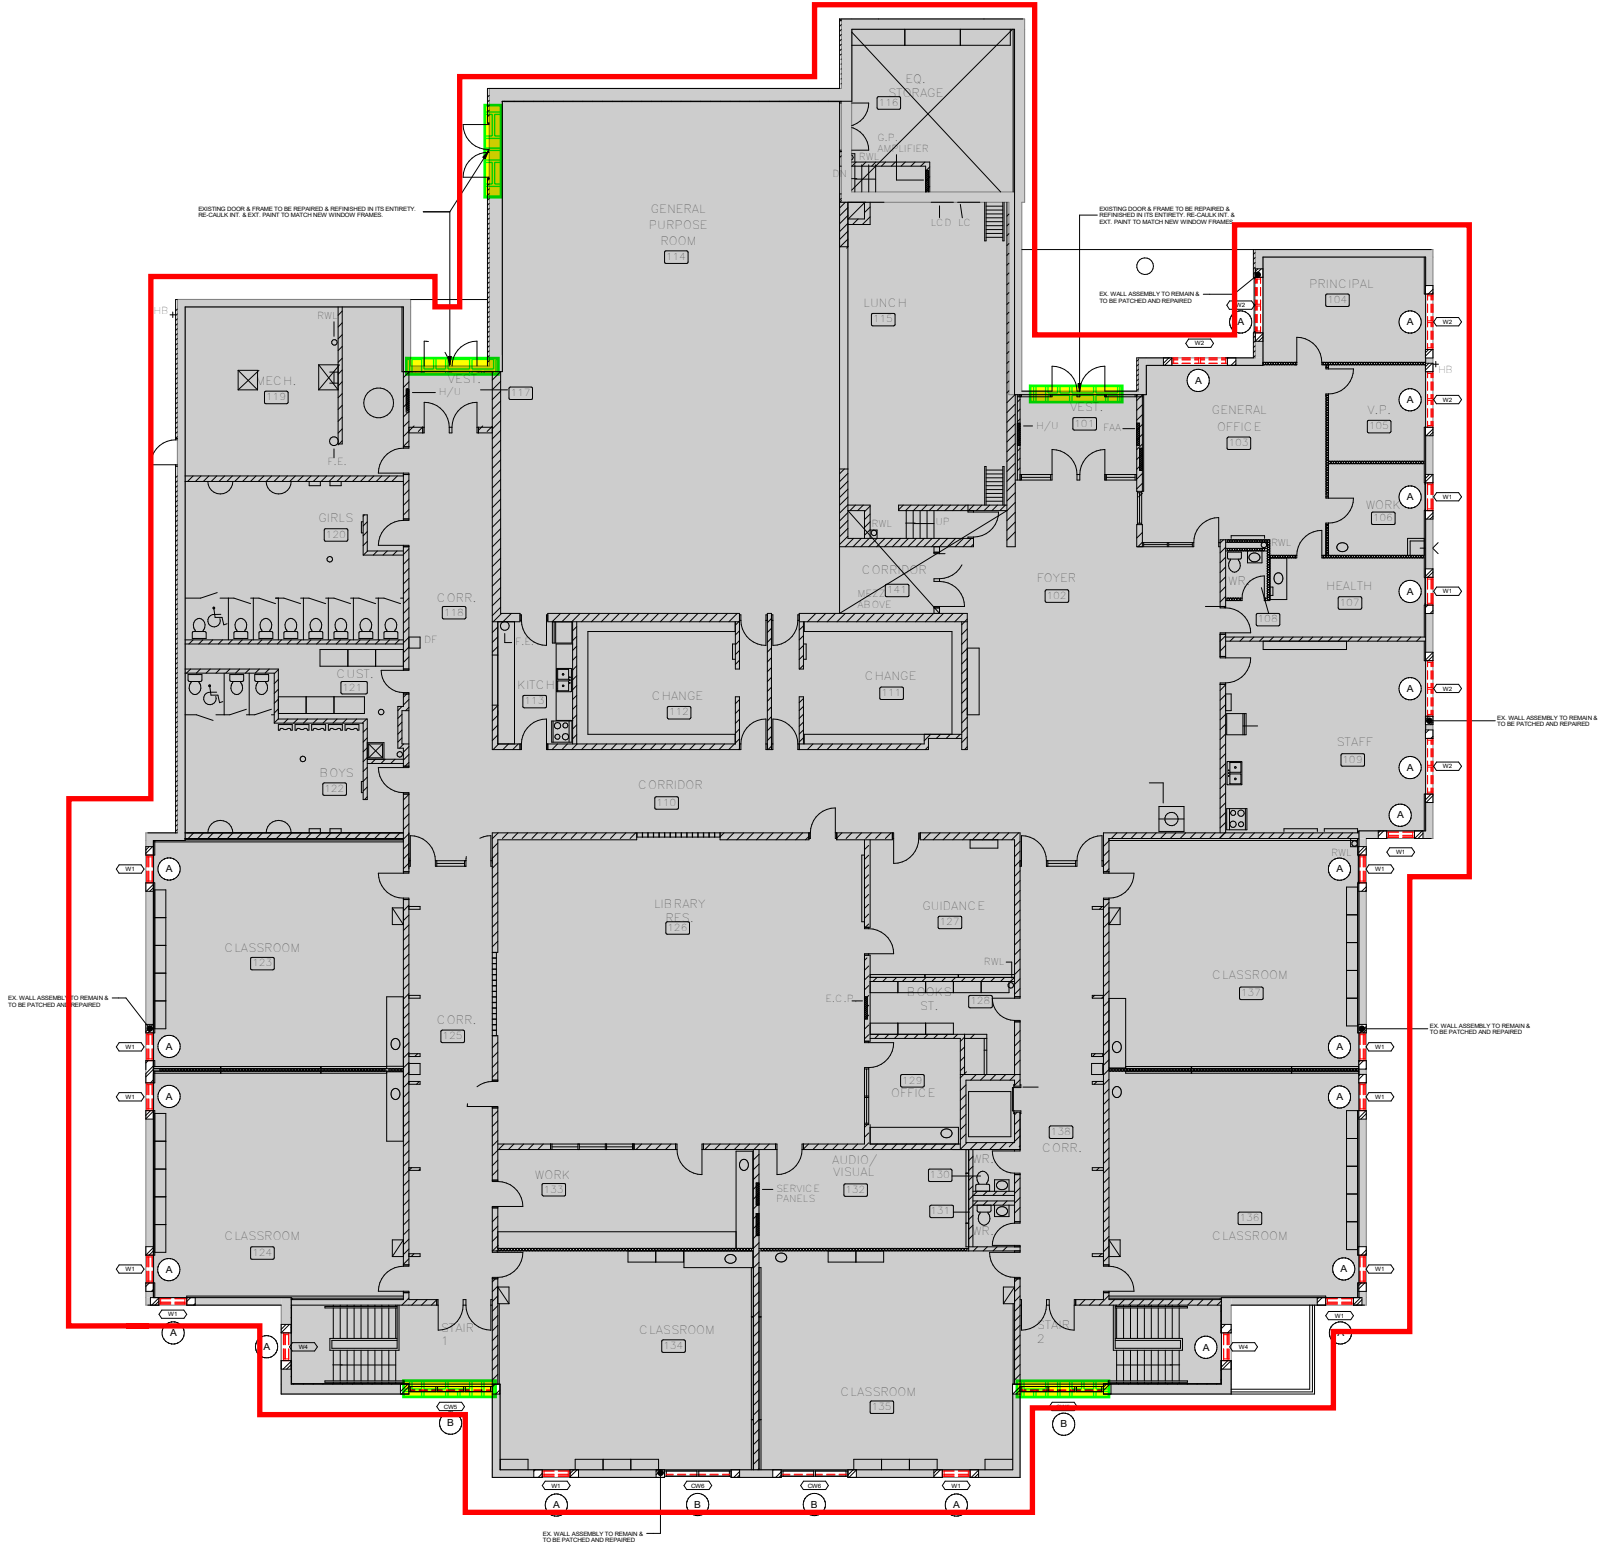
MAIN LEVEL	DRAWING NO.
WINDOW REPLACEMENT	WD-1
340 LEACOCK DRIVE BARRIE, ON	DATE: APRIL 21, 2025
	SAFETECH PROJECT NO. 4-4250091

- AREA(S) ASSESSED
- THRESHOLD DOOR CAULKING (ACM)
