September 9, 2024

**Re: Hazardous Building Materials Assessment (Preconstruction)**  
140 Commercial Avenue, Ajax, Ontario  
Pinchin File: 345995

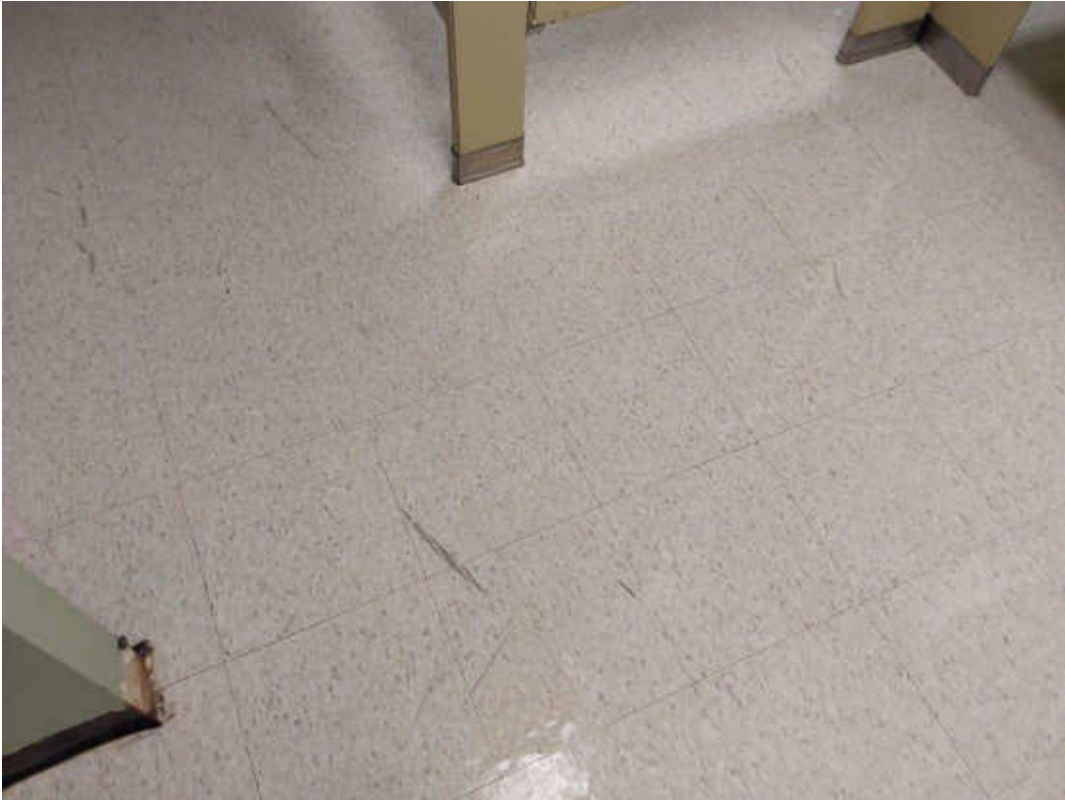
S0001B (None), 12" x 12" grey mottled, Floor, Vinyl Floor Tile and Mastic, Men's Washroom (Location #: 1)

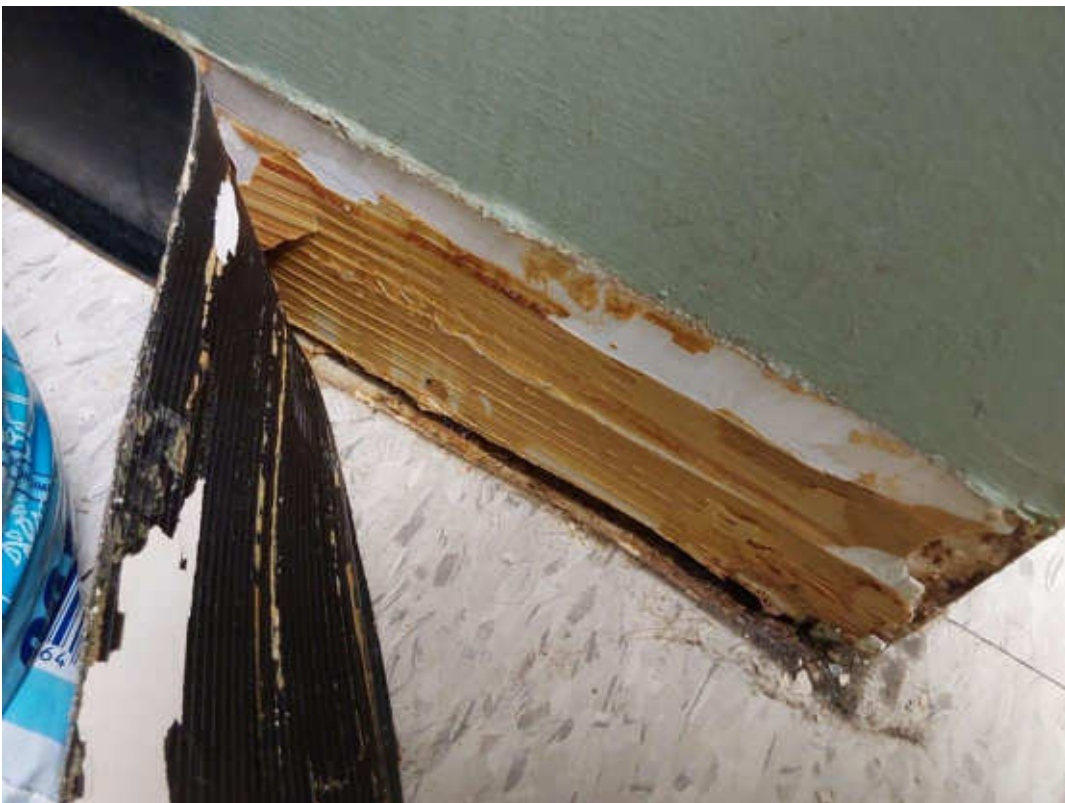
S0002B (None), Yellow baseboard mastic, Wall, Base, Adhesive/mastic, Men's Washroom (Location #: 1)

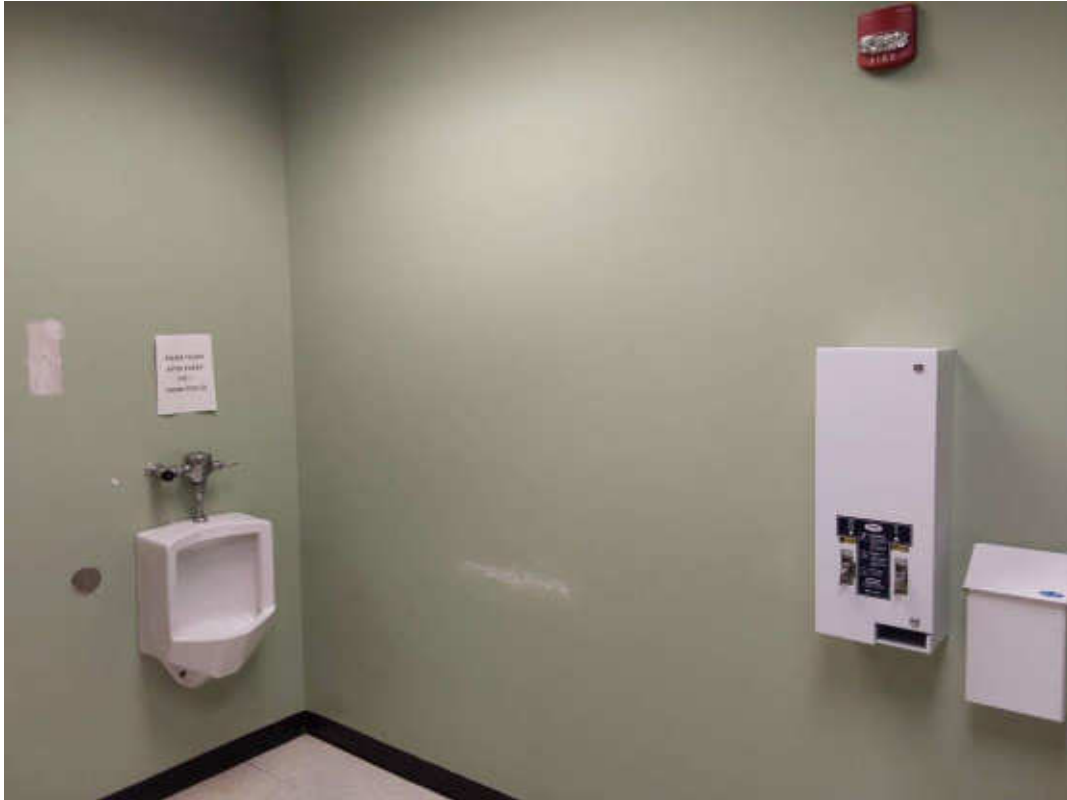
S0003B (None), Drywall on walls, Wall, Drywall and joint compound, Men's Washroom (Location #: 1)

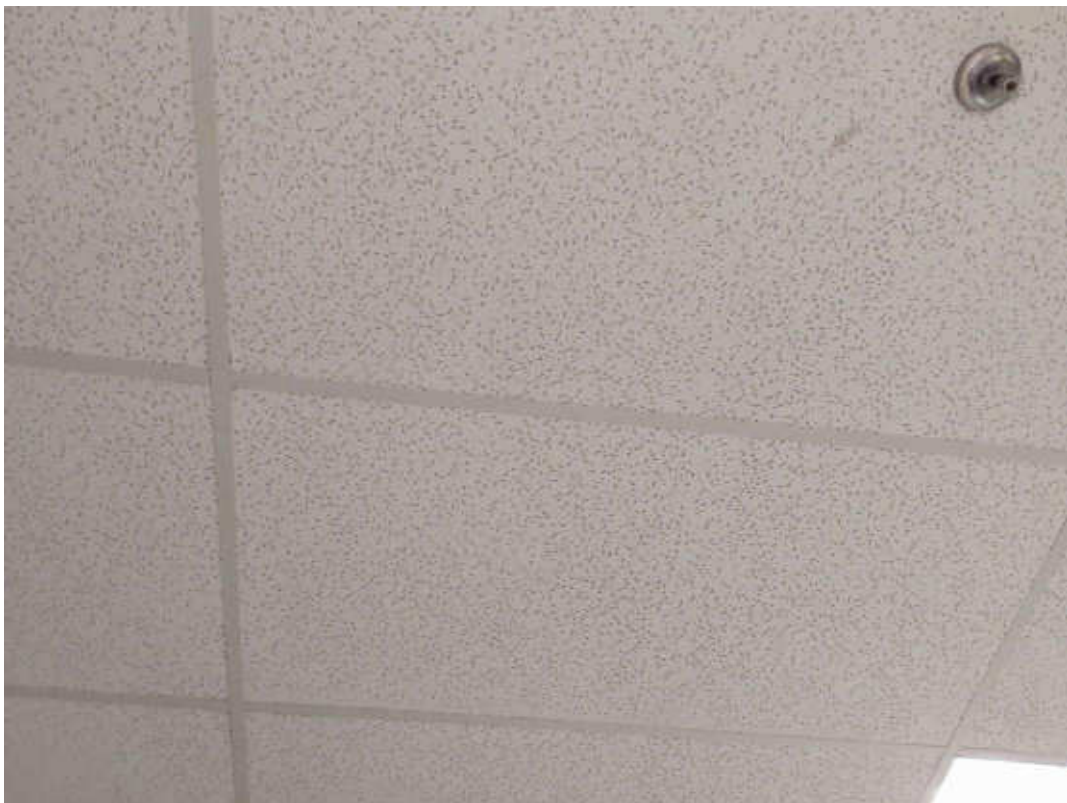
S0004B (None), 24" x 48" pinhole and small fleck, Ceiling, Ceiling Tiles (lay-in), Men's Washroom (Location #: 1)

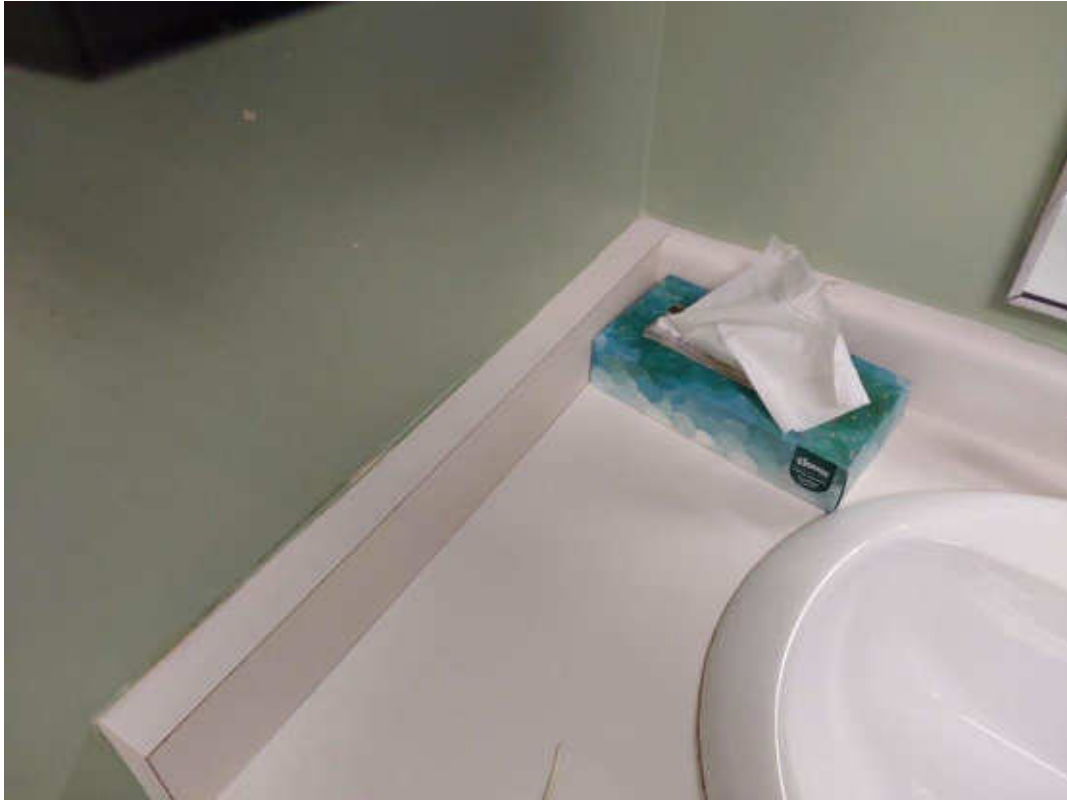
S0005B (None), White caulking on sink shelf, Other, Caulking, Men's Washroom (Location #: 1)

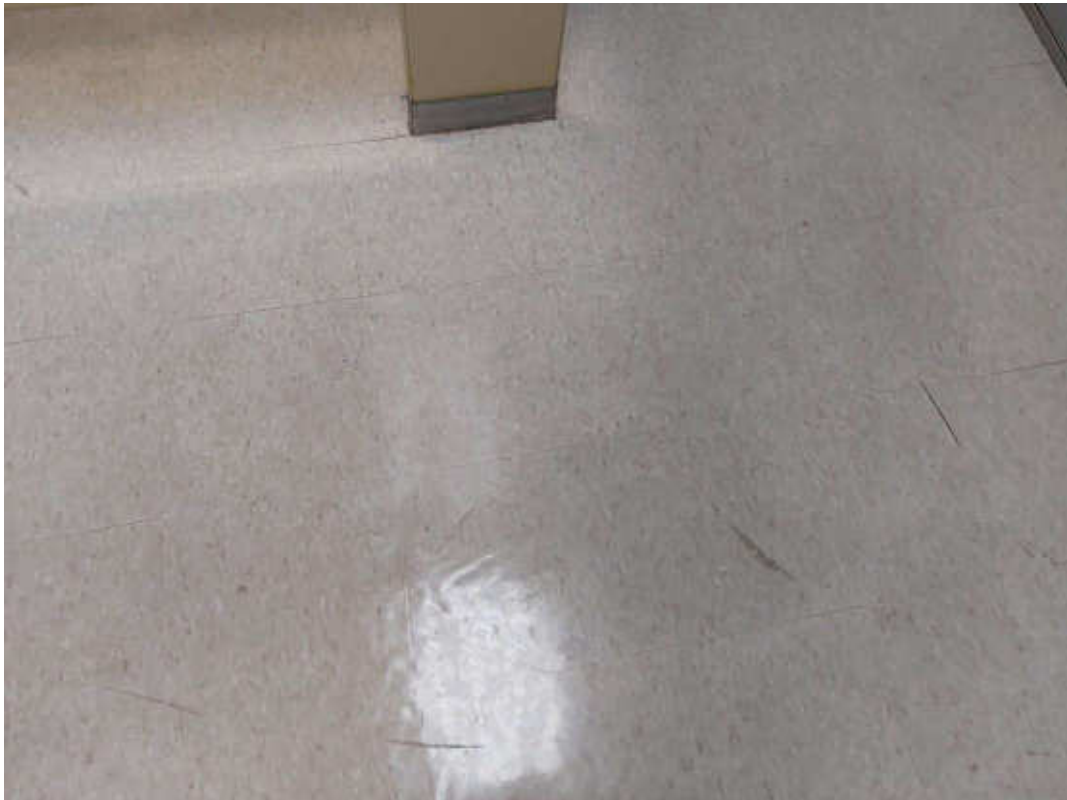
S0006C (None), 12" x 12" grey with light grey streaks, Floor, Vinyl Floor Tile and Mastic, Women's Washroom (Location #: 2)

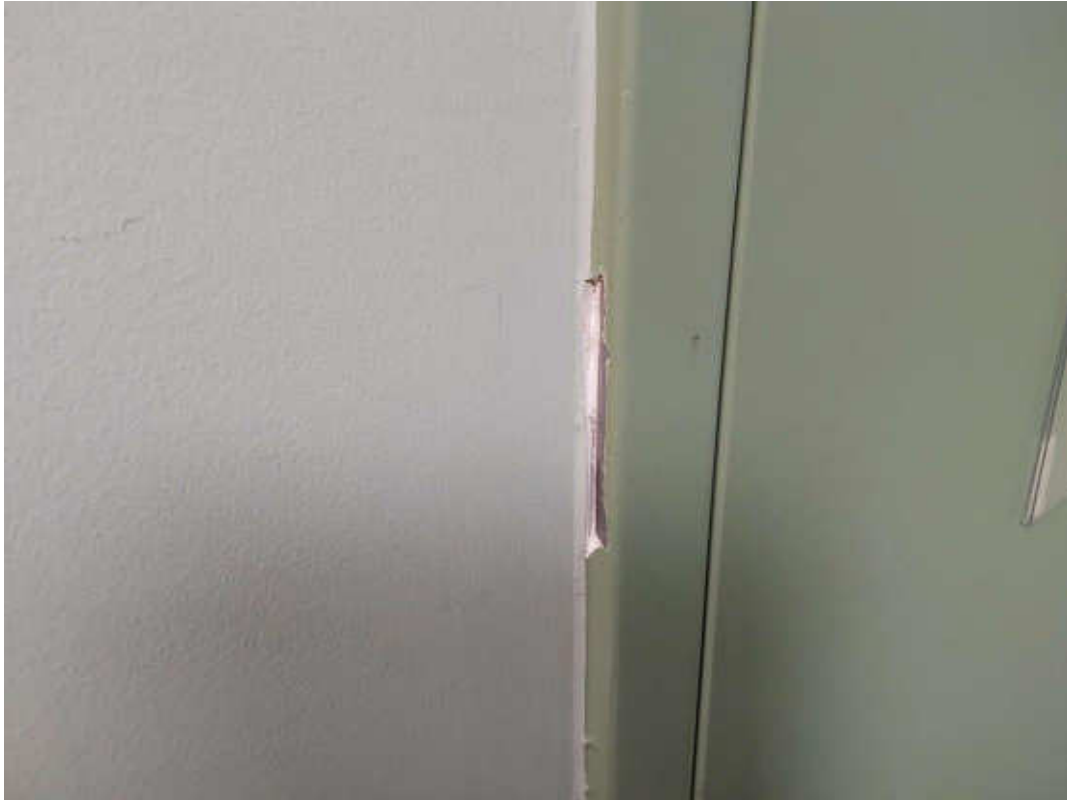
S0007A (None), White caulking on door frame, Other, Caulking, Women's Washroom (Location #: 2)

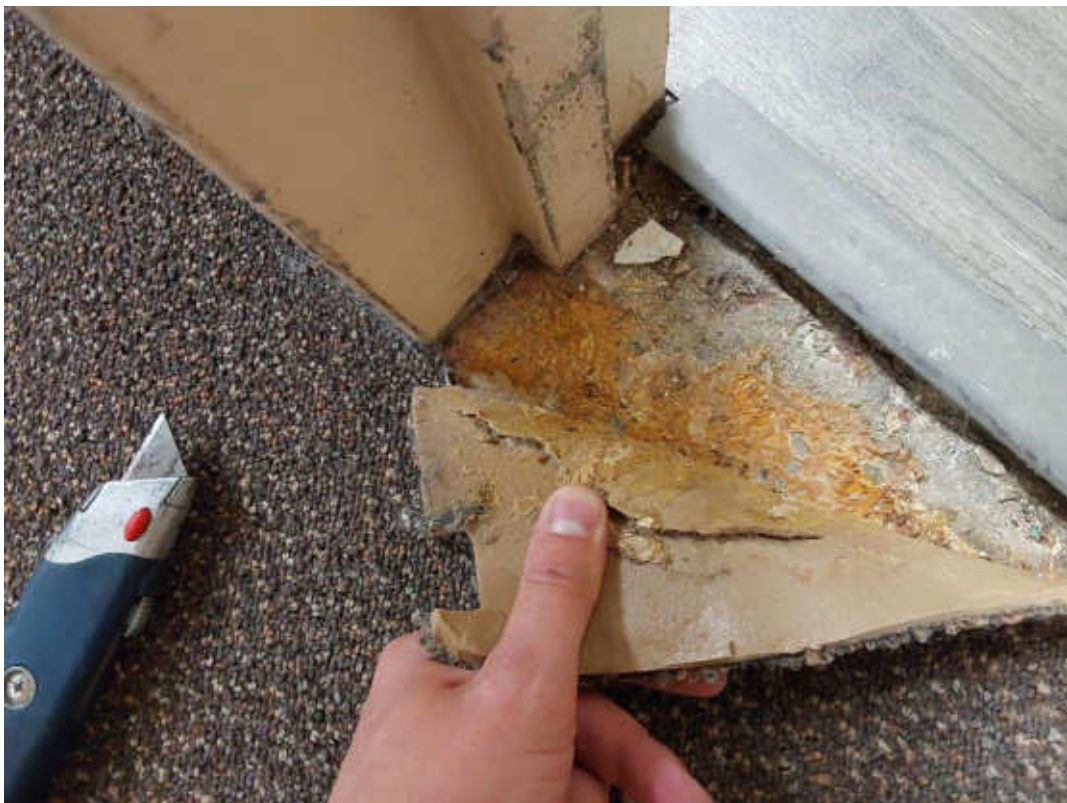
S0008A (None), Yellow carpet mastic, Floor, Adhesive/mastic, Office Area And Corridors (Location #: 3)

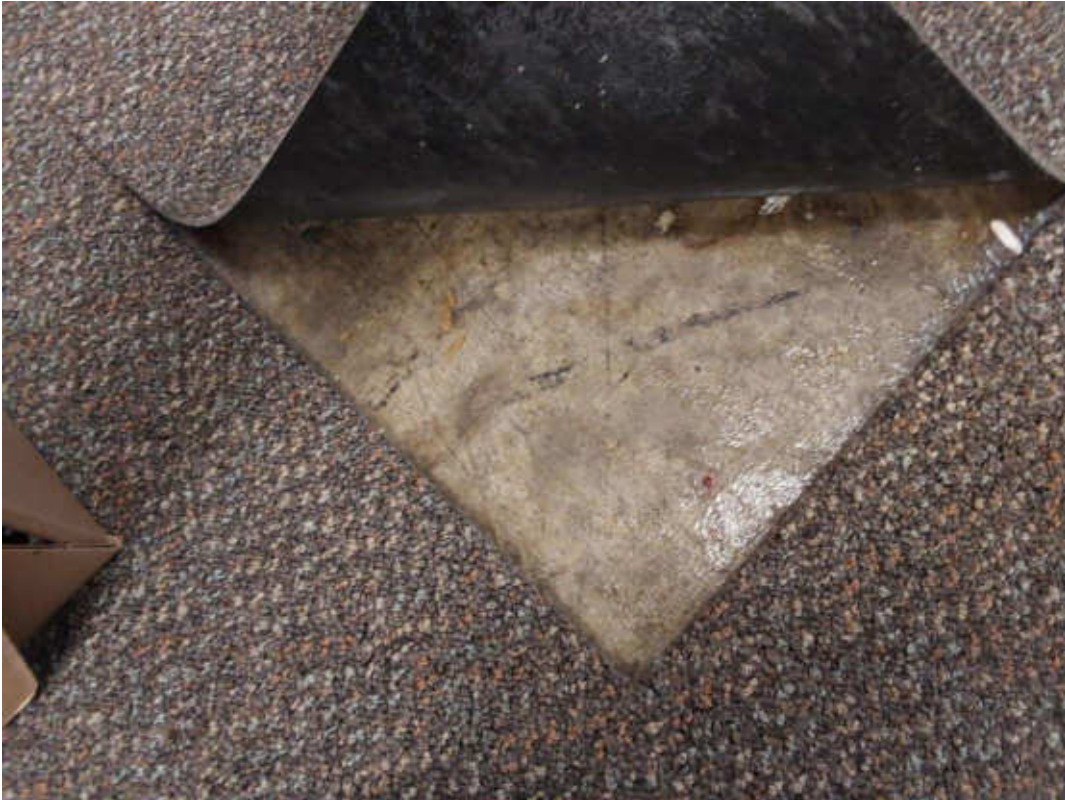
S0009C (None), Clear carpet mastic, Floor, Adhesive/mastic, Filing Room (Location #: 6)

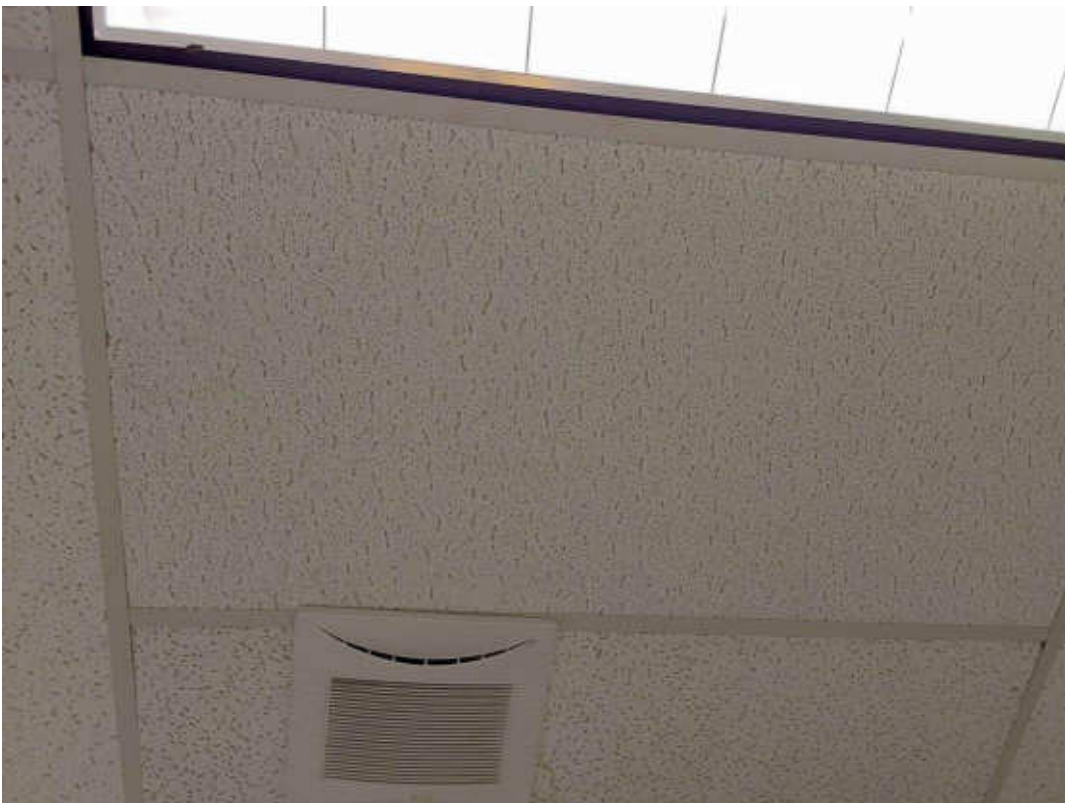
V0000 (None), 24" x 48" pinhole and large fleck, Ceiling, Ceiling Tiles (lay-in), Men's Washroom (Location #: 1)  
Date stamp 10/08/01

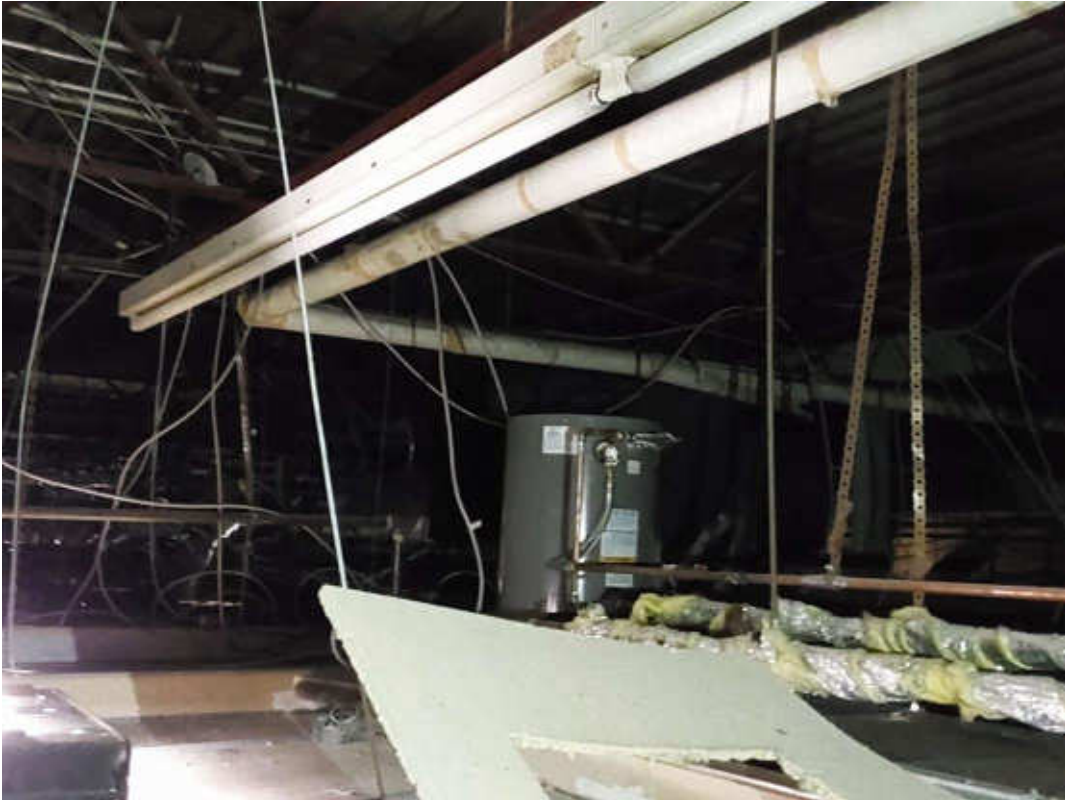
V0000 (None), Mechanical Equipment, Heating Water Tank, Fibreglass, Men's Washroom (Location #: 1)

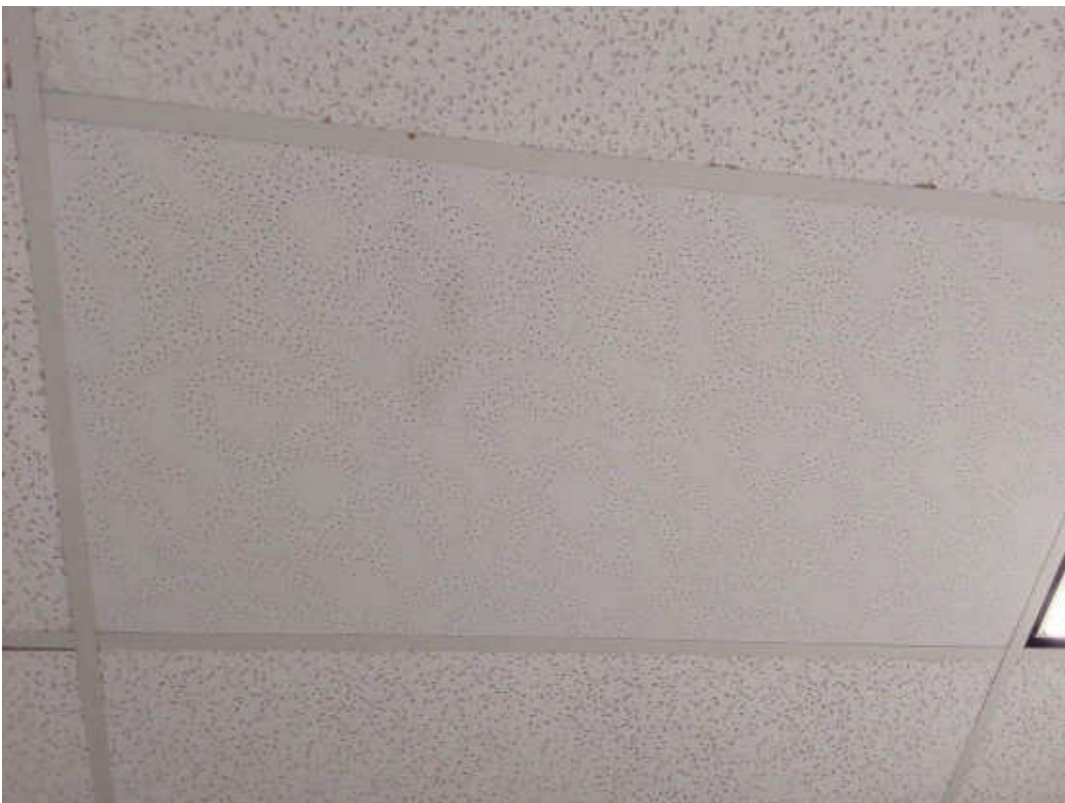
V0000 (None), 24" x 48" small and large pinhole, Ceiling, Ceiling Tiles (lay-in), Women's Washroom (Location #: 2)  
Date stamp 08/11/98

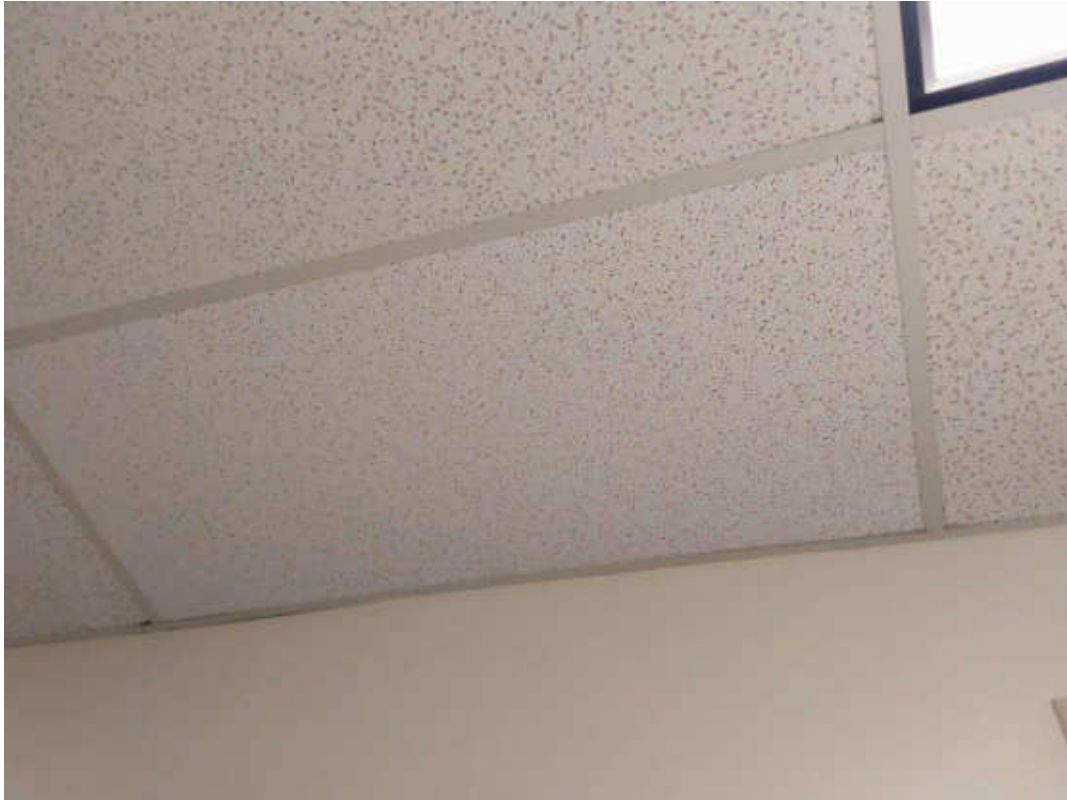
V0000 (None), 24" x 48" pinhole and small sparse fleck, Ceiling, Ceiling Tiles (lay-in), Office Area And Corridors (Location #: 3)  
Date stamp 10/02/10

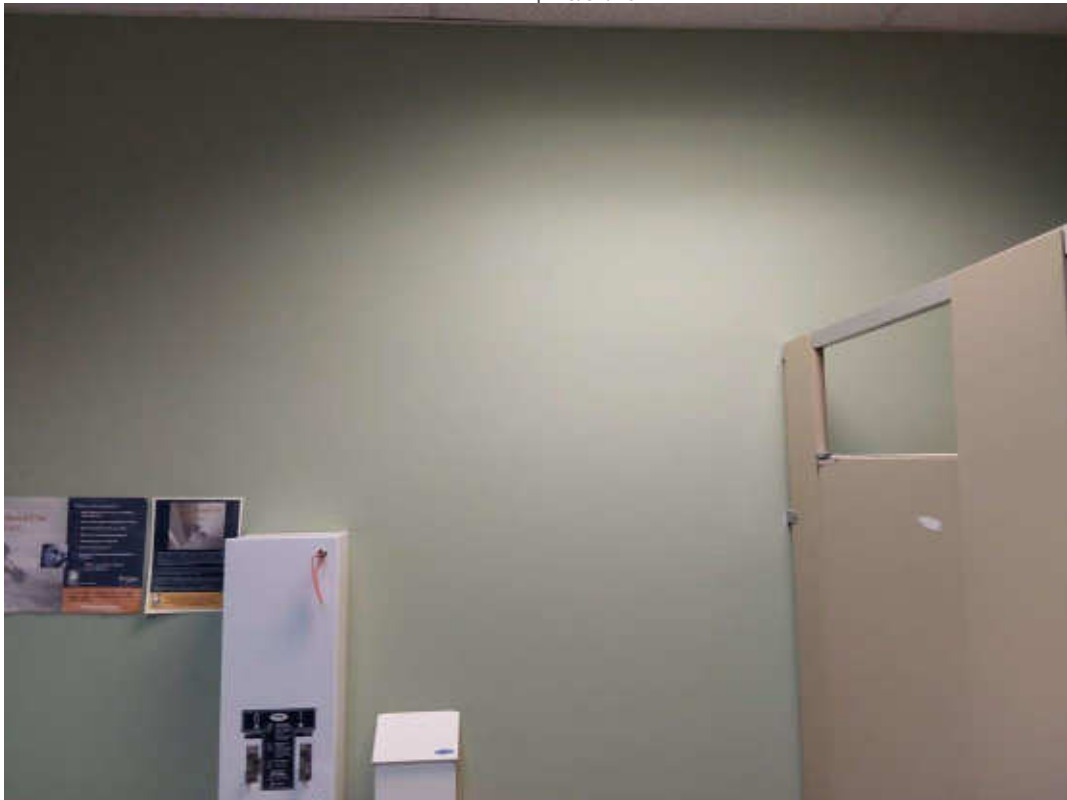
L0001(Lead, None), Light green paint on drywall, Wall, Women's Washroom (Location #: 2)

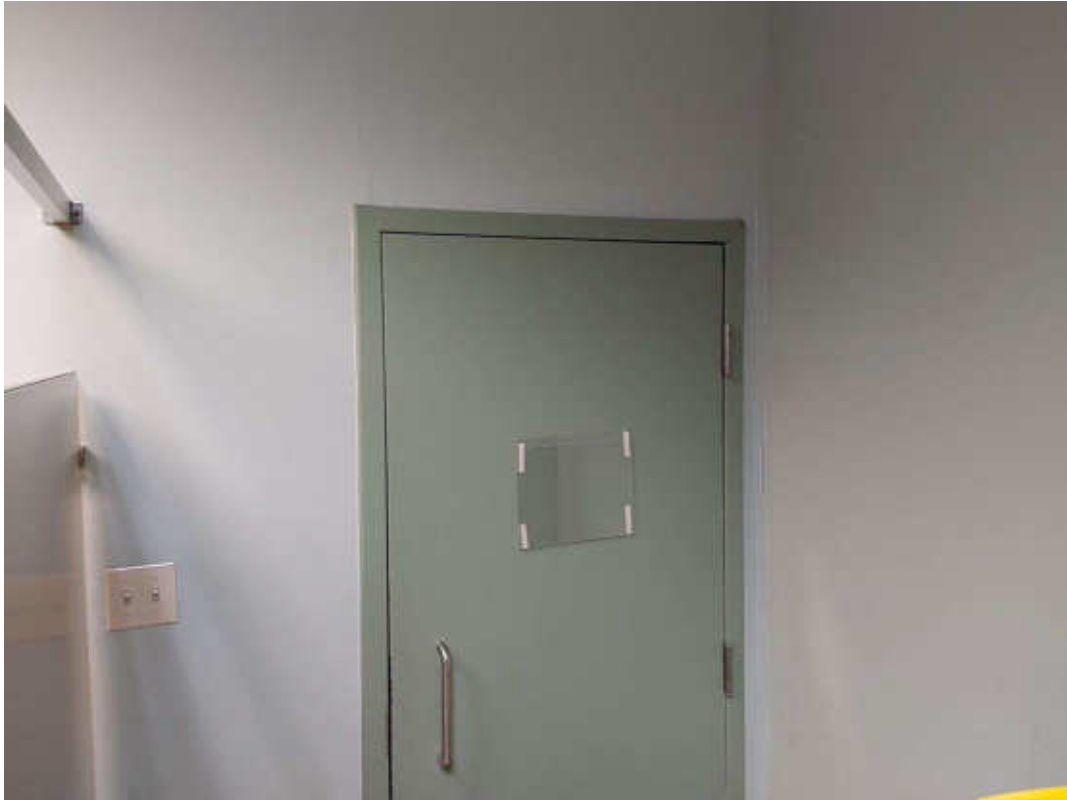
L0002(Lead, None), Dark green on door, Other, Women's Washroom (Location #: 2)

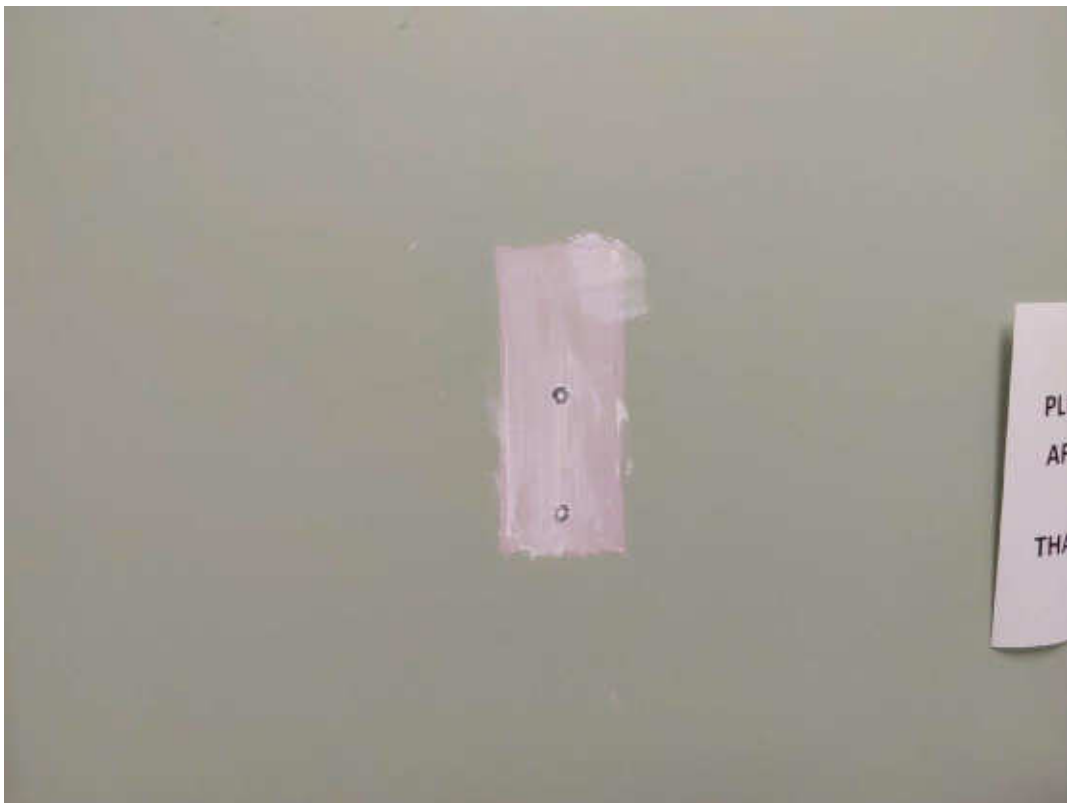
L0003(Lead, None), Lavender paint on drywall beneath green paint, Wall, Women's Washroom (Location #: 2)

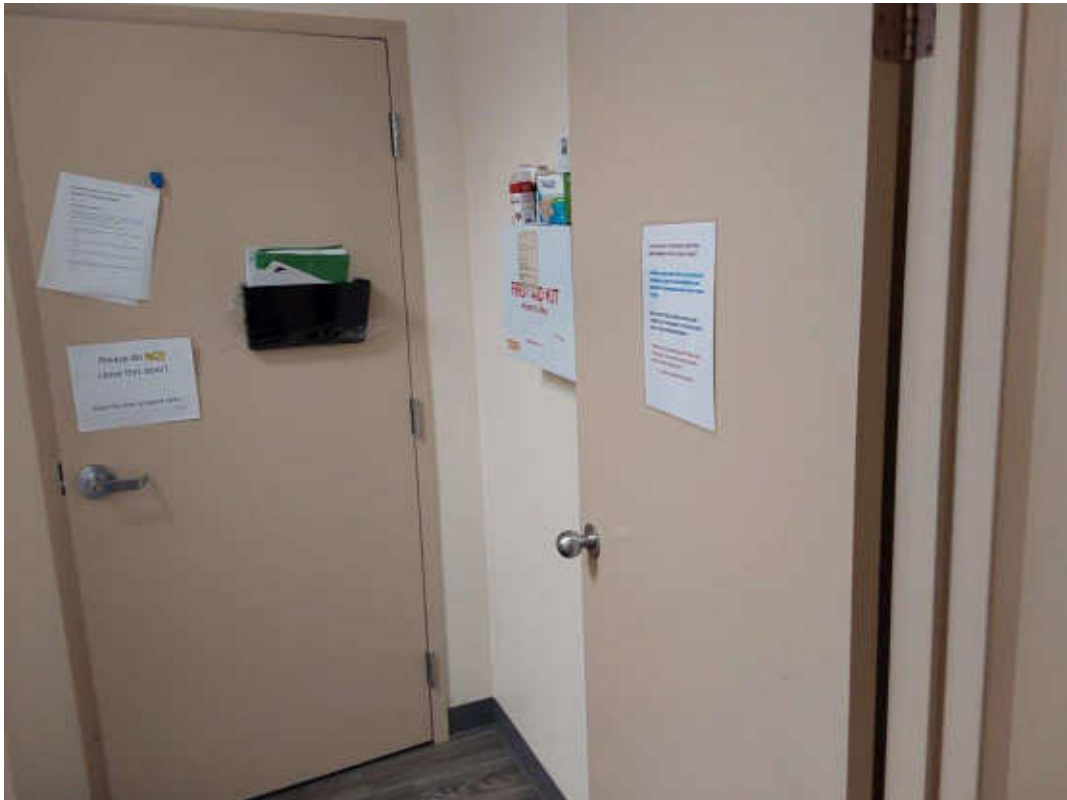
L0004(Lead, None), Tan paint on doors, Wall, Office Area and Corridors (Location #: 3)

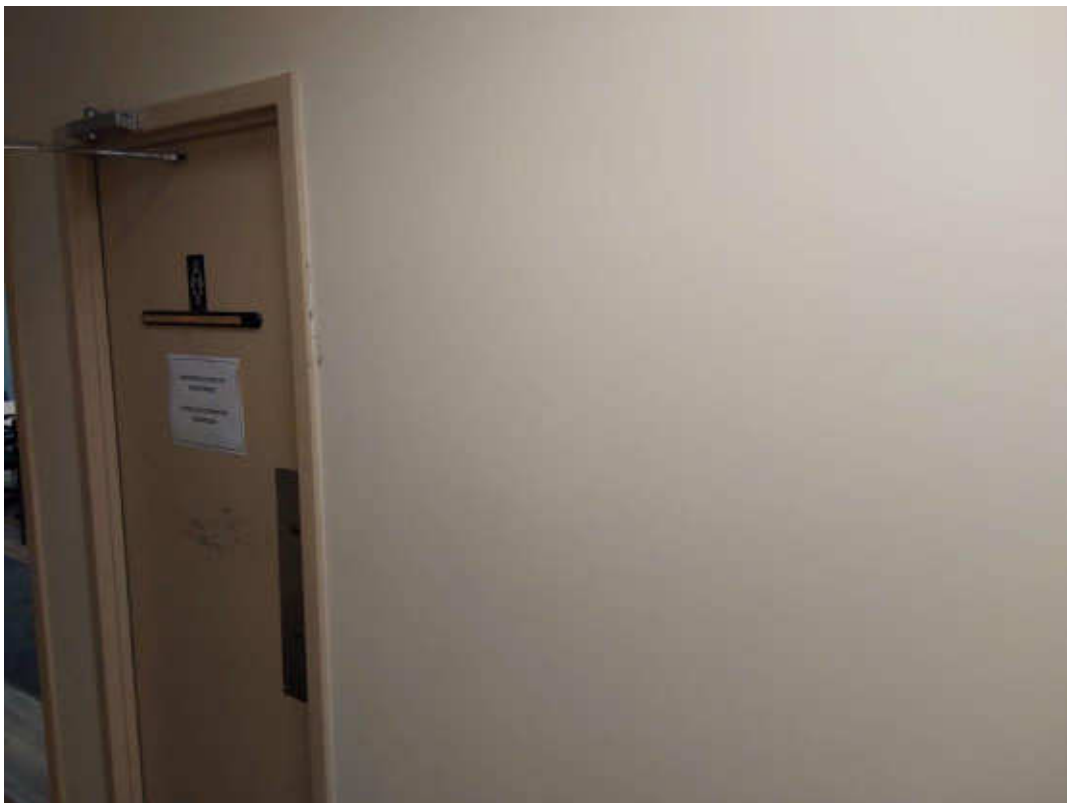
L0005(Lead, None), Beige paint on drywall, Wall, Office Area and Corridors (Location #: 3)

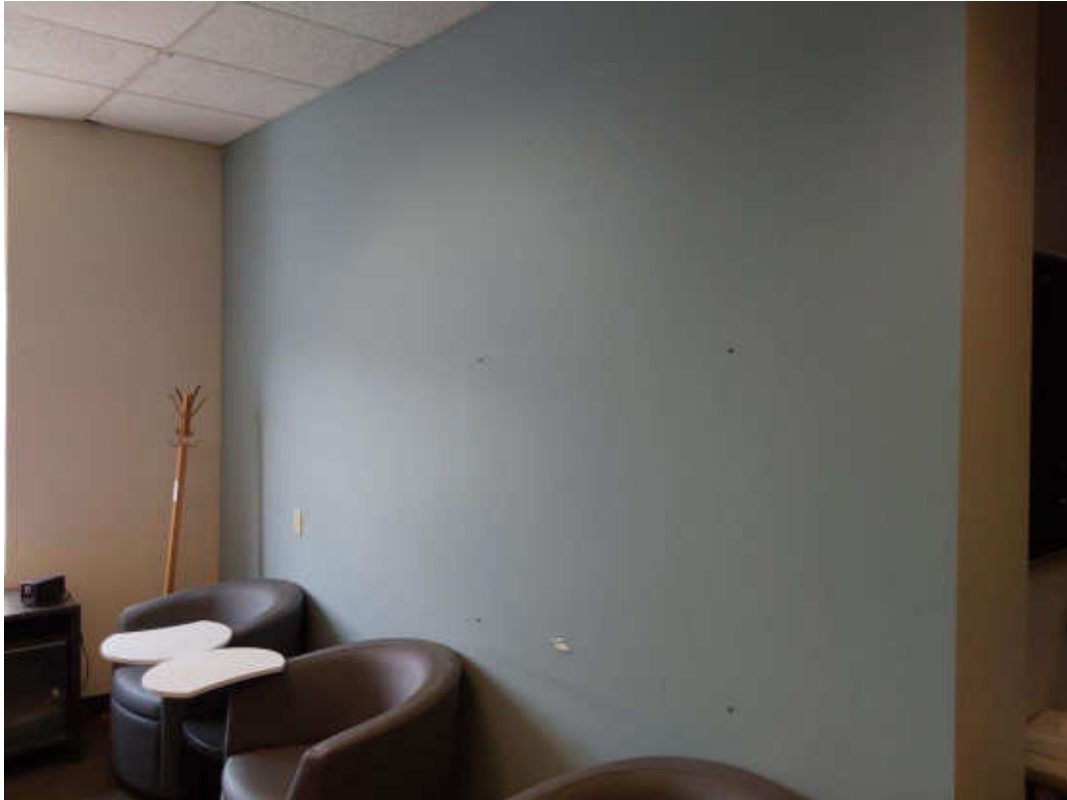
L0006(Lead, None), Blue paint on drywall, Wall, Office Area and Corridors (Location #: 3)

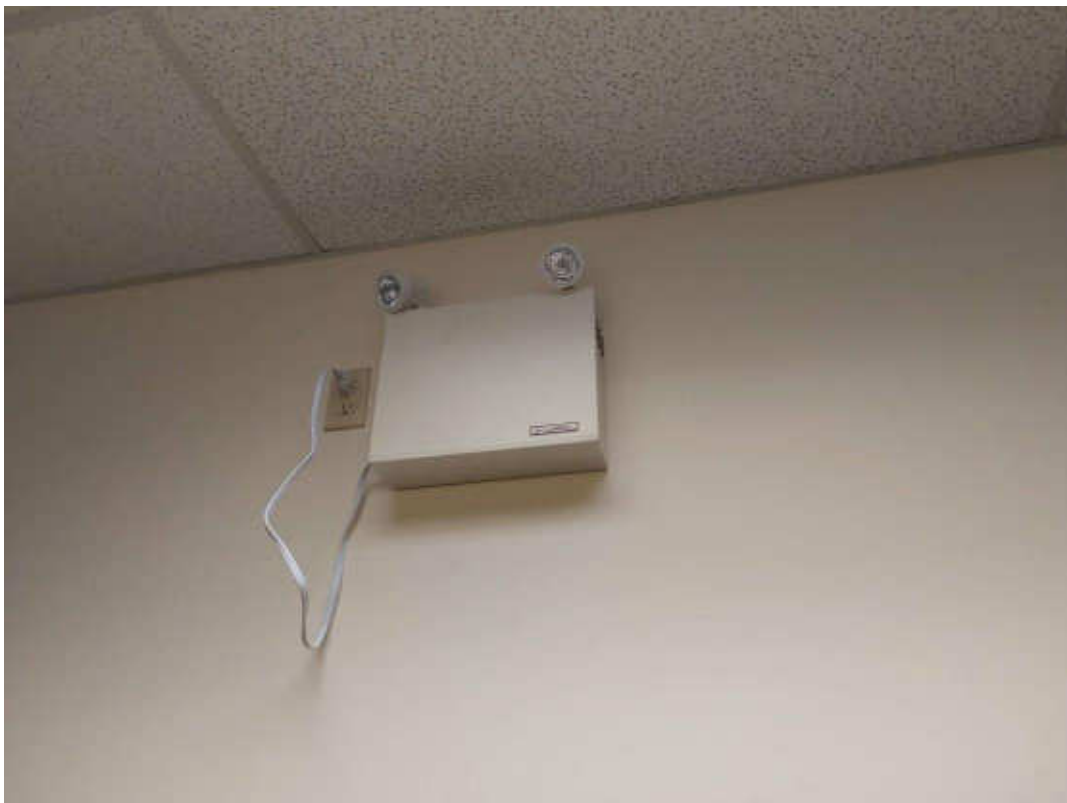
Items identified as Sample Number V9500 were observed to be present but could not be definitively determined to contain lead (e.g., inaccessible batteries).

Pb Products, V9500(Presumed), BATTERIES IN EMER. LIGHTS, Office Area and Corridors (Location #: 3)

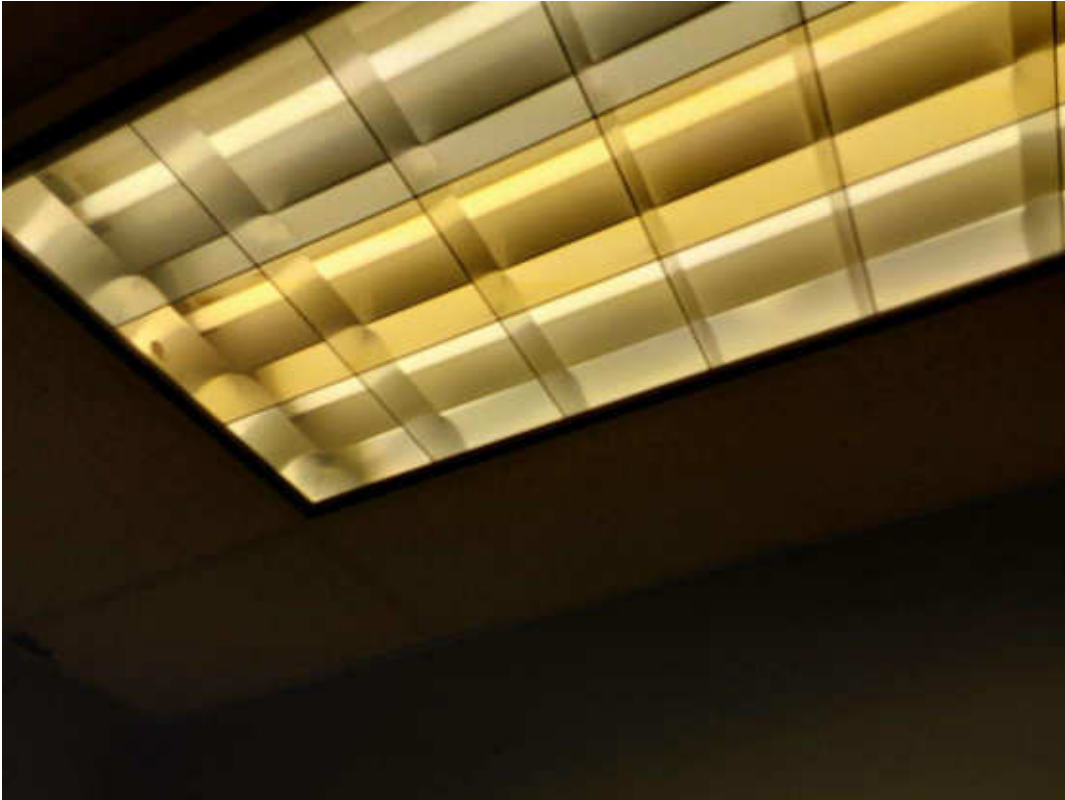
Items identified as Sample Number V9000 were observed to be present and were determined to contain mercury based on visual observation (e.g., labelled lamps and ampules in thermostats).

Mercury, V9000(Yes), LIGHT FIXTURE, T8 fixtures, Men's Washroom (Location #: 1)

Do not break lamps. Recycle and reclaim mercury from fluorescent lamps when taken out of service. Mercury is classified as a hazardous waste and must be disposed of in accordance with applicable regulations.

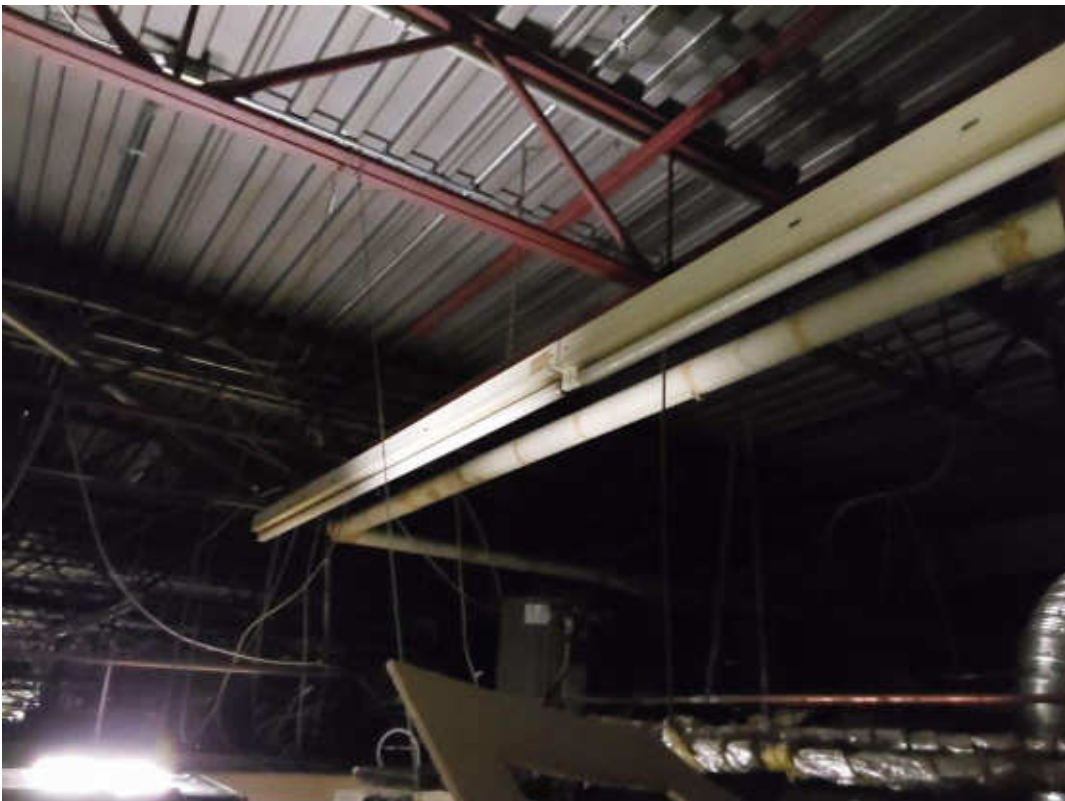
Materials identified as Sample Number V9500 were either observed to be present or based on the construction of the building/equipment are likely present in concealed locations. These materials have not been sampled and are presumed to contain PCBs based on historical known use (e.g. concealed ballasts of fluorescent fixtures with T12 tubes). Sampling of these materials may be completed prior to disturbance.

PCB, V9500(Presumed), LIGHT BALLASTS, T12 fixtures above ceiling, Men's Washroom (Location #: 1)
