# Annual ACM and Designated Substances Inspection

**Notre Dame Catholic  
Elementary School**

**760 Burnham Street,  
Cobourg, Ontario**

September 13, 2024

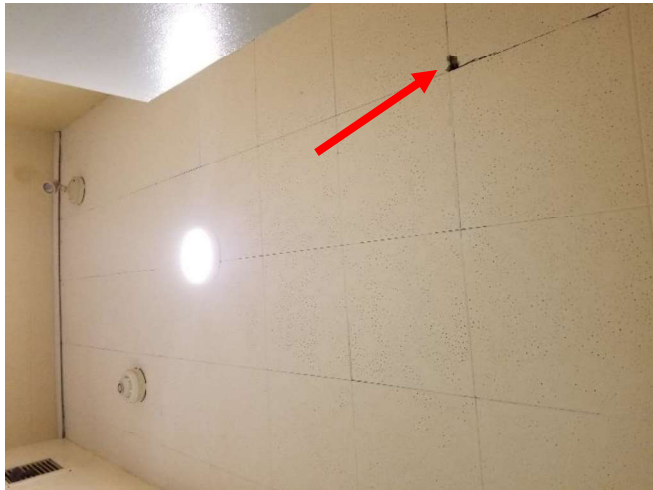
**Photo 1: View of asbestos containing 1'x1' white acoustic ceiling tiles with small pinholes observed to be in fair condition (see arrow) observed within Room 111.**

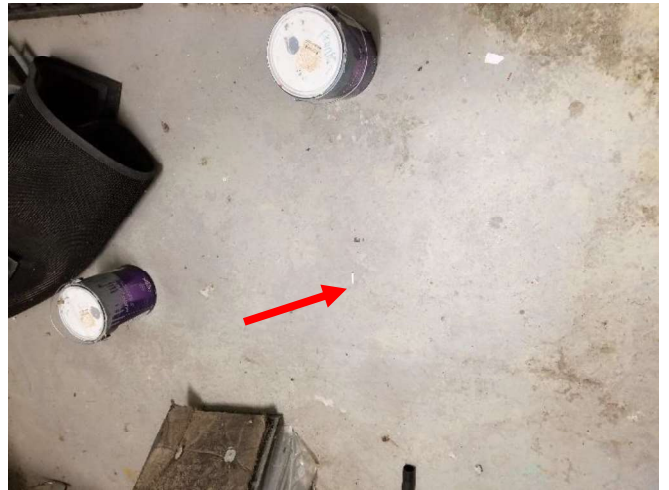
**Photo 2: View of lead containing grey paint (see arrow) observed to be in fair condition on the Electrical Room floor.**

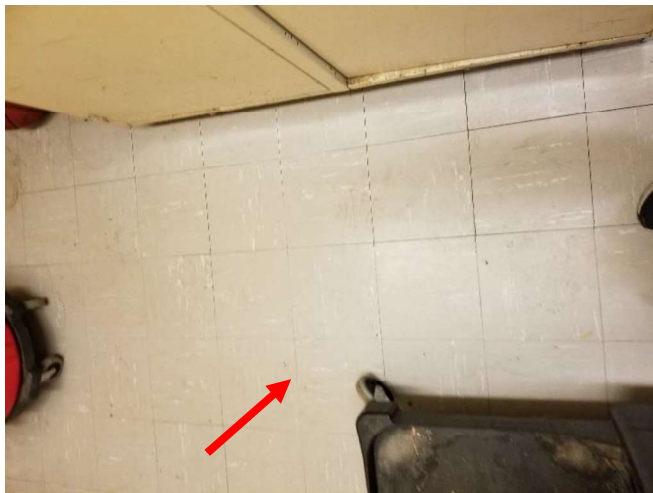
**Photo 3: View of asbestos containing 9"x9" grey with light and dark streaks vinyl floor tiles (see arrow) observed to be in good condition within Room 113 of the Subject Building.**

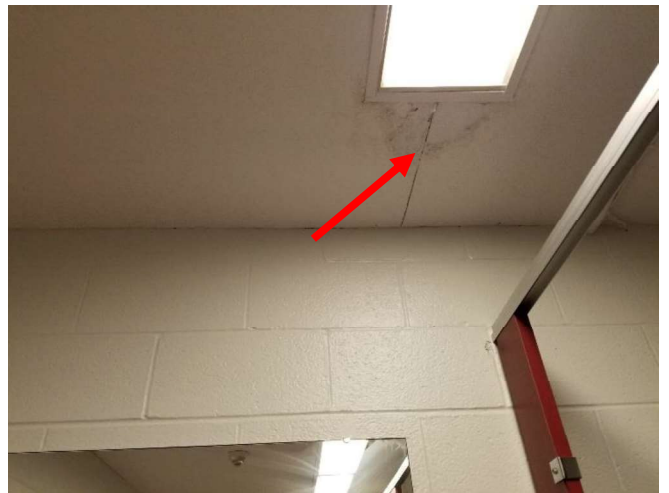
**Photo 4: View of asbestos containing texture coat (see arrow) observed to be in fair condition on the ceiling within Washroom 221.**

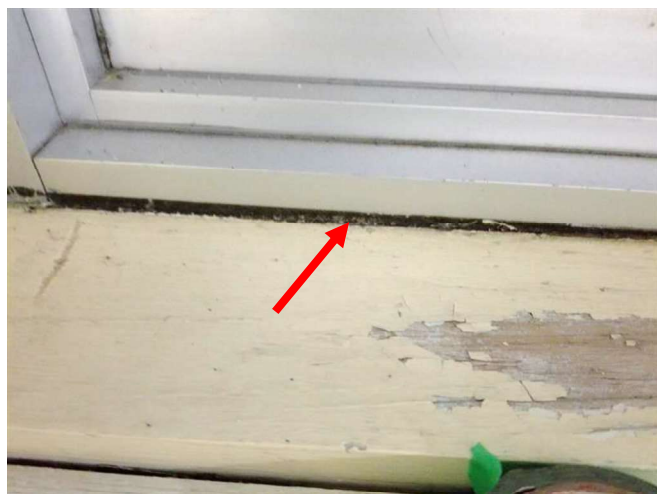
**Photo 1:** View of the asbestos containing white/grey caulking (see arrow) observed to be in good condition within Classroom 8 of the 1962 section of the Subject Building.

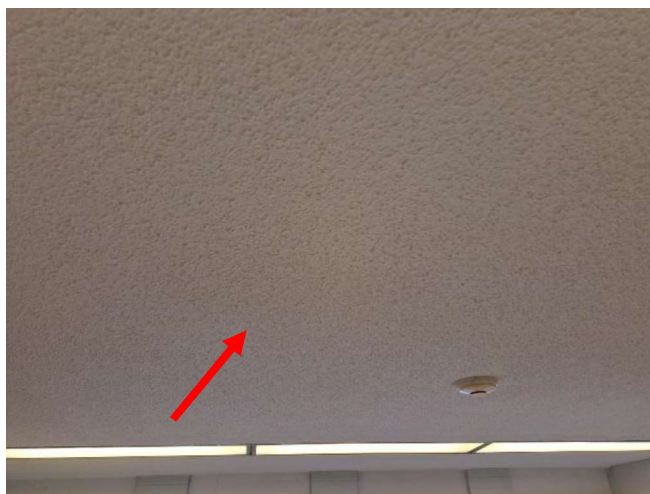
**Photo 2:** View of the asbestos containing white texture coating (see arrow) observed to be in good condition throughout the 1967 section of the Subject Building.

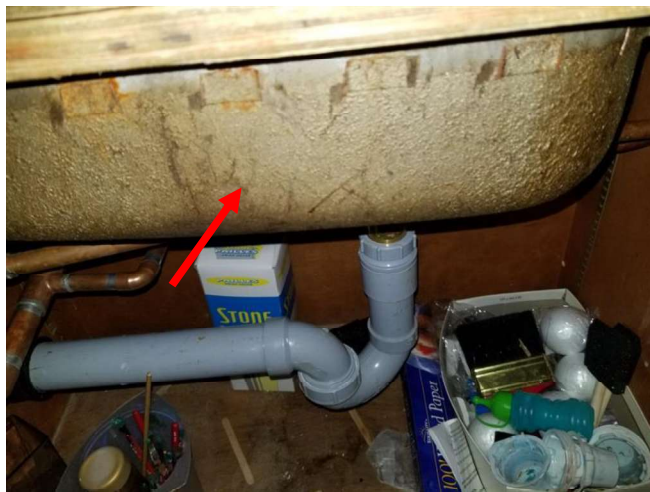
**Photo 4:** View of the asbestos containing gold sink coating (see arrow) observed to be in good condition within Classroom 3 of the 1967 section of the Subject Building.

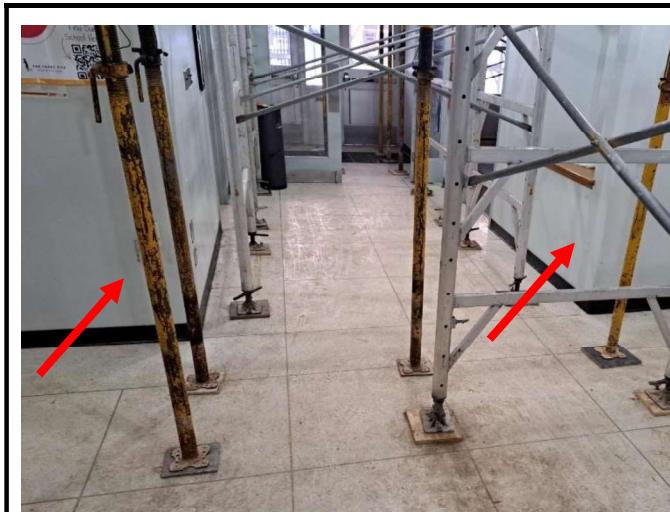
**Photo 5:** View of the asbestos containing plaster (see arrows) observed to be in good condition throughout the 1967 section of the Subject Building

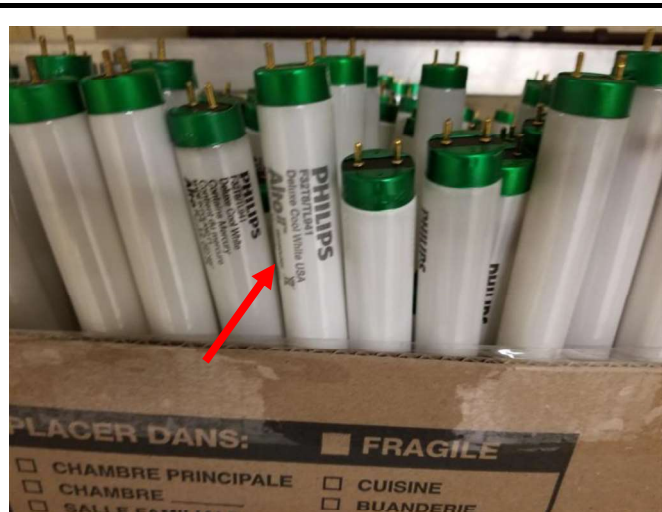
**Photo 6:** View of the mercury containing fluorescent light tubes (see arrow) observed to be in good condition throughout the Subject Building.

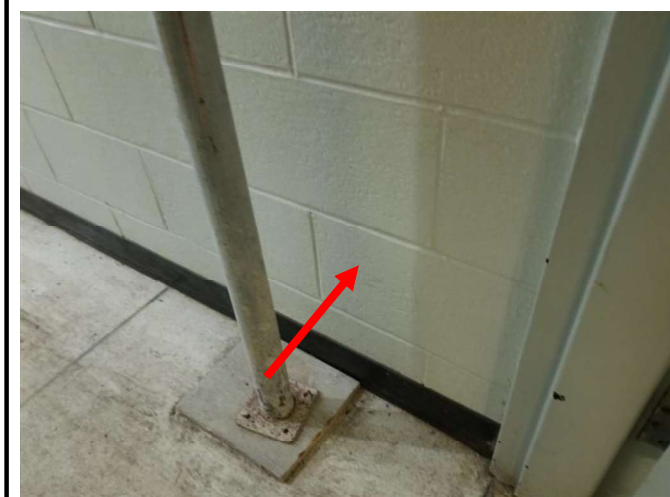
**Photo 7:** View of the lead containing light grey paint (see arrow) observed on the concrete block walls throughout the 1962 section of the Subject Building.

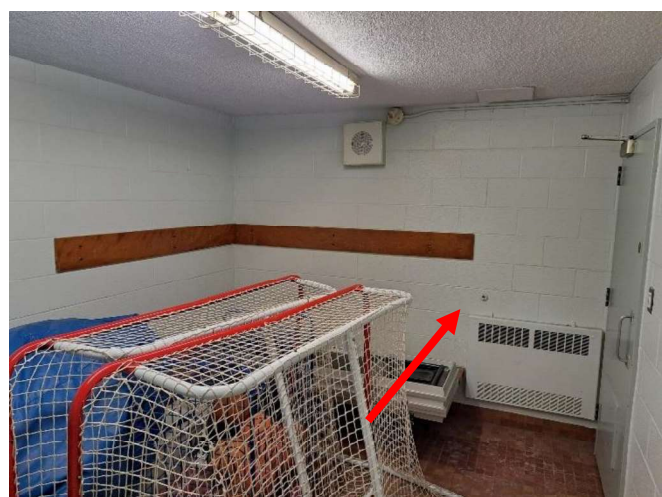
**Photo 8:** View of the containing light grey paint (see arrow) observed on the concrete block walls throughout the 1967 section of the Subject Building.

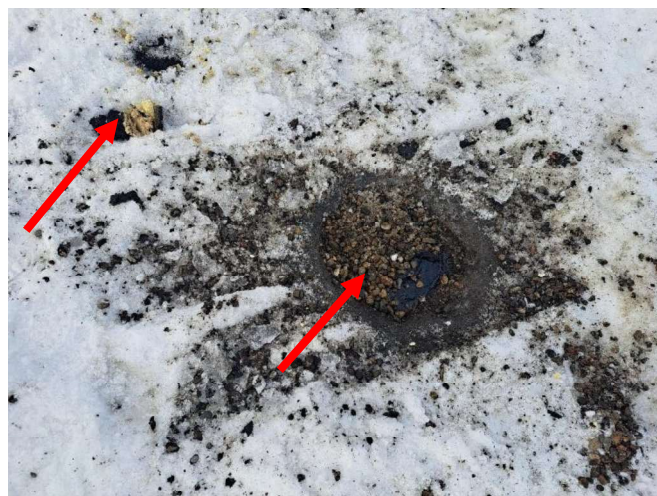
**Photo 9:** View of a typical roof core sample (see left arrow) and roof core sample location following repair (see right arrow) on the Roof of the Subject Building.

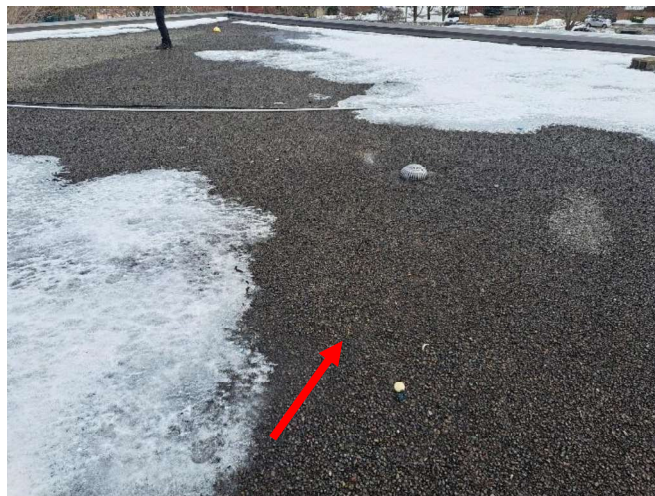
**Photo 10:** A view of the non-asbestos containing built-up roofing system (see arrow) observed throughout the Roof of the Subject building.

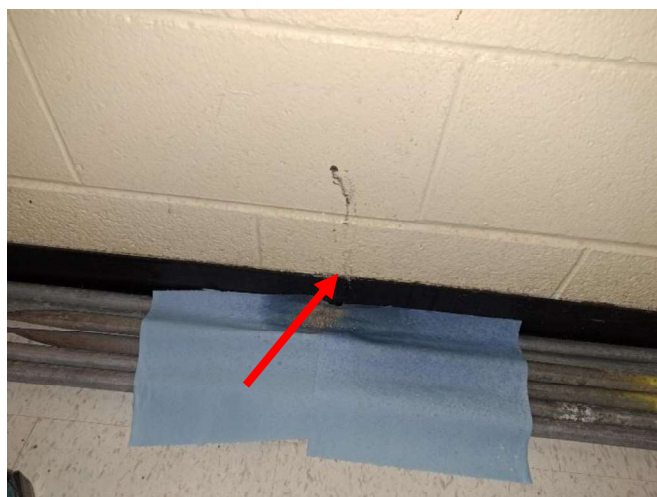
**Photo 11:** View of the concrete block wall during the vermiculite investigation and drilling activities (see arrow) within Classroom 8 of the 1962 section of the Subject Building.

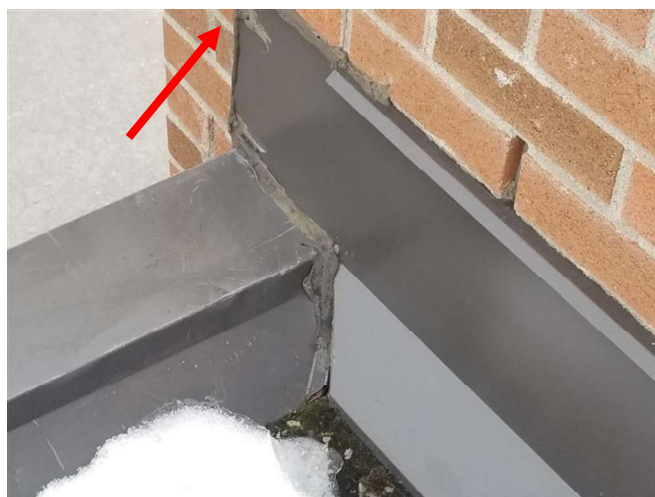
**Photo 12:** View of the non-asbestos containing black caulking (see arrow) adjacent to the flashing observed on the 1967 section of the Roof of the Subject Building.

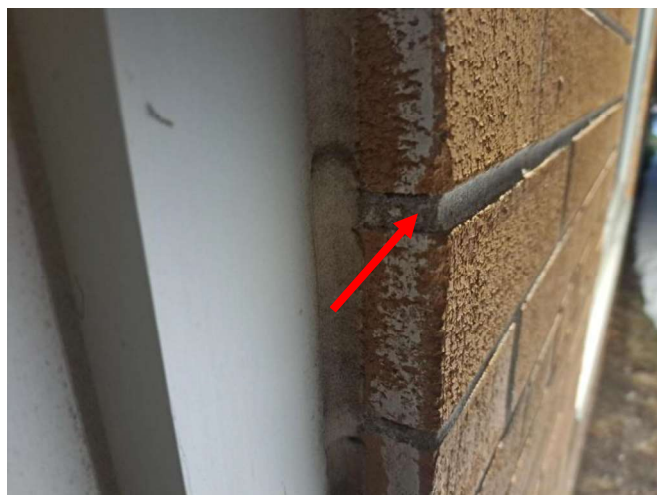
**Photo 13:** View of the non-asbestos containing white exterior caulking (see arrow) observed on the windows of the Subject Building.

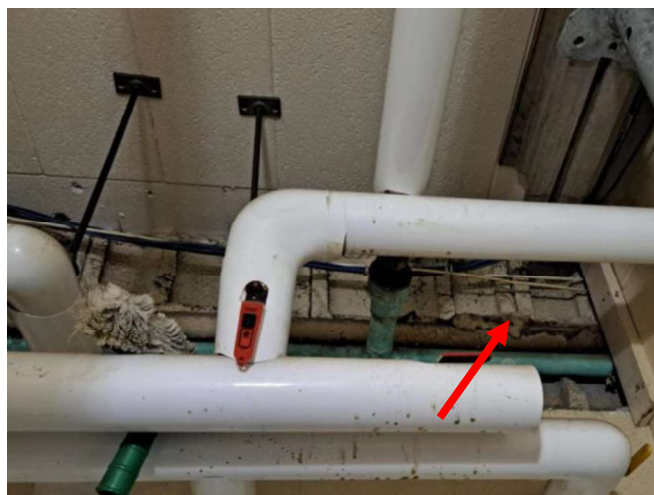
**Photo 14:** View of the suspect asbestos containing remnant pipe straight insulation identified to be non-asbestos containing grey cement mixture/build-up on the piping within Custodian Room 112 of the Subject Building.
