December 17, 2021

Project No. 21498087(1000)

**2021 ASBESTOS-CONTAINING MATERIALS CONDITION ASSESSMENT – 77 CENTRE STREET NORTH,  
OSHAWA, ONTARIO**

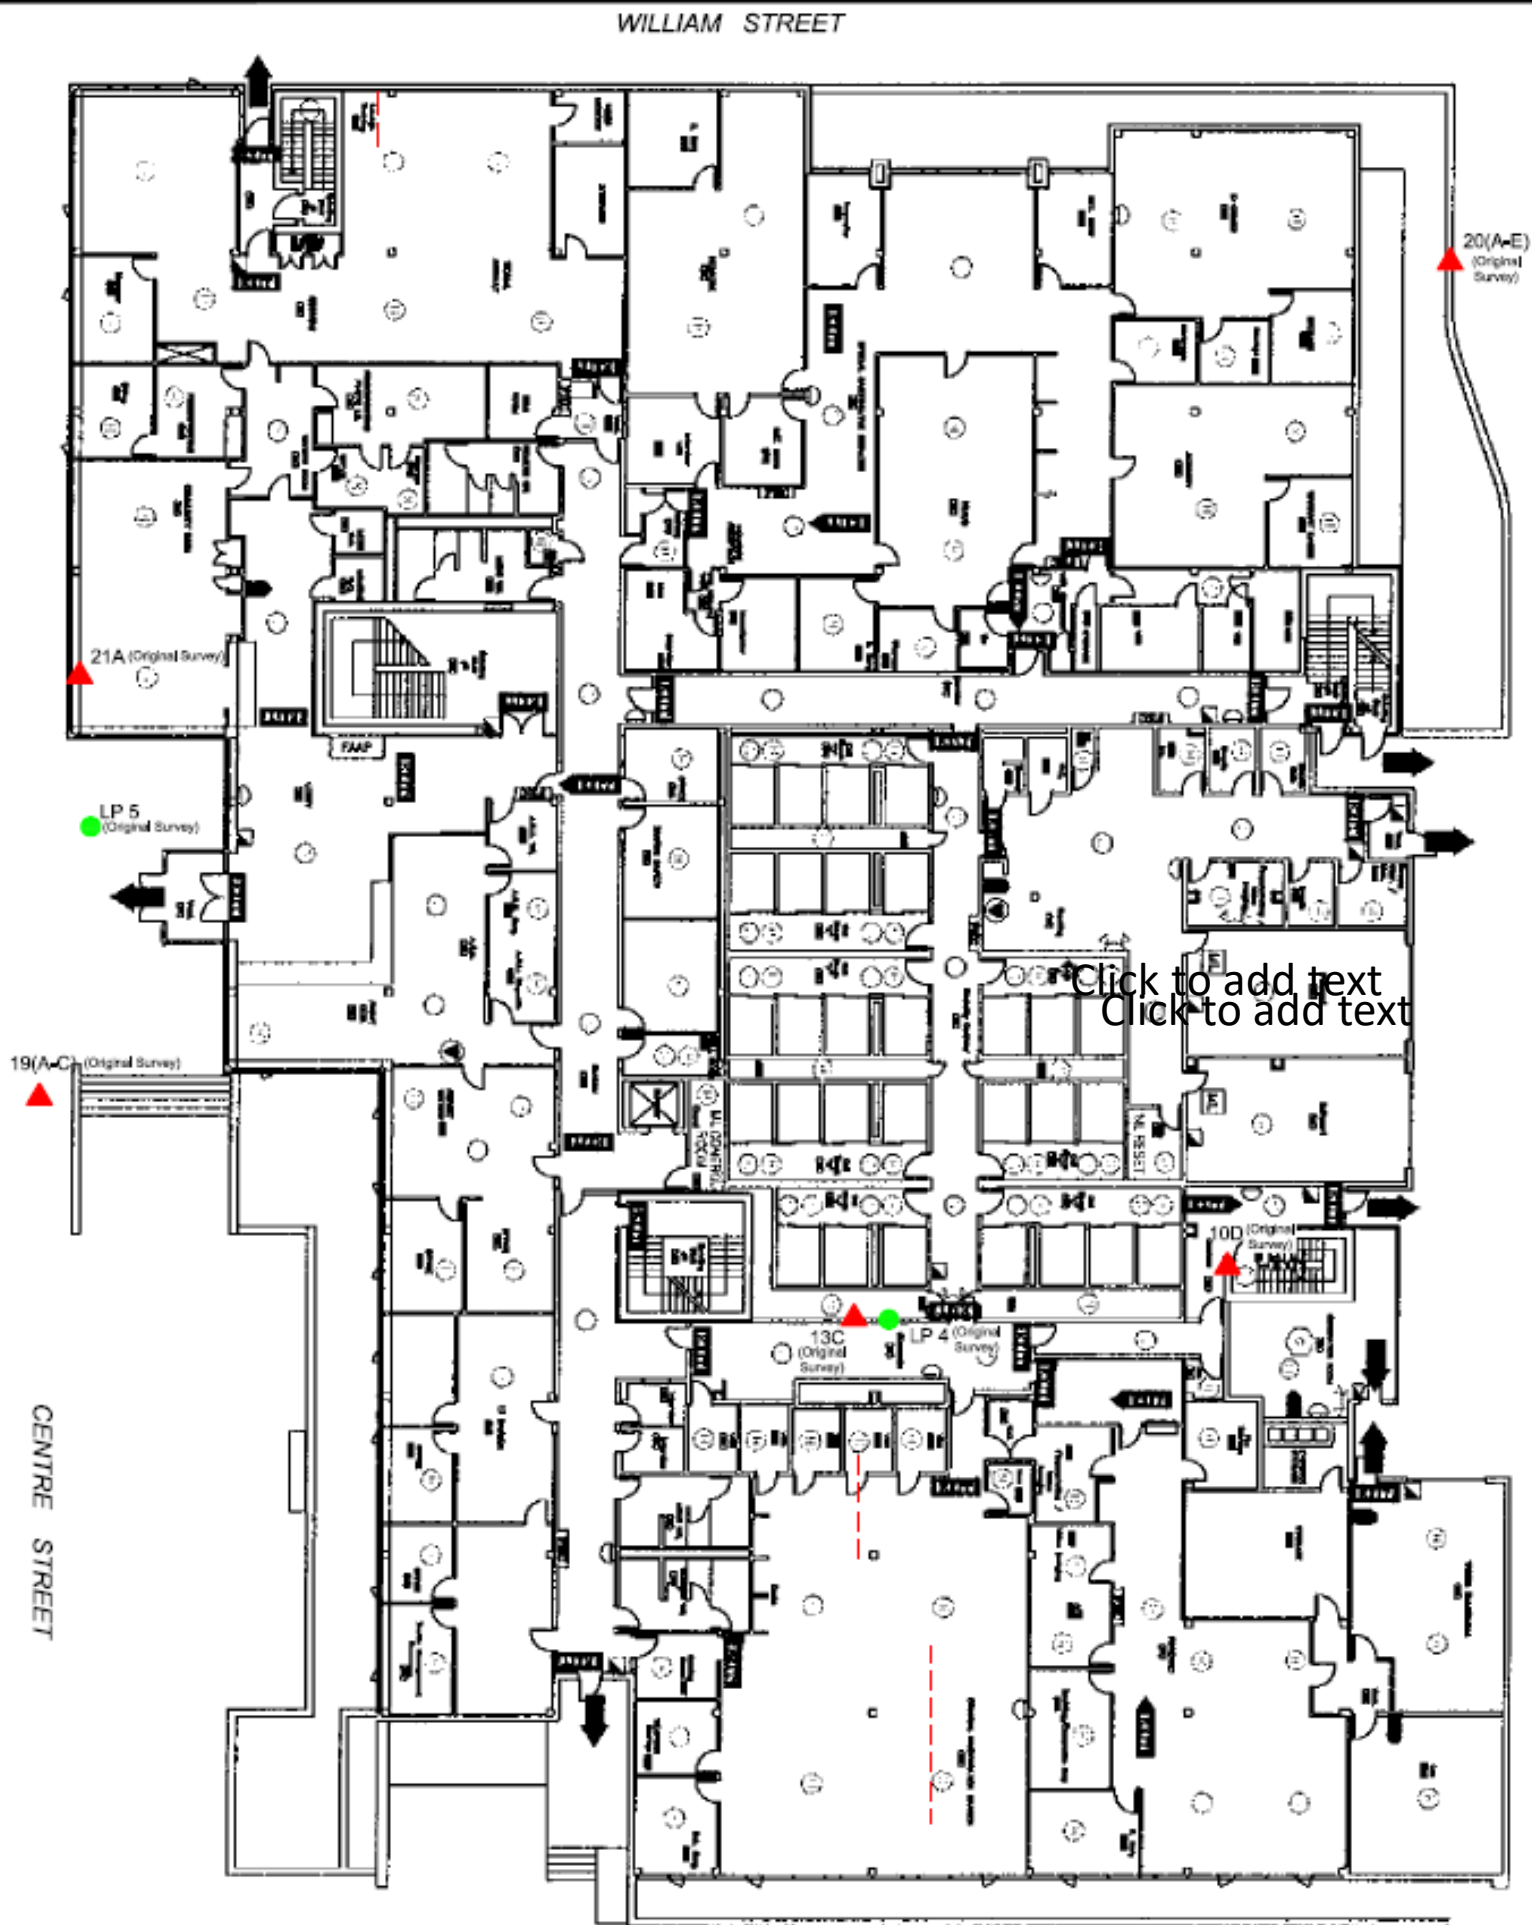
### LOCATION PLAN – MAIN FLOOR

**Comments:** Two locations: north-centre and southeast corner of South Office.

**Comments:** Transite pipe is present behind drywall and difficult to visually assess.

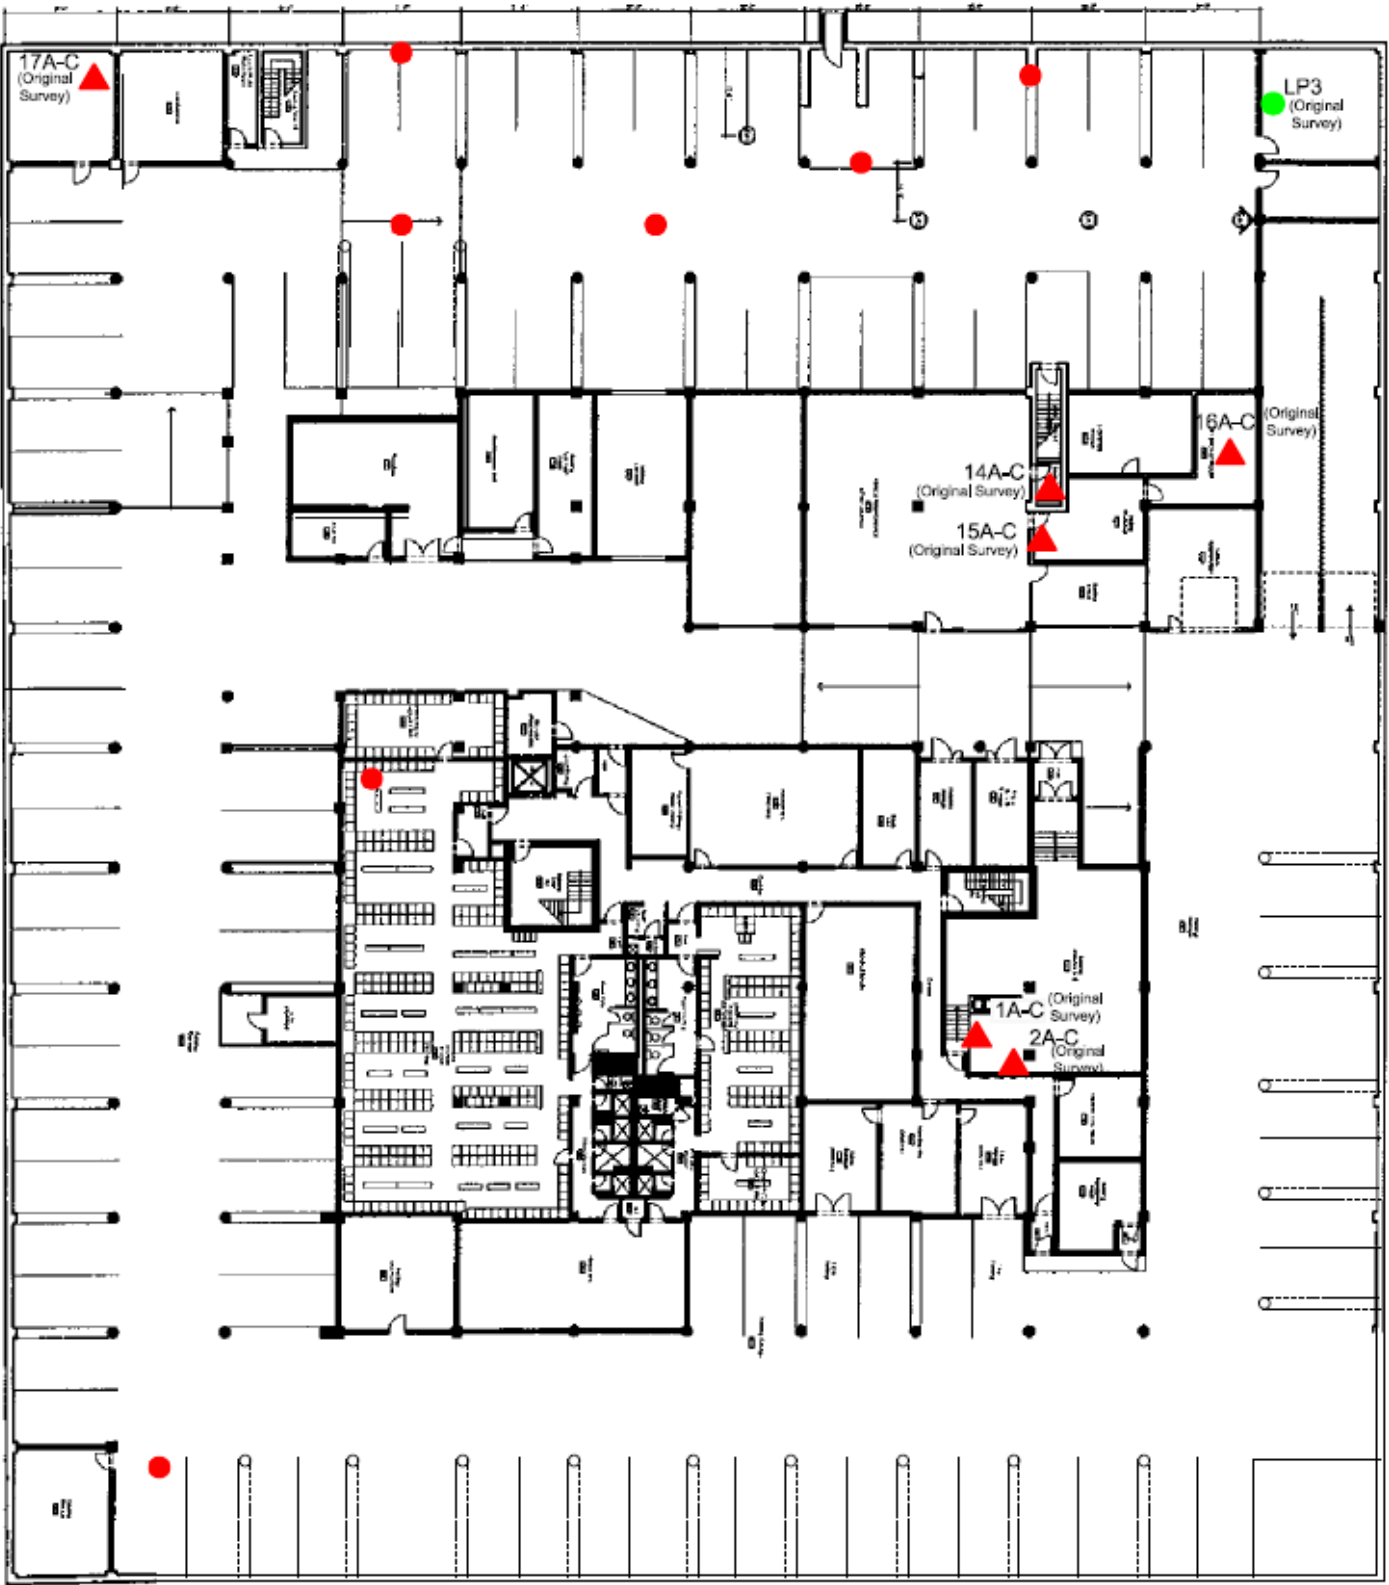
**TITLE  
LOCATION PLAN – BASEMENT**

**Comments:** Transite pipe has been cut out and replaced with a non-asbestos piping and all that remains are sections of Transite pipe below the underside and in the concrete deck.
