**Re: Revised Hazardous Building Materials Assessment (Preconstruction)**

Sunnycrest Nursing Home, 1635 Dundas Street East, Whitby, Ontario  
Pinchin File: 329911.001

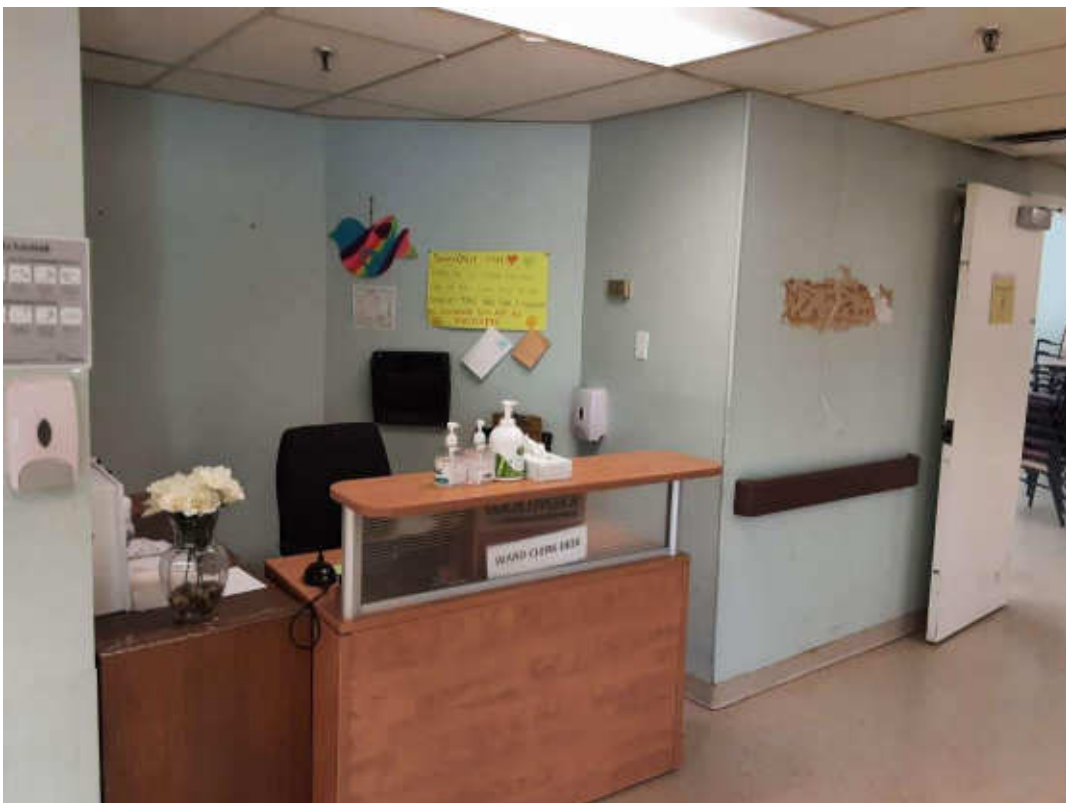
V0009 (Confirmed Asbestos), Wall, Drywall and joint compound, Lobby (Location #: 4)

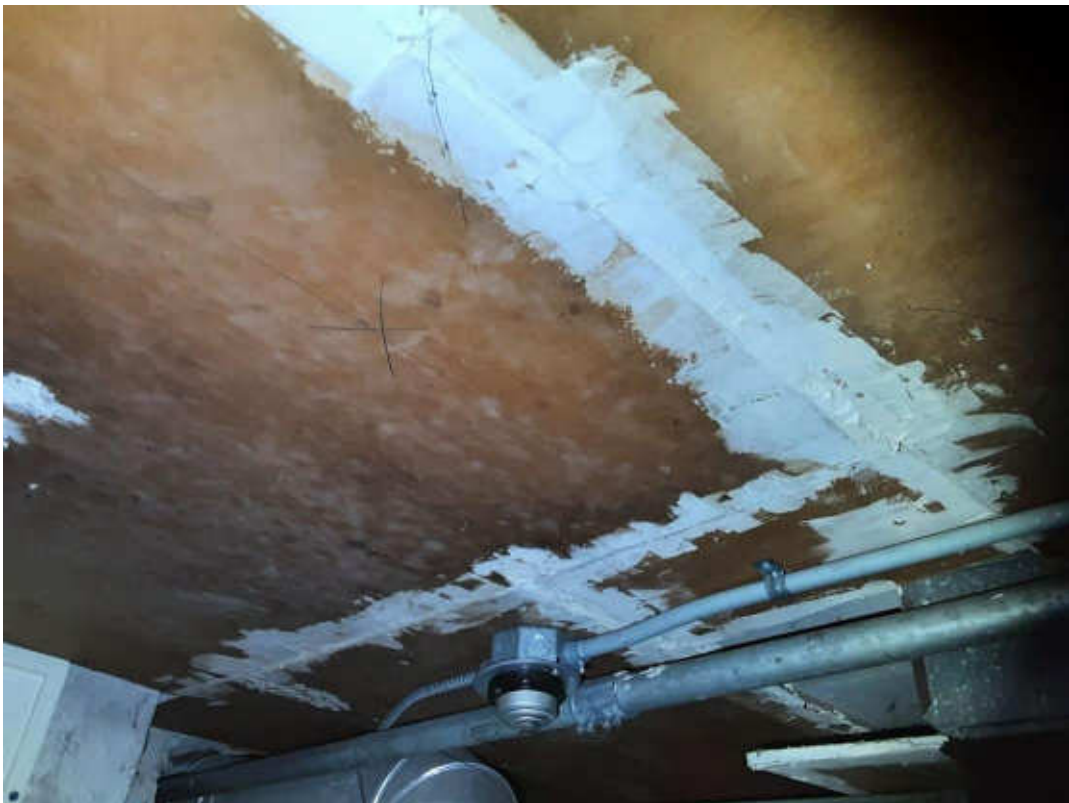
S0040A (Confirmed Asbestos), Ceiling, Drywall and joint compound, Old House - Basement (Location #: 135)

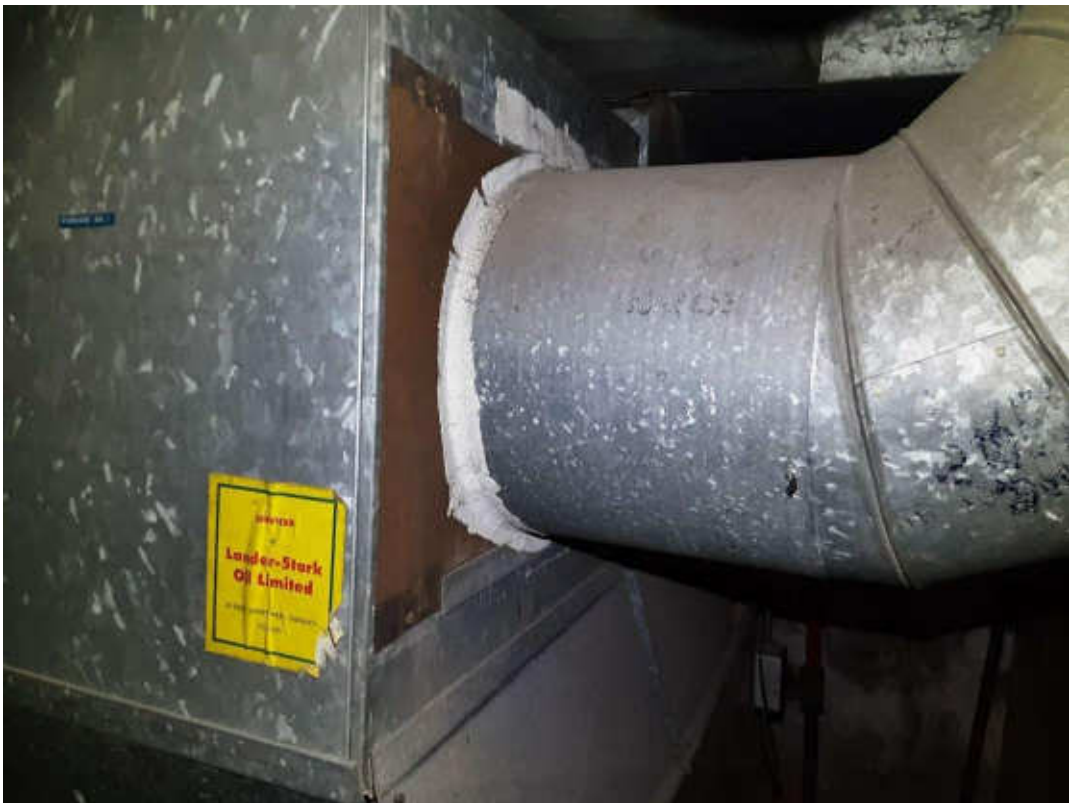
S0042A (Confirmed Asbestos), Duct, Textile, Old House - Basement (Location #: 135)

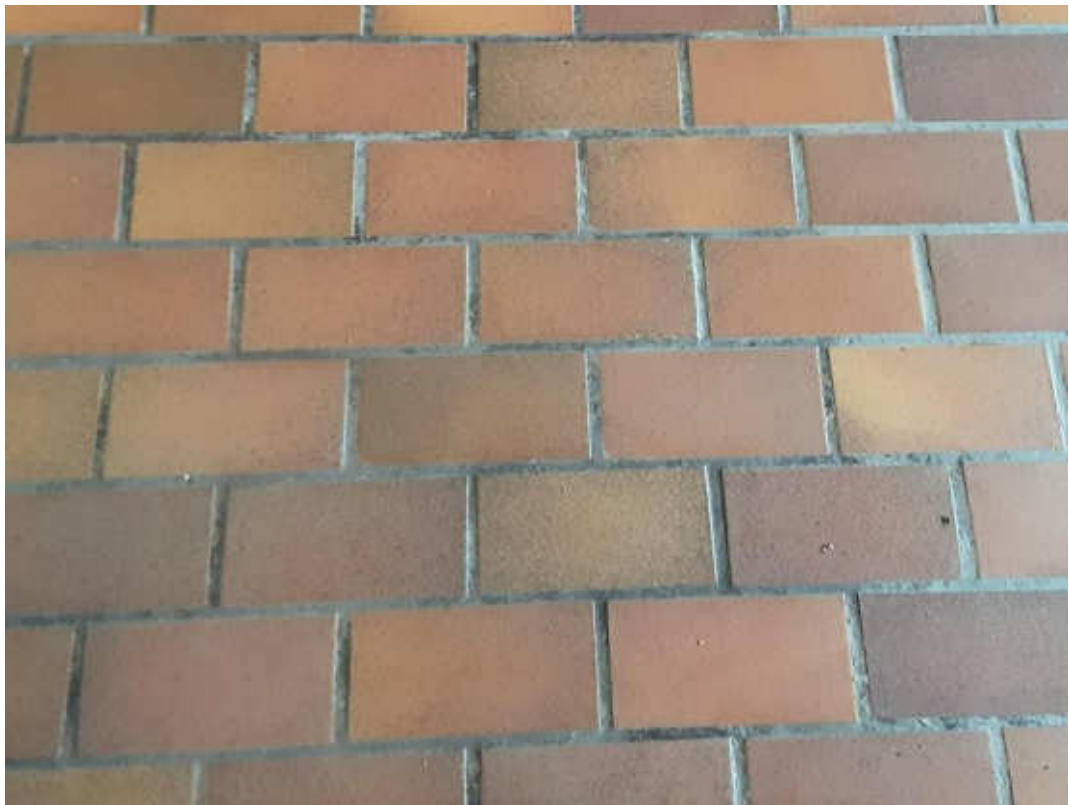
S0079A (Confirmed Asbestos), Floor, Thinset below 2" x 6" red faux brick ceramic tile, Vestibule (Location #: 116)

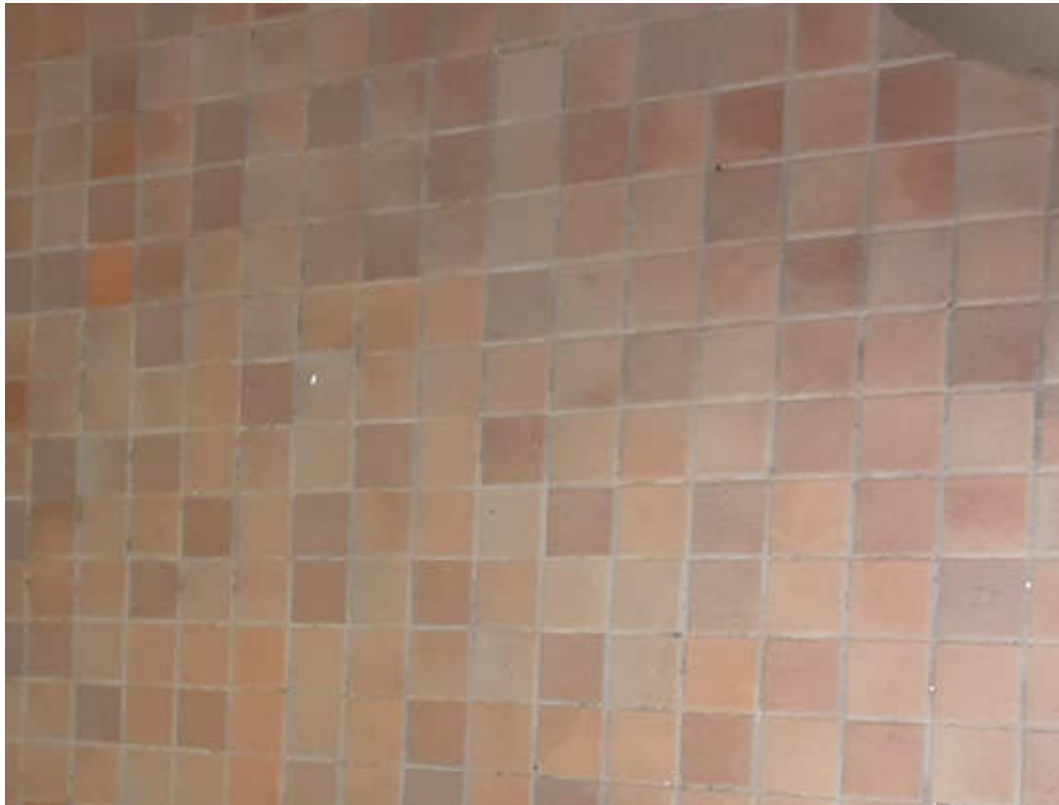
S0080A (Confirmed Asbestos), Floor, Thinset below 1" x 1" red brick ceramic tile, Women's Washroom (Location #: 114)

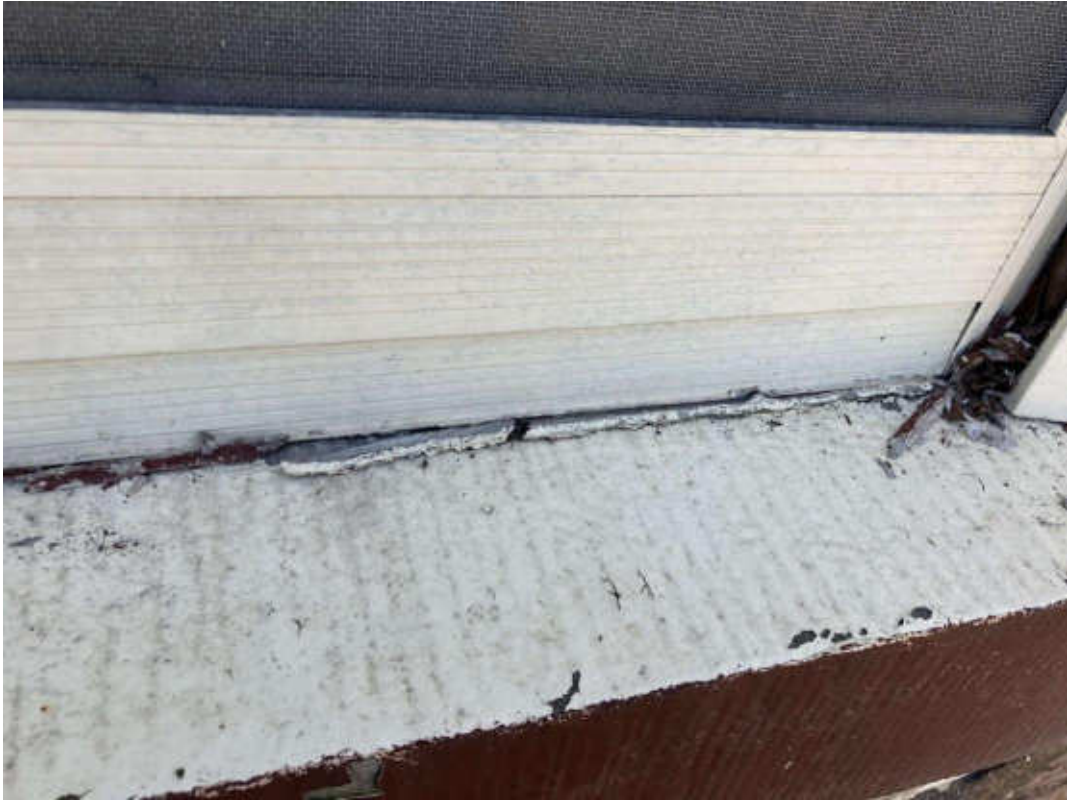
S0099C (Confirmed Asbestos), Light grey window caulking, Other, Caulking, Exterior (Old House) (Location #: 180)

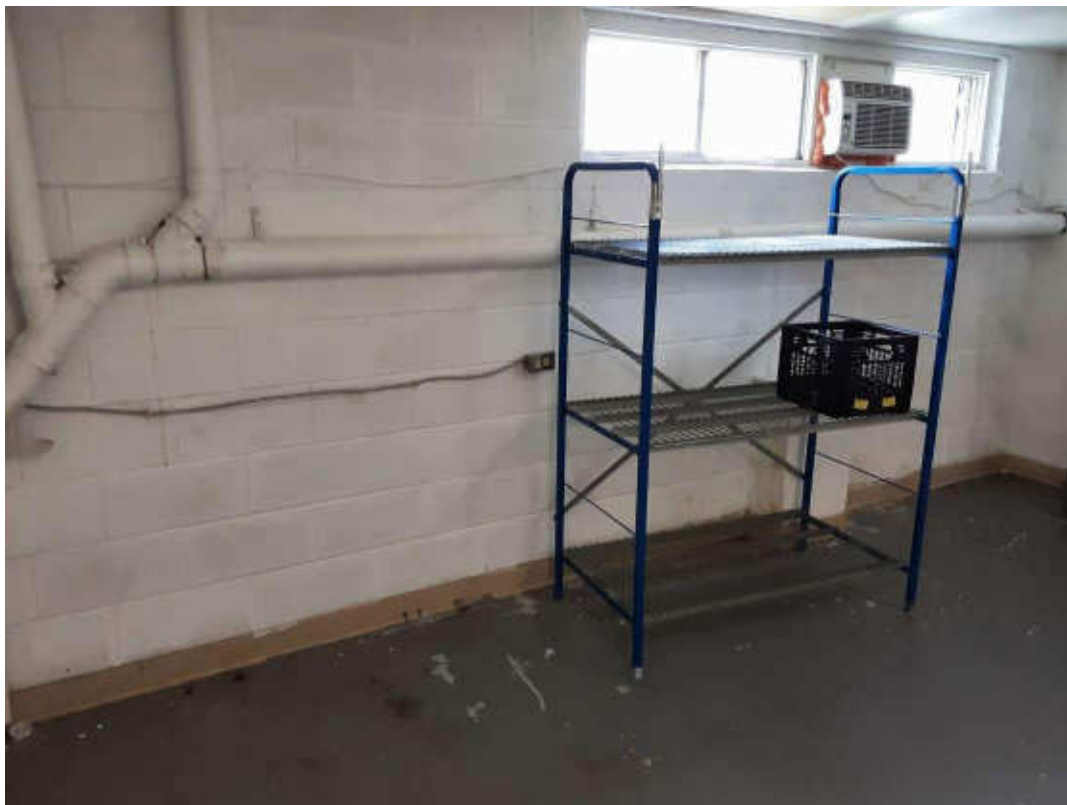
V9000 (Confirmed Asbestos), Piping, Rainwater Leader, Transite Cement, Dietary Storage (Location #: 130)

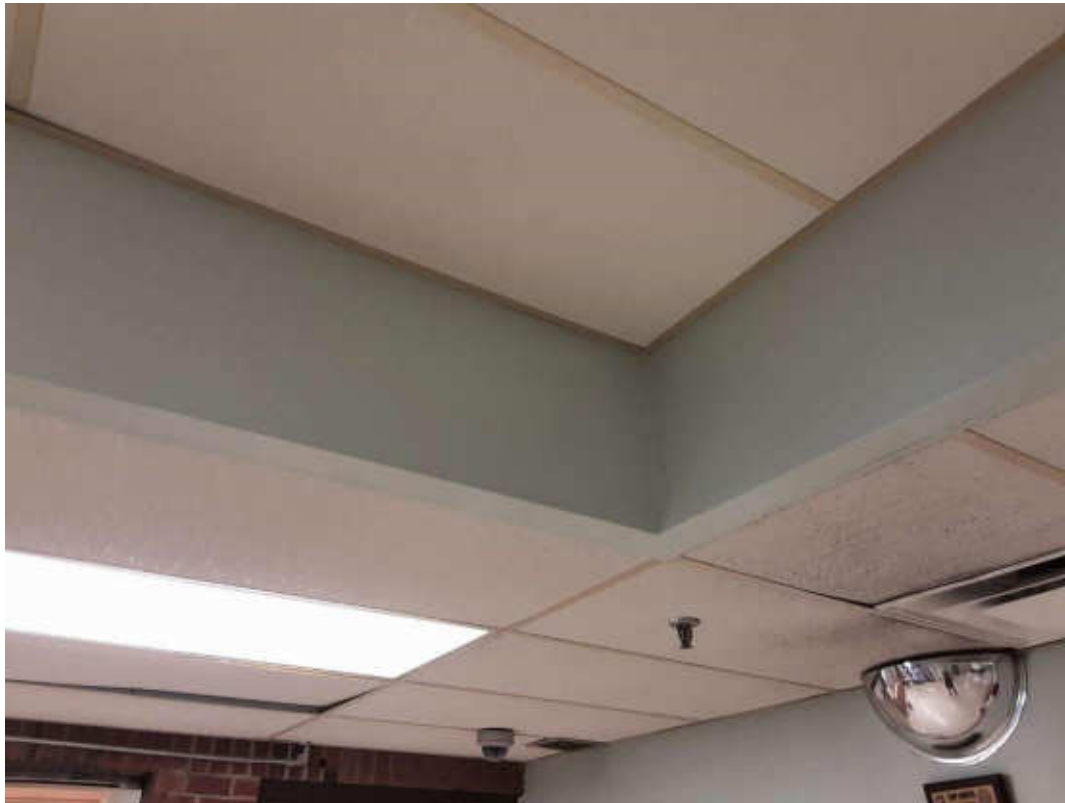
V0009 (confirmed Asbestos), Ceiling, Drywall on bulkhead, Lobby (Location #: 4)

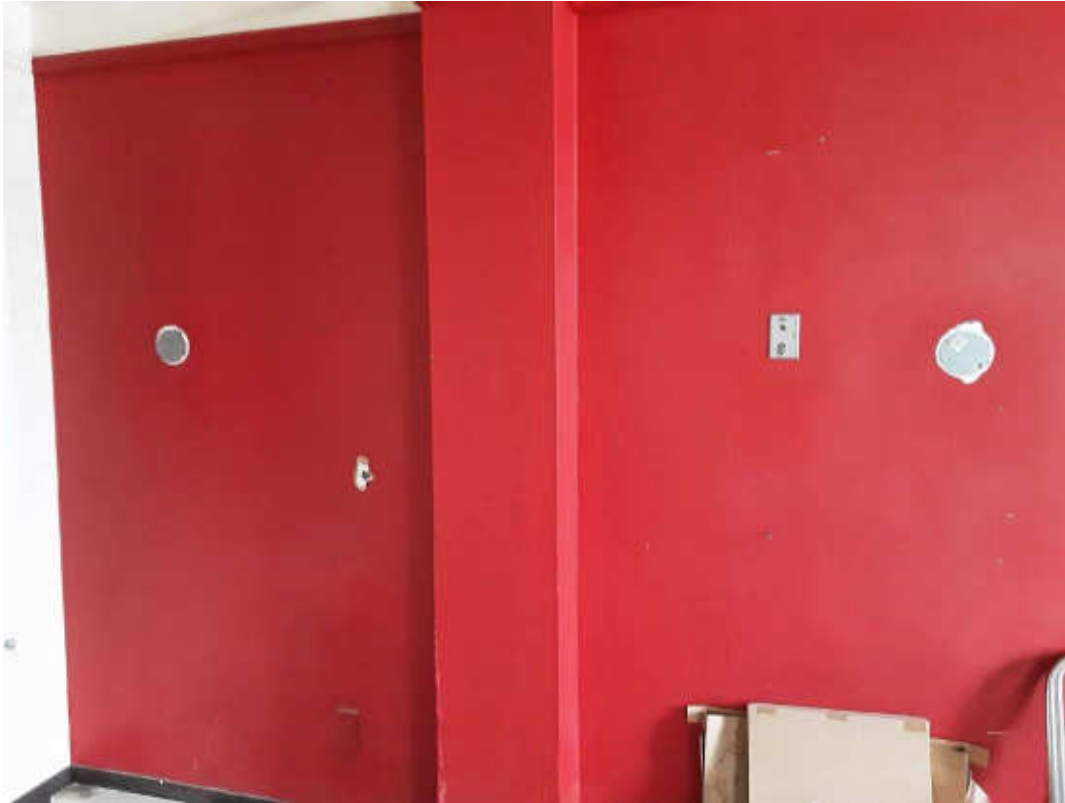
Drywall and joint compound, Red, L0017(Lead (High)), Old House - Ground Floor (Location #: 177)

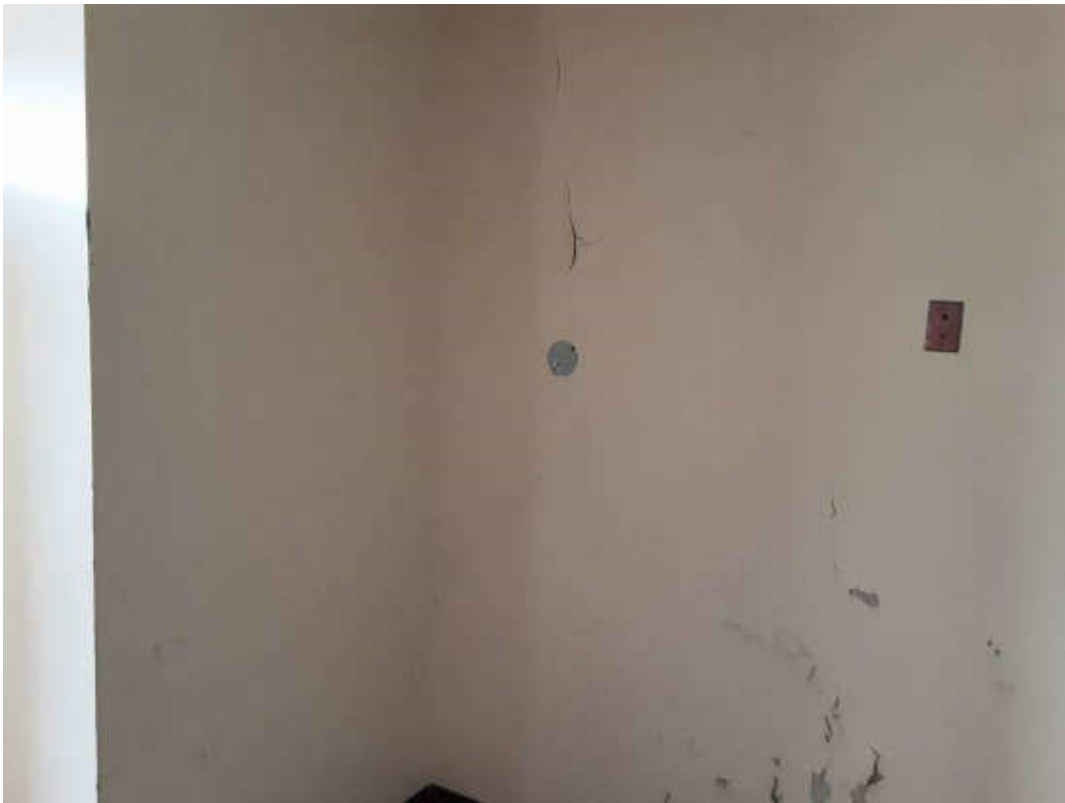
Drywall and joint compound, Off-white, L0016(Lead (High)), Old House - Ground Floor (Location #: 177)

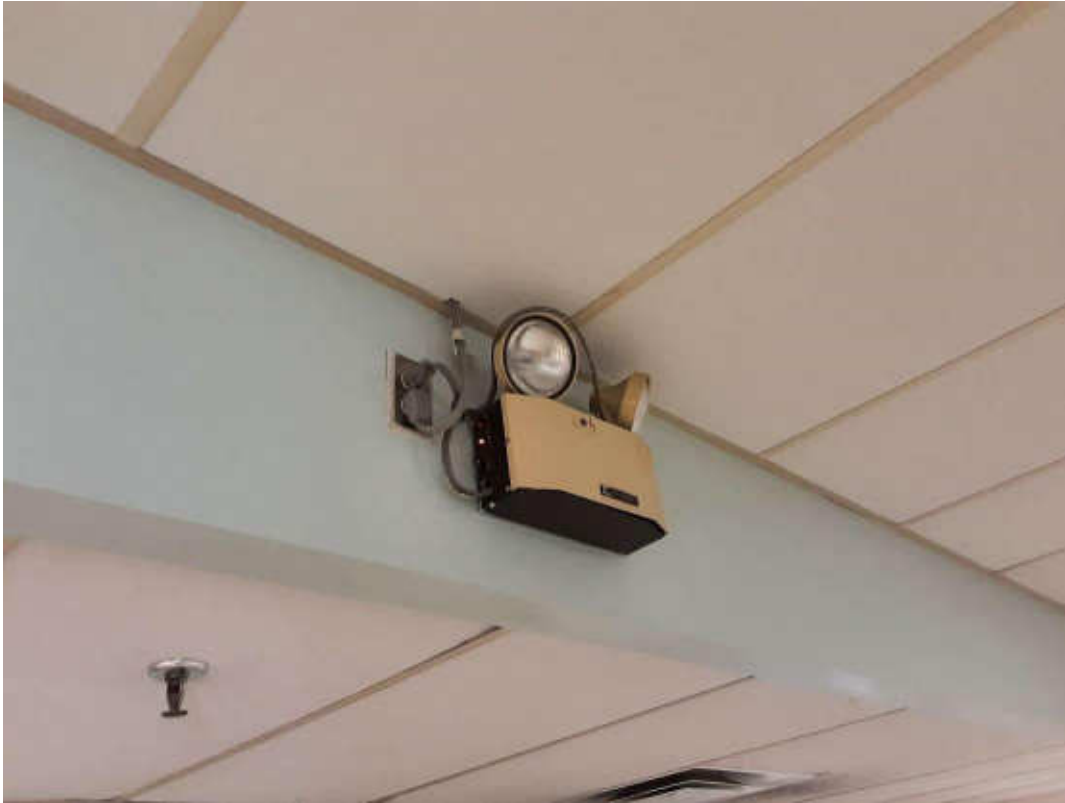
Pb Products, Lobby (Location #: 4)

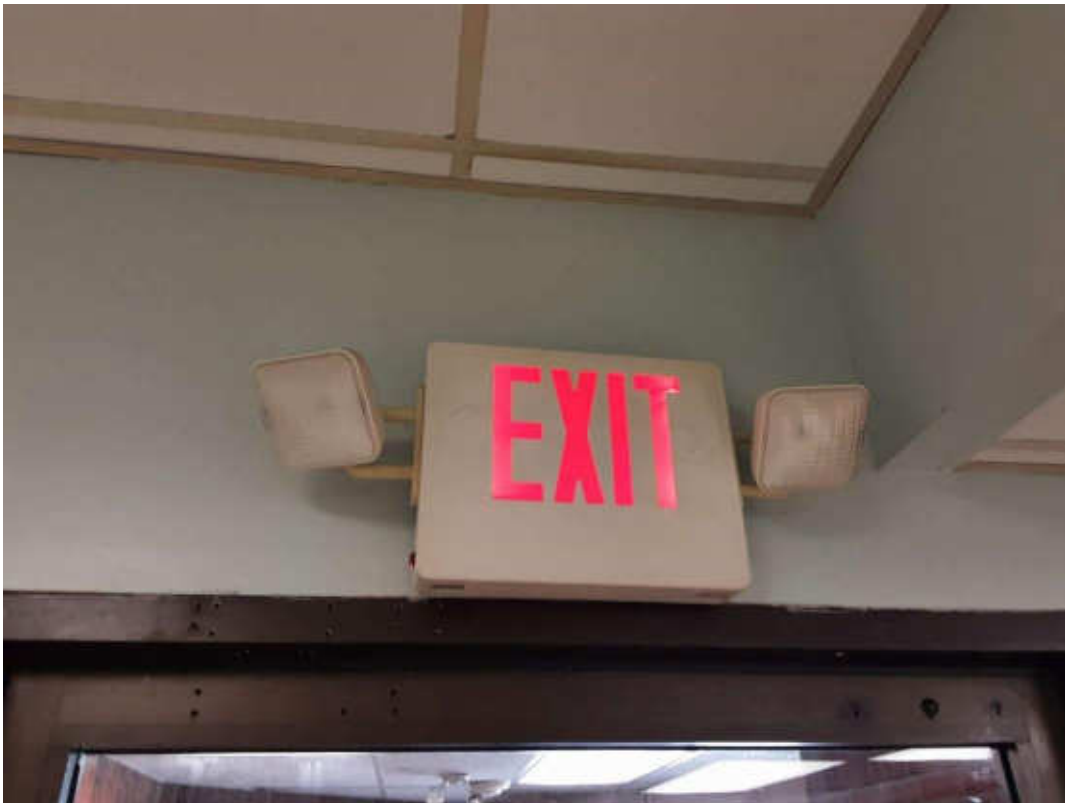
Pb Products, Lobby (Location #: 4)

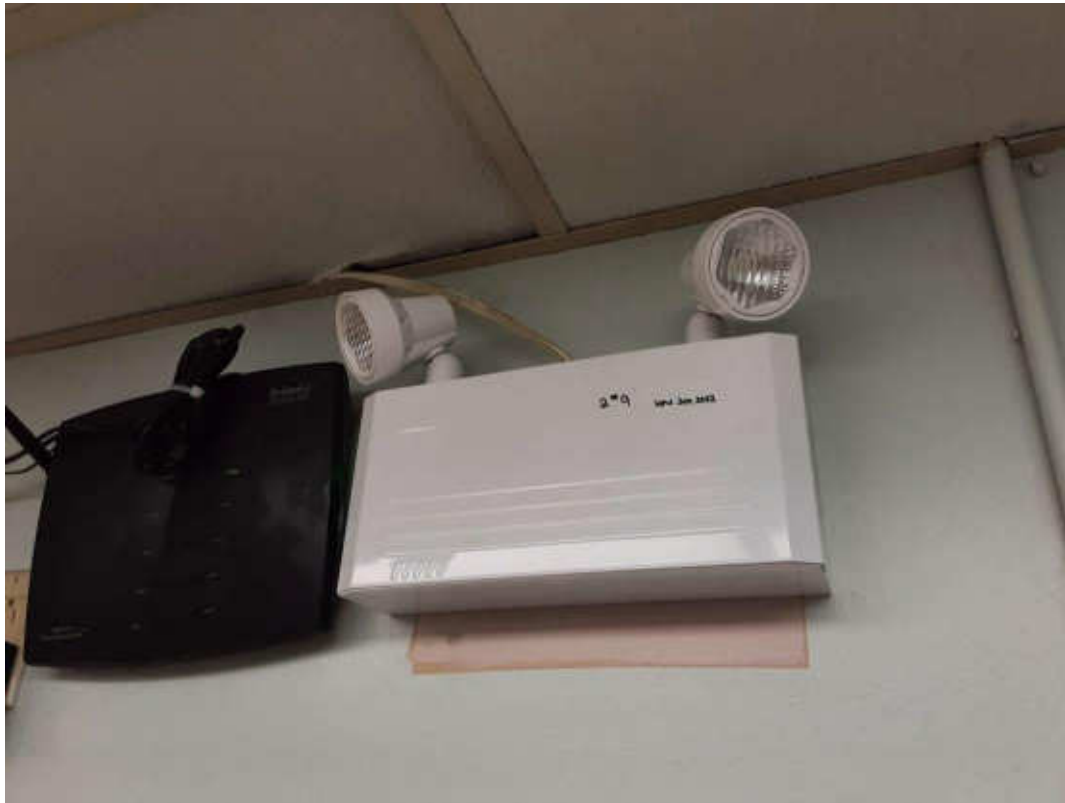
Pb Products, Lobby (Location #: 4)

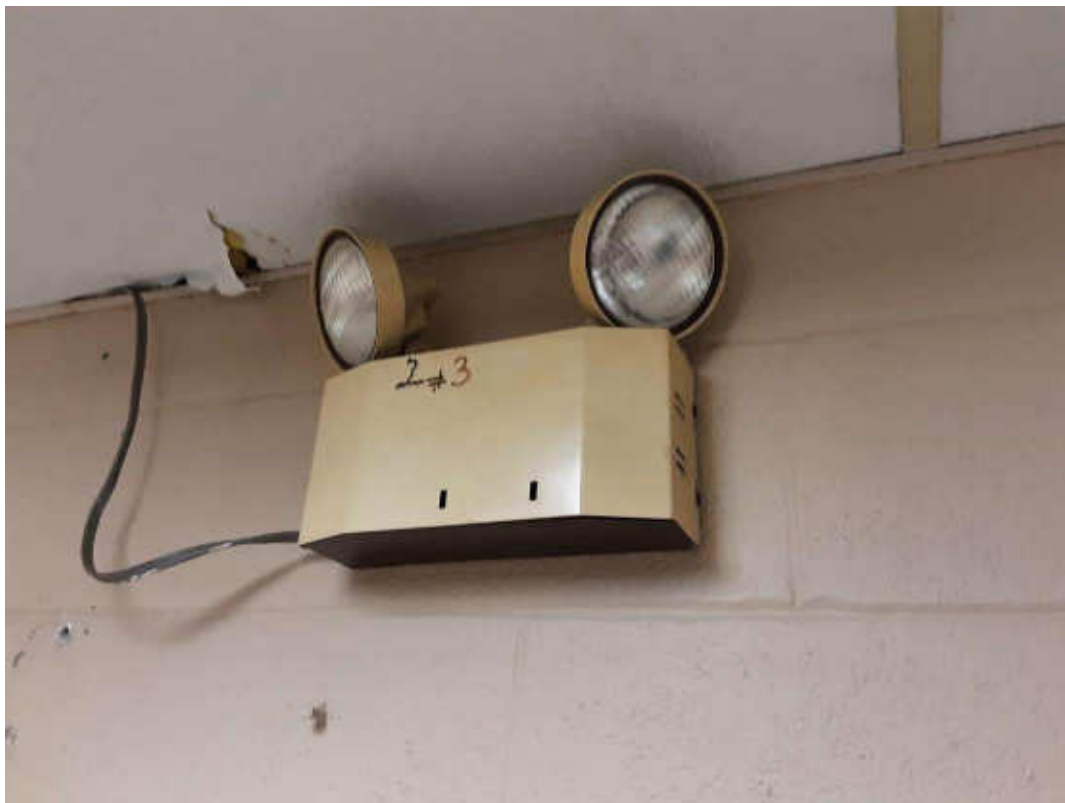
Pb Products, West Corridor (Location #: 56)

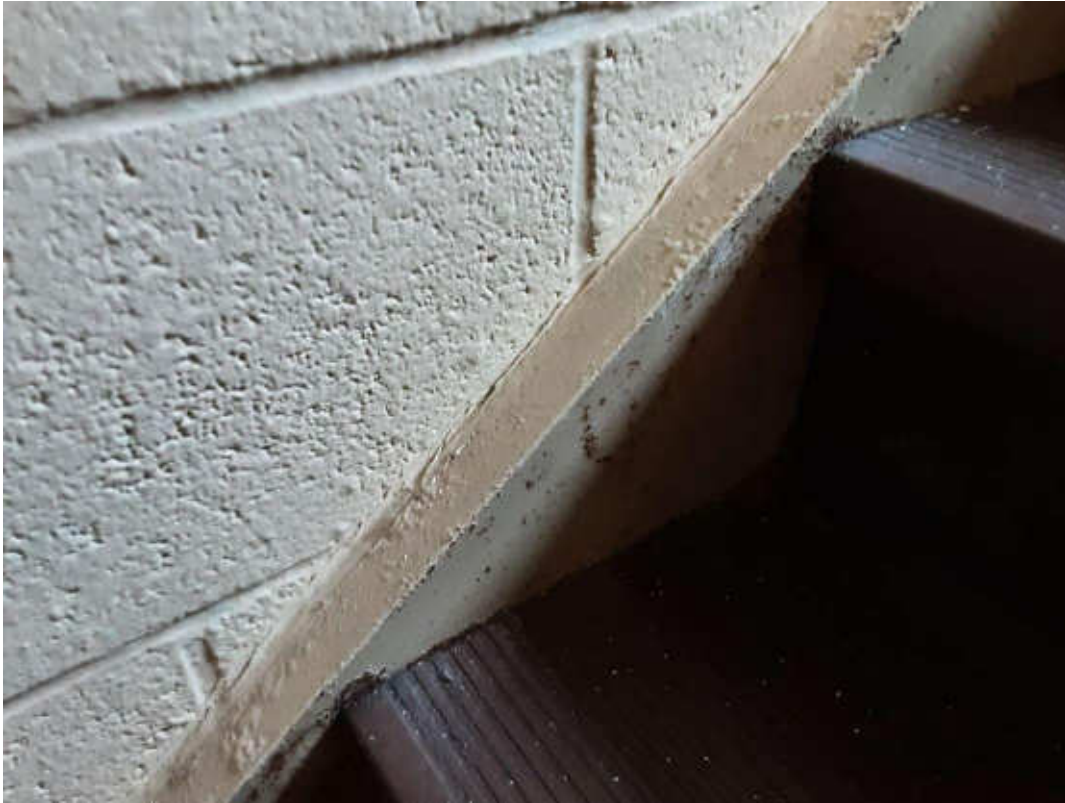
PCB, South Stairwell (Location #: 143)

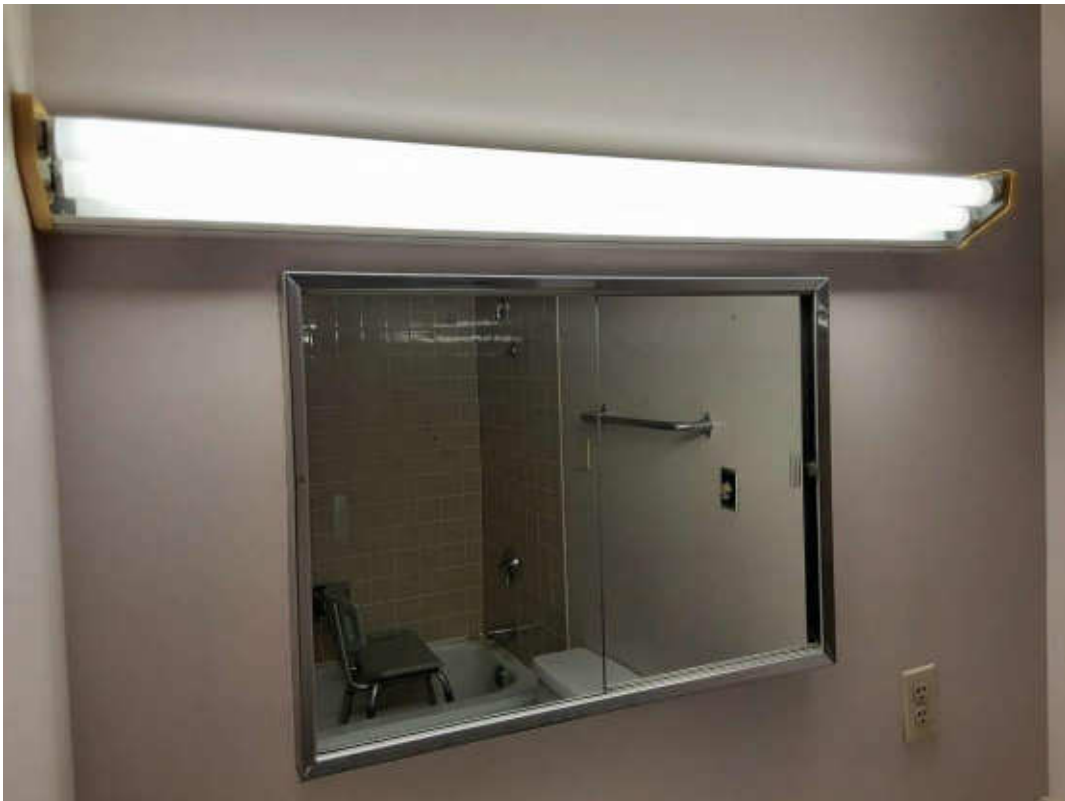
PCB, Medical Supply (Location #: 174)

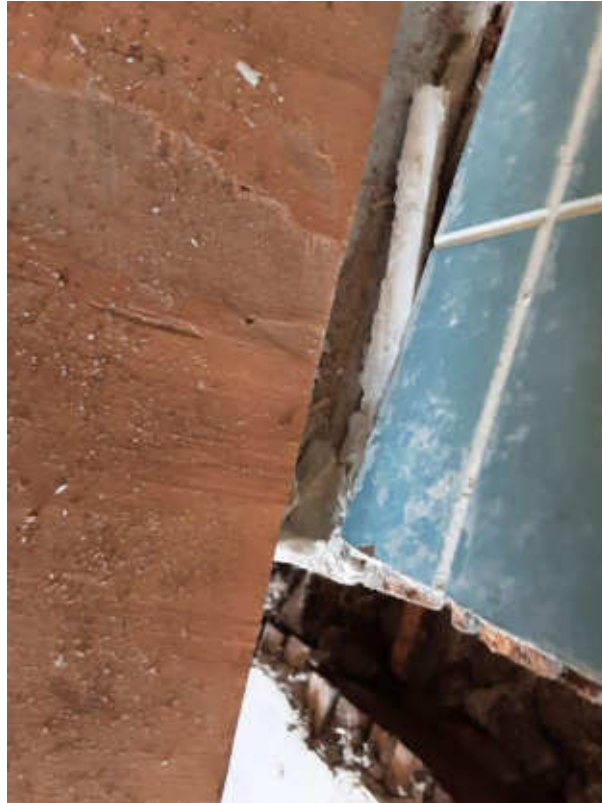
PCB, Old House - 2nd Floor (Location #: 178)
