**Re: Asbestos Reassessment**

Centennial Secondary School, 160 Palmer Road, Belleville, ON  
Pinchin File: 200584.085

Hastings and Prince Edward District School Board (Client) retained Pinchin Ltd. (Pinchin) to conduct an asbestos-containing materials (ACM) reassessment of Centennial Secondary School located at 160 Palmer Road, Belleville, ON.

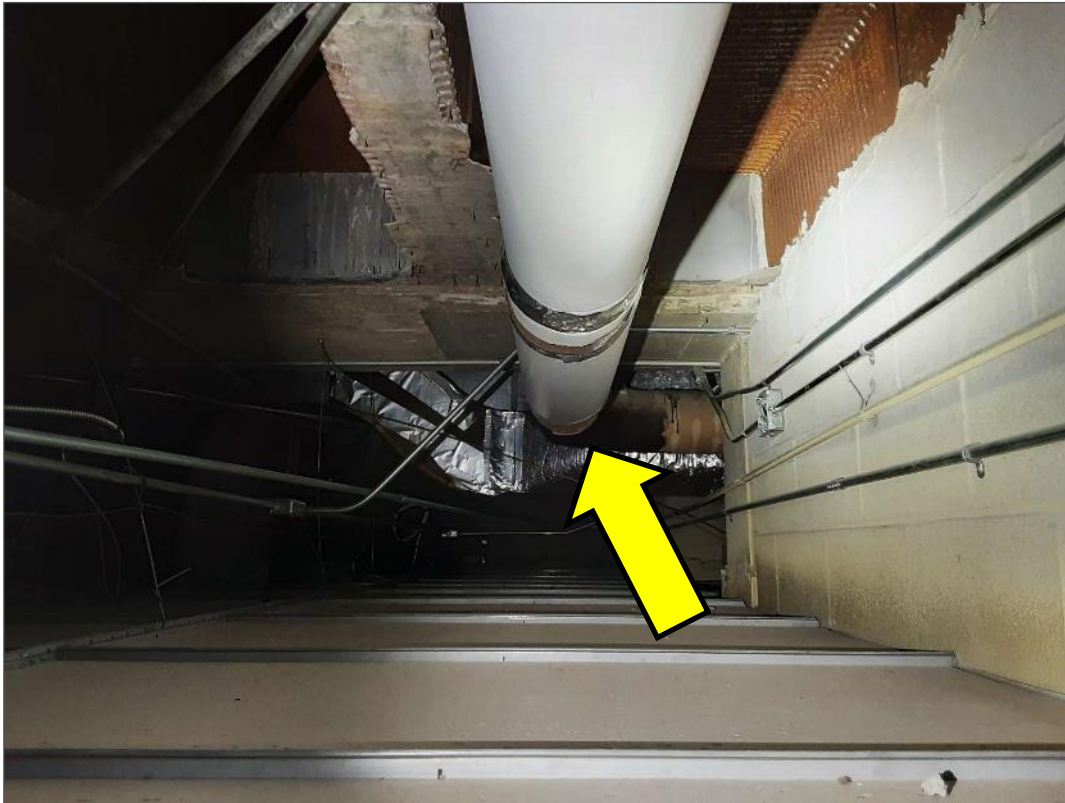
V0001 - (Confirmed Asbestos) Piping, Mastic, Over Parging Cement, 293 (Location #: 2920)

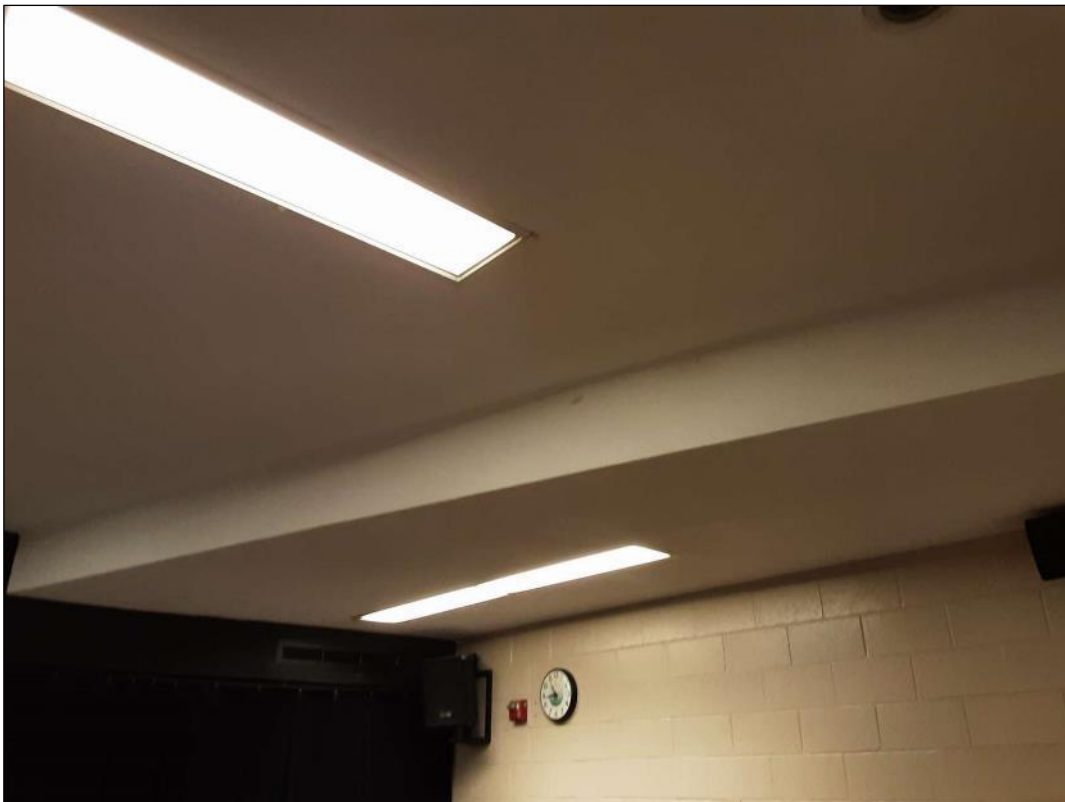
S0004A - (Confirmed Asbestos) Ceiling, Texture Coat, 102 (Location #: 1000)

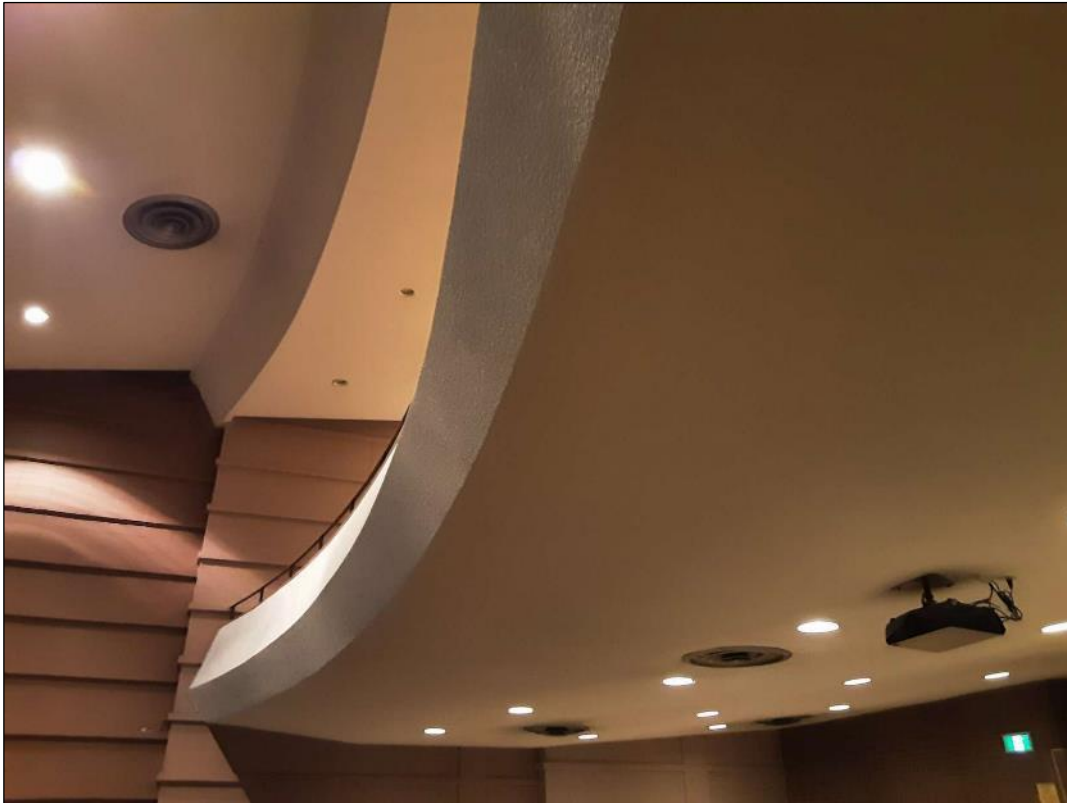
S0005A - (Confirmed Asbestos) Ceiling, Texture Coat, 101 (Location #: 1610)

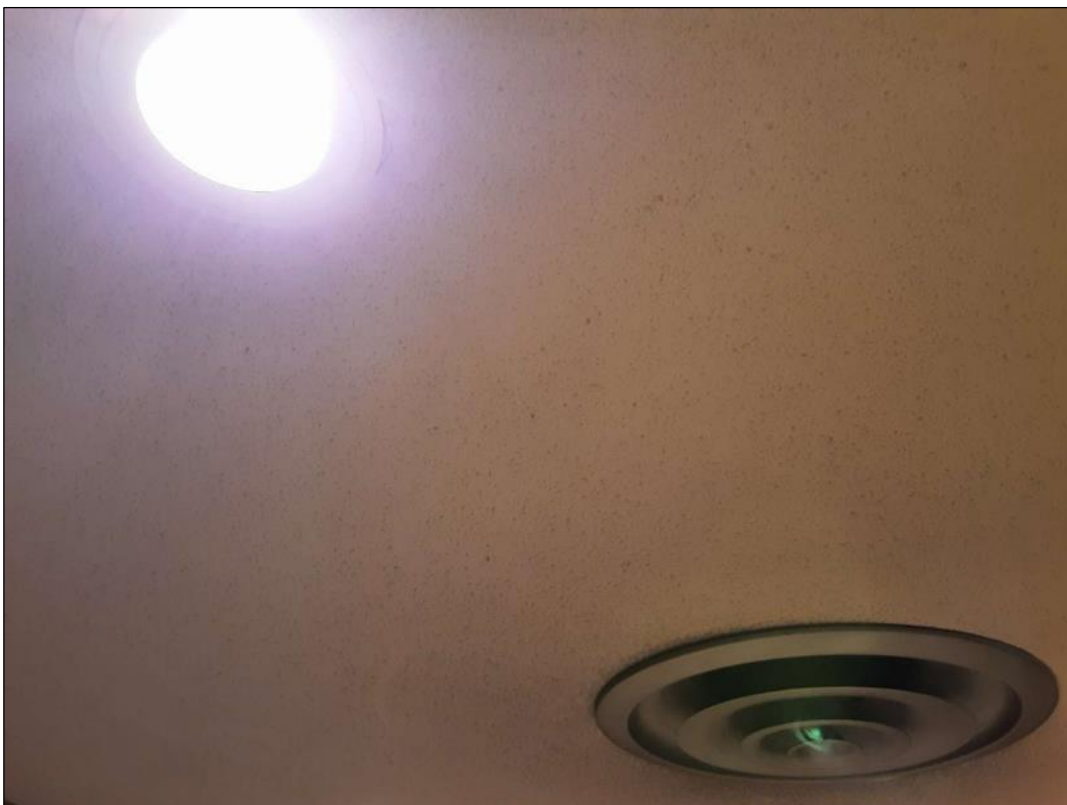
S0005F - (Confirmed Asbestos) Ceiling, Texture Coat, 201 (Location #: 2650)

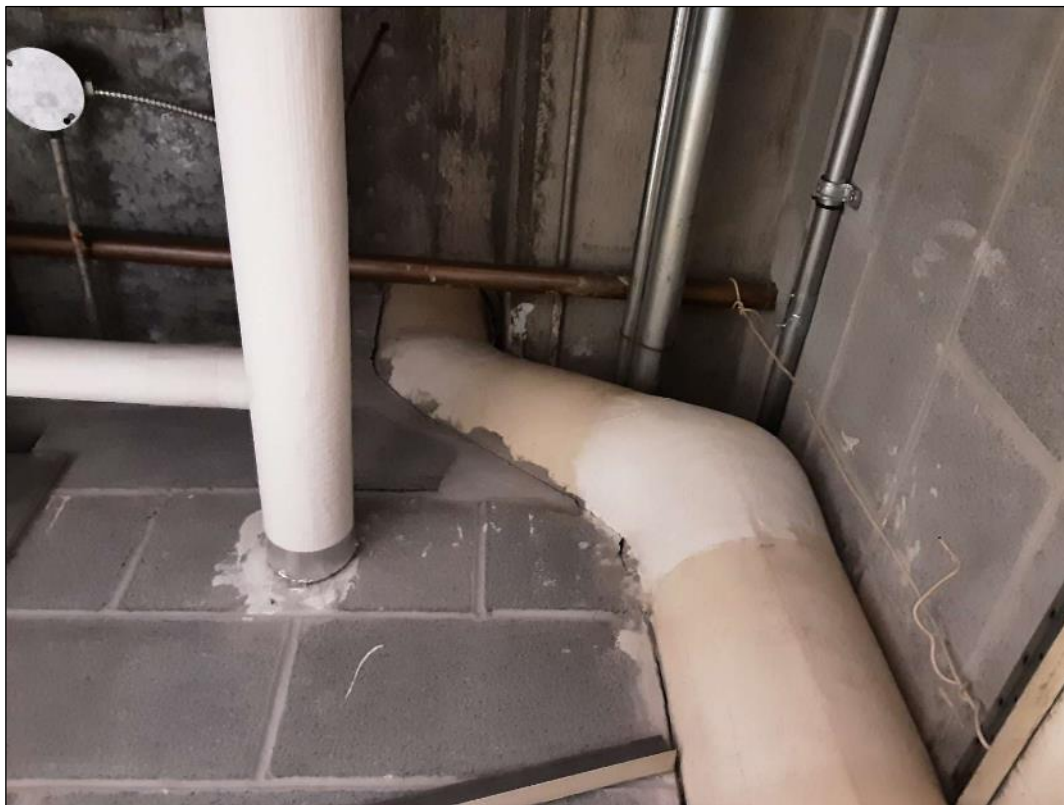
V0006 - (Confirmed Asbestos) Piping, Parging Cement, 120A (Location #: 1433)

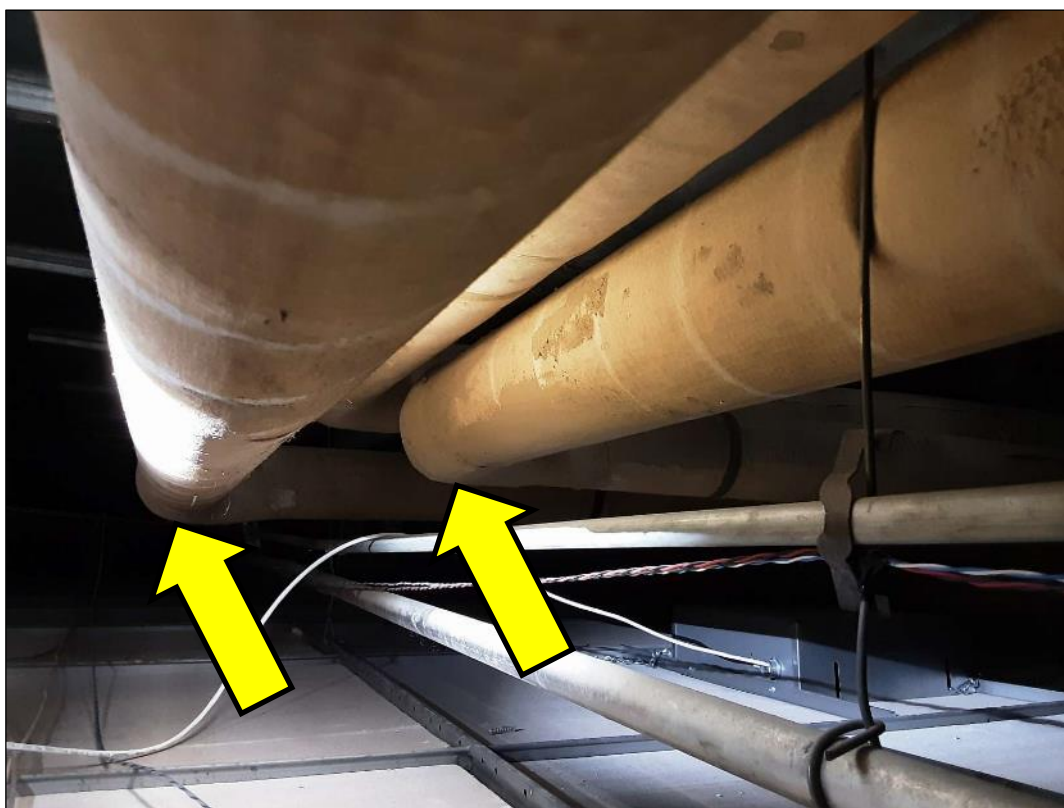
V0006 - (Confirmed Asbestos) Piping, Parging Cement, 191 (Location #: 1590)

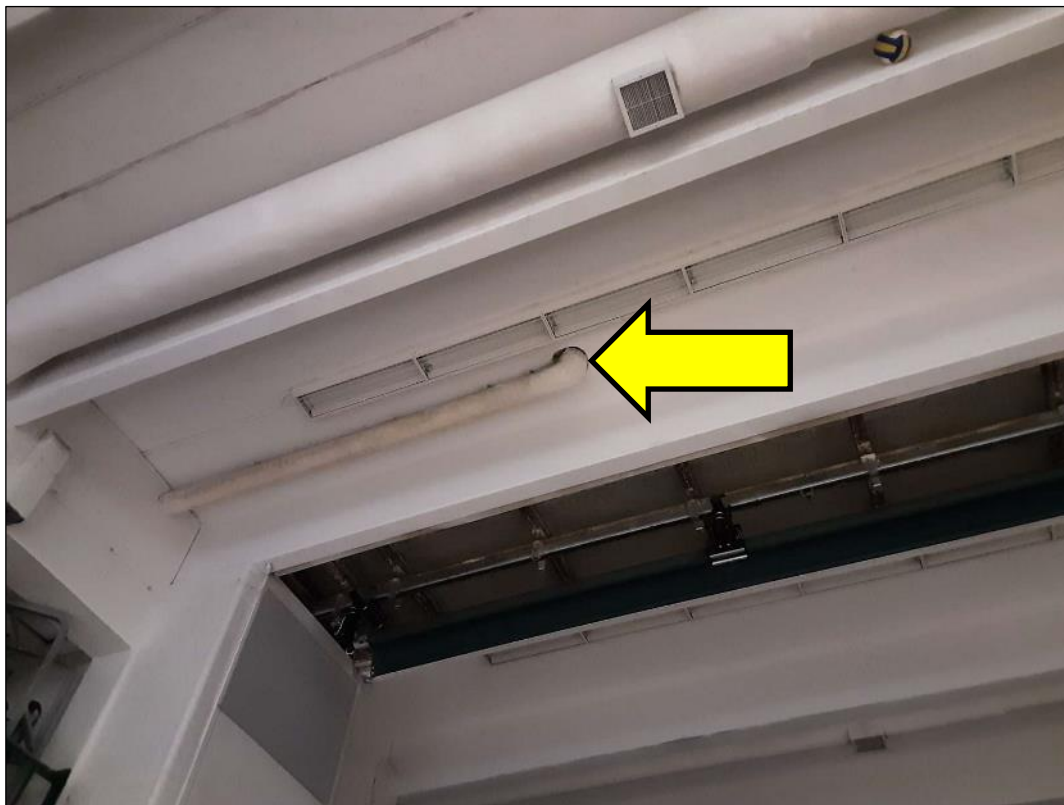
V0006 - (Confirmed Asbestos) Piping, Parging Cement, Gym 148 (Location #: 1620)

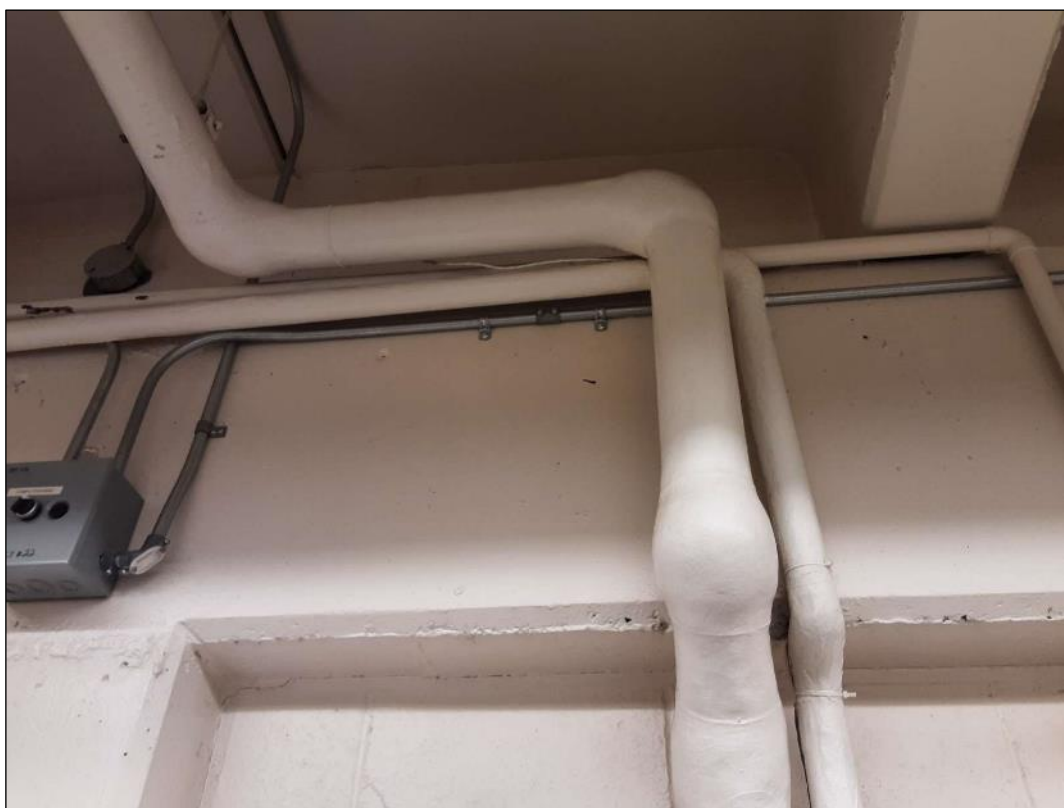
V0006 - (Confirmed Asbestos) Piping, Parging Cement, 152C (Location #: 1775)

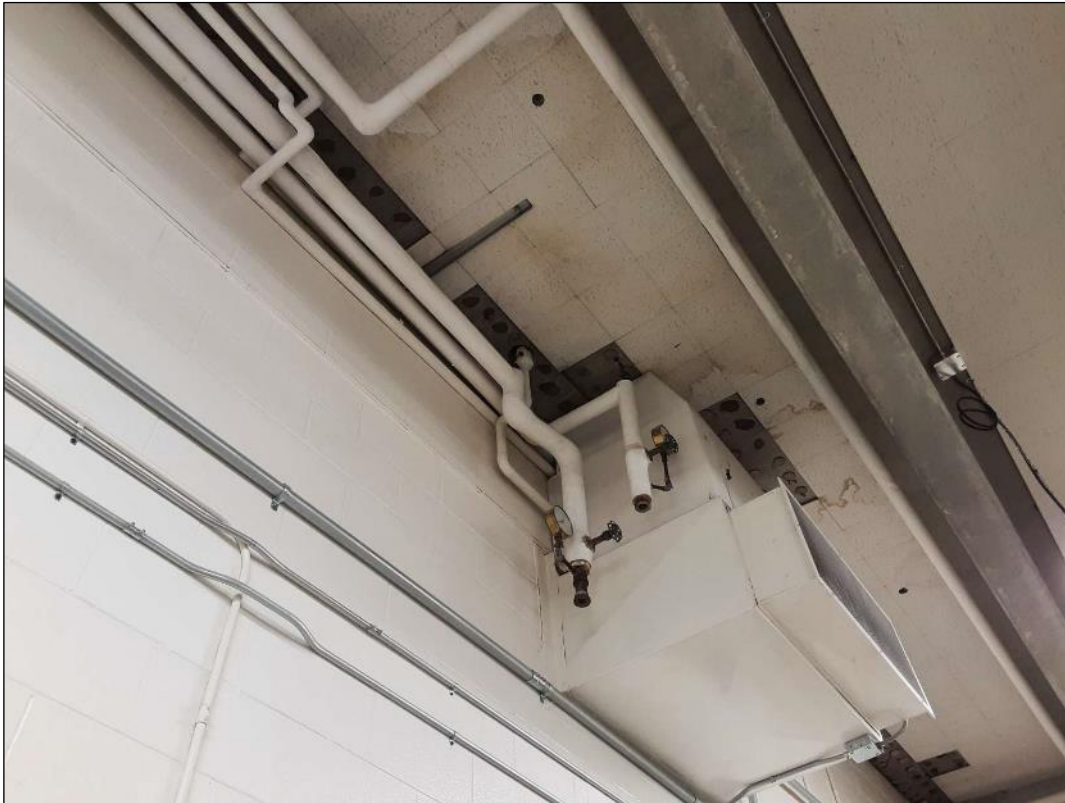
V0006 - (Confirmed Asbestos) Piping, Parging Cement, 136 (Location #: 1851)

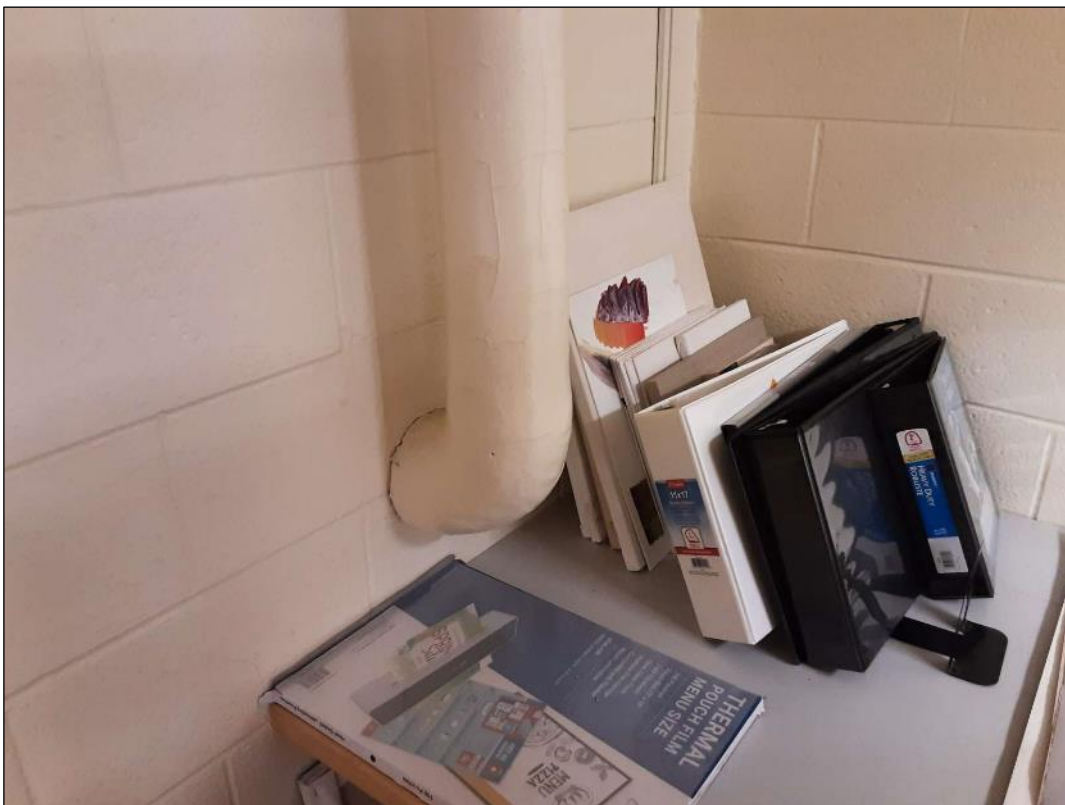
V0006 - (Confirmed Asbestos) Piping, Parging Cement, 244 (Location #: 2601)

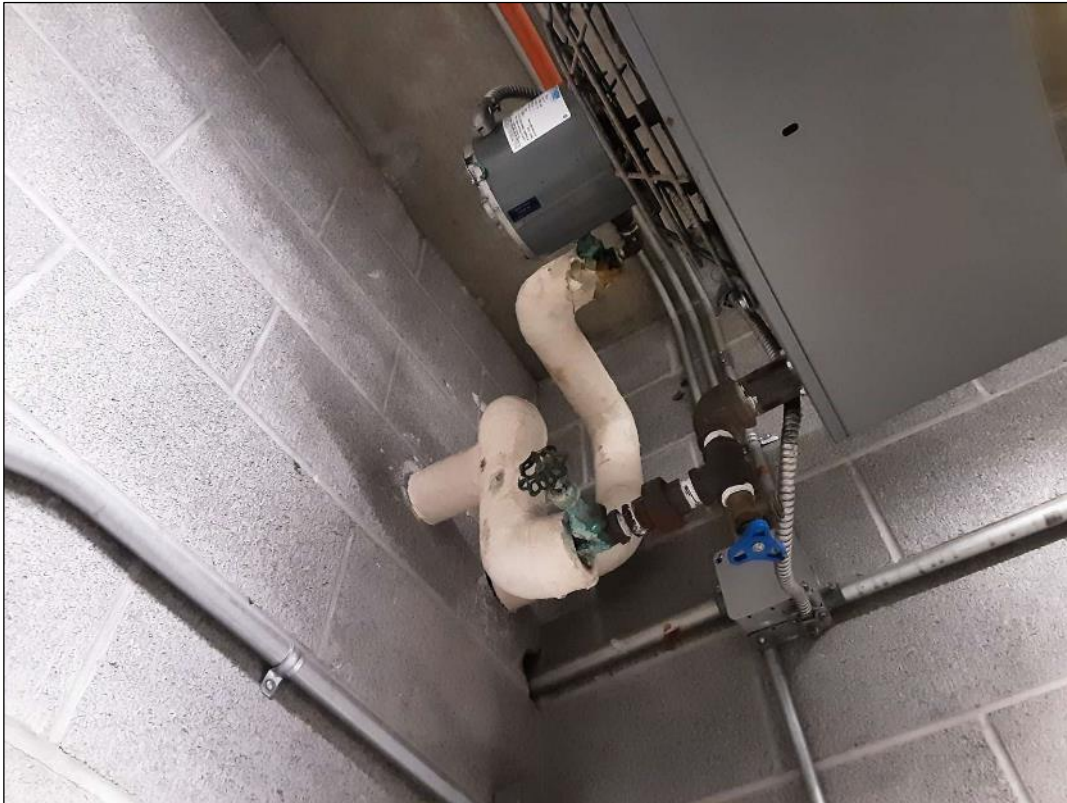
V0006 - (Confirmed Asbestos) Piping, Parging Cement, 240A (Location #: 2661)

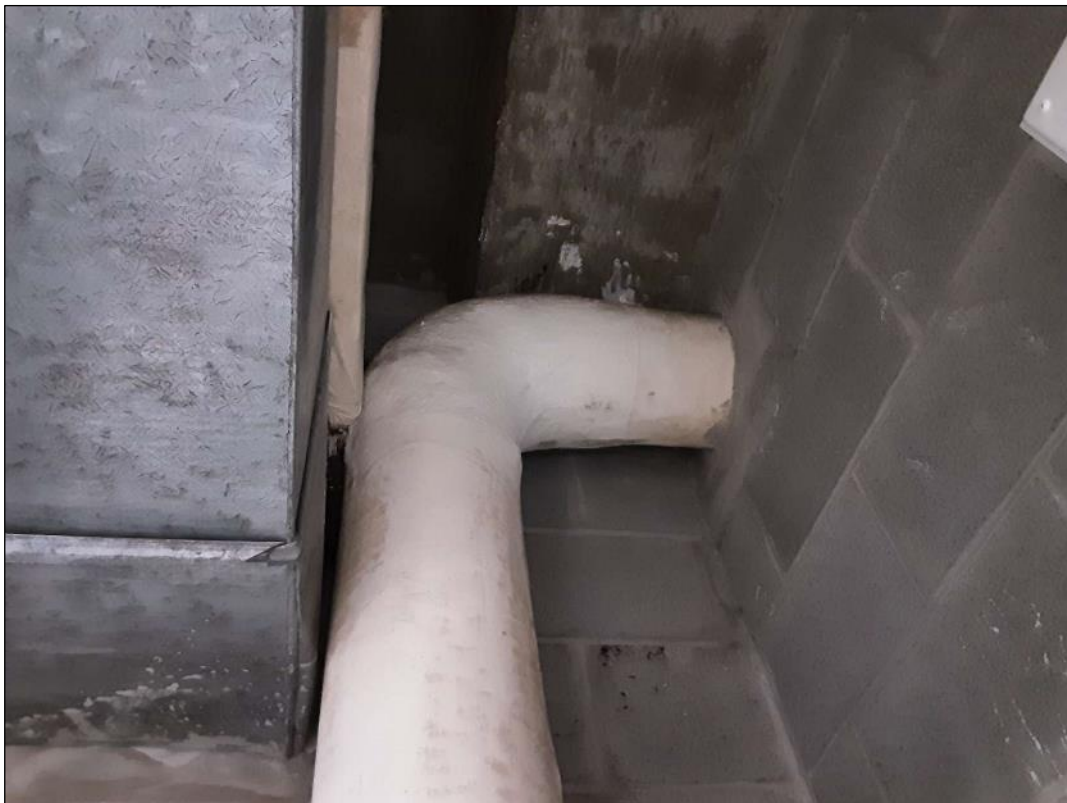
V0006 - (Confirmed Asbestos) Piping, Parging Cement, 209 (Location #: 2740)

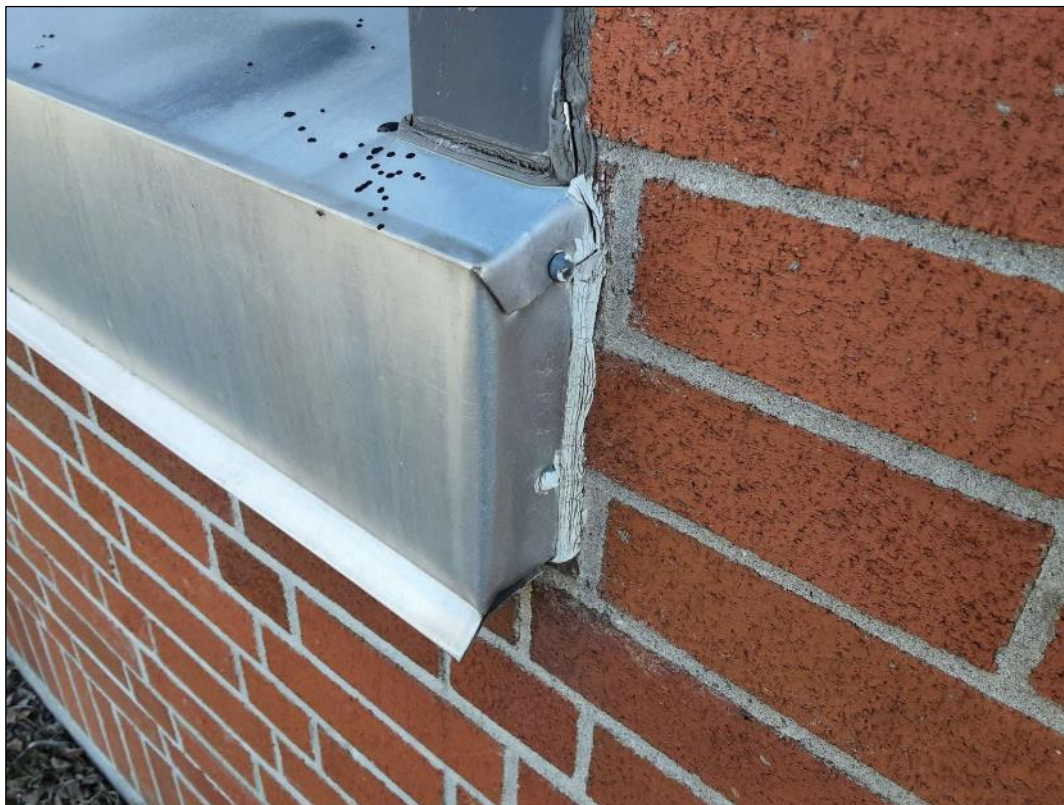
V9000 - (Confirmed Asbestos), Window, Caulking, Grey/White, South and West, Exterior (Location #: 0)  
Historic Data

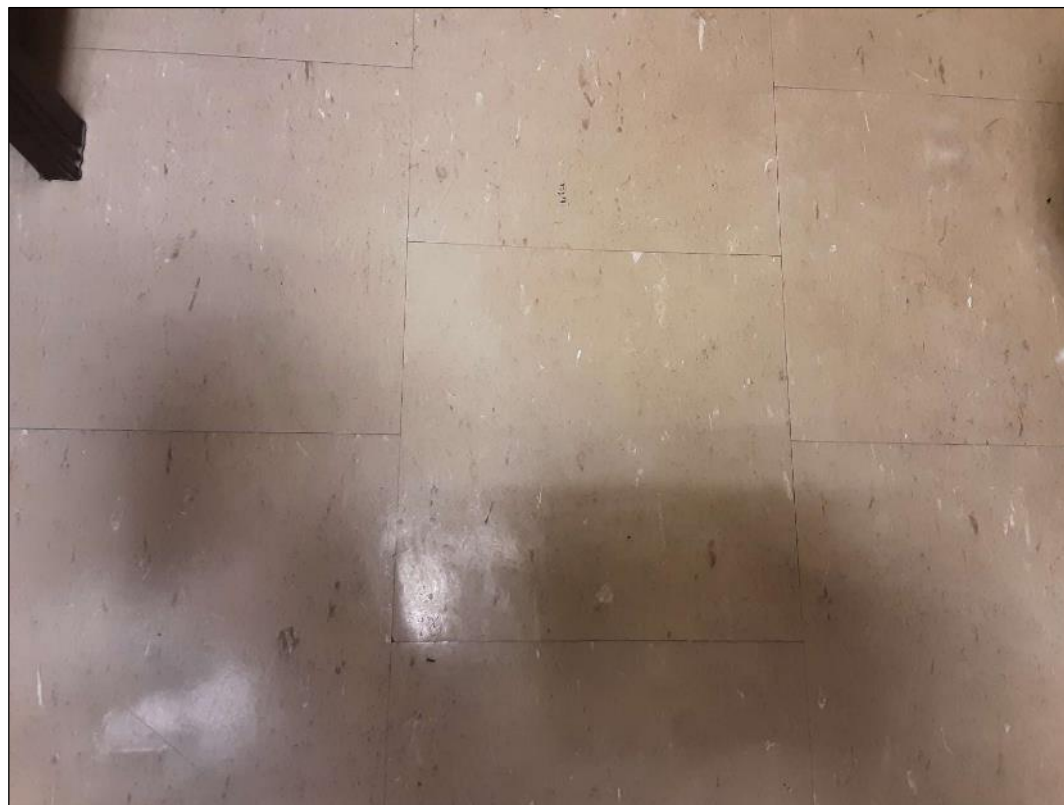
V9000 - (Confirmed Asbestos), Vinyl Floor Tile, VT-5, 12"x12" Pale Green, 103A (Location #: 1018)  
Previous Samples ASB-125.1-3

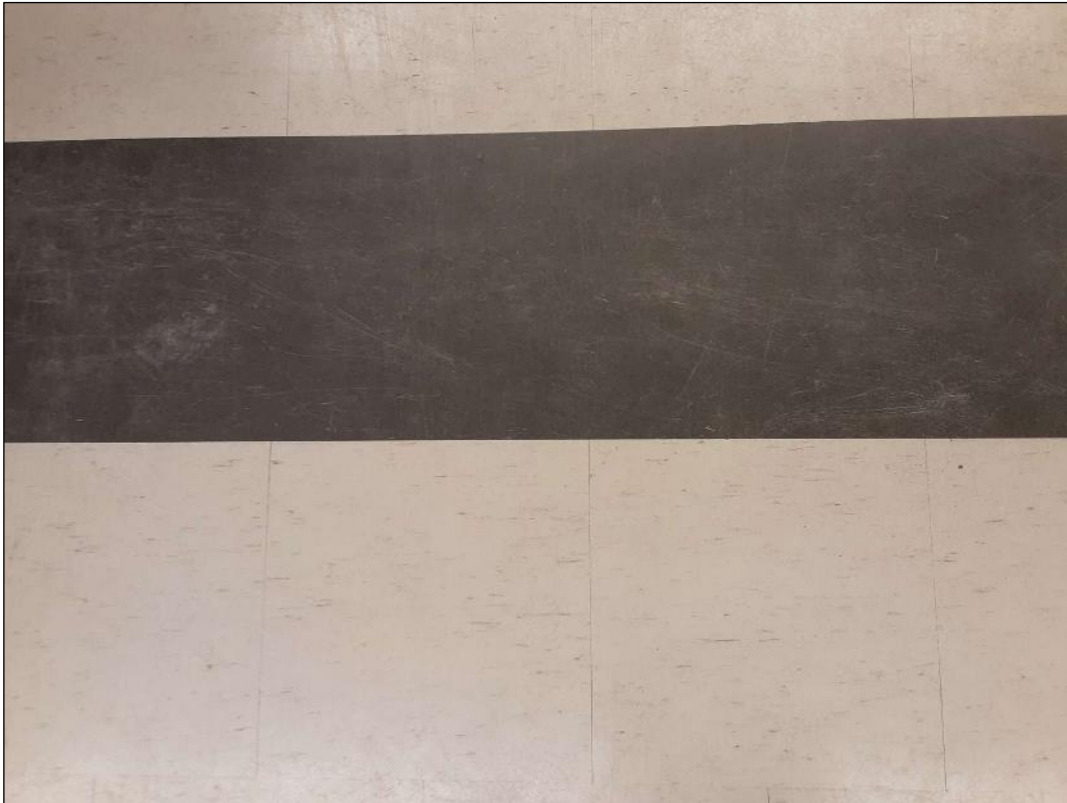
V9000 - (Confirmed Asbestos), Vinyl Floor Tile, VT-9, 12"x12" Off-White, 113 (Location #: 1100)  
Historic data

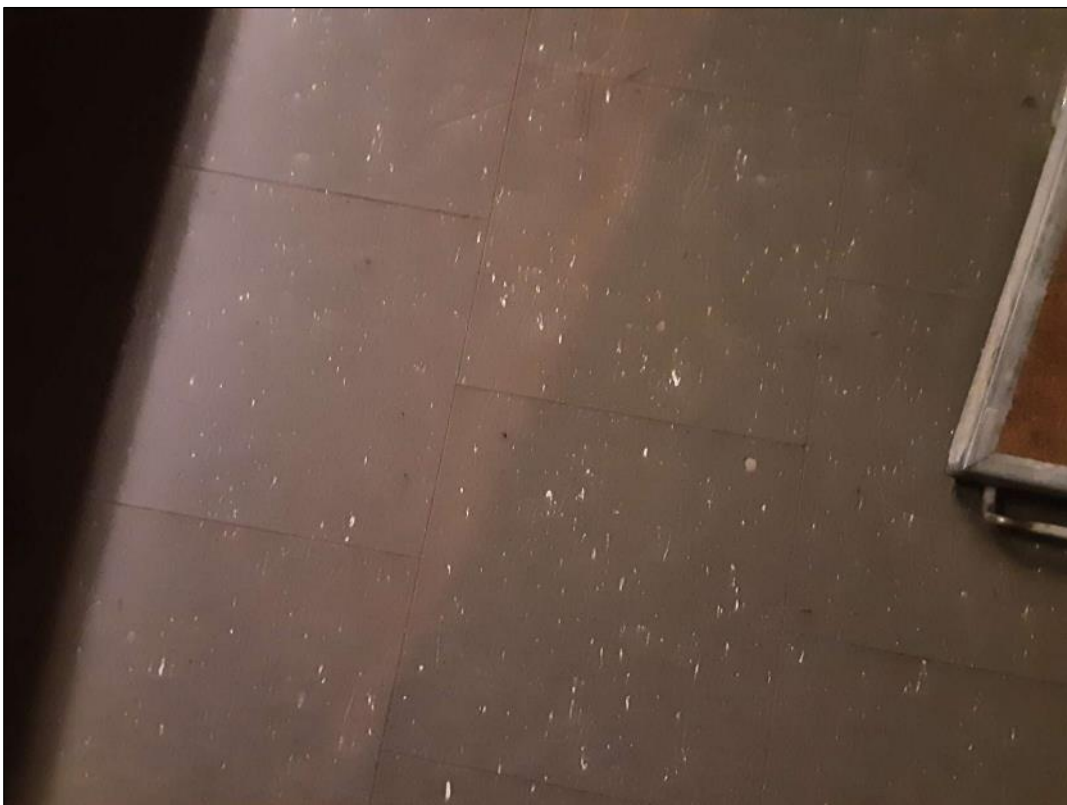
V9000 - (Confirmed Asbestos), Vinyl Floor Tile, VT-7, 12"x12", Dark Grey with White Marks, 101 (Location #: 1610)  
Previous samples ASB-130.1-3

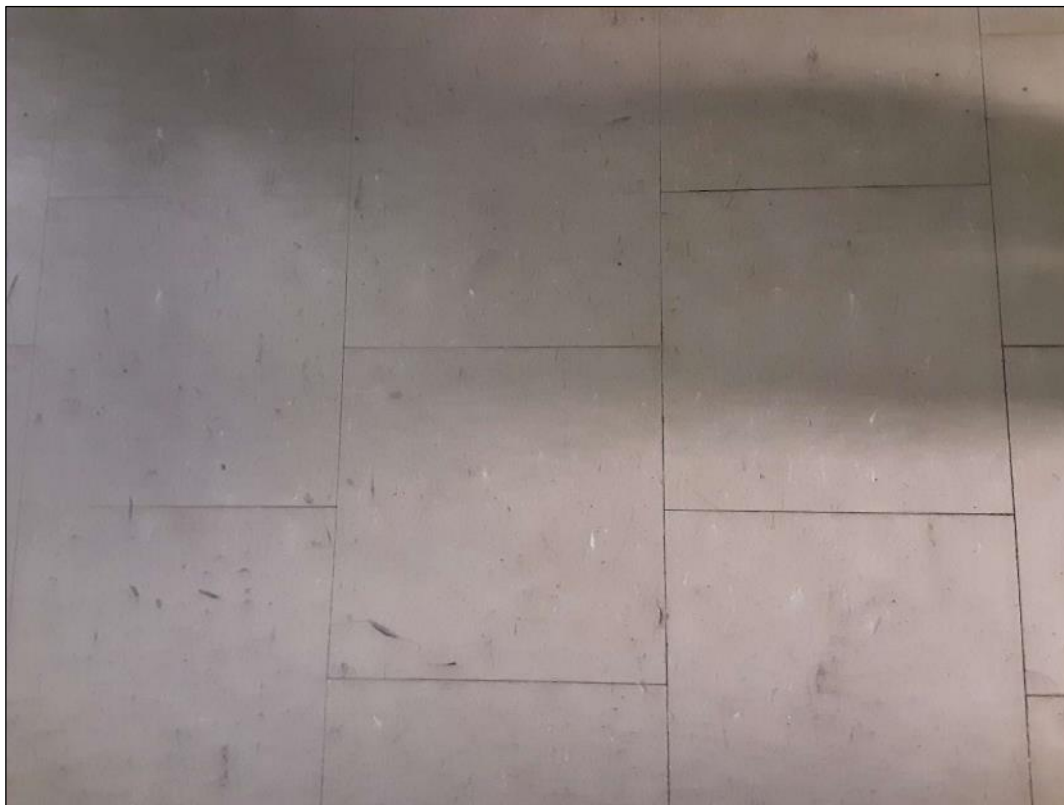
V9000 - (Confirmed Asbestos), Vinyl Floor Tile, VT-8, 12"x12", Tan with White and Brown Marks, 150 (Location #: 1640)  
Previous samples ASB-131.1-3

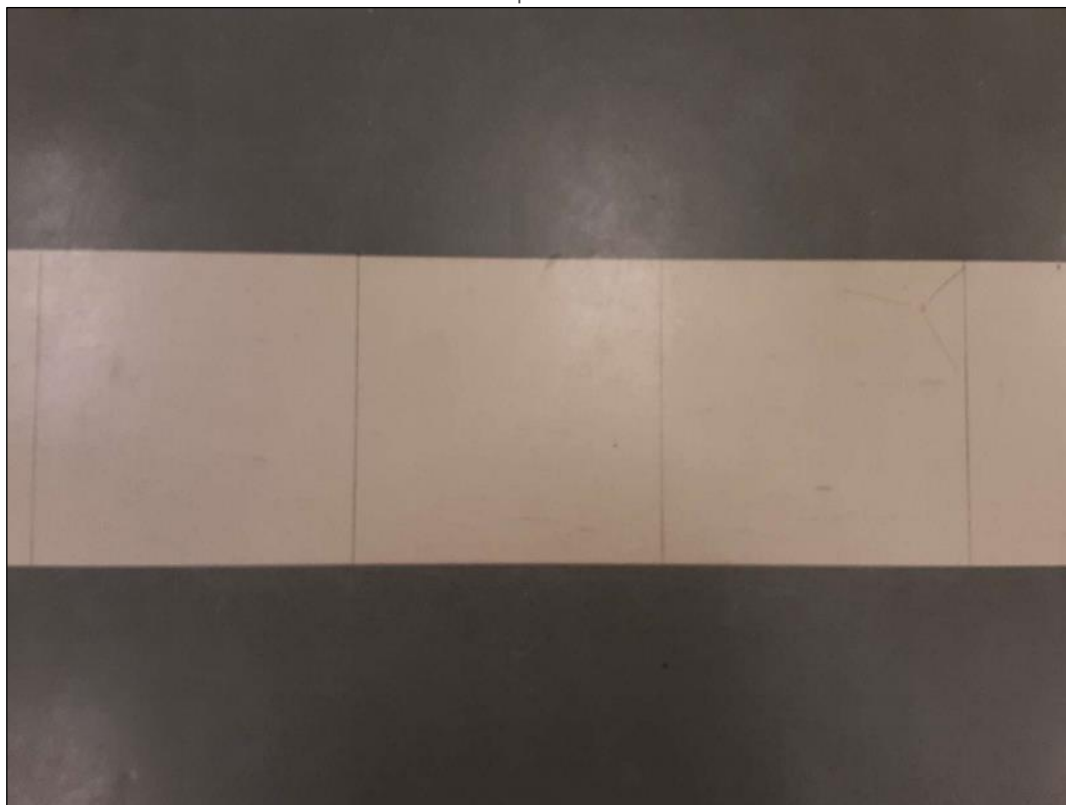
V9000 - (Confirmed Asbestos), Vinyl Floor Tile, VT-3, 9"x9" Beige, 164 (Location #: 1650)  
Previous Samples ASB-122.1-3

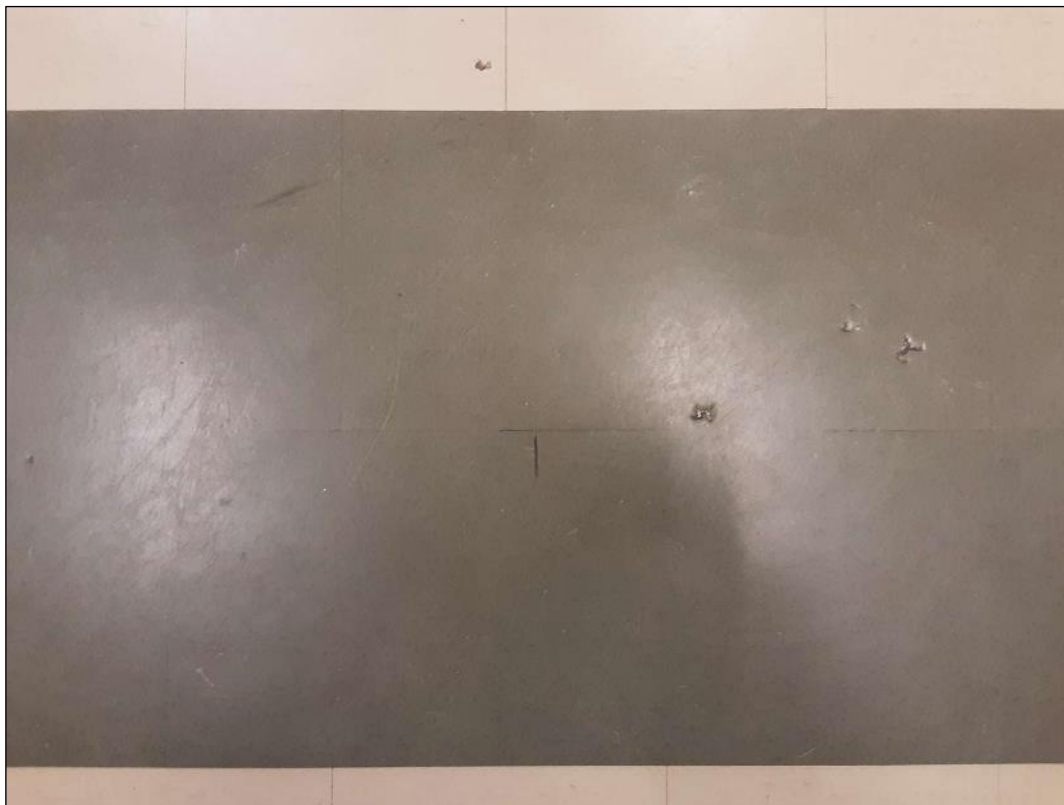
V9000 - (Confirmed Asbestos), Vinyl Floor Tile, VT-2, 9"x9", Dark Grey, 164 (Location #: 1650)  
Previous samples ASB-121.1-3

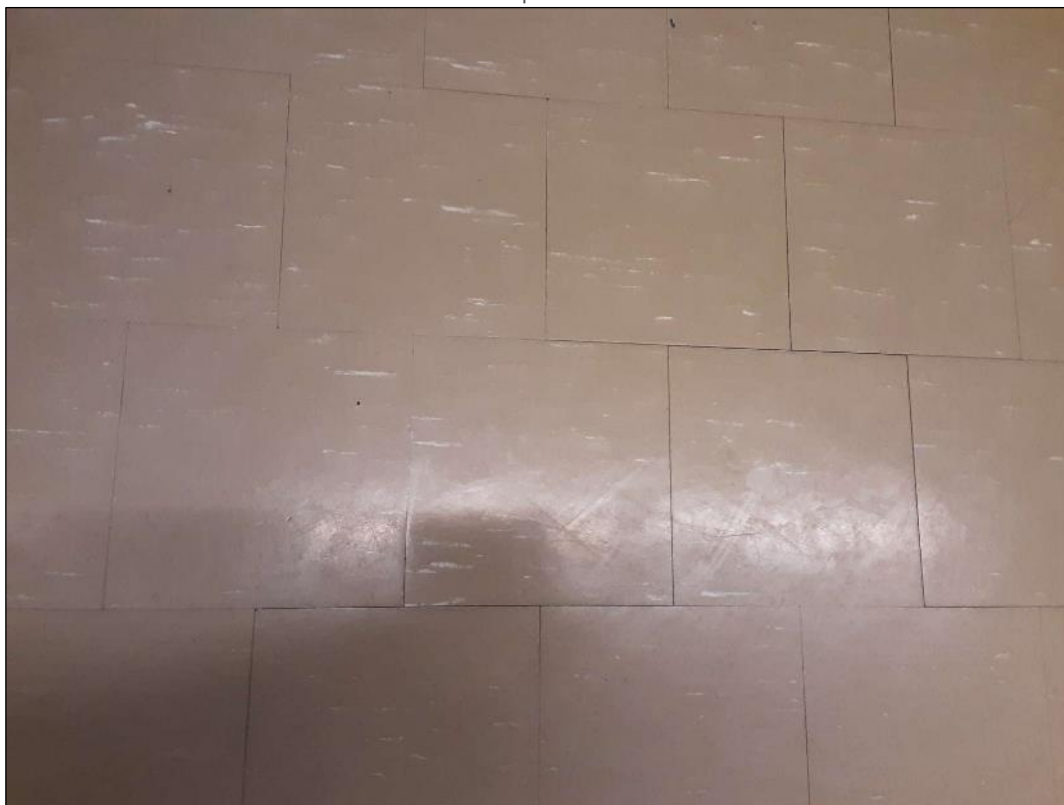
V9000 - (Confirmed Asbestos), Vinyl Floor Tile, VT-11, 9"x9" Olive, 161 (Location #: 1660)  
Historic data

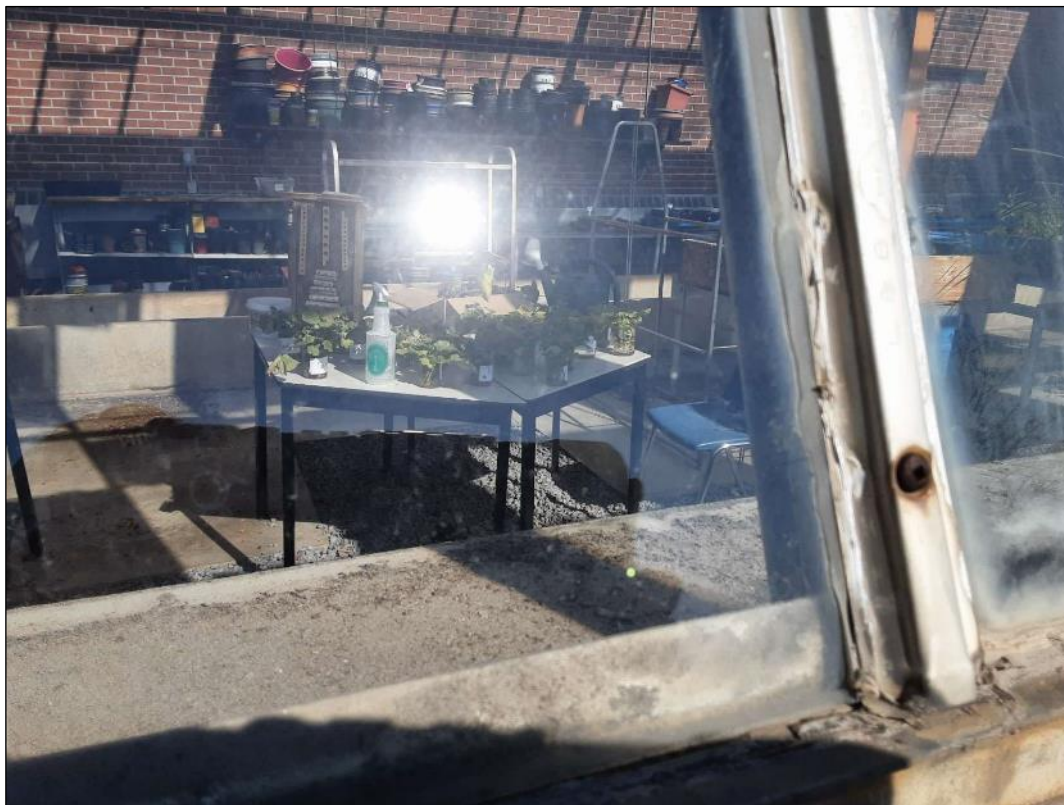
V9000 - (Confirmed Asbestos), Window, Putty, White, 160 (Location #: 1670)  
Greenhouse, Historical data

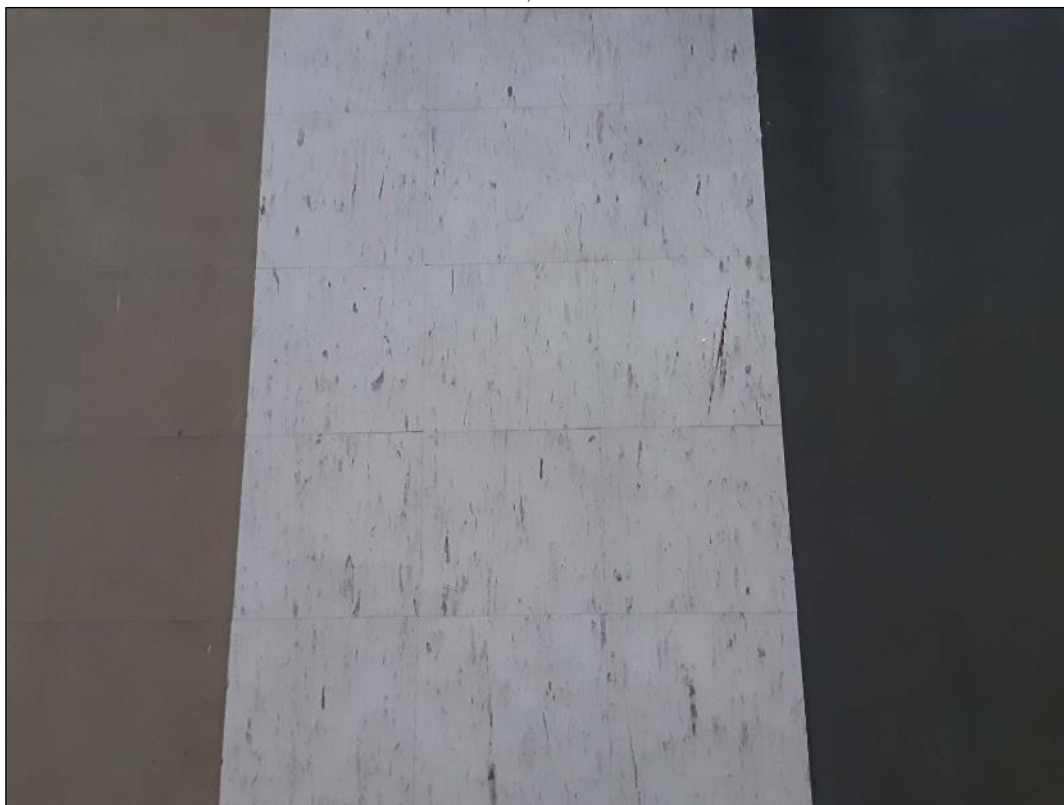
V9000 - (Confirmed Asbestos), Vinyl Floor Tile, VT-4, 9"x9", Beige with Brown Streaks, 153 (Location #: 1760)  
Previous Samples ASB-123.1-3

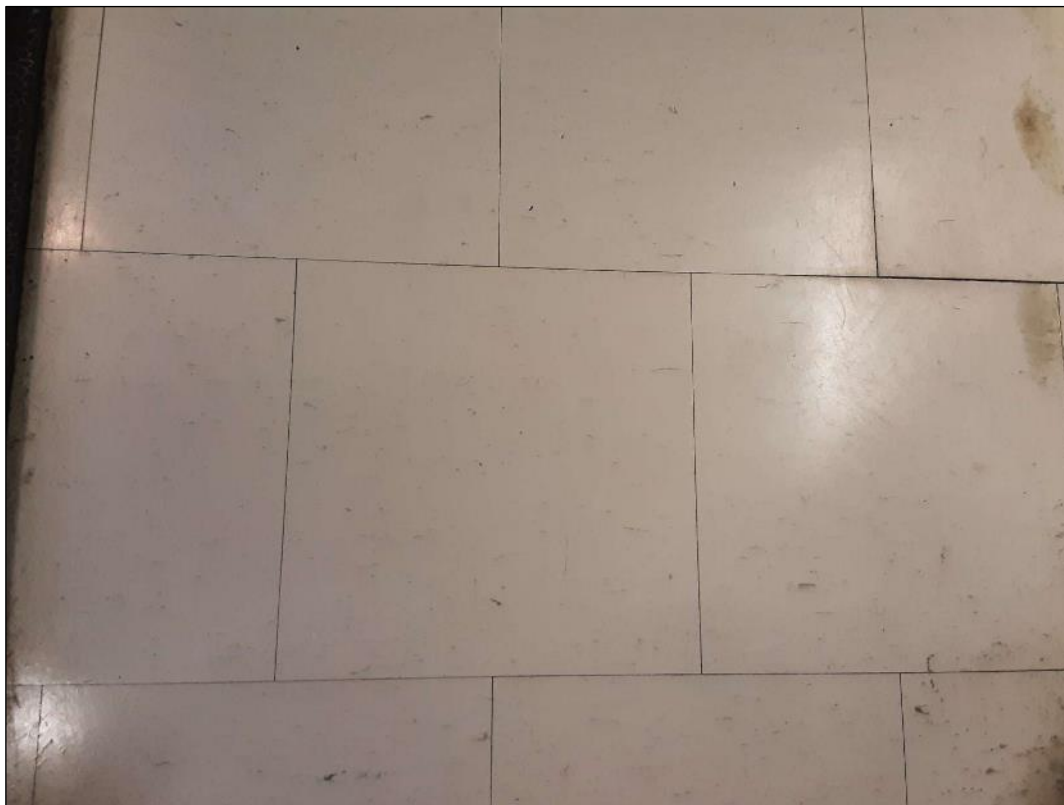
V9000 - (Confirmed Asbestos), Vinyl Floor Tile, VT-1, 12"x12", Off-White with Fine Black Streaks, 152F (Location #: 1774)  
Historic data

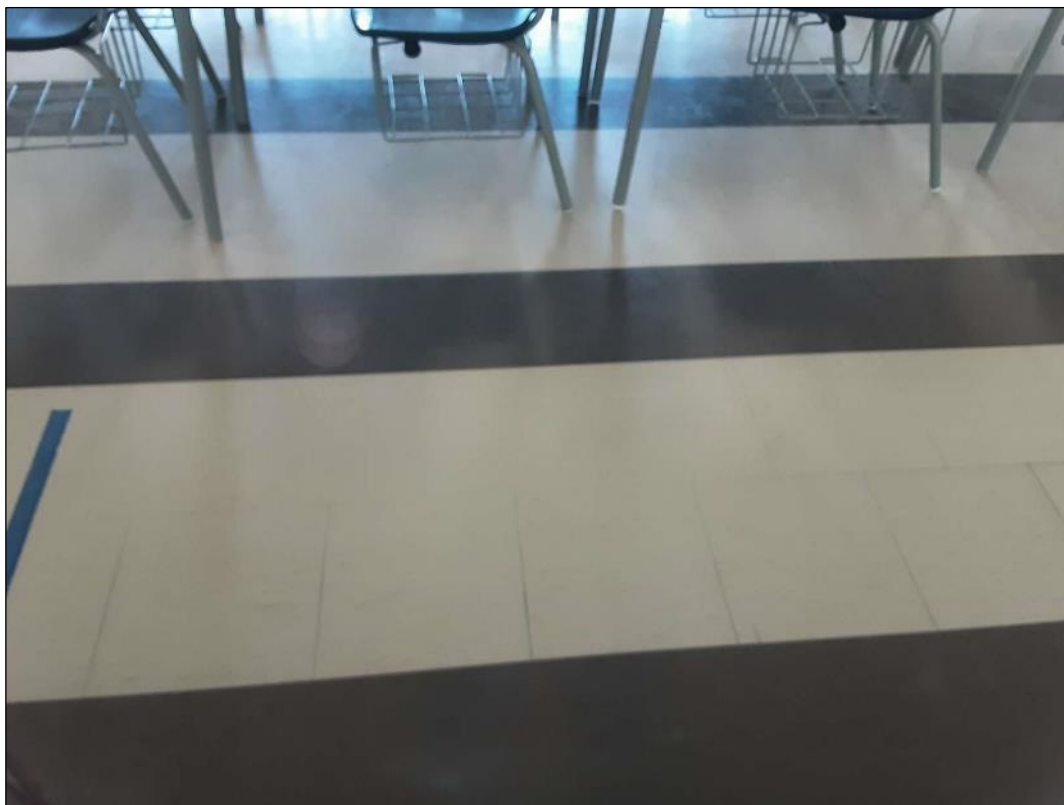
V9000 - (Confirmed Asbestos), Vinyl Floor Tile, VT-10, 12"x12", Grey, 223 (Location #: 2900)  
Historic Data

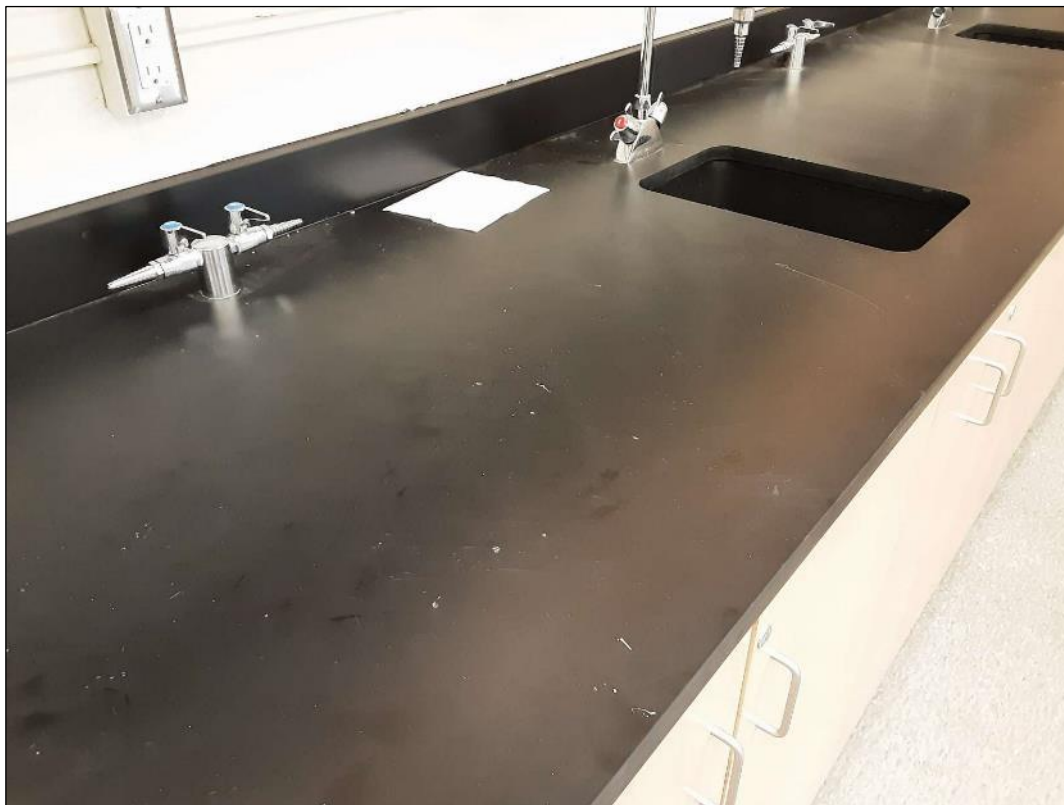
V9500 - (Presumed Asbestos) Other, Countertop, Cement Product (Transite), 156 (Location #: 1690)

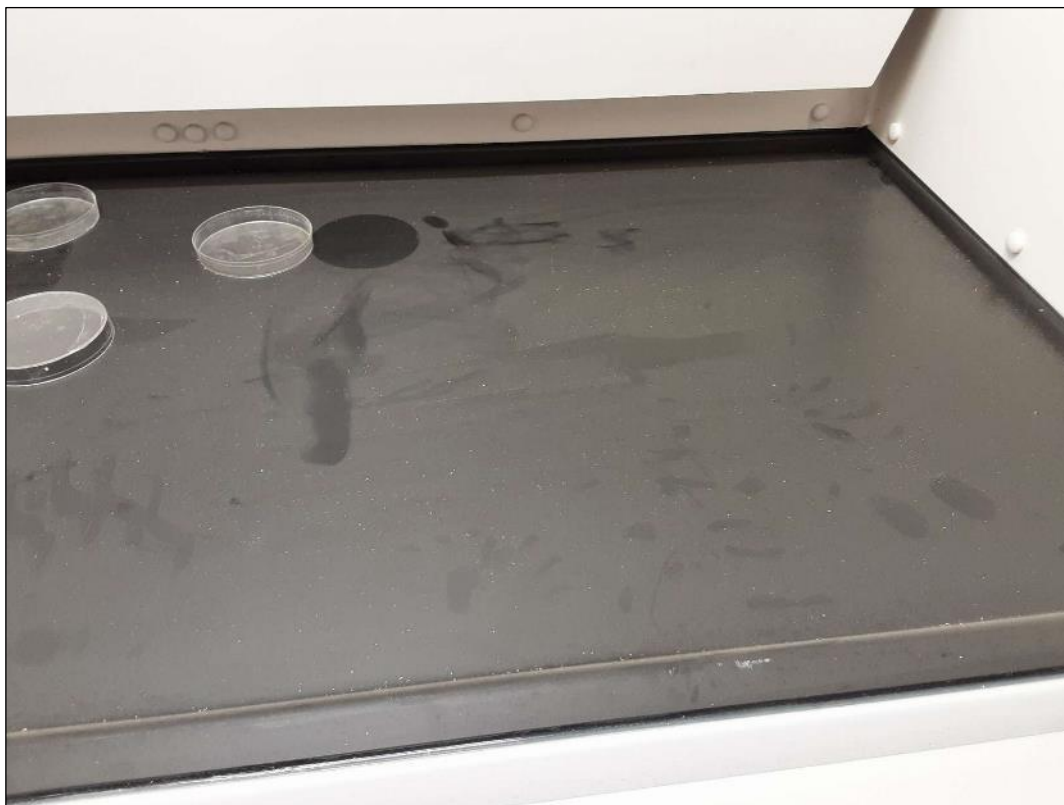
V9500 - (Presumed Asbestos) Other, Fumehood, Cement Product (Transite), 156 (Location #: 1690)
