**Re: Asbestos Reassessment**

Centennial Secondary School, 160 Palmer Road, Belleville, ON  
Pinchin File: 200584.085

Hastings and Prince Edward District School Board (Client) retained Pinchin Ltd. (Pinchin) to conduct an asbestos-containing materials (ACM) reassessment of Centennial Secondary School located at 160 Palmer Road, Belleville, ON.

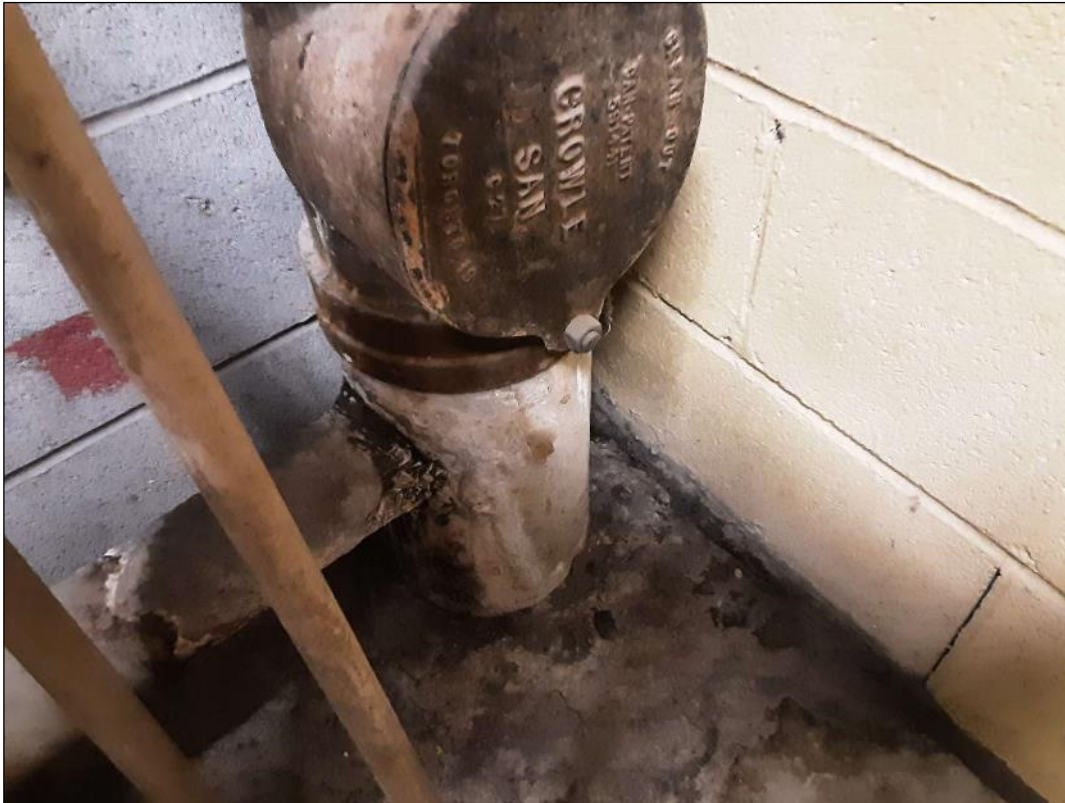
V9500 - (Presumed Asbestos), Piping, Rain Water Leader, Cement Product (Transite), 154 (Location #: 1730)

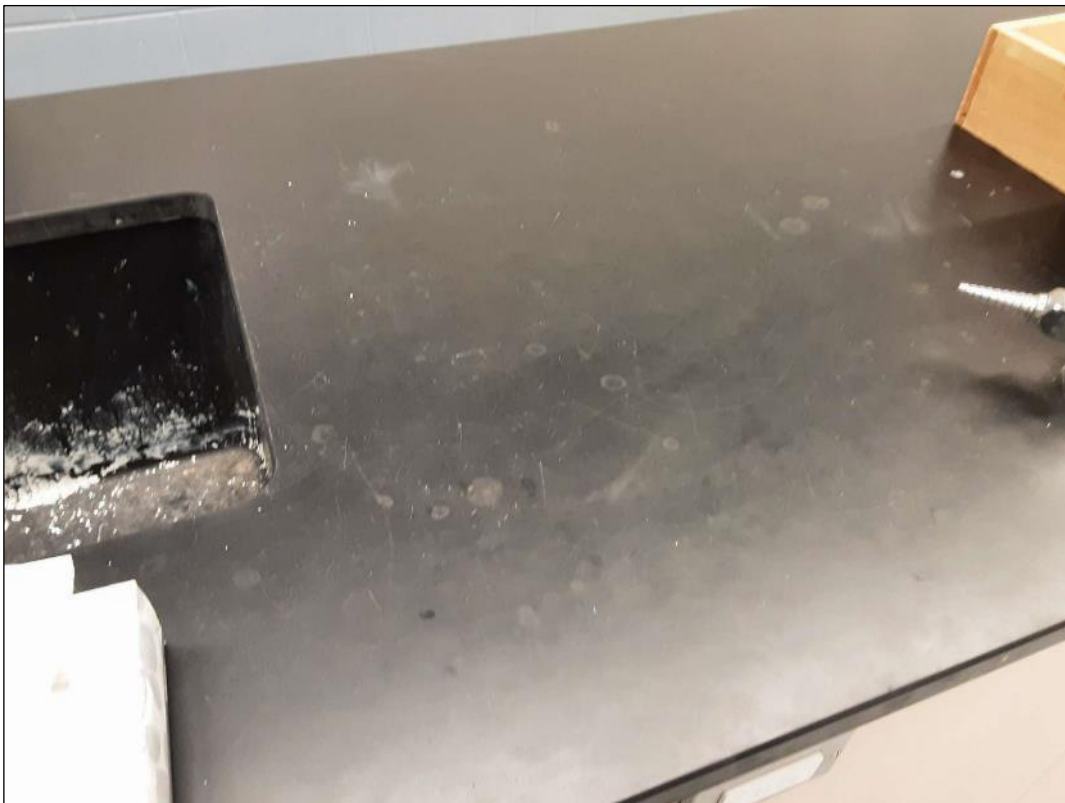
V9500 - (Presumed Asbestos), Other, Countertop, Cement Product (Transite), 239 (Location #: 2800)

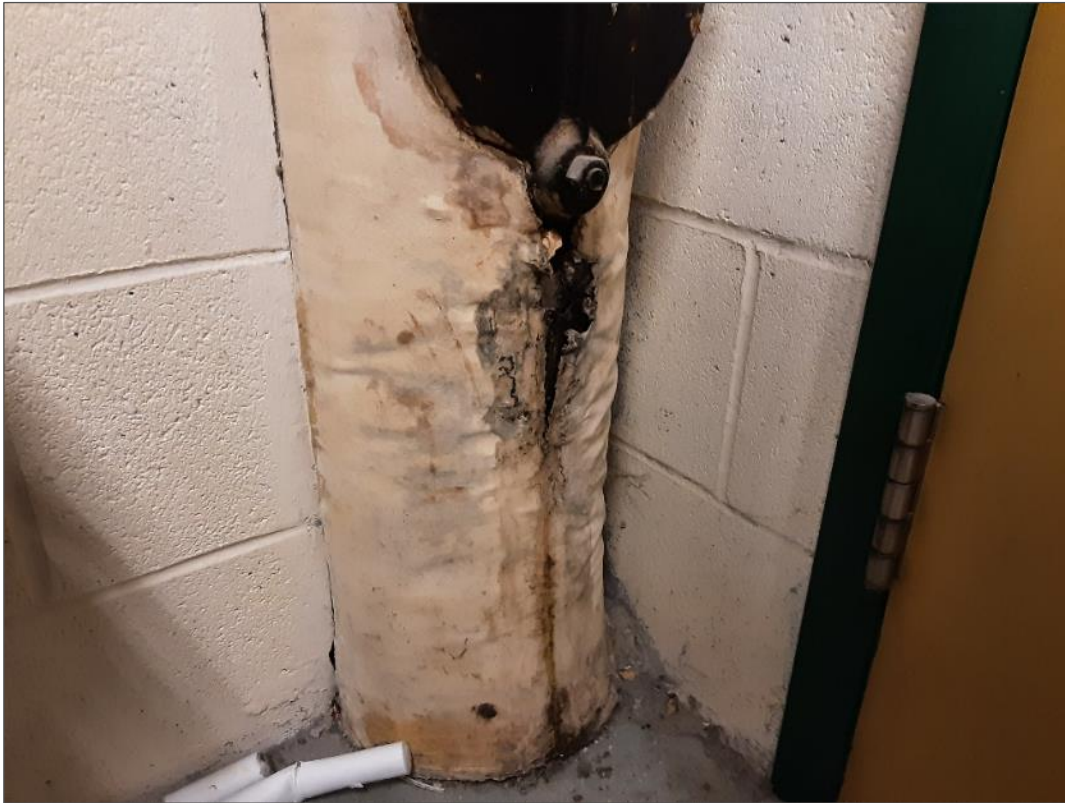
Damaged asbestos-containing parging cement insulation present on valve in Room 120A (Location #1433).

| System | Material Description | Quantities per Condition | | Location Name, (Location No.) | Recommended Procedure |
|---|---|---|---|---|---|
| Piping | Parging Cement | 1 EA (Valve) | | 120A (Loc. 1433) | Remove in accordance with Type 2 or Glove Bag asbestos abatement procedures |

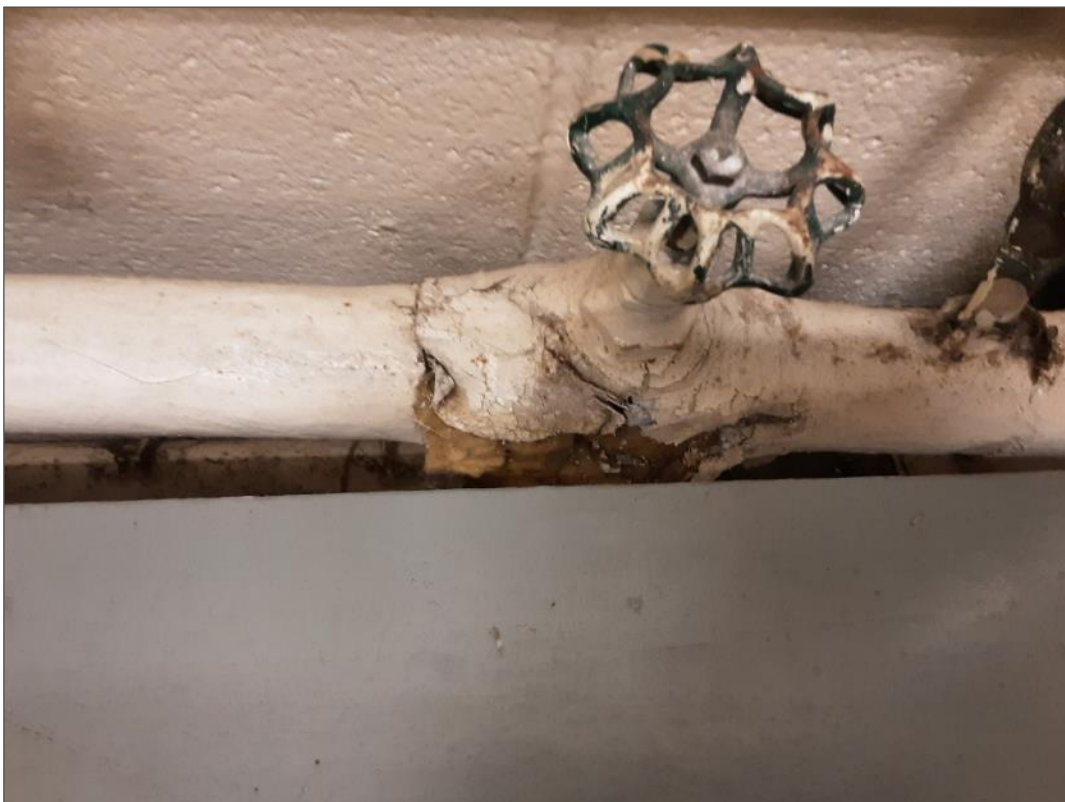
Damaged asbestos-containing parging cement insulation present on valve in Room 152B (Location #1771).

| System | Material Description | Quantities per Condition | | Location Name, (Location No.) | Recommended Procedure |
|---|---|---|---|---|---|
| Piping | Parging Cement | | 1 EA (Valve) | 152B (Loc. 1771) | Remove in accordance with Type 2 or Glove Bag asbestos abatement procedures |

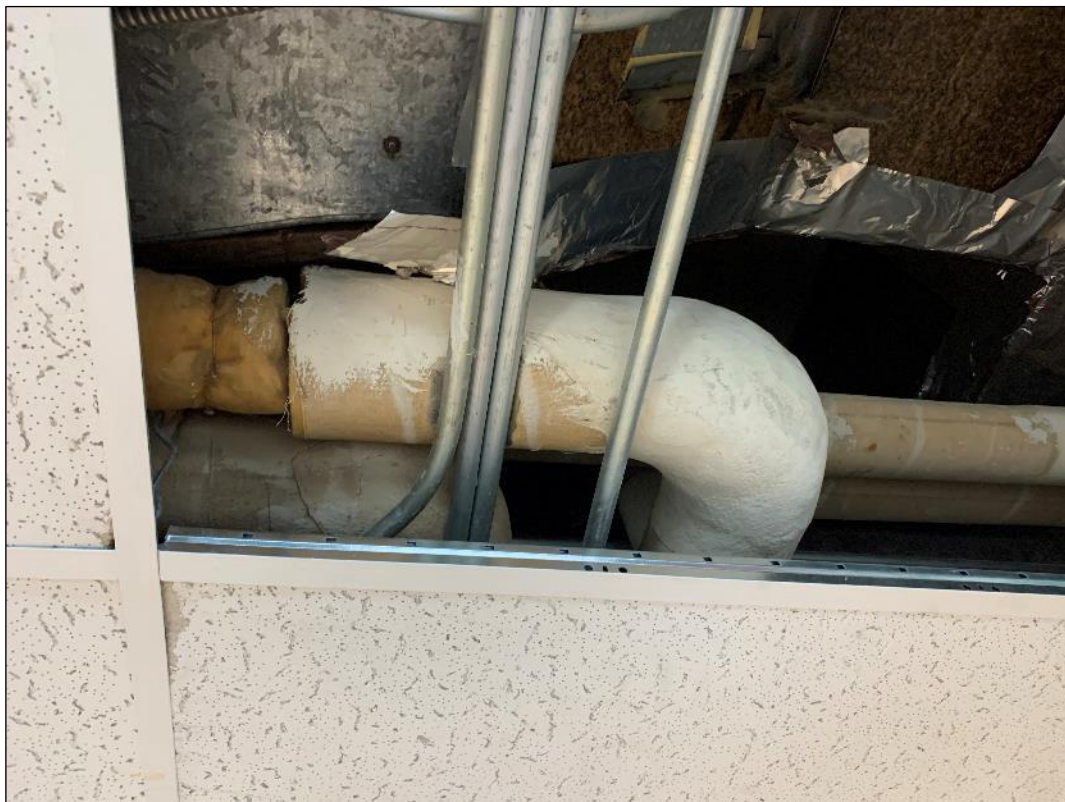
Damaged asbestos-containing parging cement insulation present on pipe end in Room 134A (Location #1870).

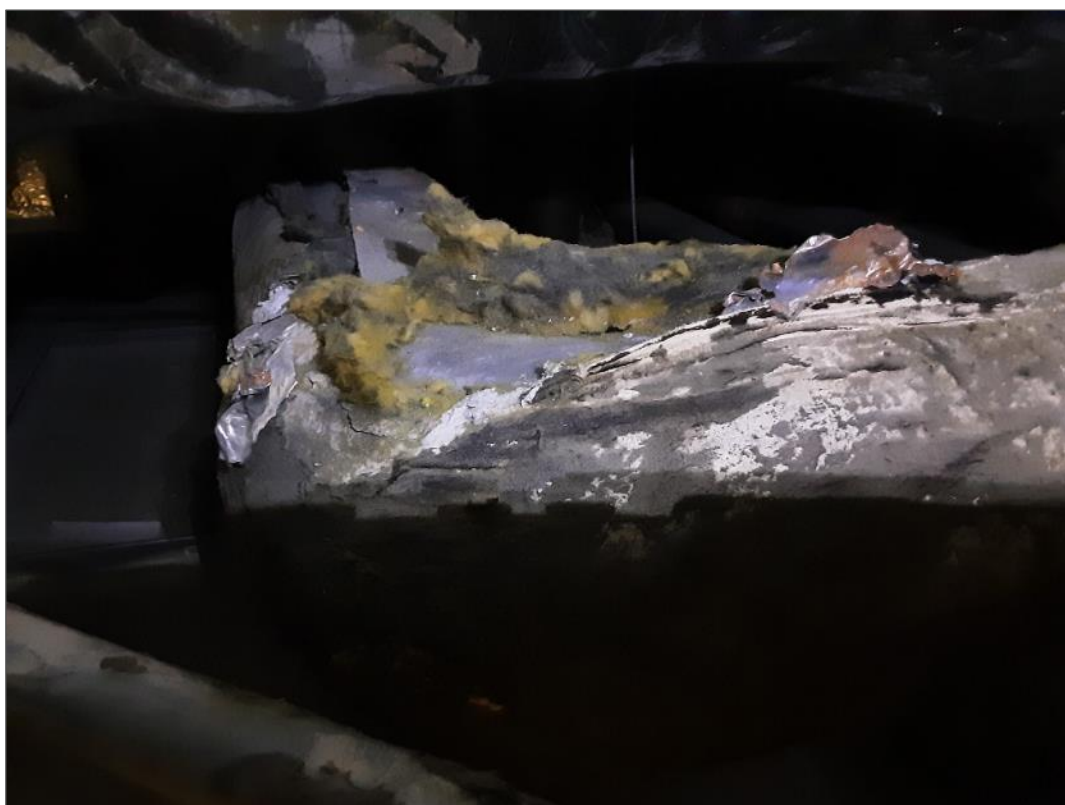
Damaged asbestos-containing parging cement insulation present on elbow in Room 195 (Location #1950).

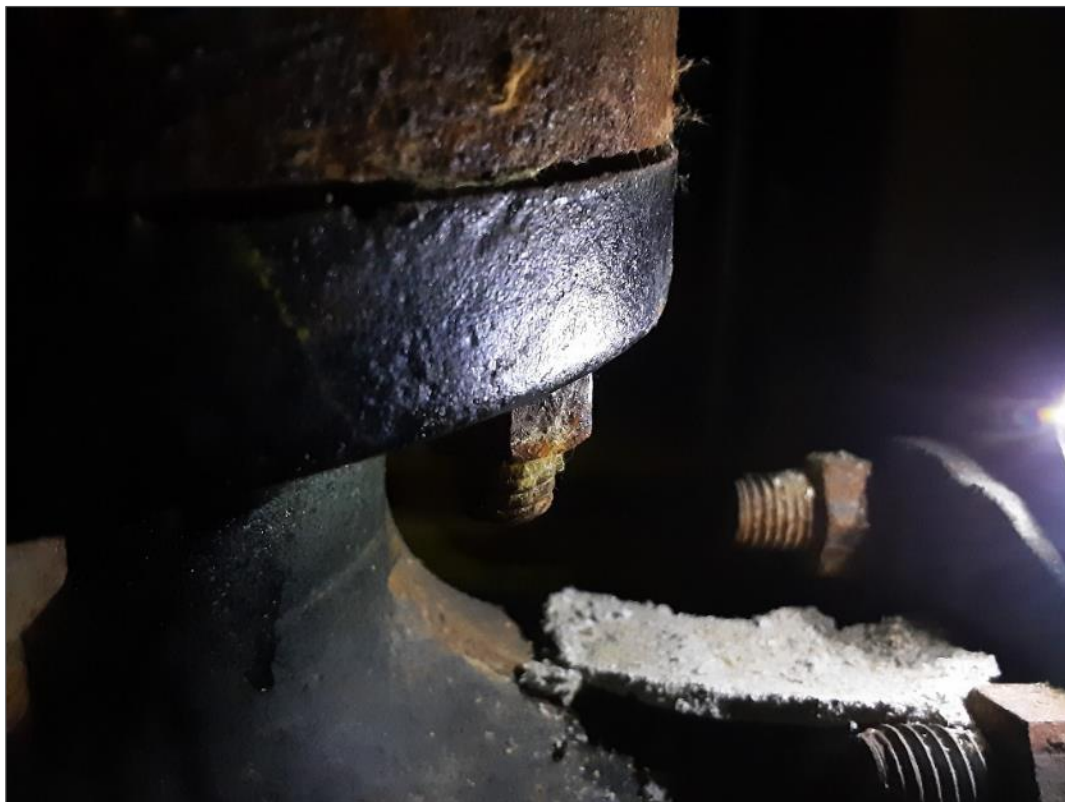
Damaged asbestos-containing piping cement insulation present on elbow and debris in Room 198 (Location #1960).
