ADDENDUM #2

PROJECT: Aesthetics Lab and Classroom
Renovation at Centennial Secondary
School RFQ-VOR 2526-102

Re: Hazardous Building Materials Assessment (Preconstruction)
Centennial Secondary School, 160 Palmer Road, Belleville, ON
Pinchin File: 200584.110

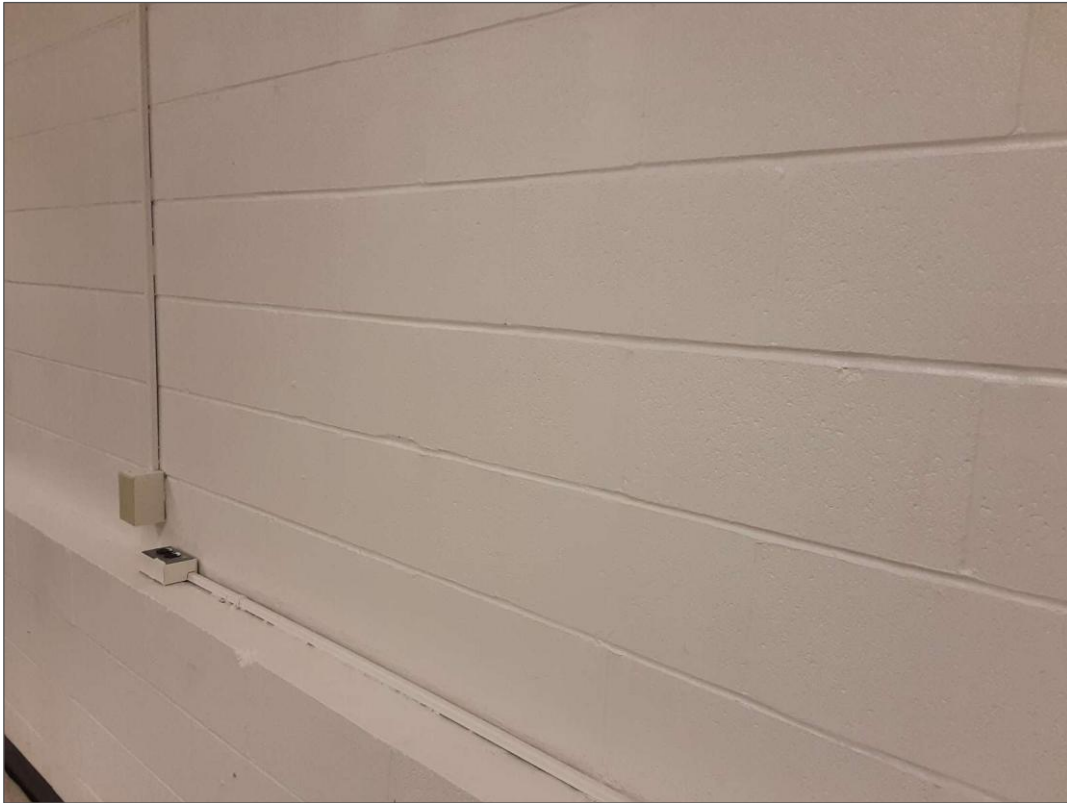
V0015 (None), Wall, Paint, on Concrete Block, 204 (Location #: 2040)

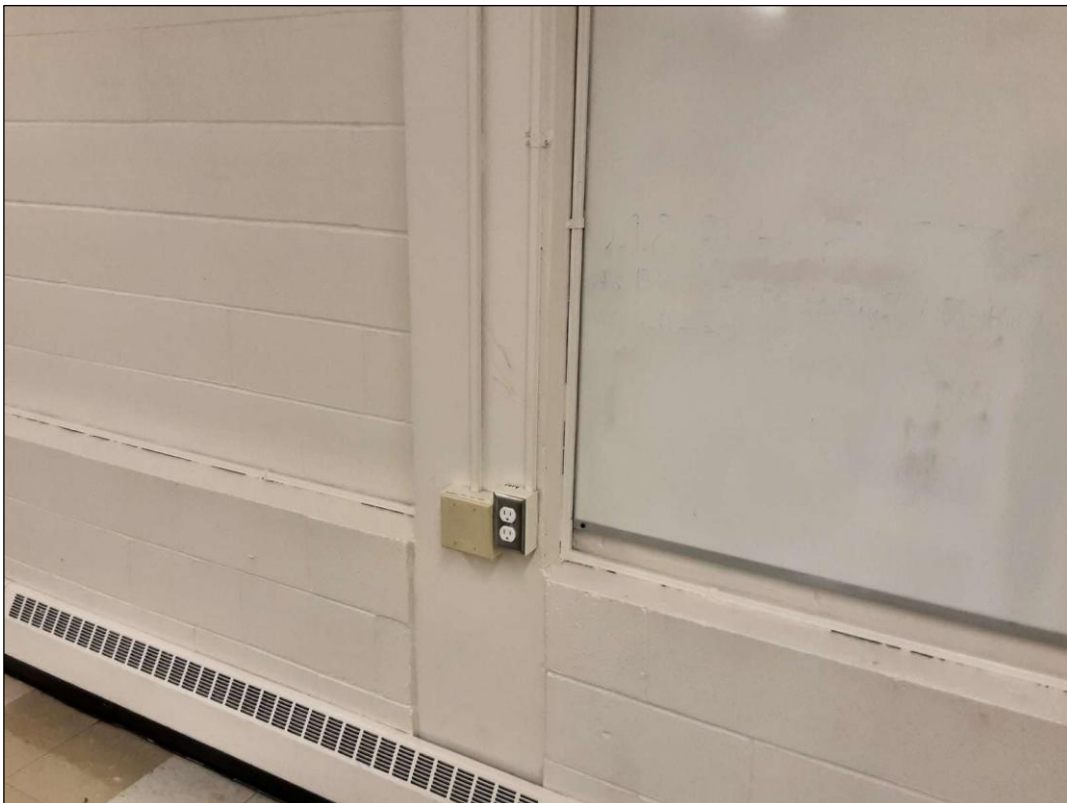
V0016 (None), Structure, Column, Paint, on Concrete column, 204 (Location #: 2040)

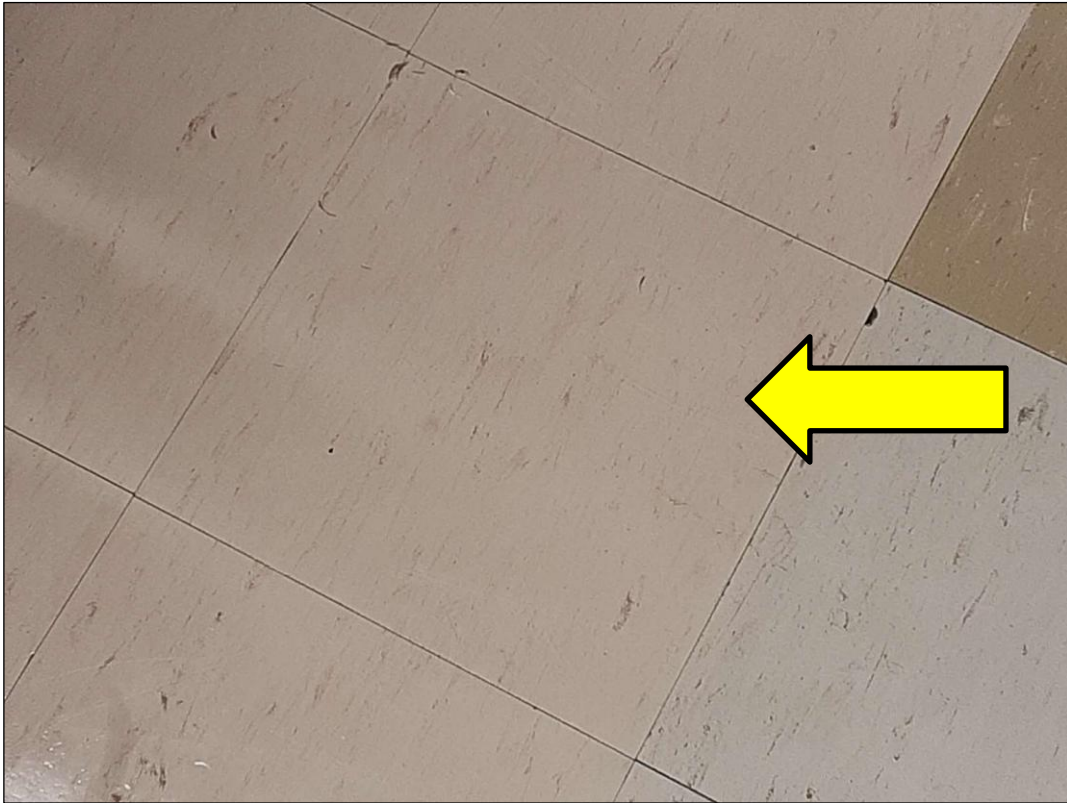
S0021A (None), Floor, Vinyl Floor Tile and Mastic, 12"x12" beige with pink streaks, 204 (Location #: 2040)

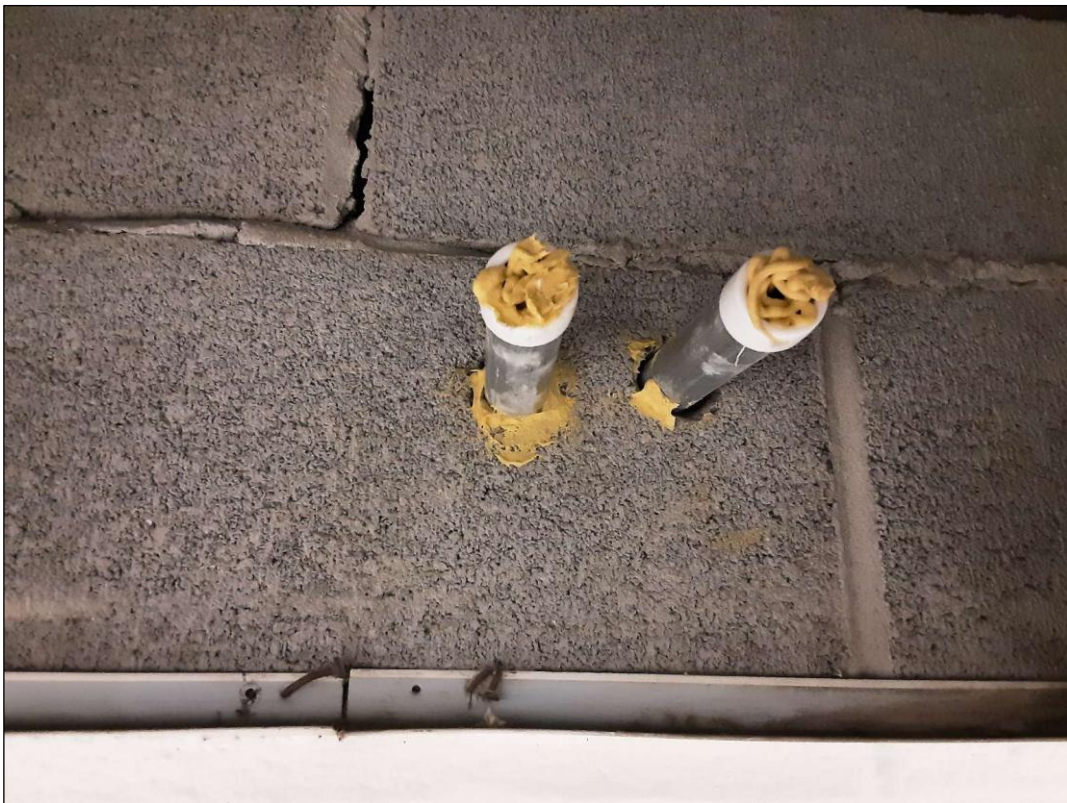
S0023A (None), Other, Firestopping (mastic), Yellow, 204 (Location #: 2040)

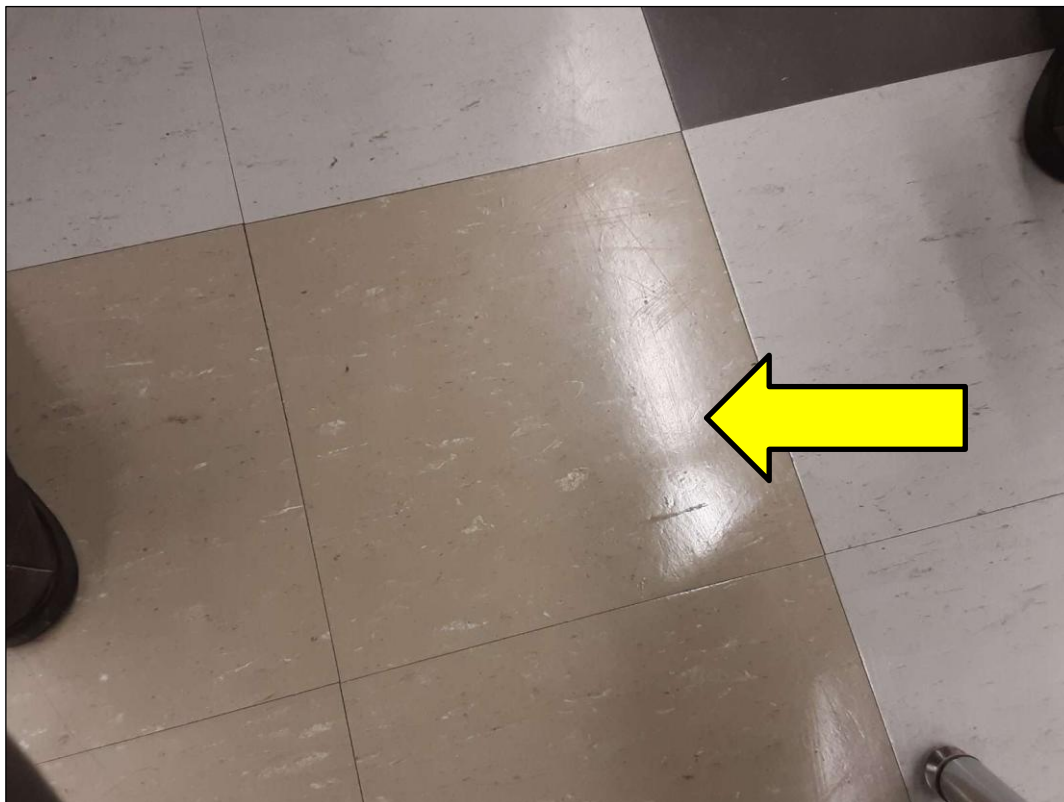
V9000 (**Confirmed Asbestos**), , Vinyl Floor Tile, VT-5, 12x12 pale green, Floor 204 (Location #: 2040)
Previous samples ASB-125.1-3

Remove asbestos-containing materials (ACM) prior to renovation, alteration, or maintenance if ACM may be disturbed by the work.

Asbestos-containing materials must be disposed of at a landfill approved to accept asbestos waste.

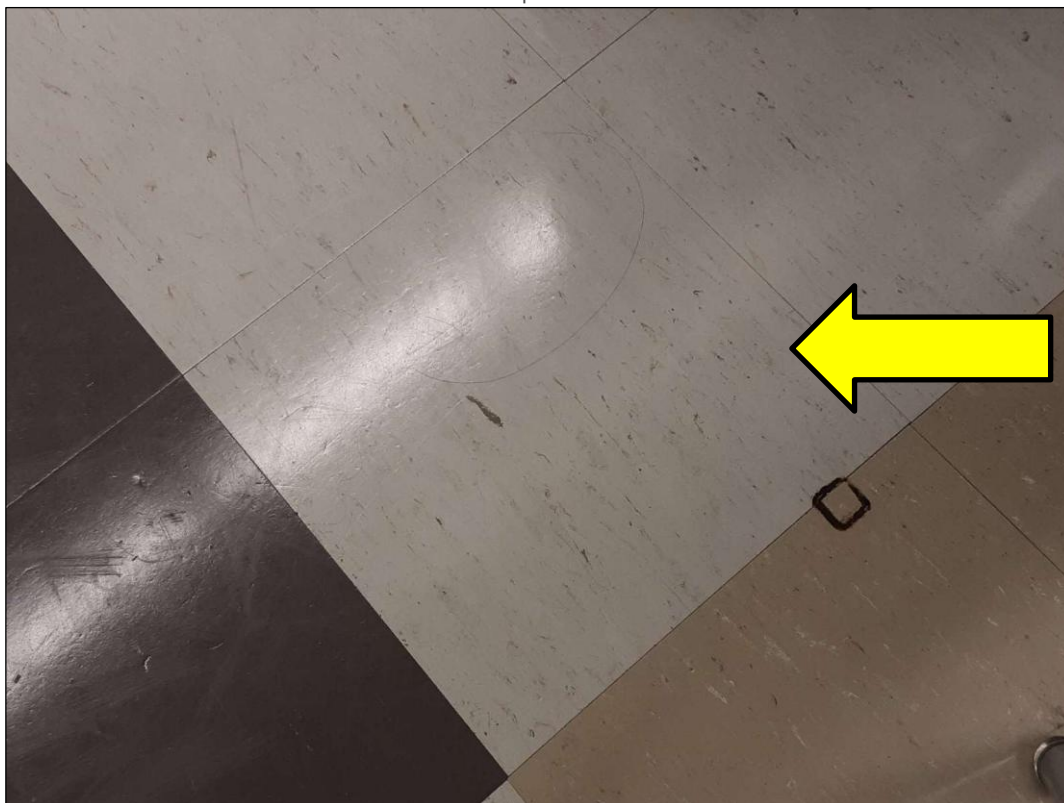
V9000 (**Confirmed Asbestos**), Floor, Vinyl Floor Tile, VT-9, 12x12 off-white, 204 (Location #: 2040)
Historic data

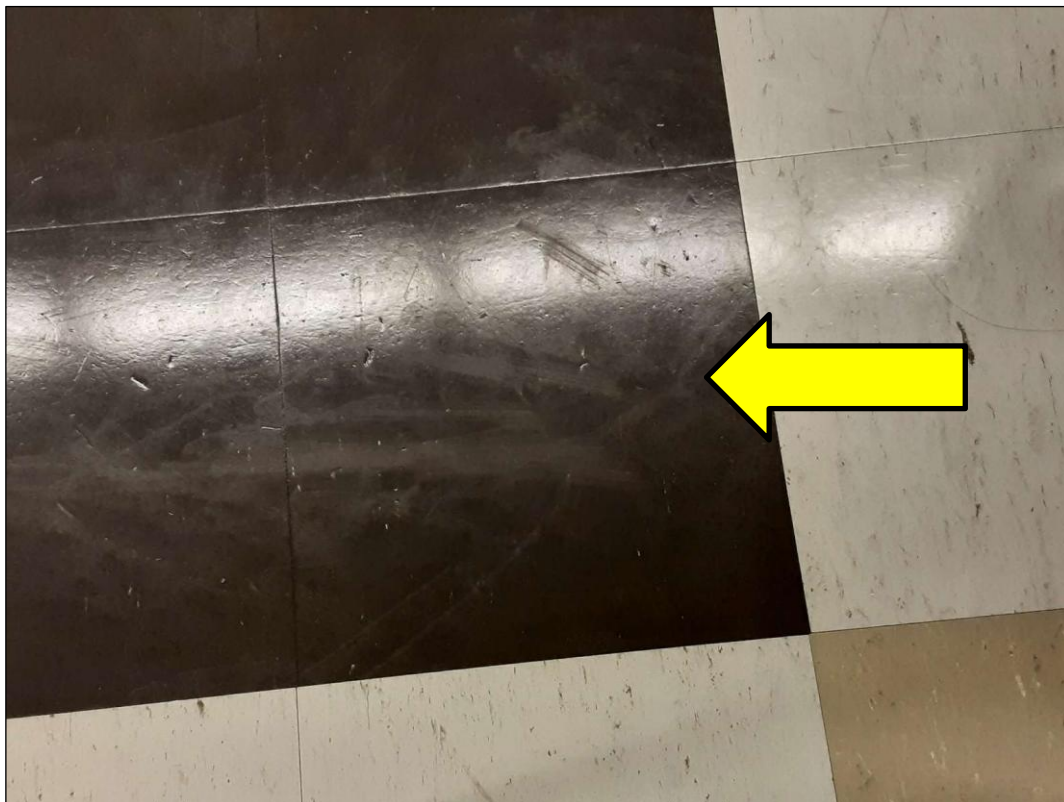
V9000 (Confirmed Asbestos), Floor, Vinyl Floor Tile, VT-10, 12x12 grey, 204 (Location #: 2040)
Historic Data

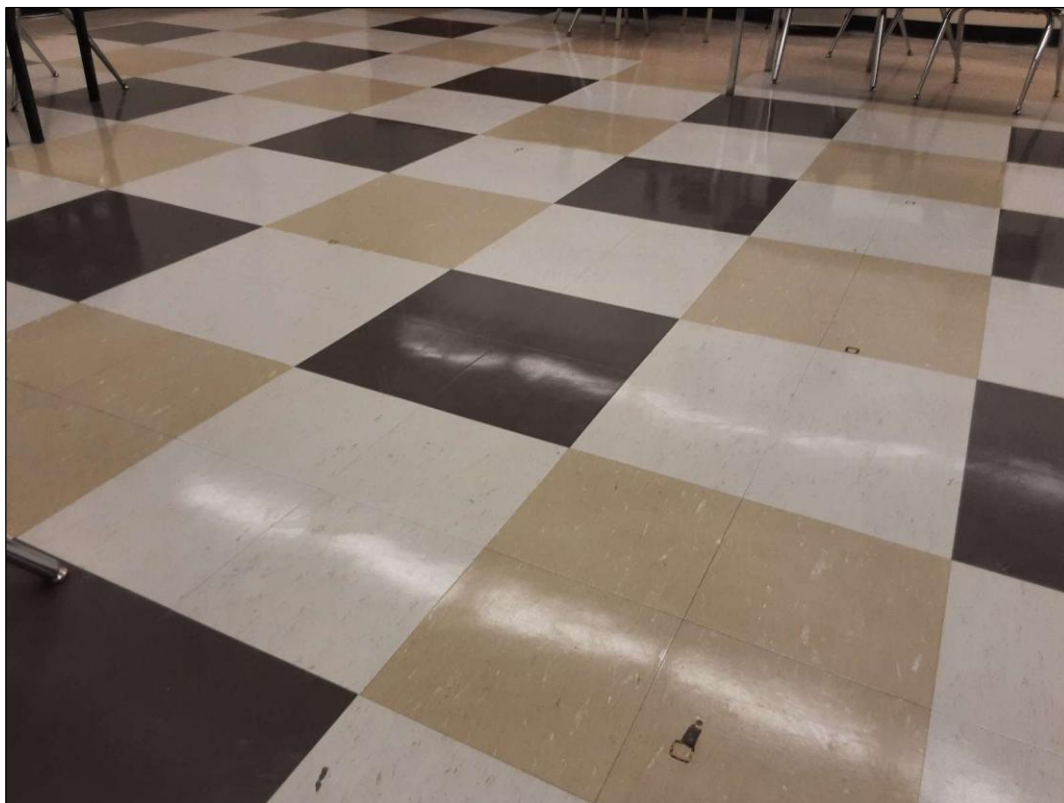
V0000 (None), Floor, Mastic, Under vinyl floor tiles, 204 (Location #: 2040)
Previous samples ASB-125.1-3, A0012A-C and A0013A-C

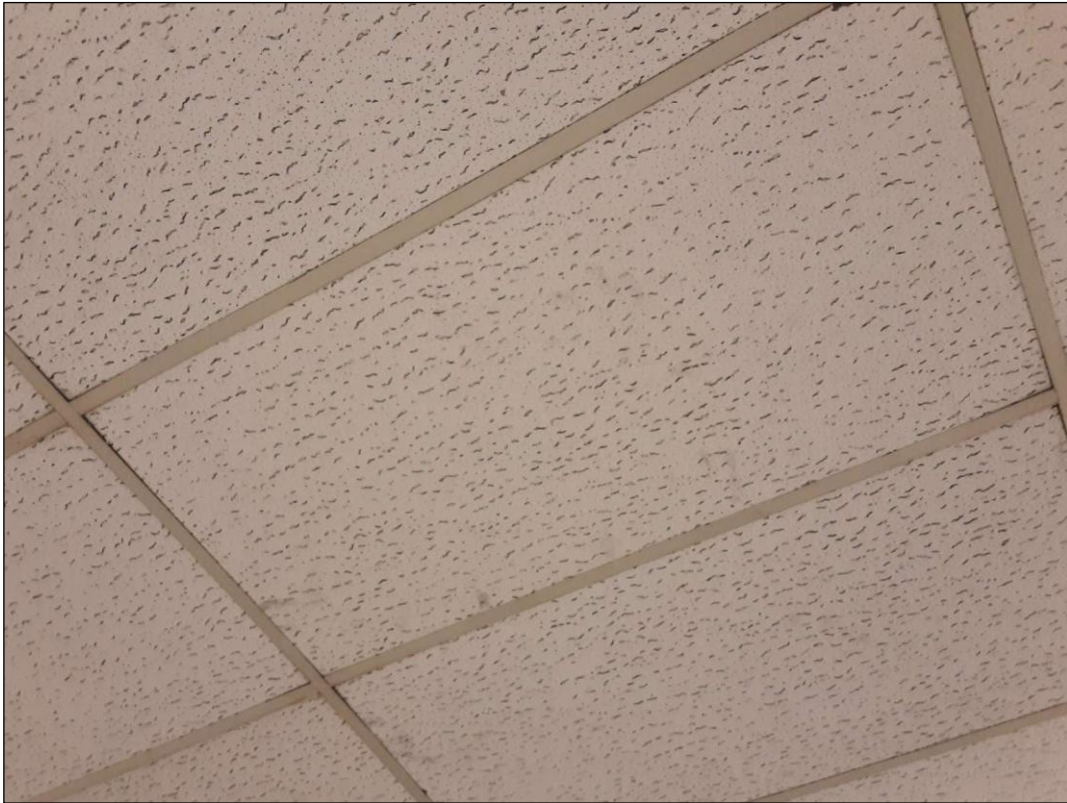
V0000 (None), Ceiling, Ceiling Tiles (lay-in), 2'x4' lay-in, fissures across length, 204 (Location #: 2040)
Previous samples ASB-103.1-3

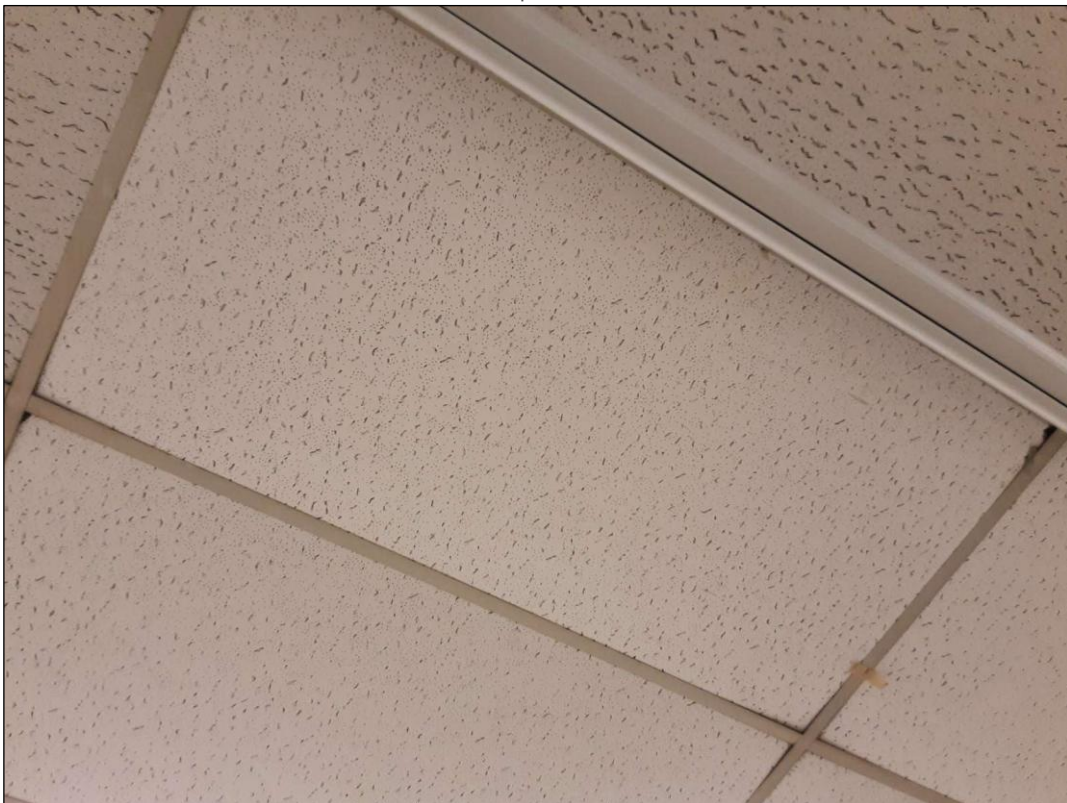
V0000 (None), Ceiling, Ceiling Tiles (lay-in), 2'x4' lay-in, fissures across width, 204 (Location #: 2040)
Previous samples ASB-104.1-3

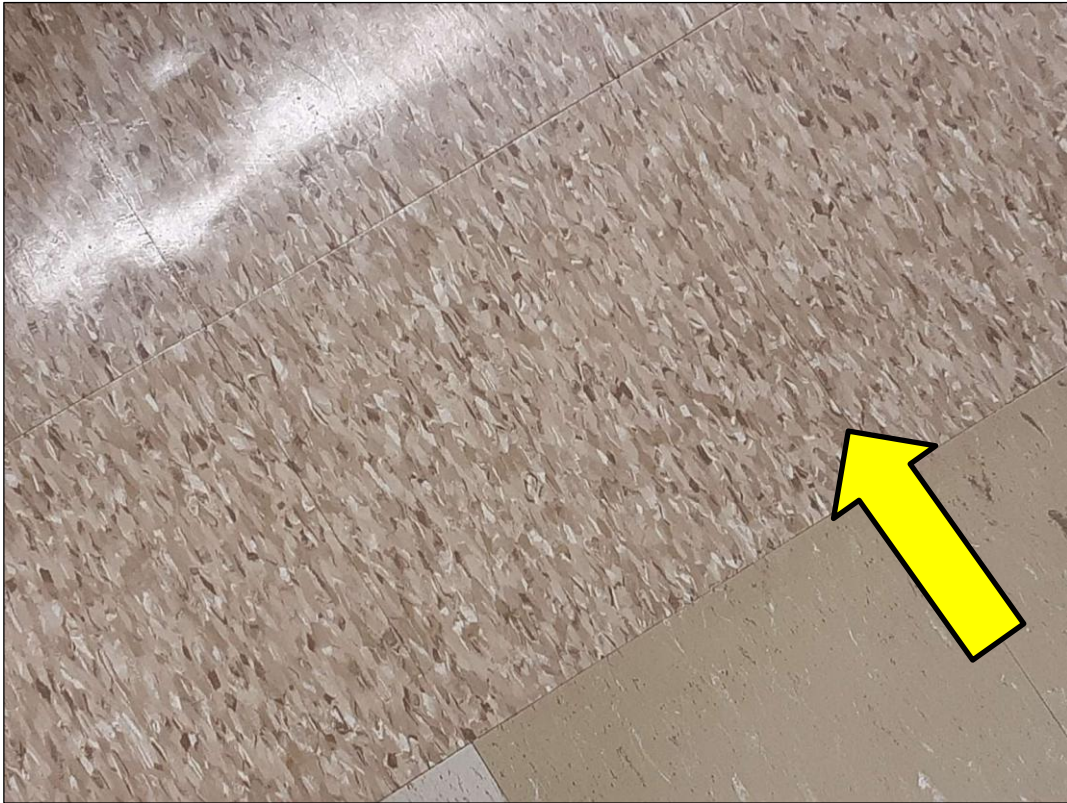
V0000 (None), Floor, Vinyl Floor Tile and Mastic, 12"x12" light brown with dark brown and white smears, installed post 2017, 204 (Location #: 2040)

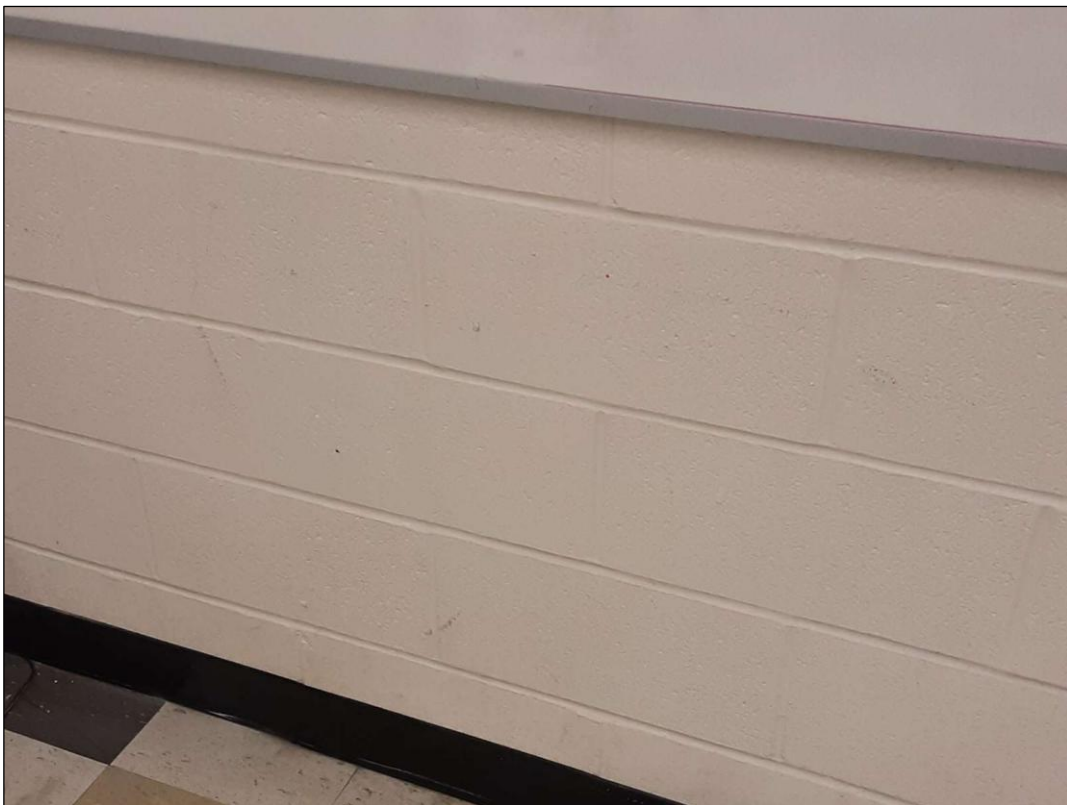
V0002(Lead, Low), Wall, Concrete (Precast), Various colours, 204 (Location #: 2040)

For paints identified as having low levels of lead (i.e., equal to or above 0.009% (90 mg/kg) but less than or equal to the EACC guideline of 0.1% (1,000 mg/kg) for lead-containing paints) special precautions are not recommended unless aggressive disturbance (grinding, blasting, torching) is planned.

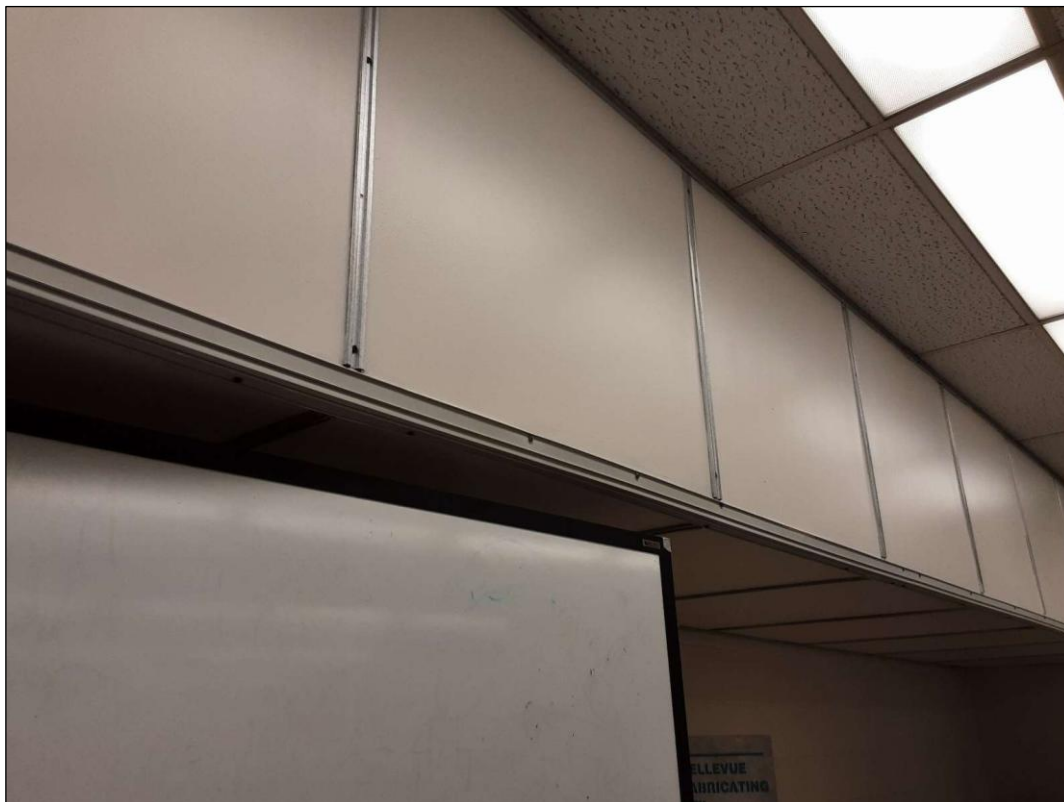
L0009(Lead, None), Ceiling, Drywall (no compound), Off-white, 204 (Location #: 2040)

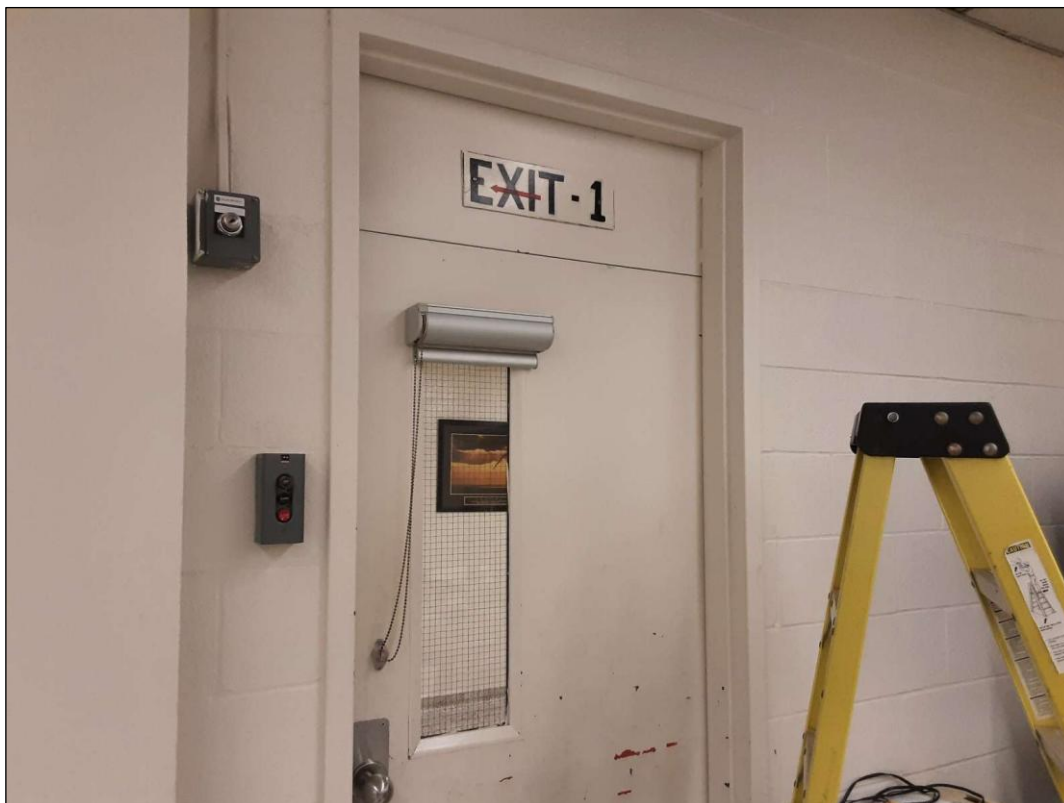
L0010(Lead, High), Wall, Metal, Red/white on door and frame, 204 (Location #: 2040)

For lead-containing or lead-based paints (i.e., greater than the EACC guideline of 0.1% (1,000 mg/kg) for lead-containing paints, and 0.5% (5,000 mg/kg) for lead-based), construction disturbance may result in over-exposure to lead dust or fumes. The need for work procedures, engineering controls and personal protective equipment should be assessed on a site-specific basis to comply with applicable regulations, and/or guidelines.

Items painted with paints containing elevated levels of lead may be a hazardous waste. Test lead-painted materials for leachable lead and other metals prior to disposal. Metallic components coated with lead paint do not require leachate testing and can be disposed of as non-hazardous construction and demolition (C&D) waste.
