Re: Hazardous Building Materials Assessment (Preconstruction)
Mechanical Upgrades, Grafton Public School, 654 Station Road, Grafton, Ontario
Pinchin File: 367131.004

Kawartha Pine Ridge District School Board (Client) retained Pinchin Ltd. (Pinchin) to conduct a hazardous building materials assessment at Grafton Public School located at 654 Station Road, Grafton, Ontario.

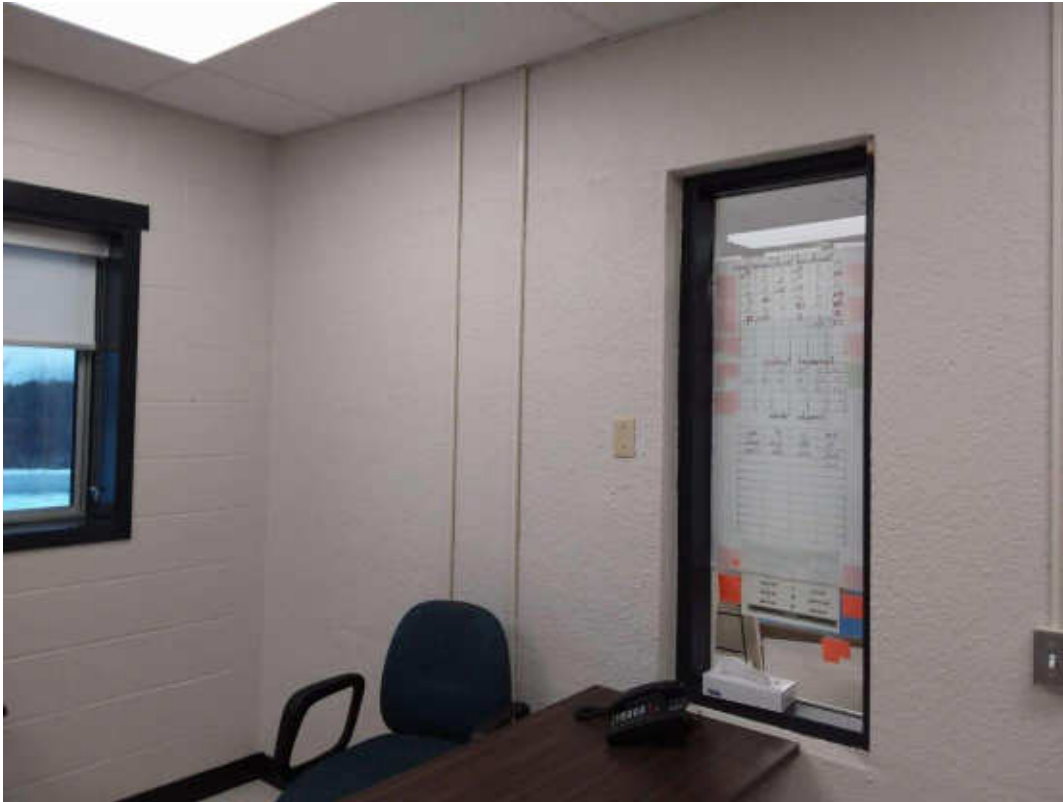
V0002 (Confirmed Asbestos), Wall, Texture Coat, Meeting Room (Location #: 12)

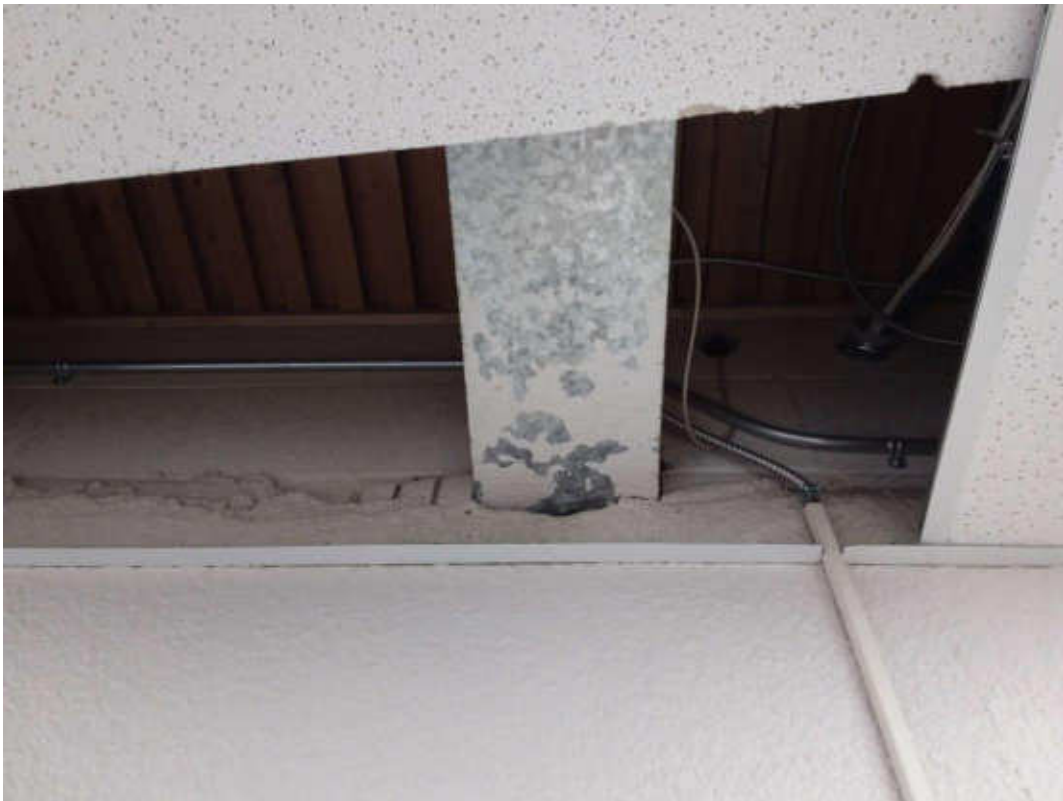
V0002 (Confirmed Asbestos), Texture coat overspray, Duct, Overspray, Meeting Room (Location #: 12)

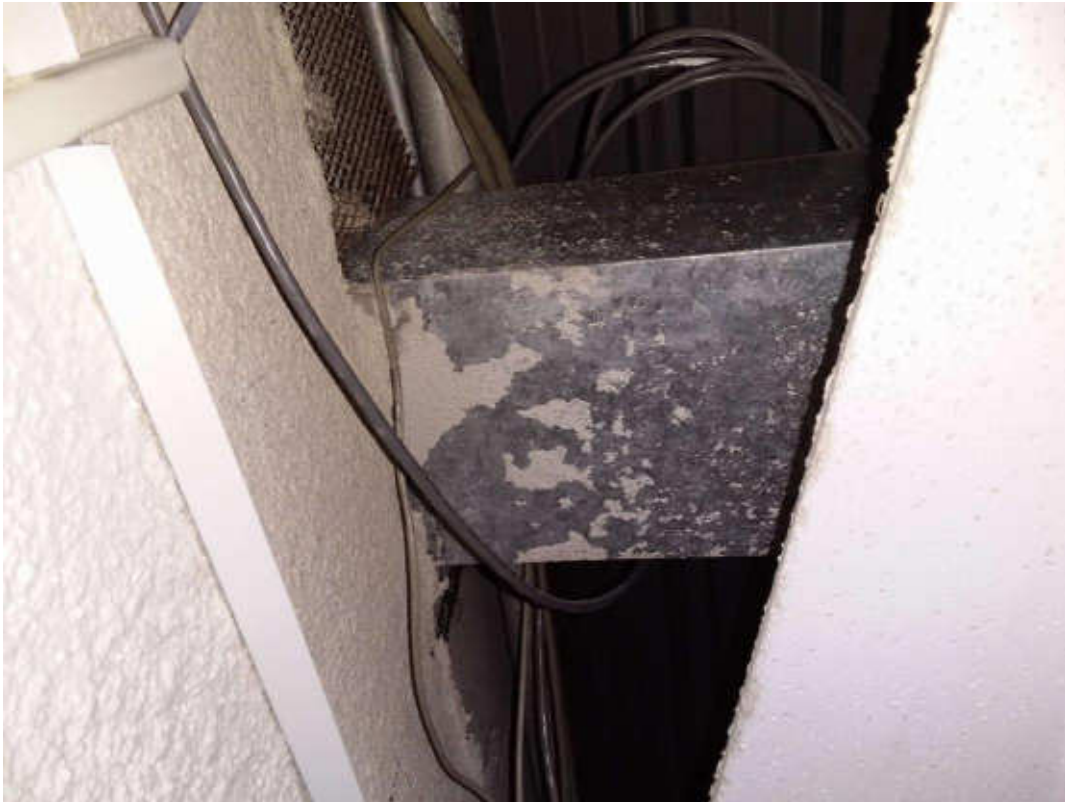
V0002 (Confirmed Asbestos), Texture coat overspray, Duct, Overspray, Meeting Room (Location #: 14)

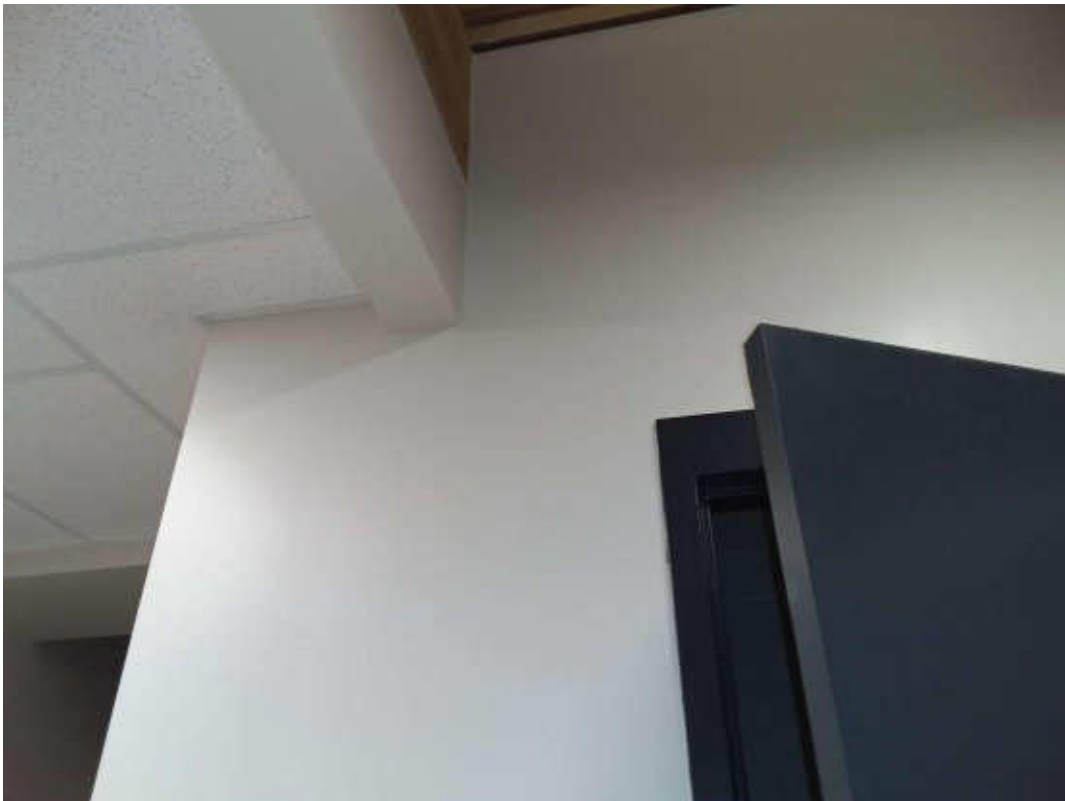
S0016 (Confirmed Asbestos), Wall, Drywall and joint compound, Photocopy (Location #: 17)

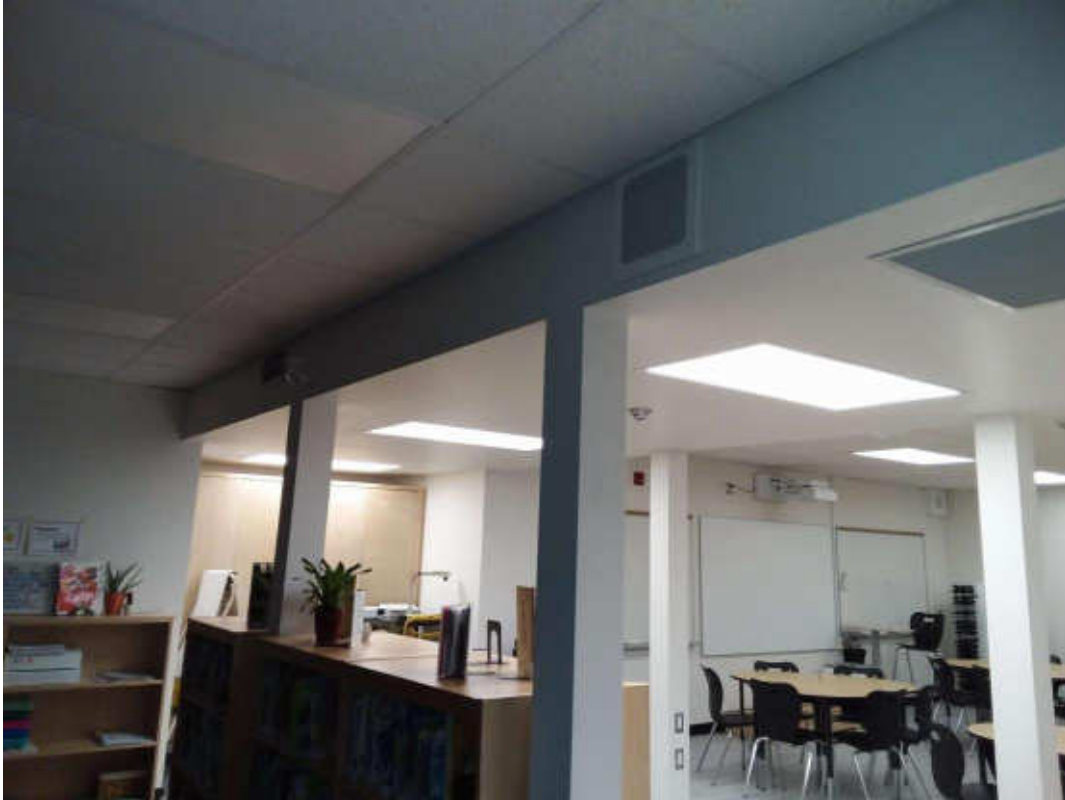
S0038A (Confirmed Asbestos), DJC ceiling/bulkhead, Ceiling, All, Drywall and joint compound, Library/Resource Room (Location #: 33)

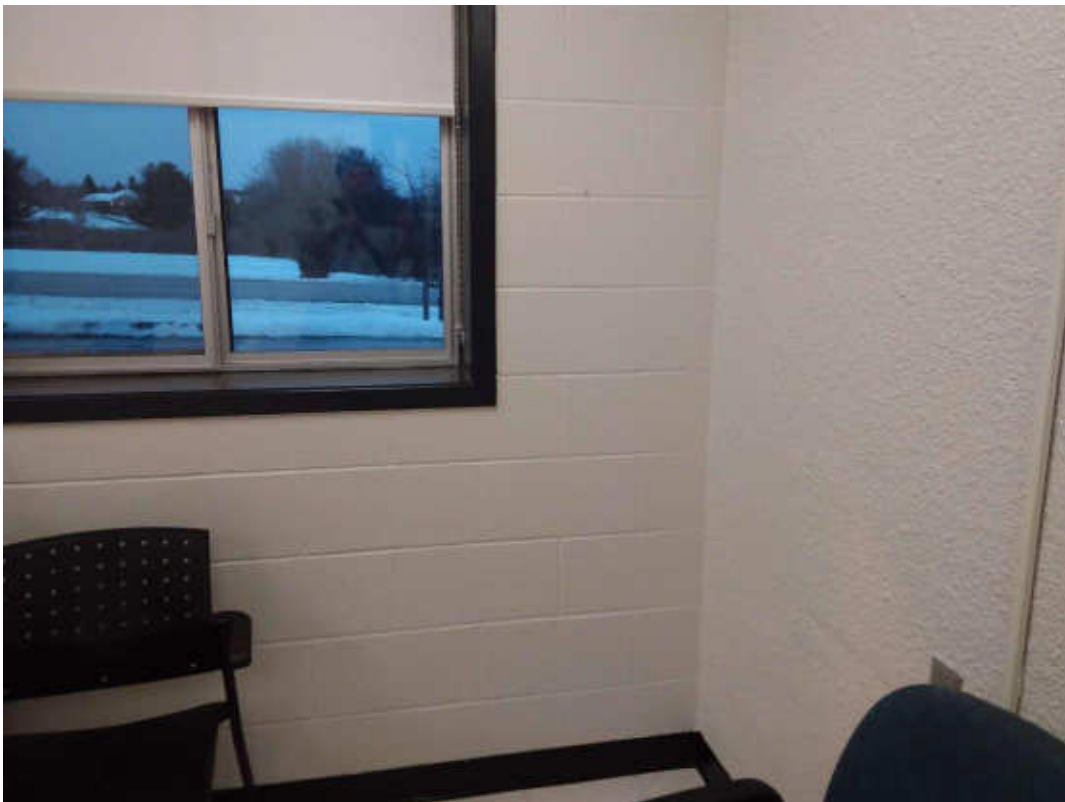
S0067A (Confirmed Asbestos), Beige/white paint on masonry, Wall, Paint, Meeting Room (Location #: 12)

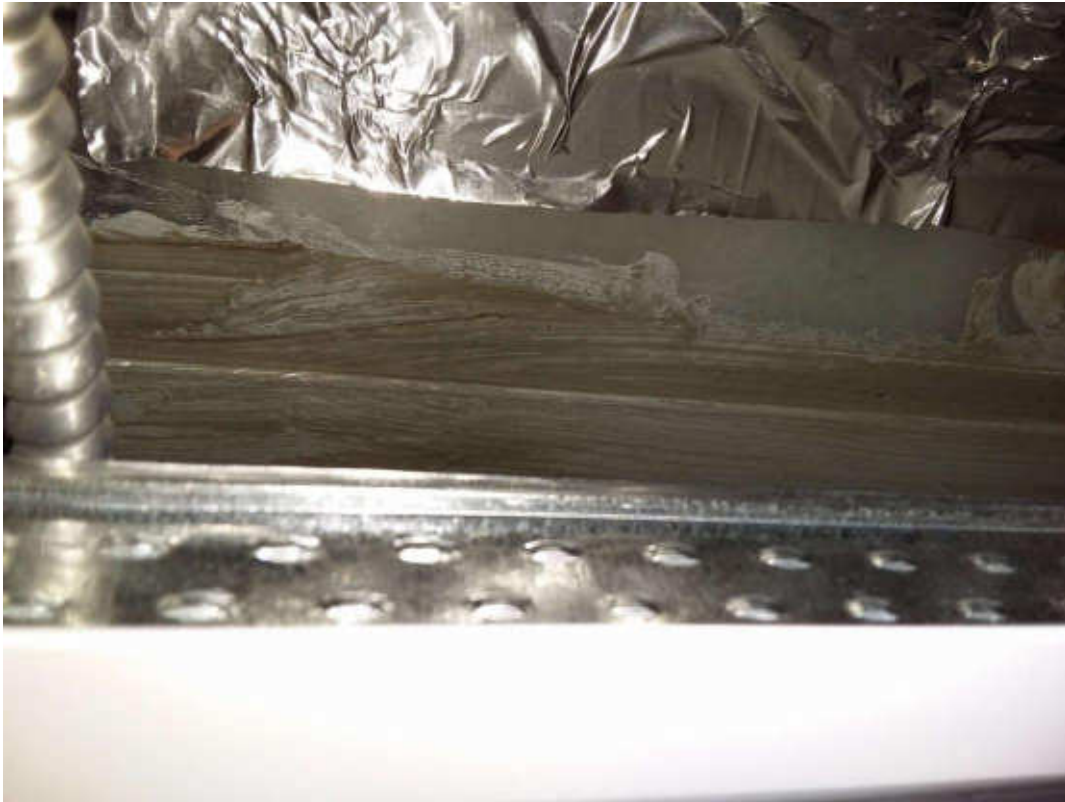
S0068A (None), Grey duct mastic, Duct, Mastic, Workroom (Location #: 36)

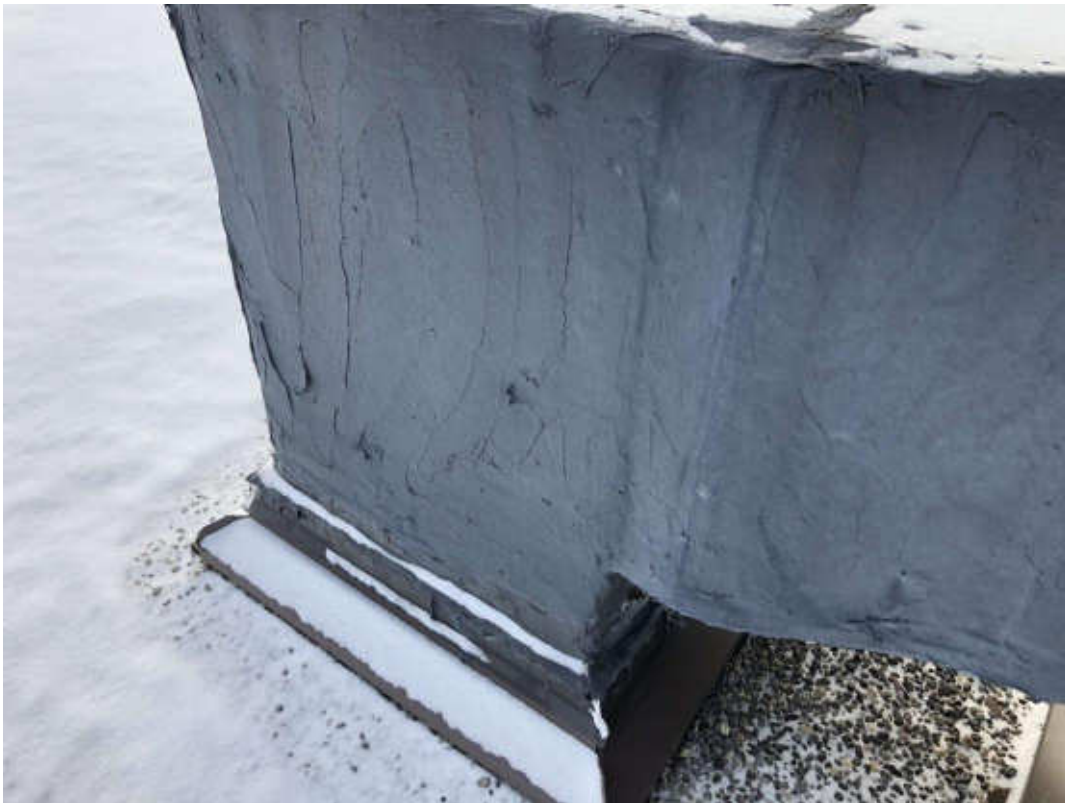
S0069C (Confirmed Asbestos), Tar On AHU Ducting, Mechanical Equipment, Air Handling Unit, Tar, Roof (Location #: 65)

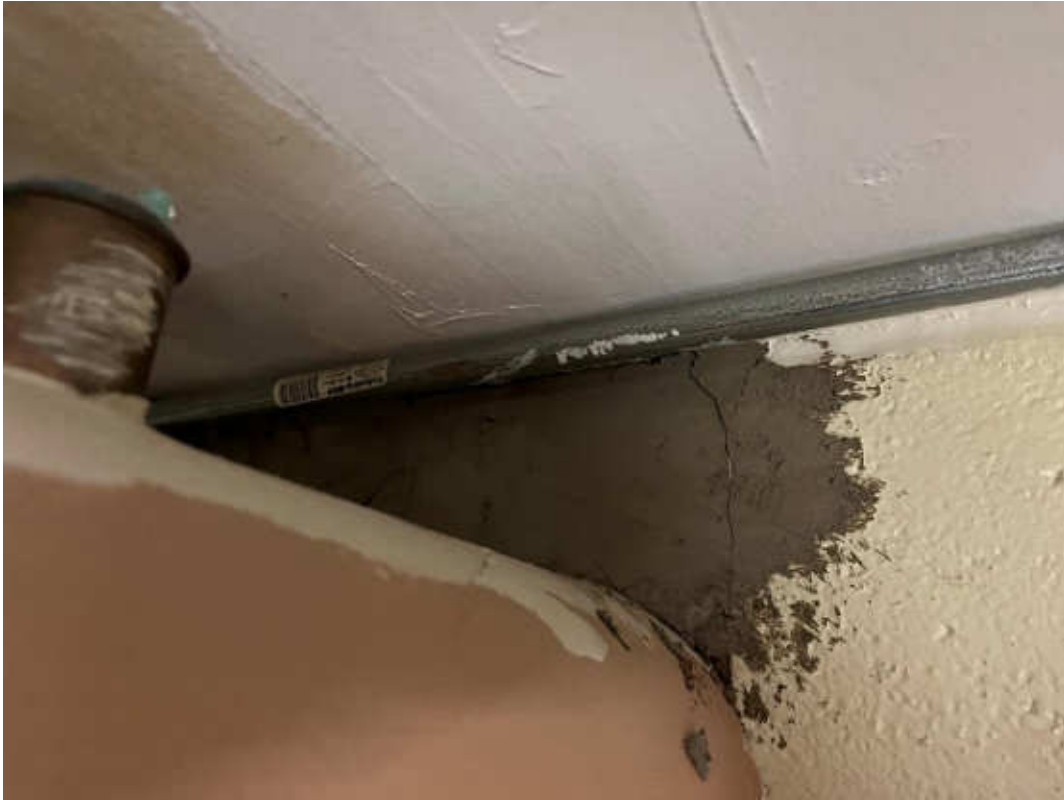
S0072C (None), Cementitious Firestopping, Other, Boiler Room (Location #: 1)

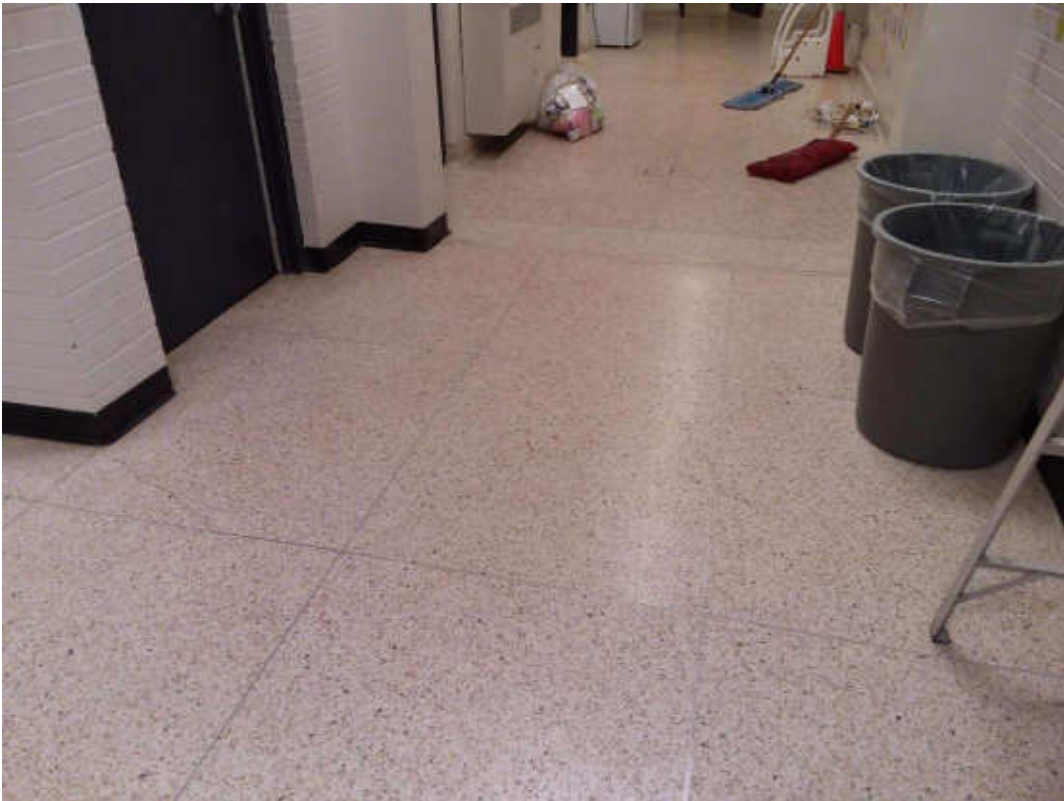
V9500 (Presumed Asbestos), Floor, Terrazzo, Ramp & Corridor (Location #: 35)

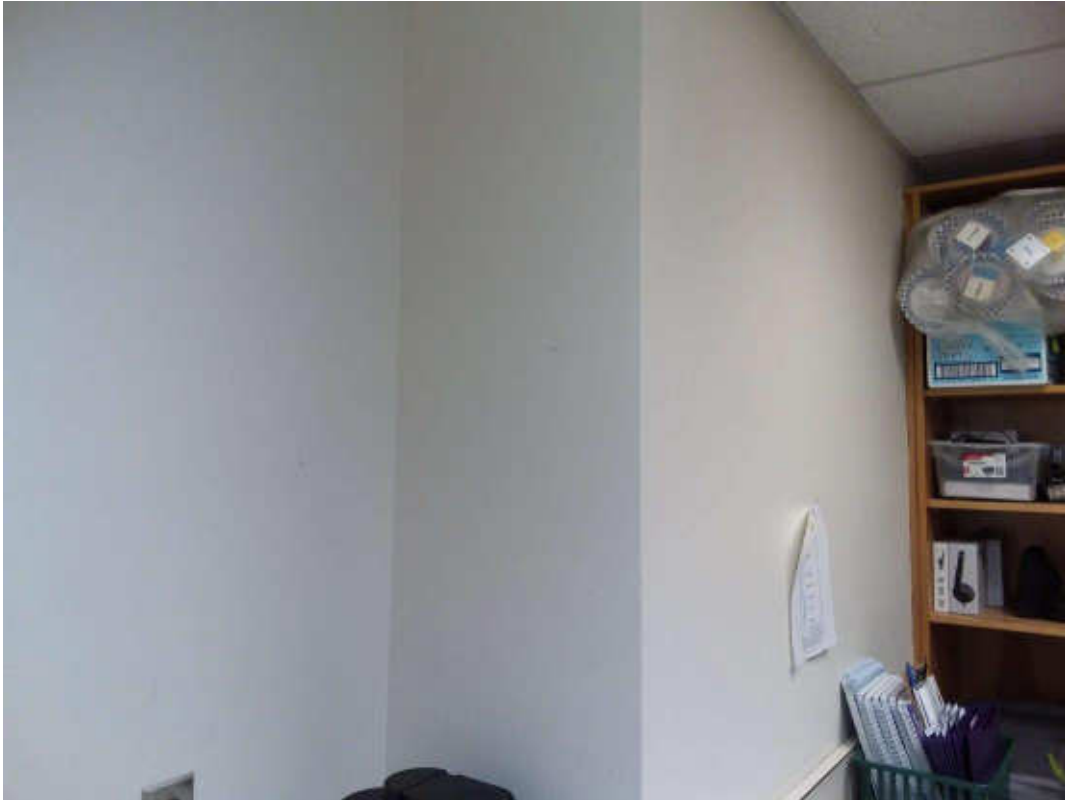
L0012(Lead, None), Beige paint on drywall, Wall, Copier Room (Location #: 15)

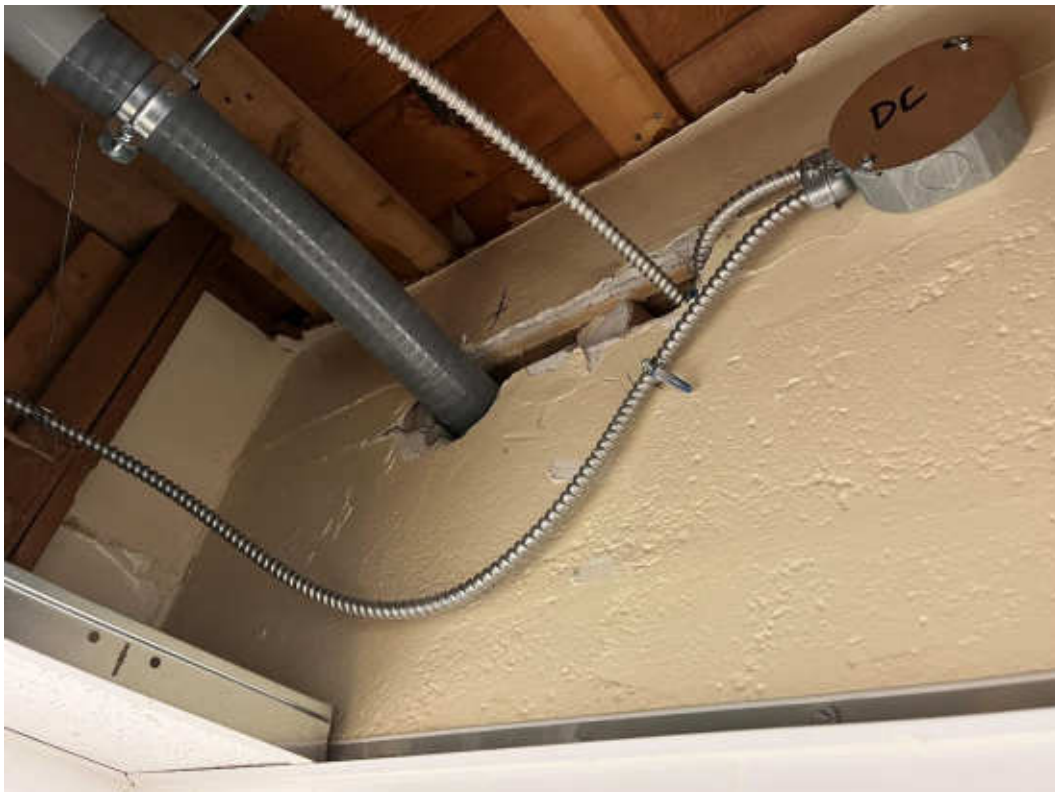
L0014(Lead, High), Paint on Plaster, Wall, Boy's Washroom (Location #: 6)

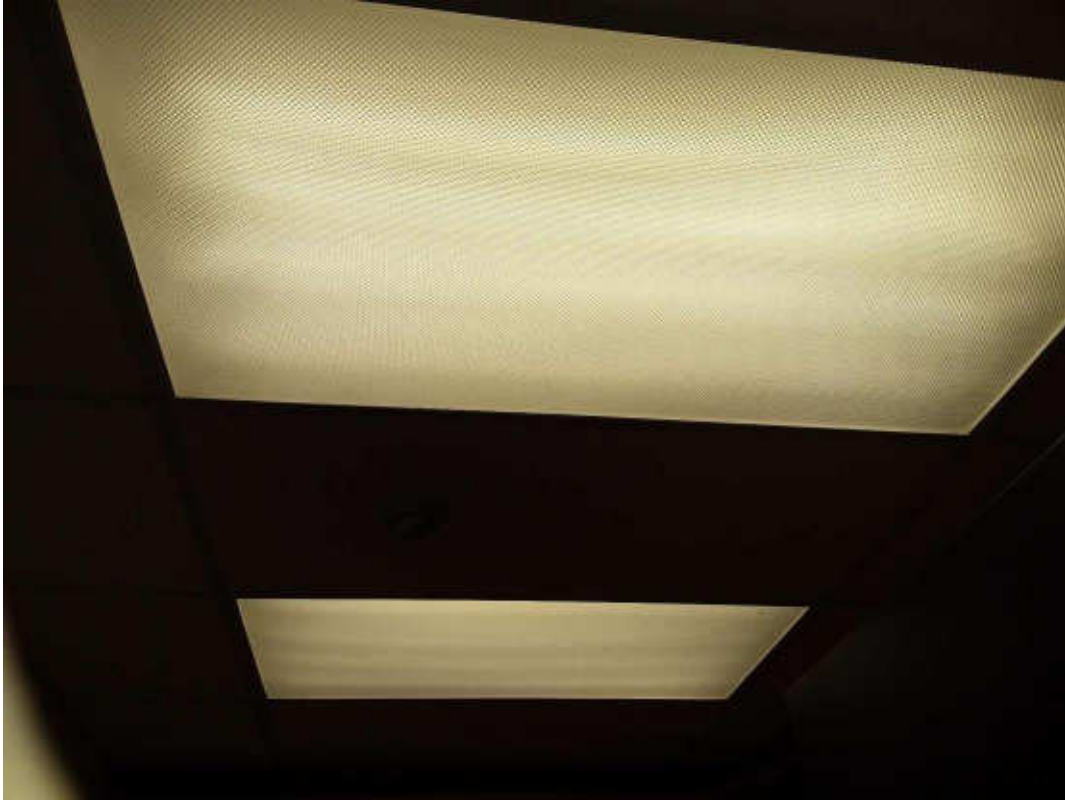
Mercury, V9000(Yes), LIGHT FIXTURE, Copier Room (Location #: 15)

Do not break lamps. Recycle and reclaim mercury from fluorescent lamps when taken out of service. Mercury is classified as a hazardous waste and must be disposed of in accordance with applicable regulations.

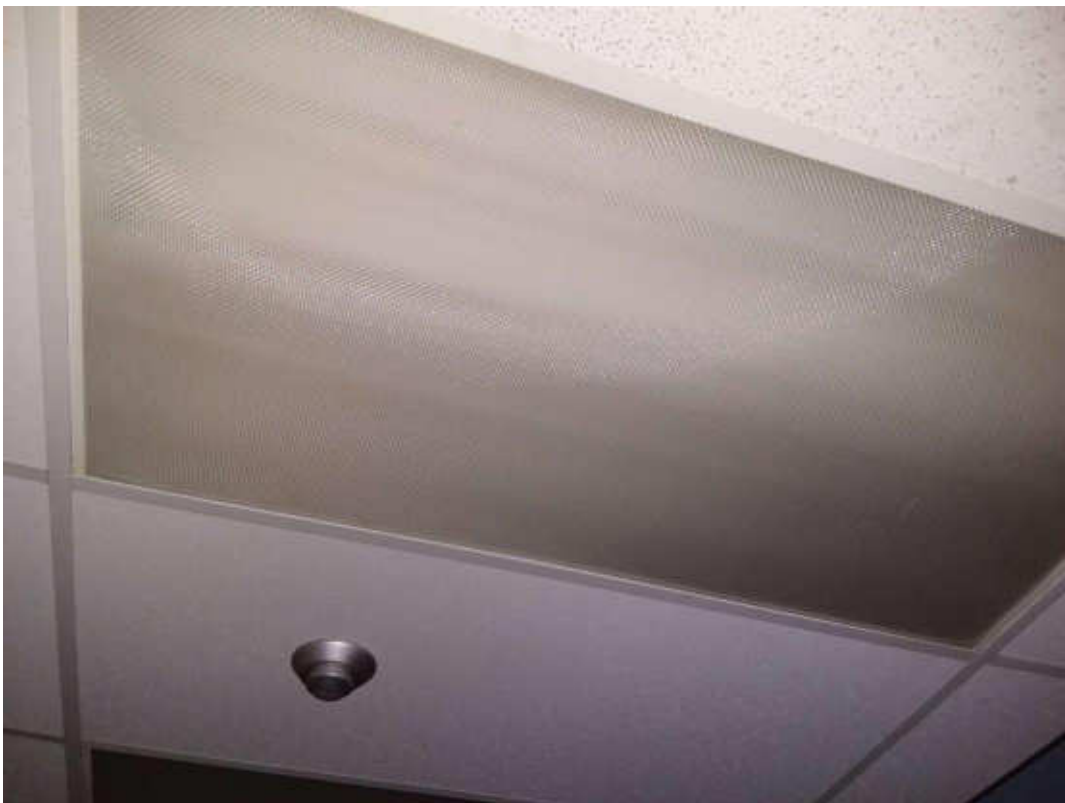
PCB, V9500(Presumed), LIGHT BALLASTS, Copier Room (Location #: 15)
