Limited Designated Substance Survey Report

Vaughan Willard Public School

1911 Dixie Road North, Pickering, Ontario

April 25, 2022
Parasol Project No: 13032

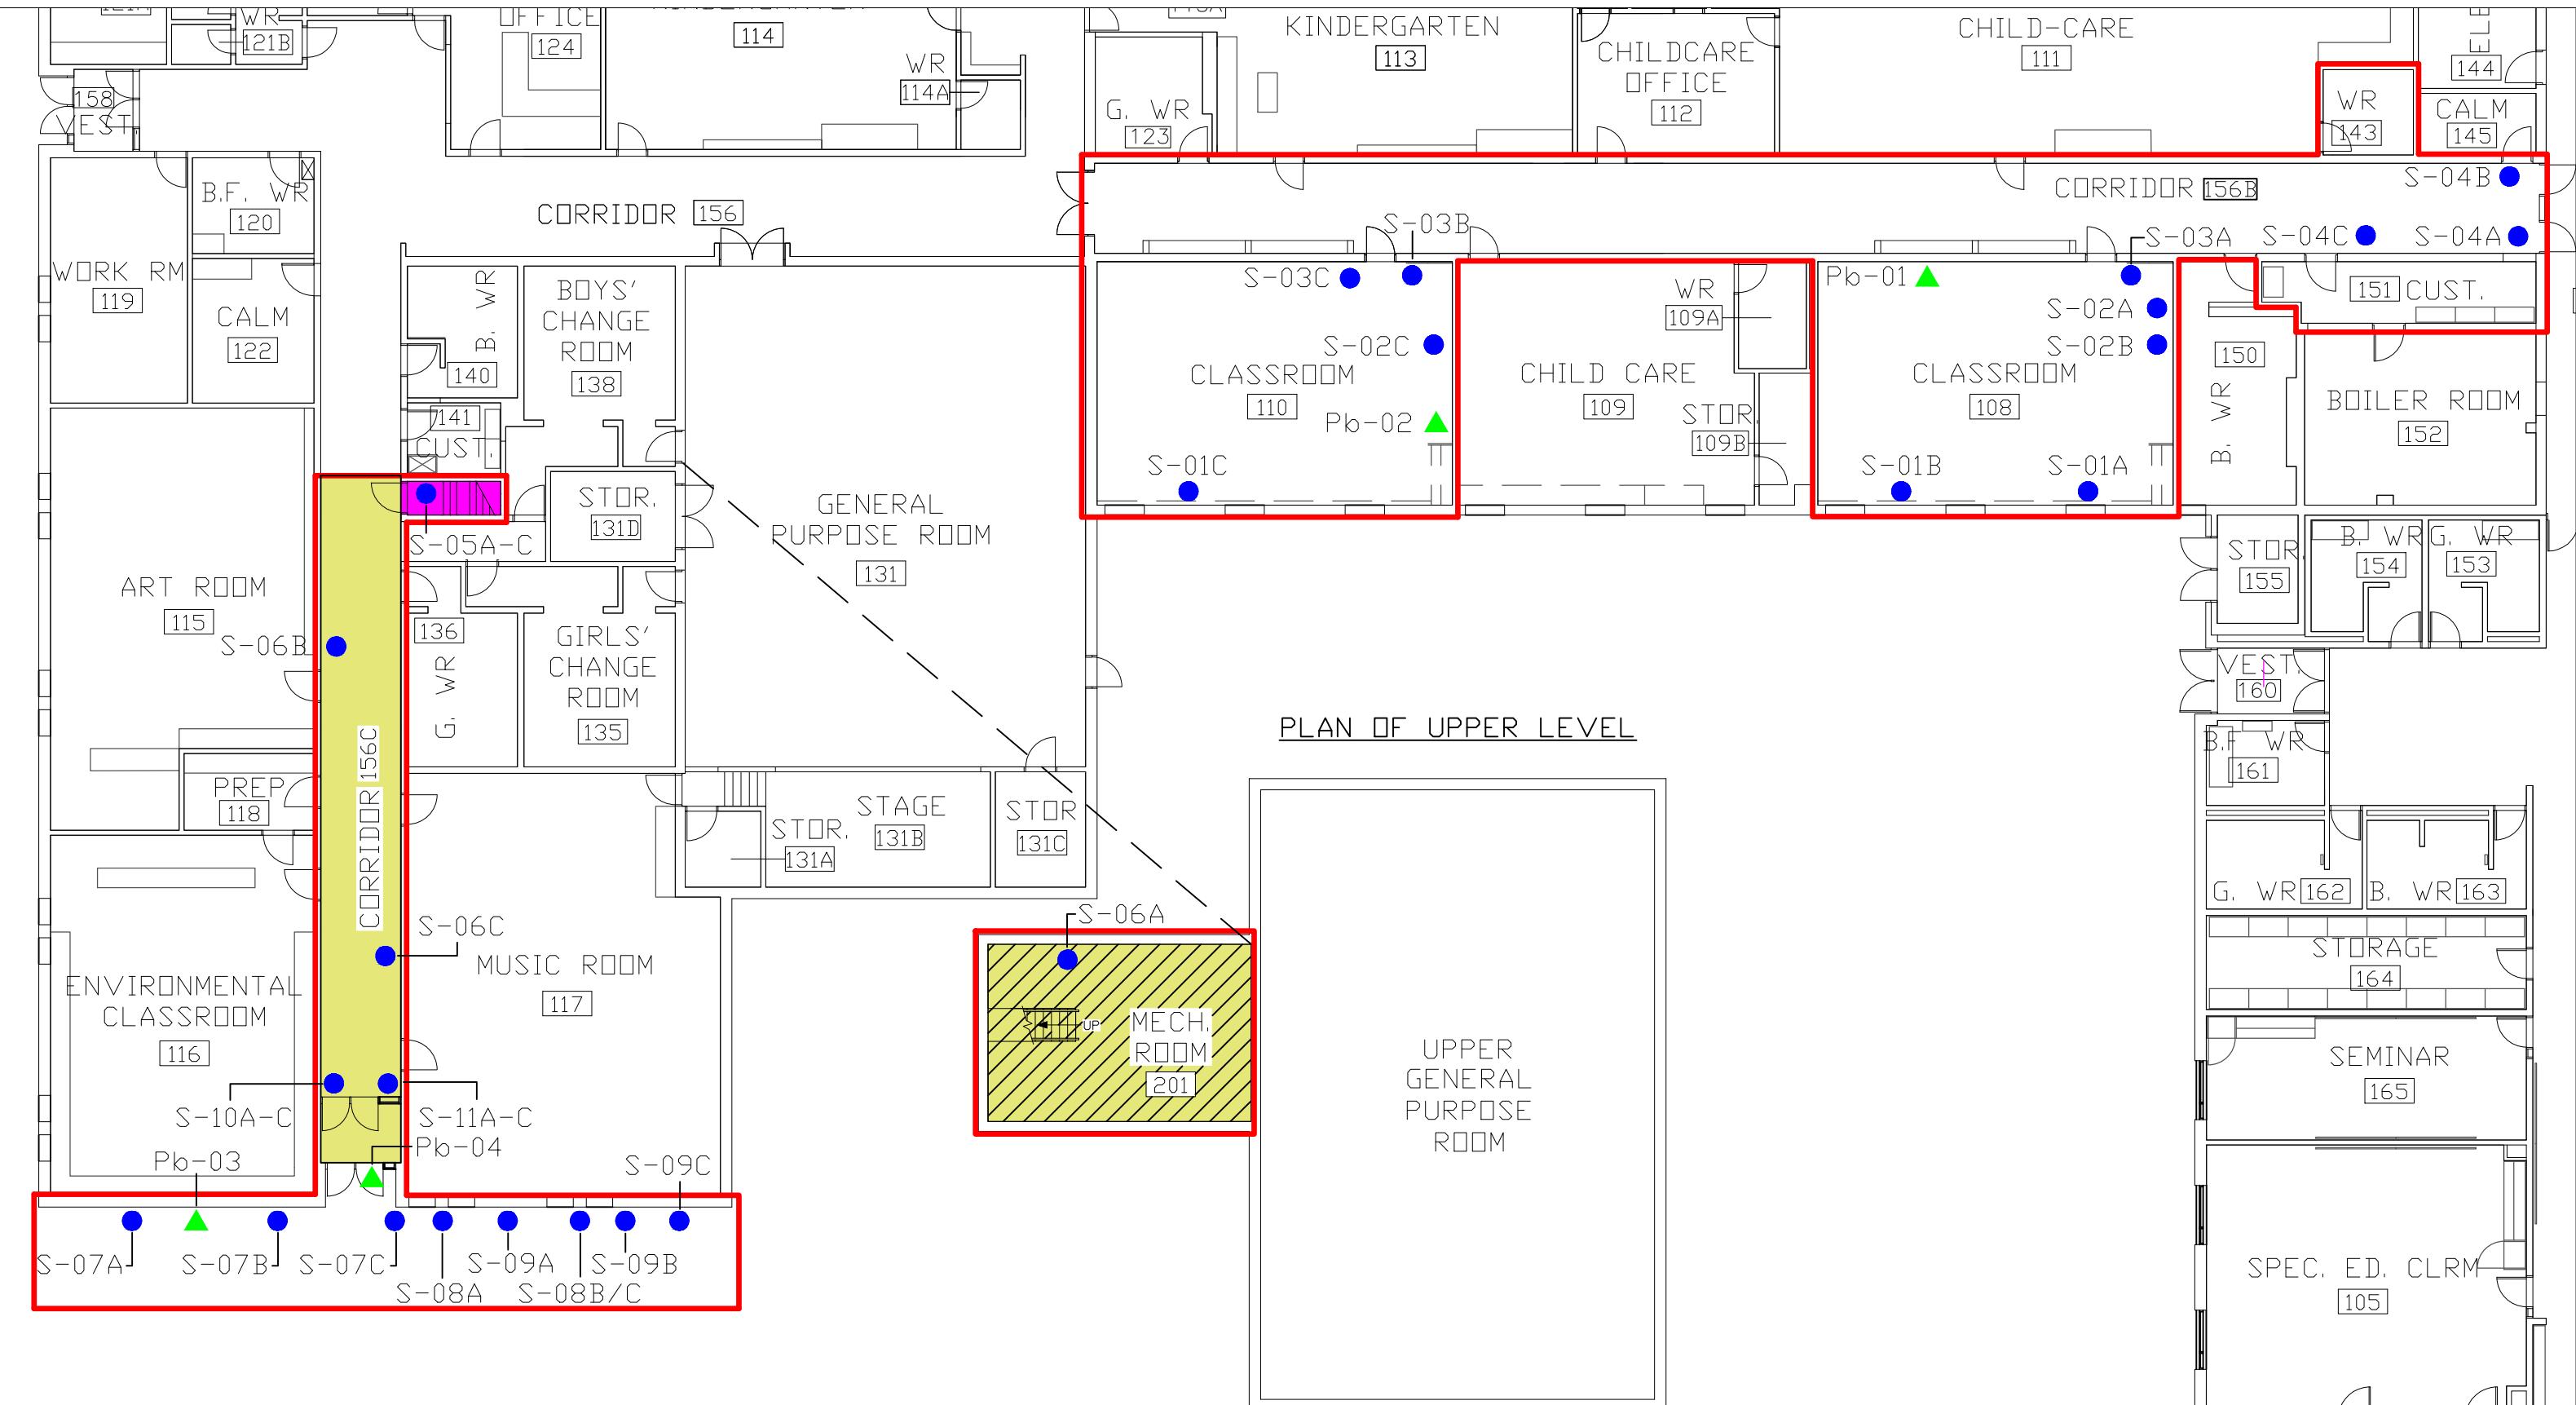
Site Drawing

Asbestos-containing Parging Cement was observed to be applied to pipe fittings within the surveyed area. Parging Cement was previously sampled by Others and confirmed to contain **25-50% Chrysotile asbestos**. At the time of the current assessment, Parging Cement was observed to be in GOOD condition.

Depending on the condition, geometry and size, the removal of mechanical insulations are to be completed using Type 2, Glove Bag or Type 3 asbestos abatement procedures.
