## Limited Designated Substance Survey Report

Vaughan Willard Public School

1911 Dixie Road North, Pickering, Ontario

February 3, 2025  
Parasol Project No: 13274

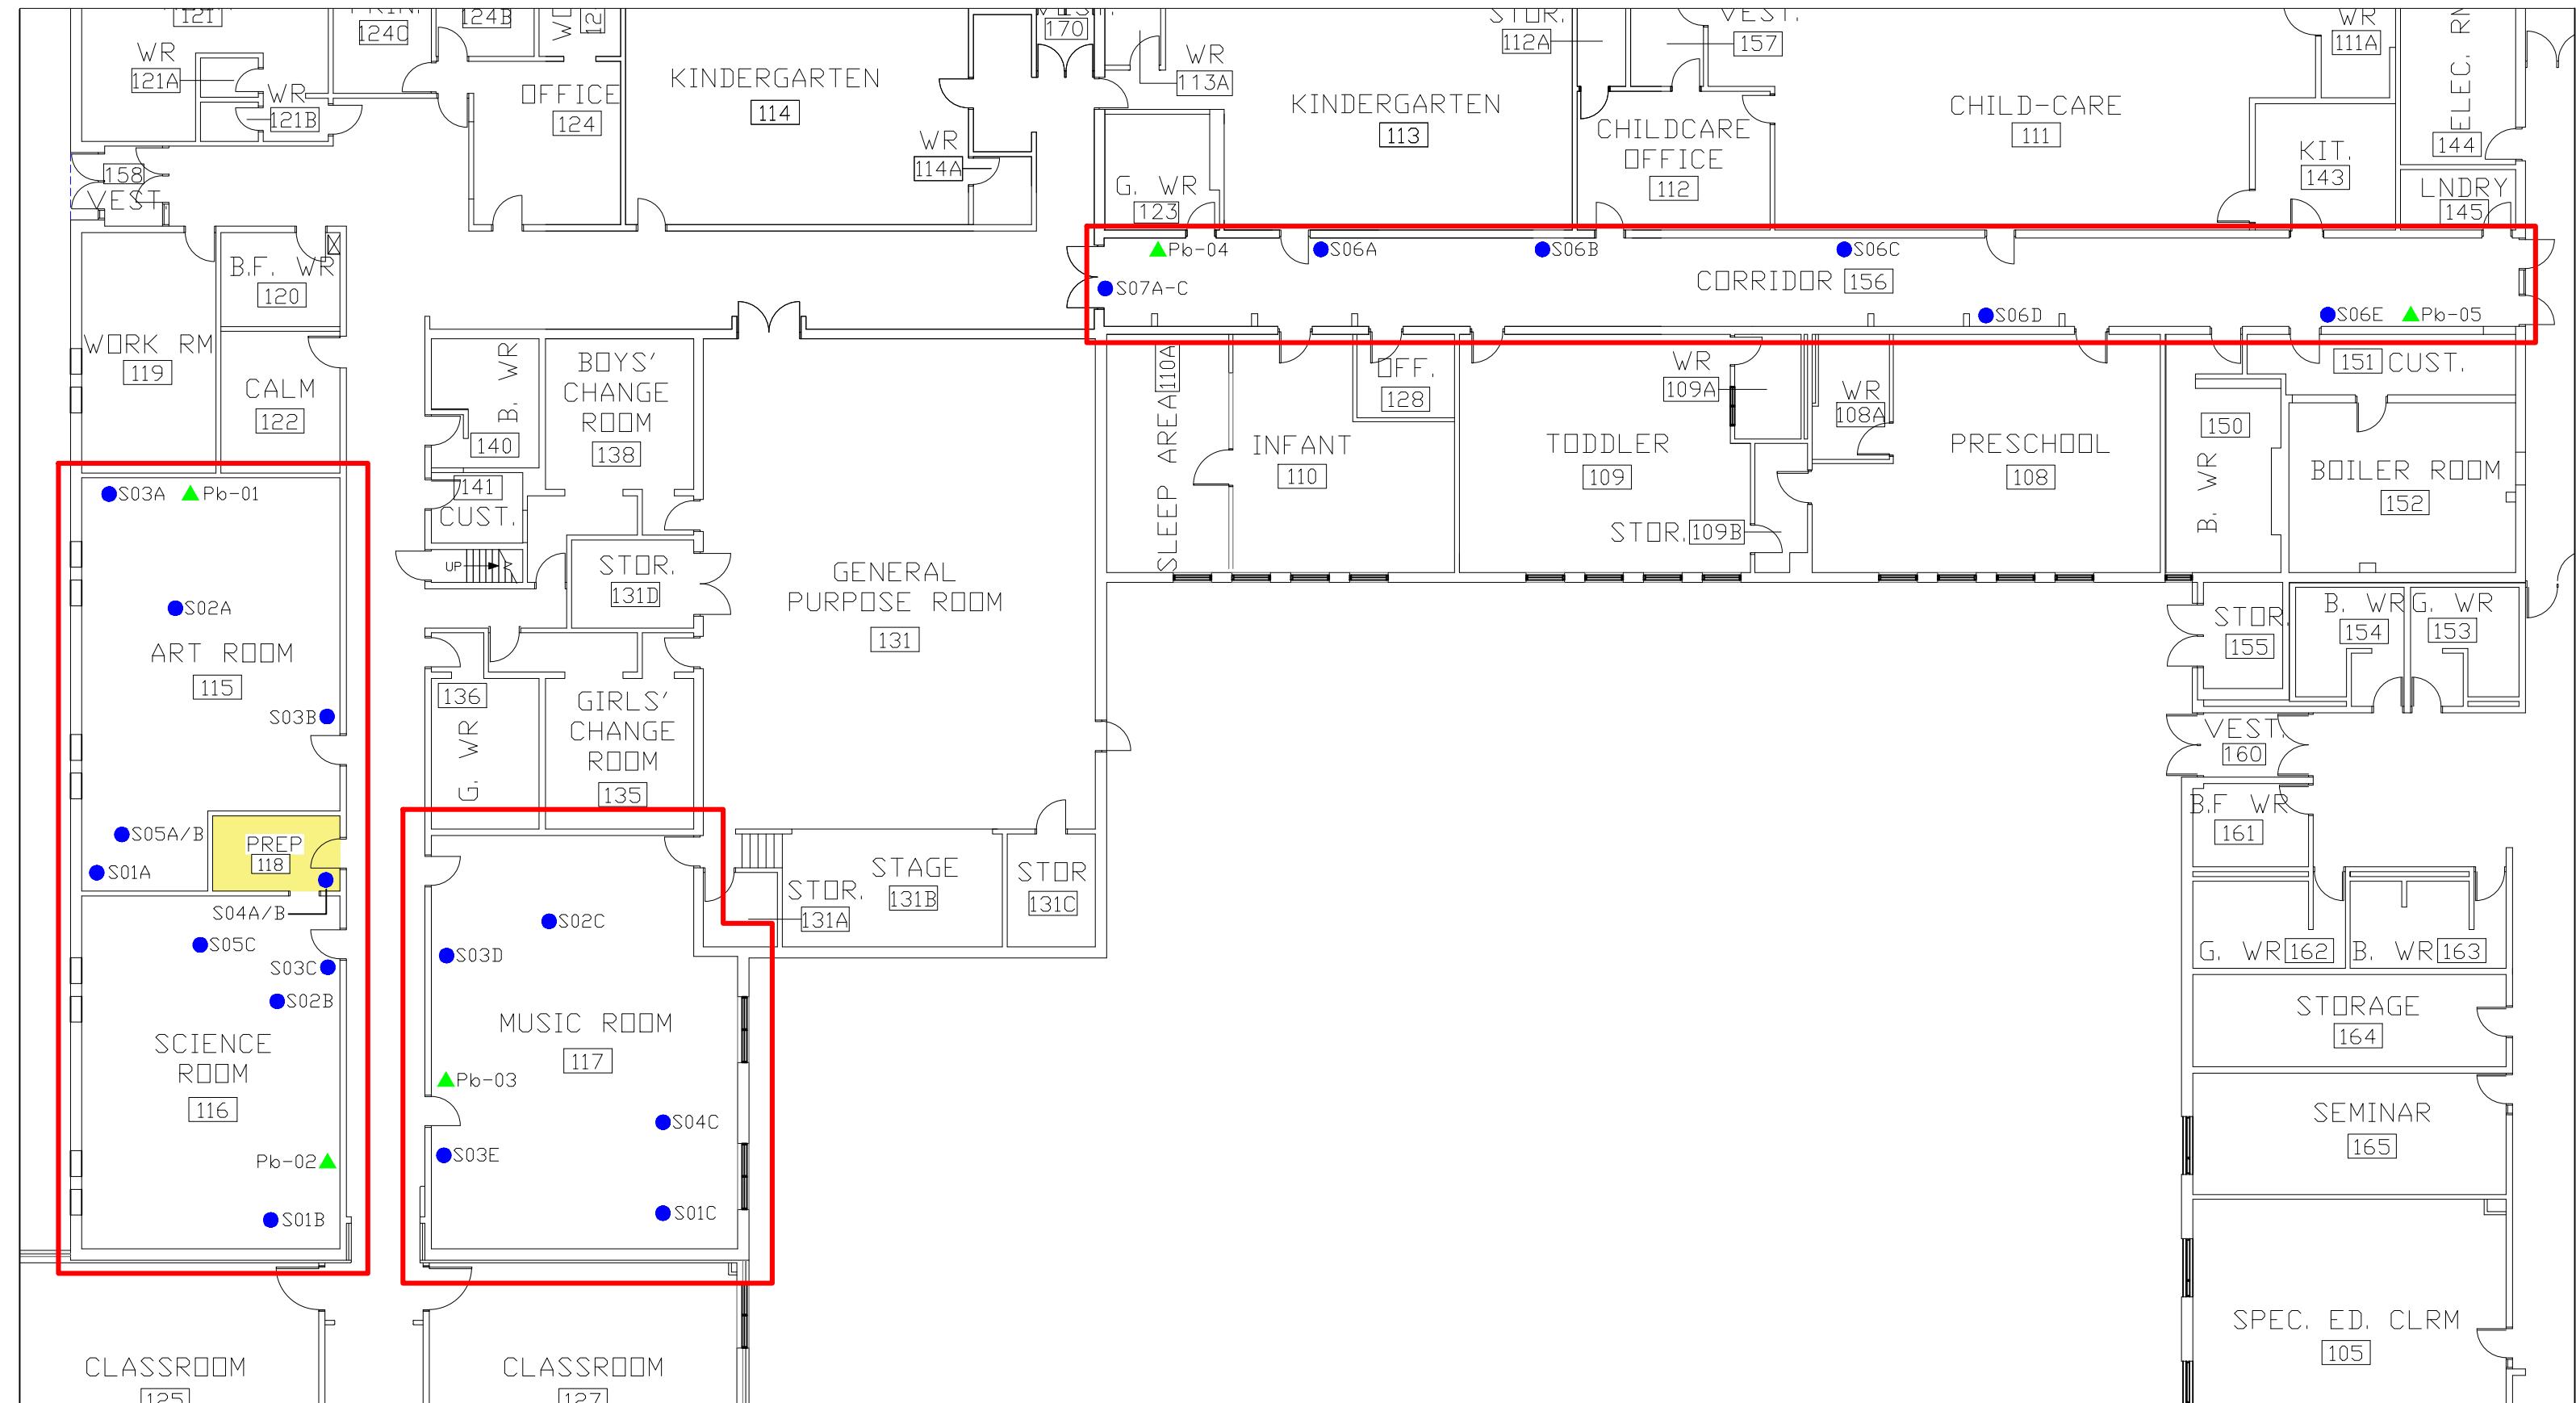
Transite cement products were observed to be present in the form of piping (rainwater leader) and is limited within the drywall pipe chase in Location #118-Prep Room.

No samples of the transite cement products were collected as sampling could disrupt the integrity of the material. Transite cement products typically contain Chrysotile or Amosite asbestos of varying percents. Visual identification is typically reliable for identifying transite cement products; however, a non-asbestos-containing equivalent of transite cement products is manufactured. Transite piping was observed in GOOD condition at the time of the assessment.
