LIMITED DESIGNATED SUBSTANCE SURVEY REPORT (Roof)

**Durham District School Board
Vaughan Willard Public School
1911 Dixie Road North
Pickering, Ontario**

April 2019

Maple Project No. 17894

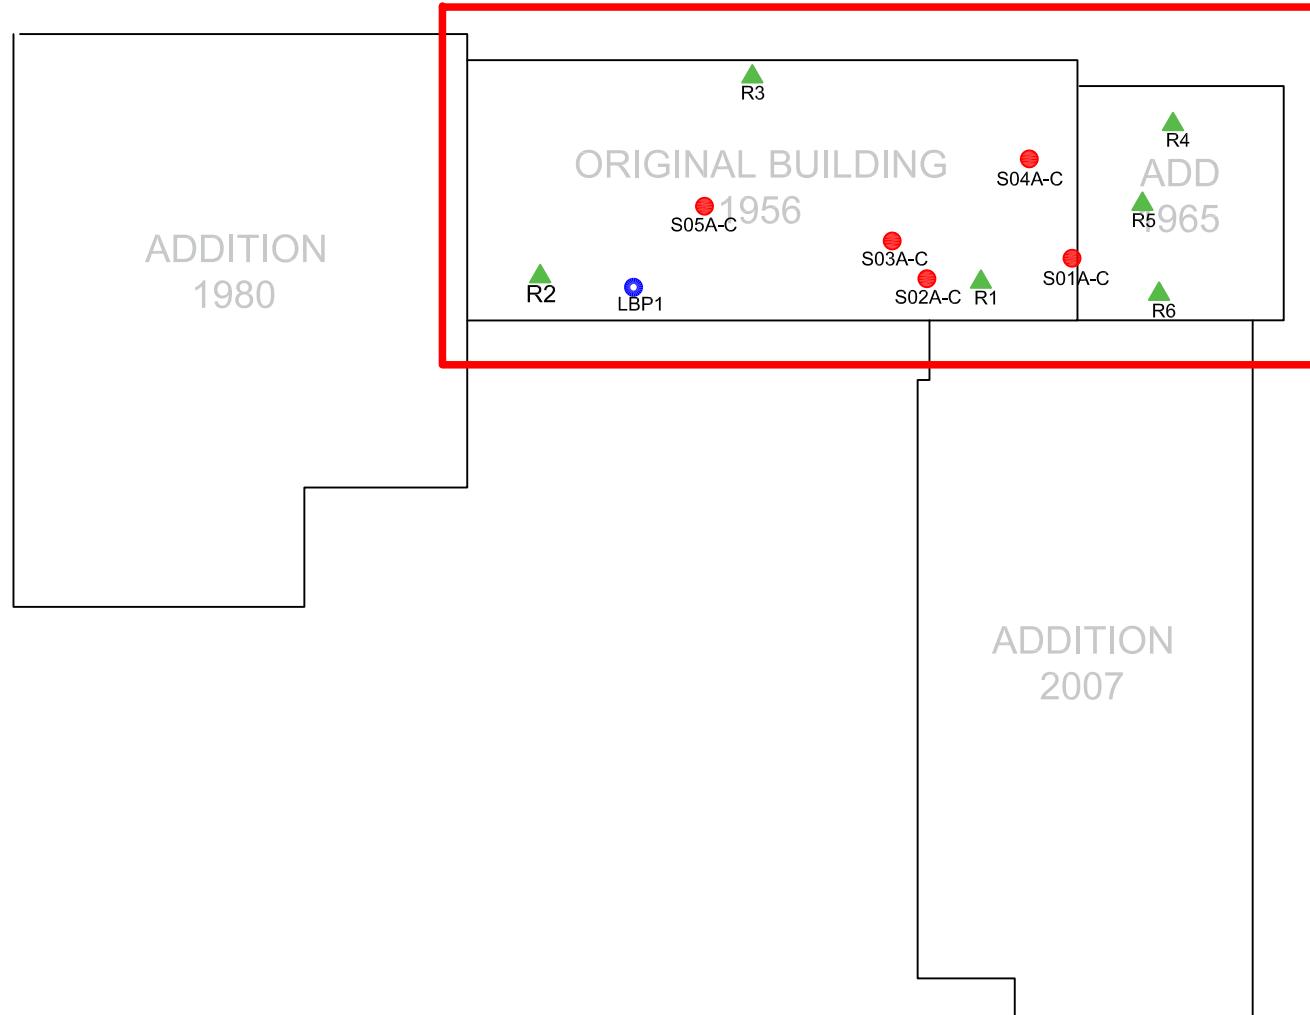
Roof Designated Substance Survey

Six (6) representative samples of roof core were collected (Sample Sets R1-R6) and analyzed for asbestos. Samples R1-R3 were collected from the 1956 roof section while samples R4-R6 were collected from the 1965 roof section. Analysis of Sample Sets R1-R6 found that the samples do not contain asbestos.
