Annual ACM and Designated Substances Inspection

**St. Thomas Aquinas
Catholic Secondary School**

**260 Angeline Street West,
Lindsay, Ontario**

August 22, 2025

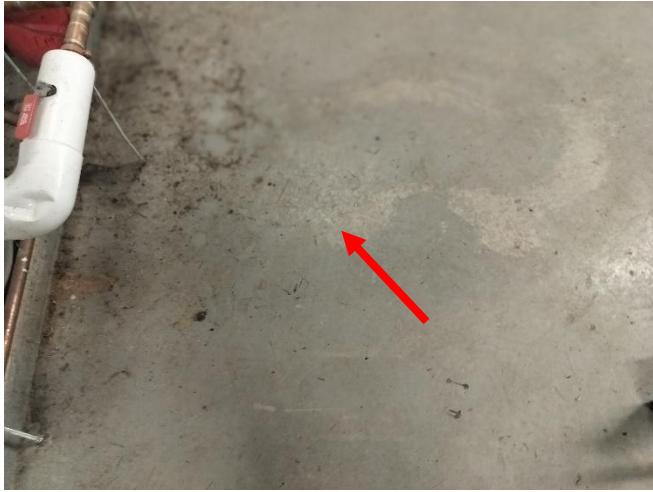
A photograph showing a close-up of a concrete floor. A red arrow points to a small, dark, irregular spot on the floor, which is identified as lead containing grey paint.

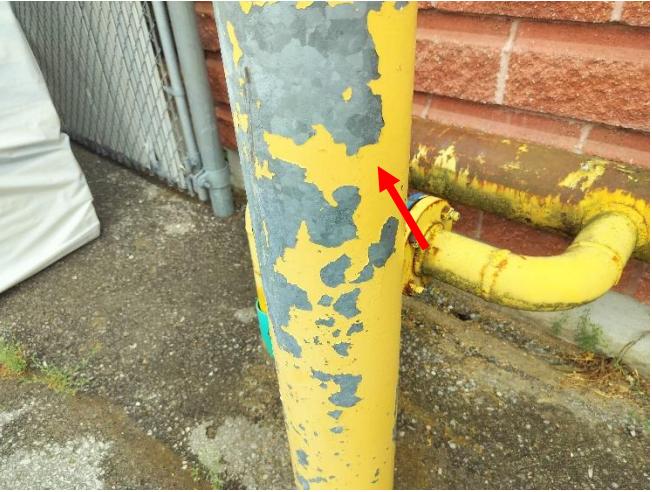
A photograph of a concrete pole painted yellow. A red arrow points to a dark, peeling area on the yellow paint, indicating lead containing yellow paint.
<p>Photo 1: View of the lead containing grey paint (see arrow) observed to be in good condition on the concrete floor within Mechanical Room 2009.</p>	<p>Photo 2: View of the lead containing yellow paint (see arrow) observed to be in fair condition on the concrete poles outside receiving doors.</p>

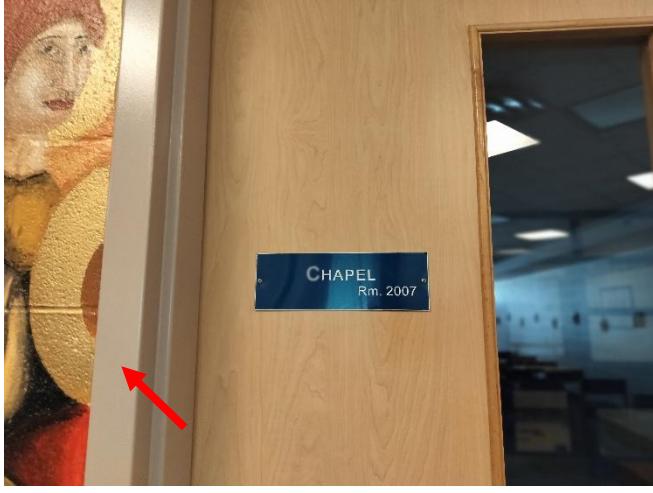
A photograph of a wooden door frame. A red arrow points to a dark, textured area on the frame, which is identified as lead containing dark beige paint.

<p>Photo 3: View of the lead containing dark beige paint (see arrow) observed to be in good condition on the door frame of Chapel Rm. 2007.</p>	<p>Photo 4: View of the apparent water staining on an acoustic ceiling tile (see arrow) observed in Science Classroom 2015.</p>

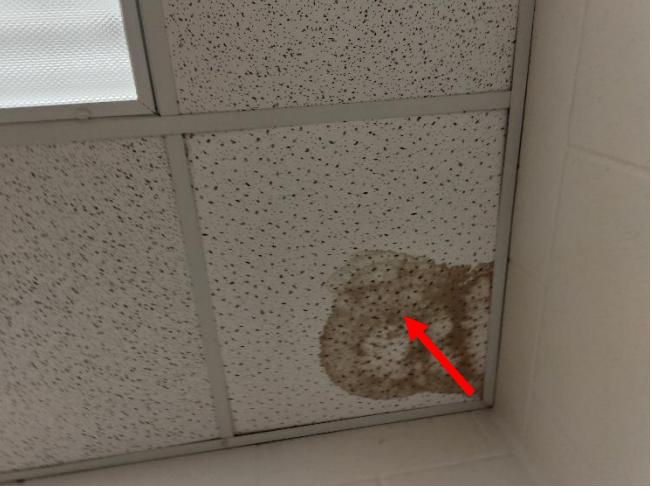
A photograph of an acoustic ceiling tile. A red arrow points to a dark, irregular stain on the tile, indicating apparent water staining.

- 7) No evidence of visual suspect mould growth was observed, however apparent water staining/damage was identified on lay-in acoustic ceiling tiles within the Subject Building and is detailed in Table 1. S2S recommends that apparent water-stained acoustic ceiling tiles be removed by trained maintenance staff and that the sources of all apparent water staining be investigated and repaired prior to the development of mould growth.
