February 20, 2025

Re: Hazardous Building Materials Assessment (Pre-construction)

Lydia Trull Public School, 80 Avondale Drive, Courtice, Ontario
Pinchin File: 349417.021

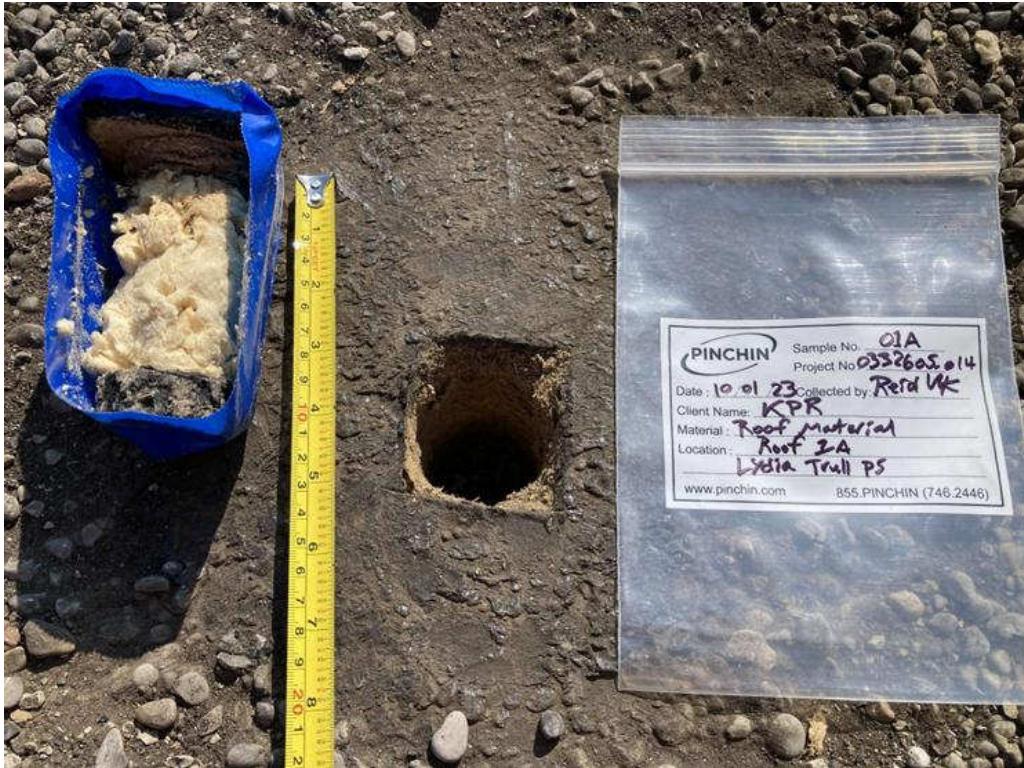
S0001A (None), Roofing material, Roof Sections 1A and 1B (Location #: 1) Roof 1a

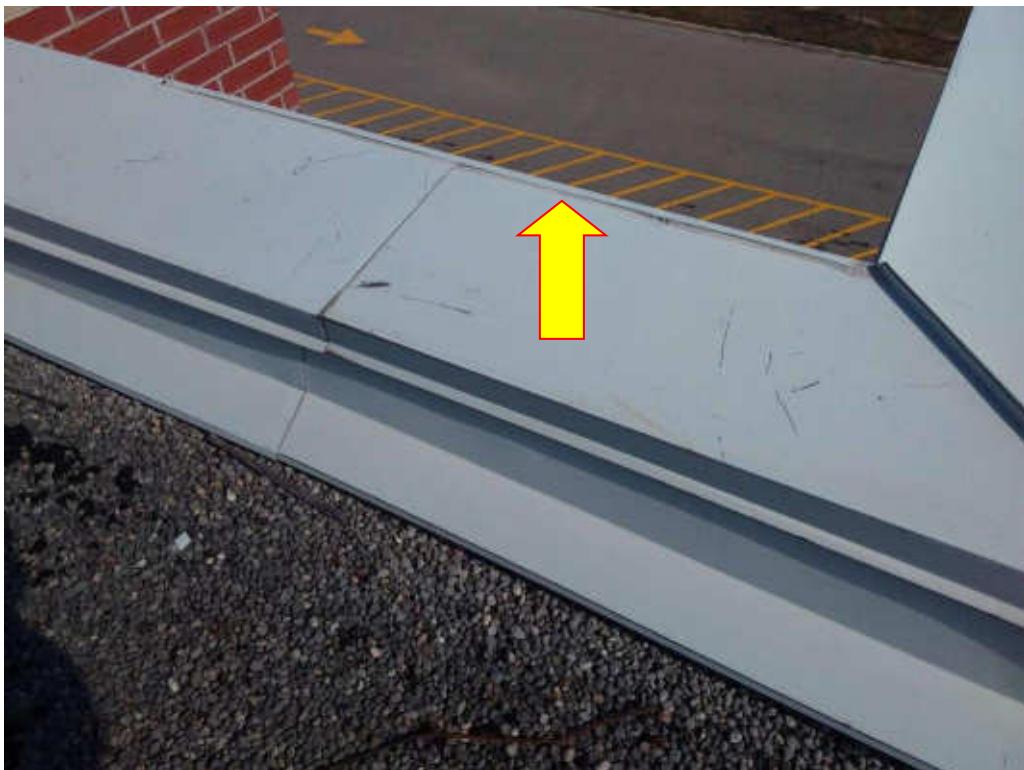
S0002A (None), Flashing caulking Roof 1A, Caulking, Roof Sections 1A and 1B (Location #: 1)

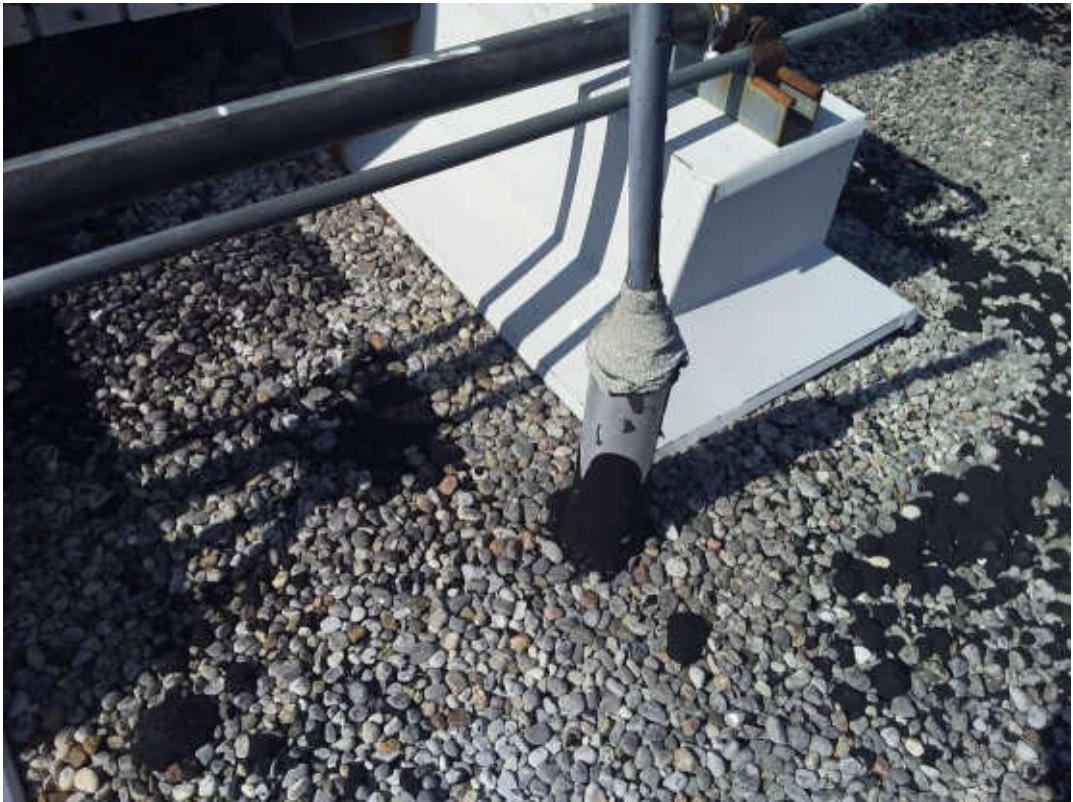
S0003C (None), Grey caulking over black Air Handling Unit conduit isolation, Roof Sections 1A and 1B (Location #: 1)

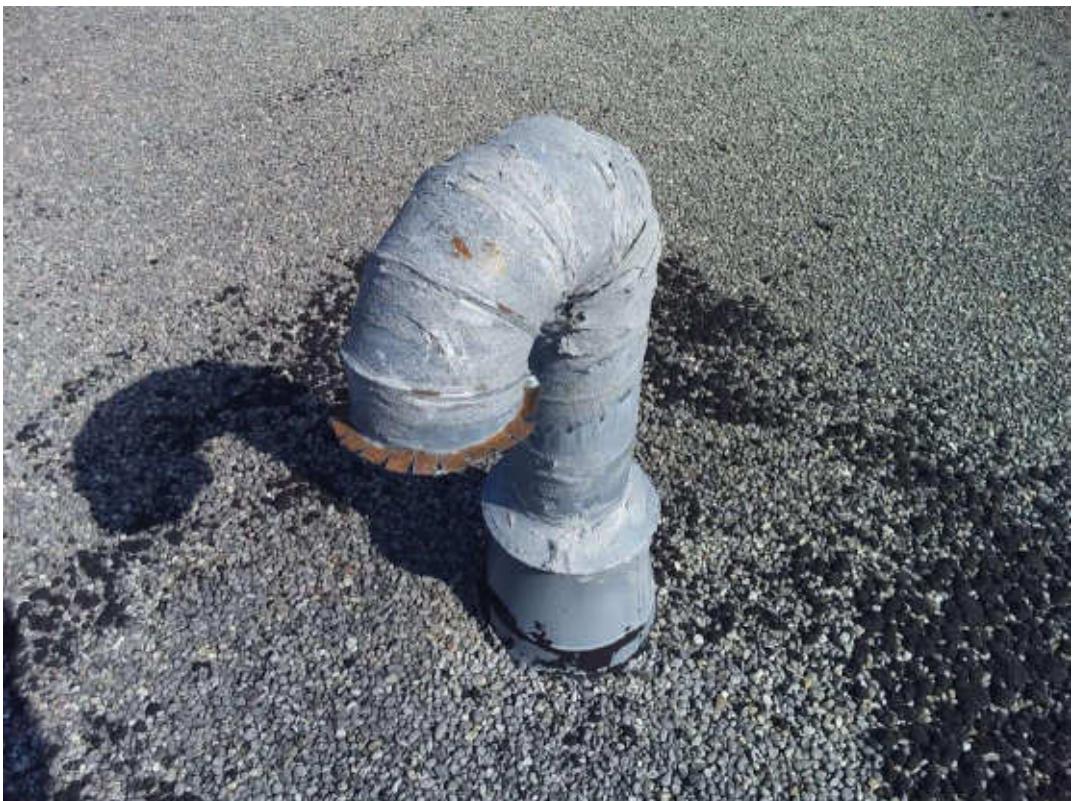
S0004A (None), Grey mastic with gold flake exhaust, Duct, Mastic, Grey, Roof Sections 1A and 1B (Location #: 1)

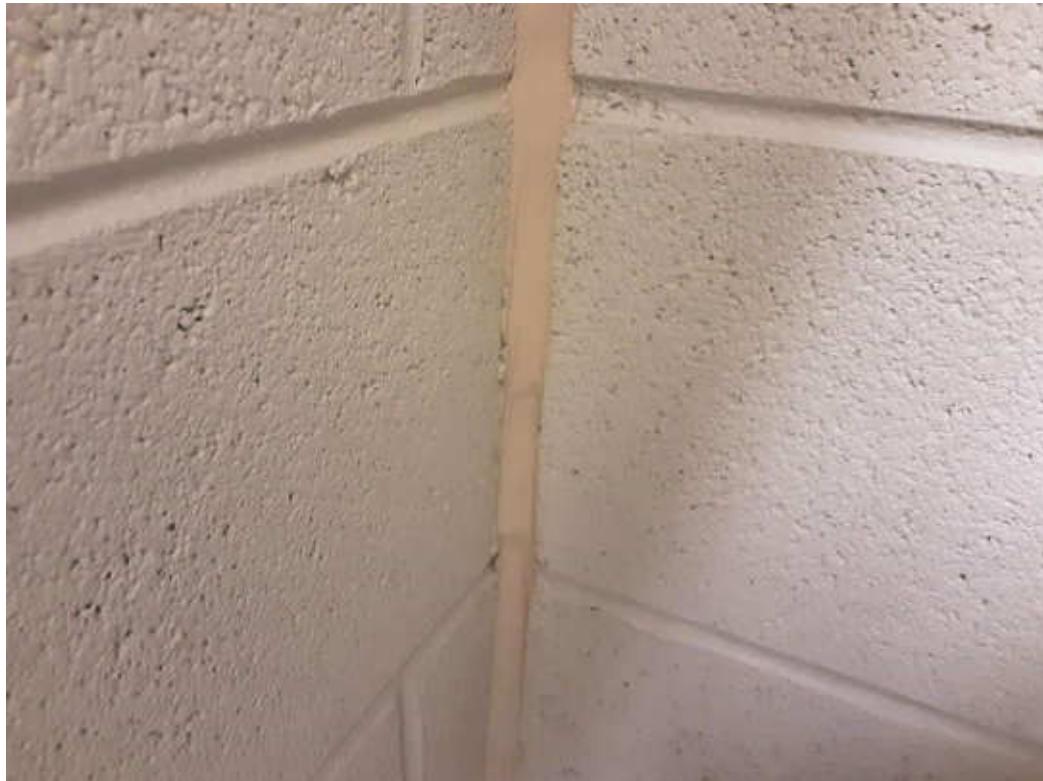
S0005C (None), White/beige caulking, Other, Caulking, Mechanical Room (Location #: 2)

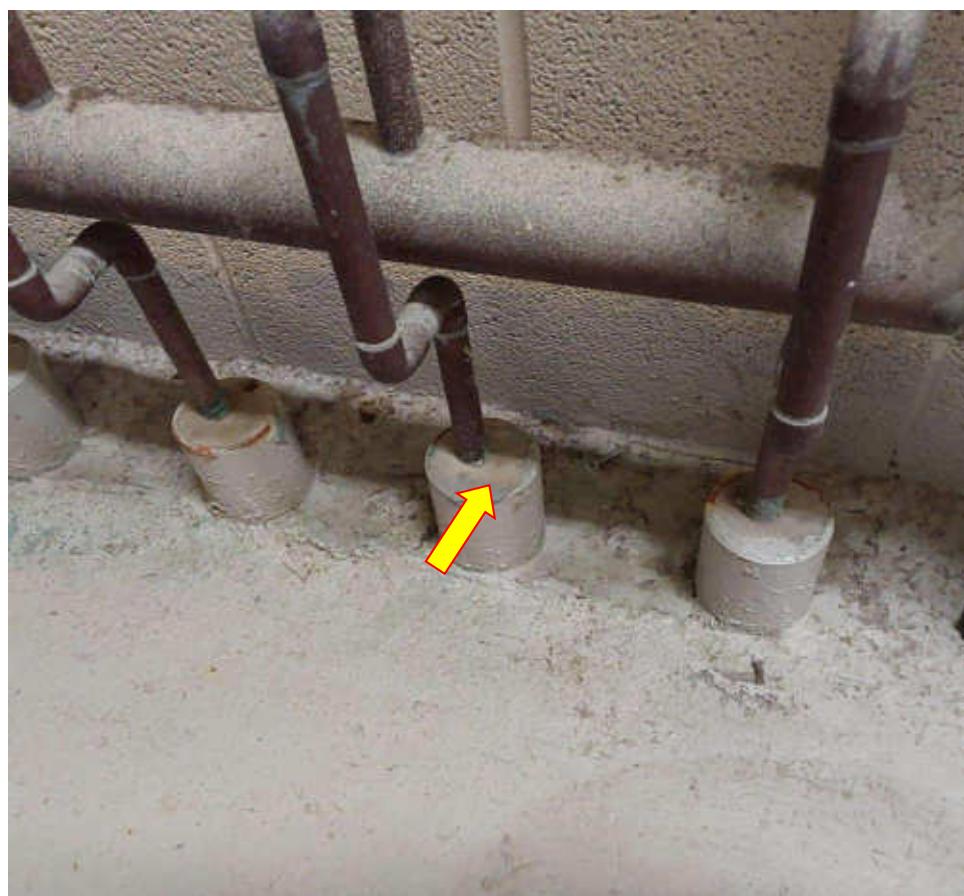
S0006C (None), Grey firestopping, Other, Firestopping (mastic), Mechanical Room (Location #: 2)

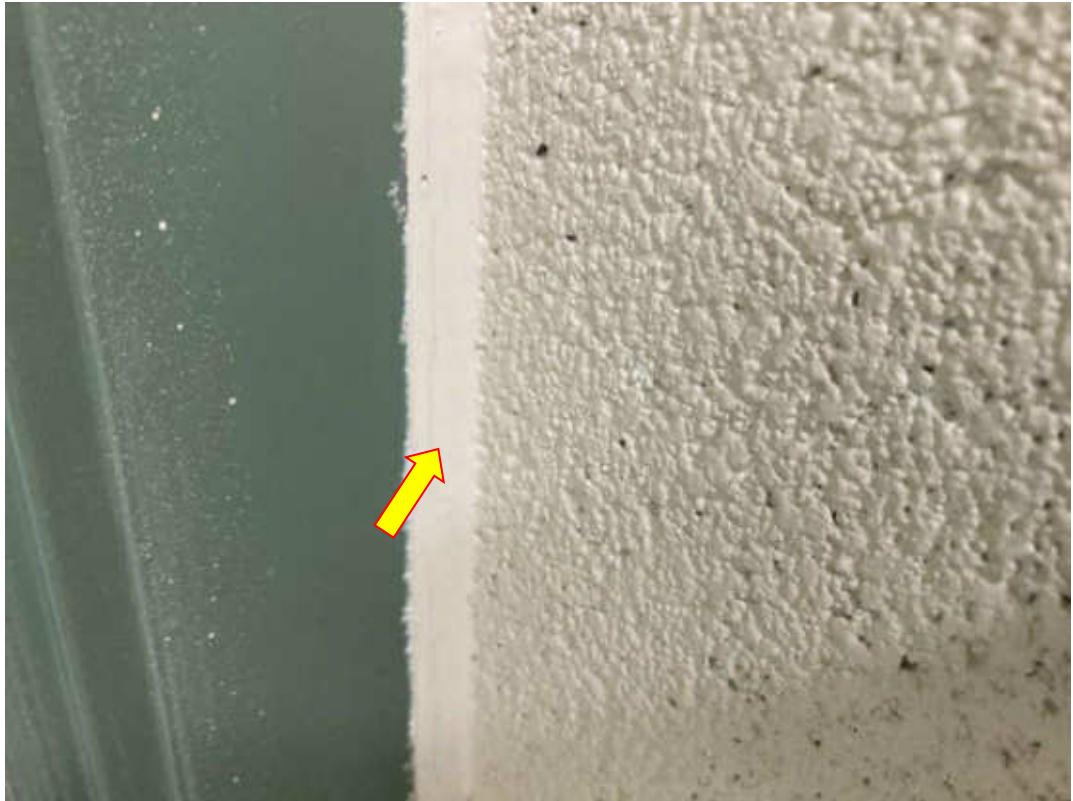
S0007C (None), Grey caulking on door frames, Other, Caulking, Mechanical Room (Location #: 2)

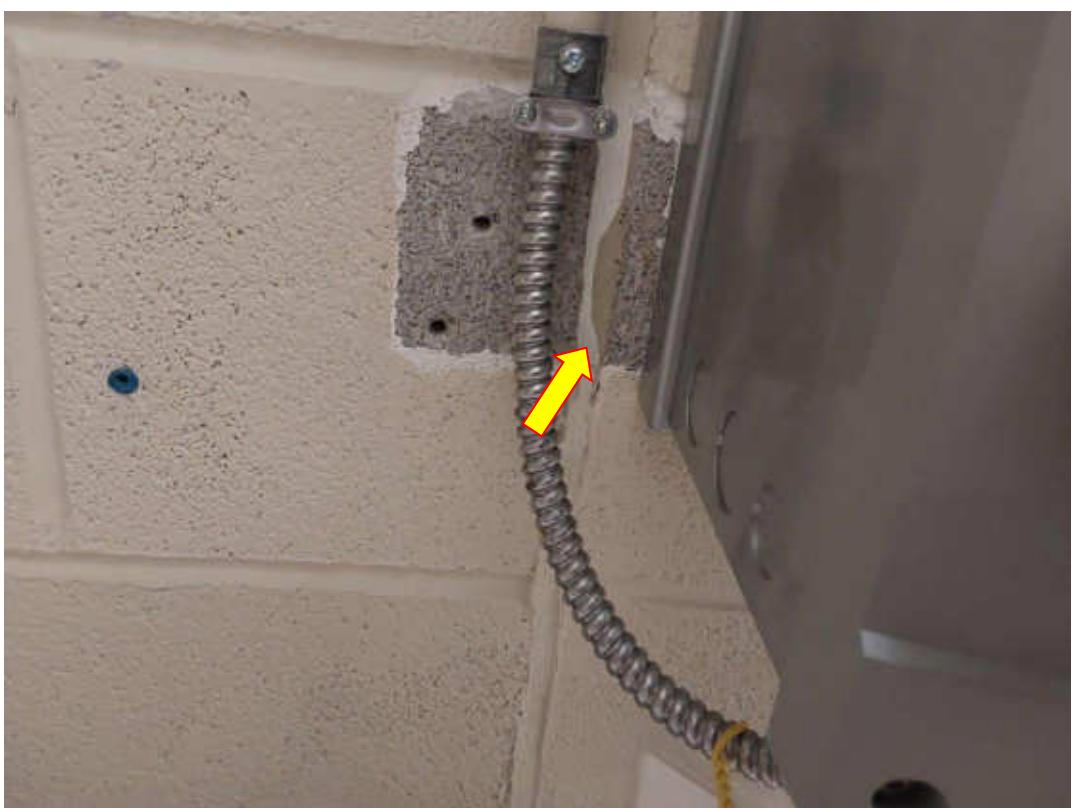
S0010C (None), Grey caulking in expansion joints, Other, Caulking, Mechanical Room (Location #: 2)

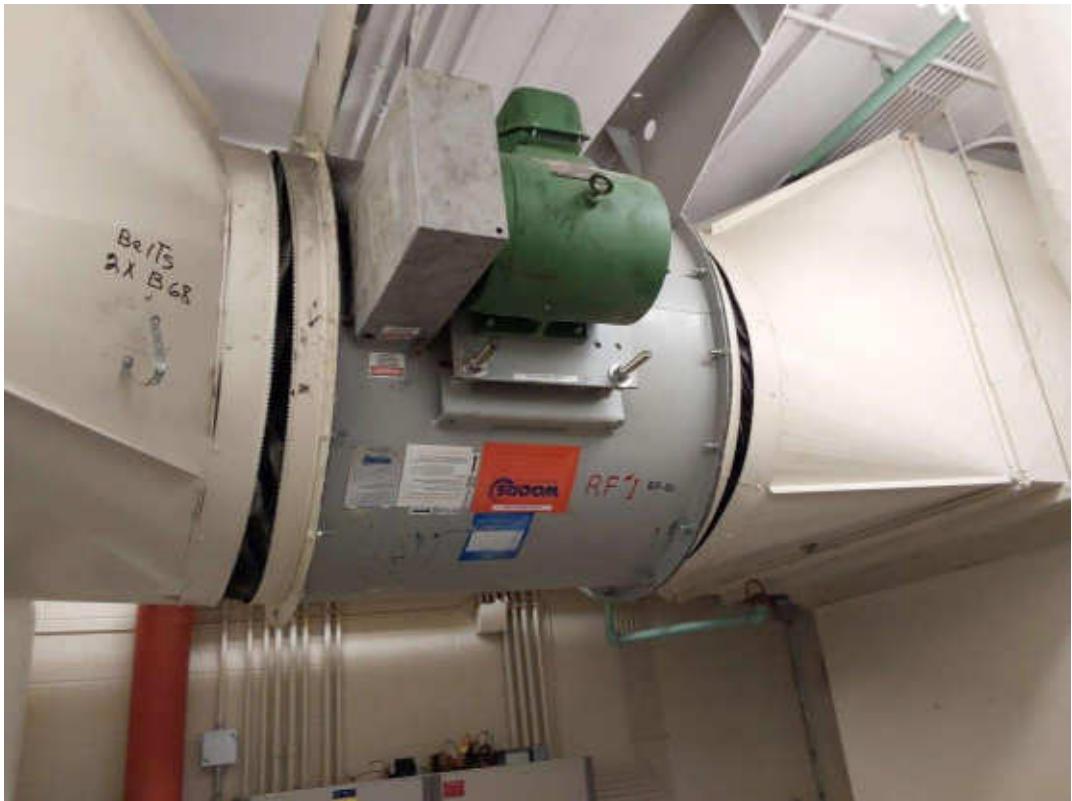
V0000 (None), Black rubber vibration damper, Duct, Duct Connector, Rubber, Mechanical Room (Location #: 2)

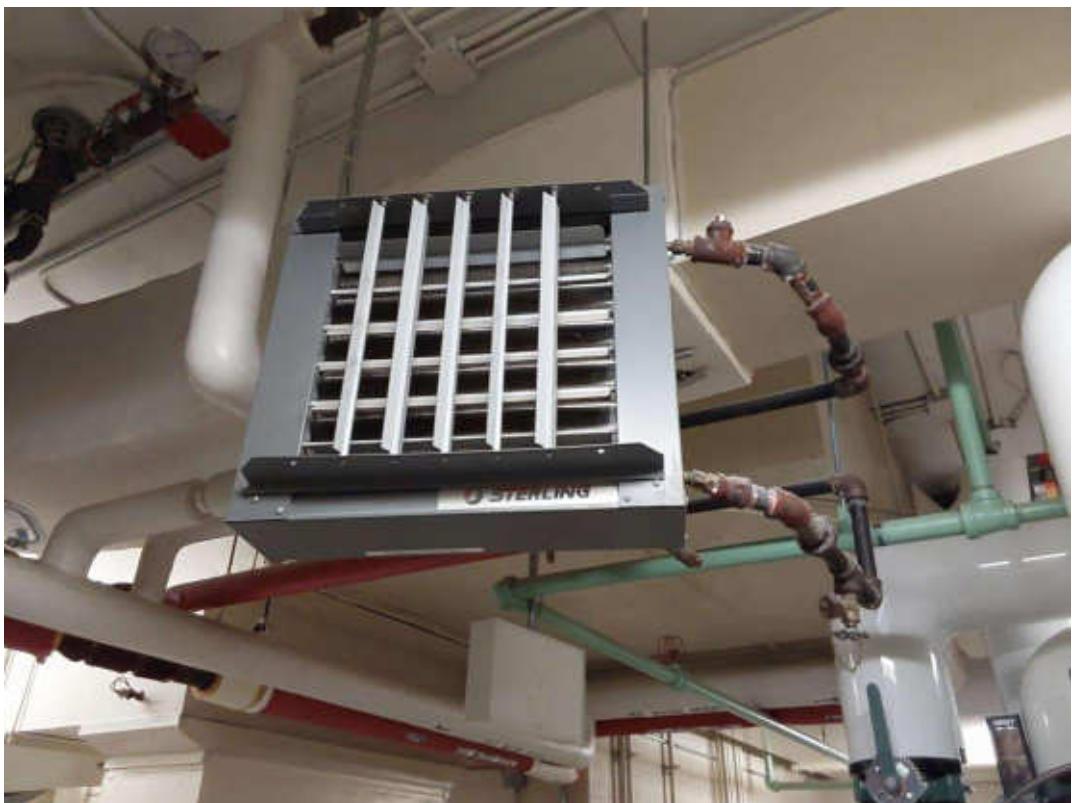
V0000 (None), Mechanical Equipment, Unit Heater, Not Insulated, Mechanical Room (Location #: 2)

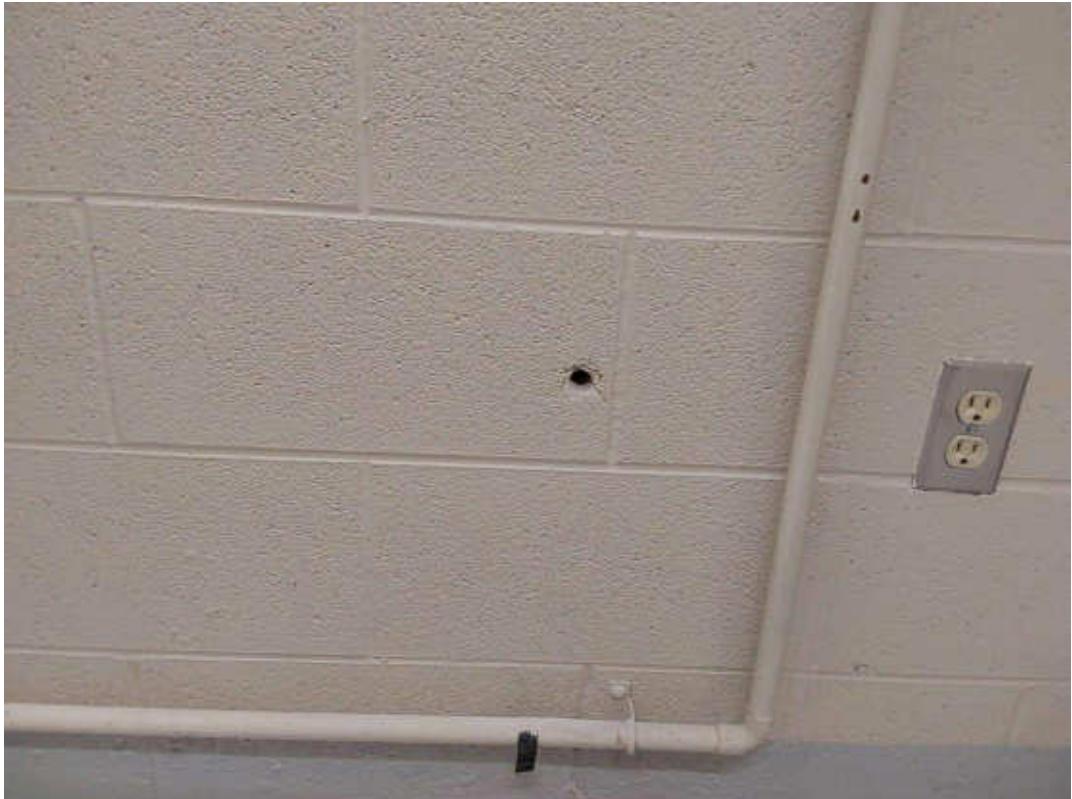
V0000 (None), Wall, Vermiculite Investigation, Mechanical Room (Location #: 2)

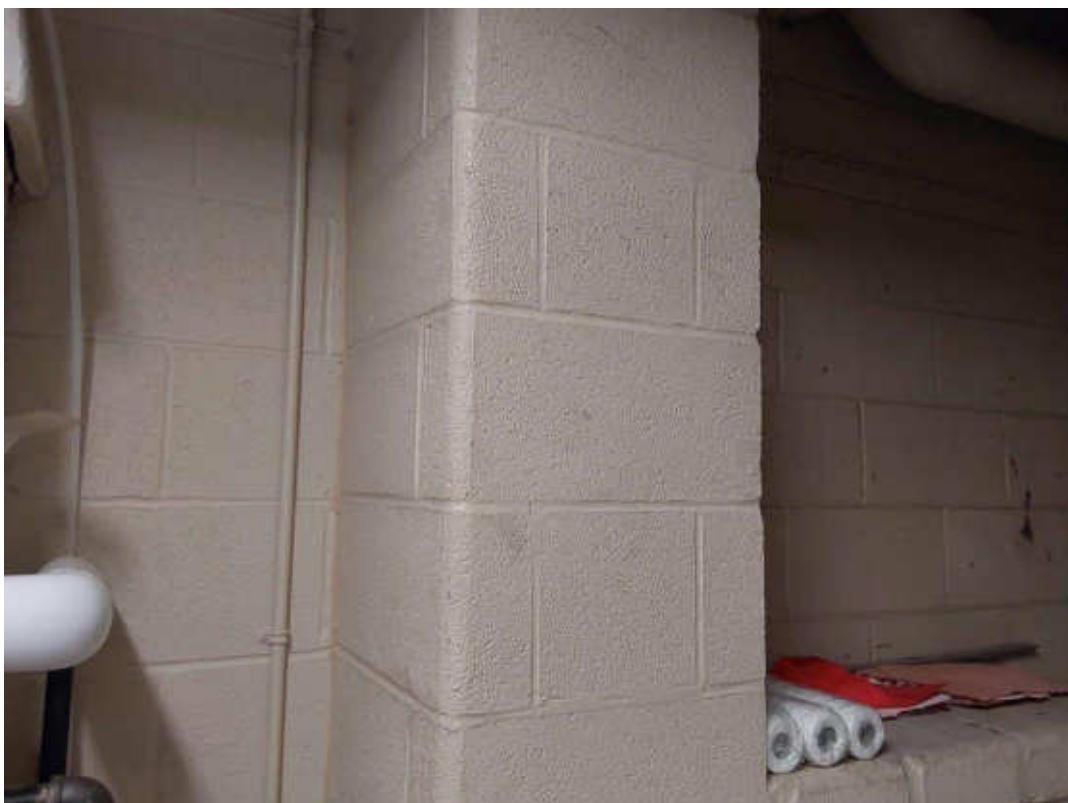
L0001(Lead, None), Beige paint on masonry, Wall, Mechanical Room (Location #: 2)

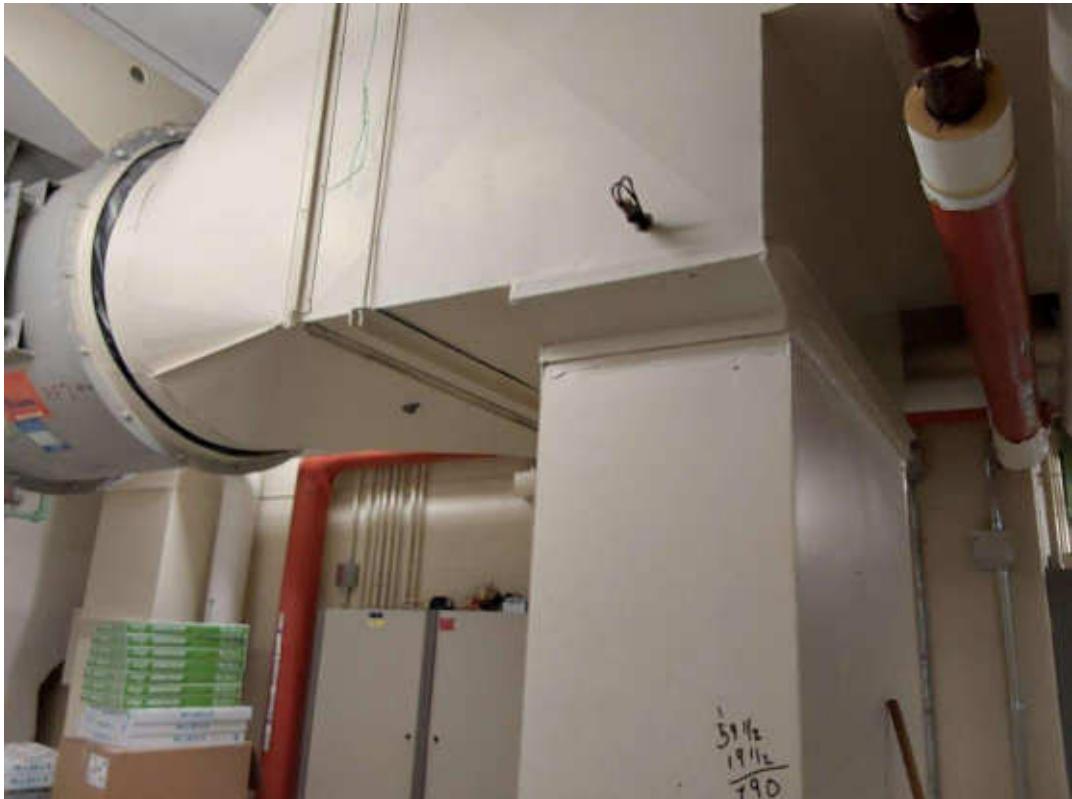
L0002(Lead, High), Beige paint on metal ducts, Duct, Mechanical Room (Location #: 2)

For lead-containing or lead-based paints (i.e., greater than the EACC guideline of 0.1% (1,000 mg/kg) for lead-containing paints, and 0.5% (5,000 mg/kg) for lead-based), construction disturbance may result in over-exposure to lead dust or fumes.

The need for work procedures, engineering controls and personal protective equipment should be assessed on a site-specific basis to comply with applicable regulations, and/or guidelines.

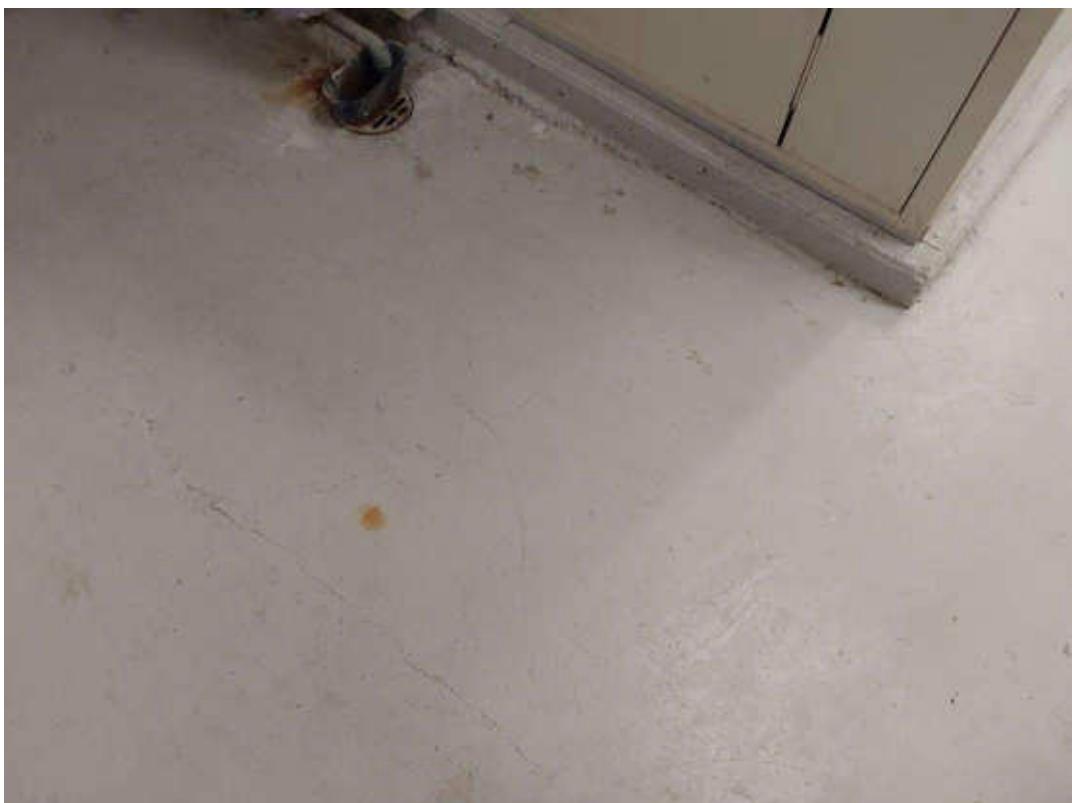
L0003(Lead, Low), Grey paint on concrete floor, Floor, Mechanical Room (Location #: 2)

For paints identified as having low levels of lead (i.e., equal to or above 0.009% (90 mg/kg) but less than or equal to the EACC guideline of 0.1% (1,000 mg/kg) for lead-containing paints) special precautions are not recommended unless aggressive disturbance (grinding, blasting, torching) is planned.

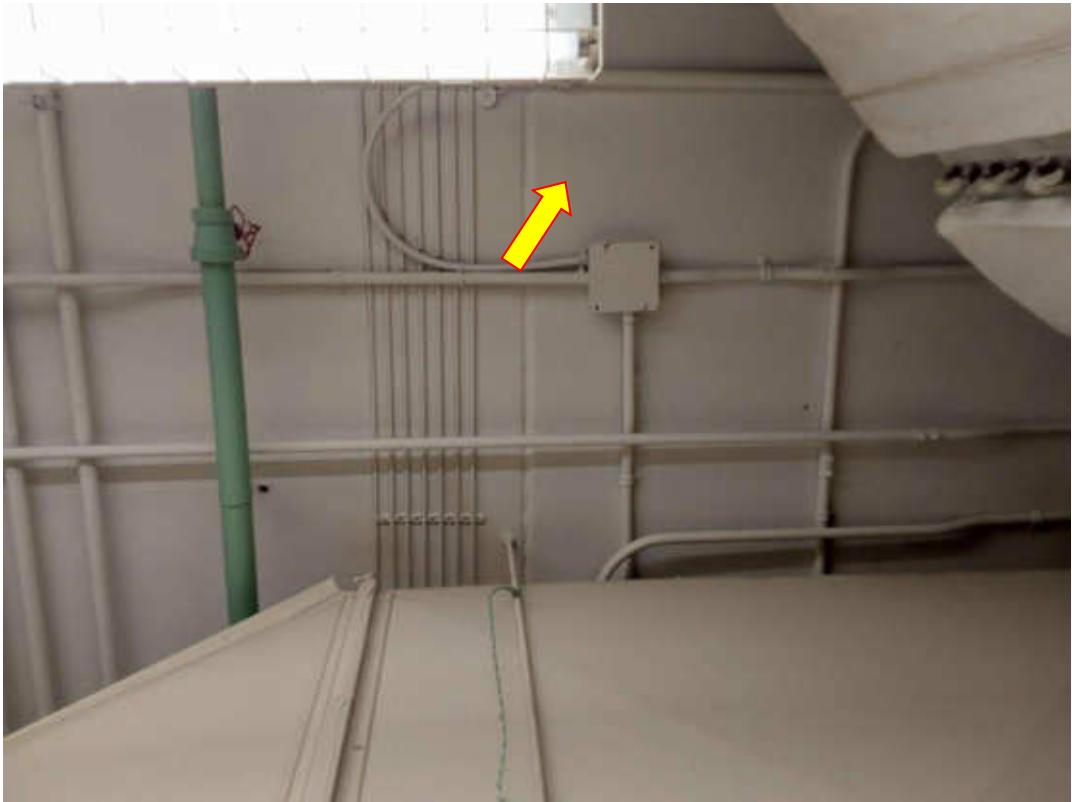
L0004(Lead, High), White paint on ceiling, Structure, Mechanical Room (Location #: 2)

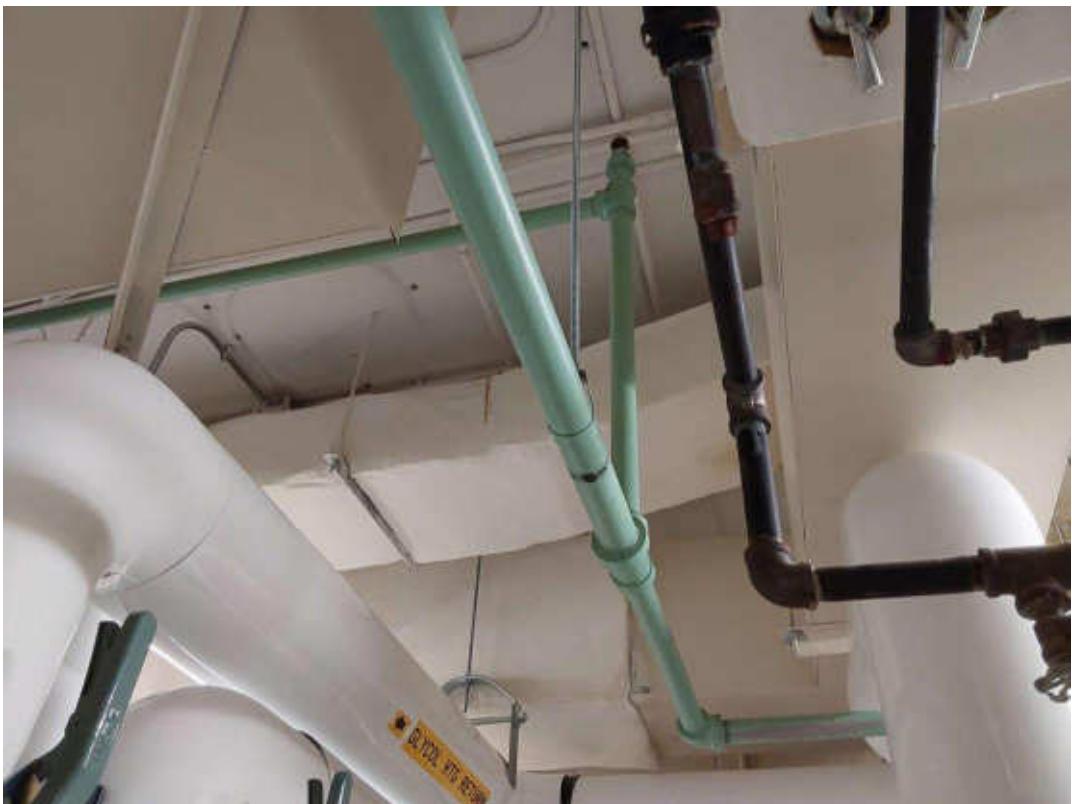
L0005(Lead, None), Light green paint on pipes, Piping, Mechanical Room (Location #: 2)

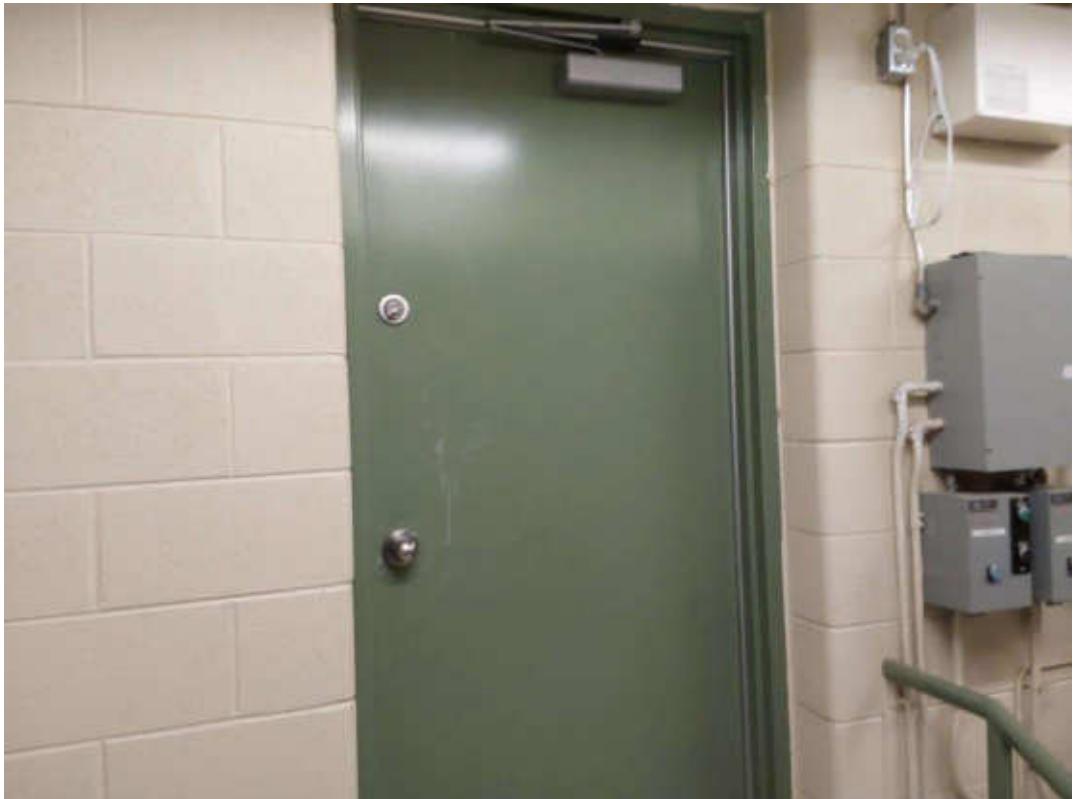
L0006(Lead, None), Green paint on doors, Other, Mechanical Room (Location #: 2)

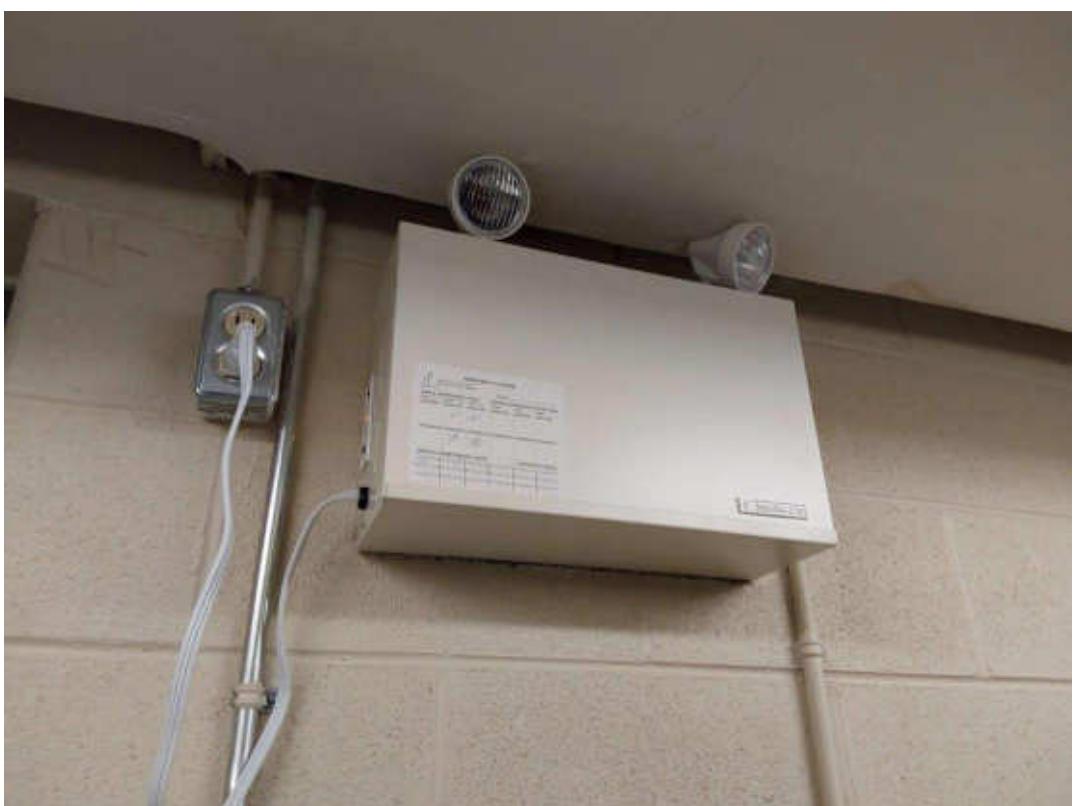
Pb Products, V9500(Presumed), BATTERIES IN EMER. LIGHTS, Mechanical Room (Location #: 2)

Lead-containing items should be recycled when taken out of service.

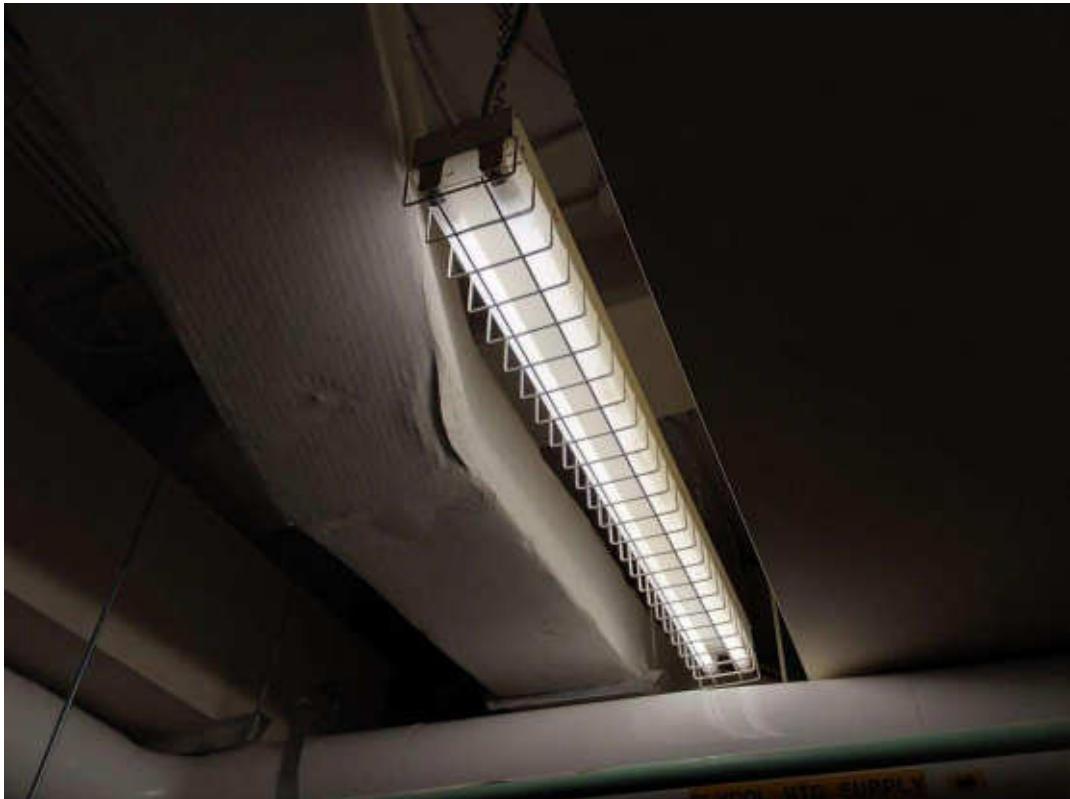
Mercury, V9000(Yes), LIGHT FIXTURE, T8, Mechanical Room (Location #: 2)

Do not break lamps. Recycle and reclaim mercury from fluorescent lamps when taken out of service. Mercury is classified as a hazardous waste and must be disposed of in accordance with applicable regulations.

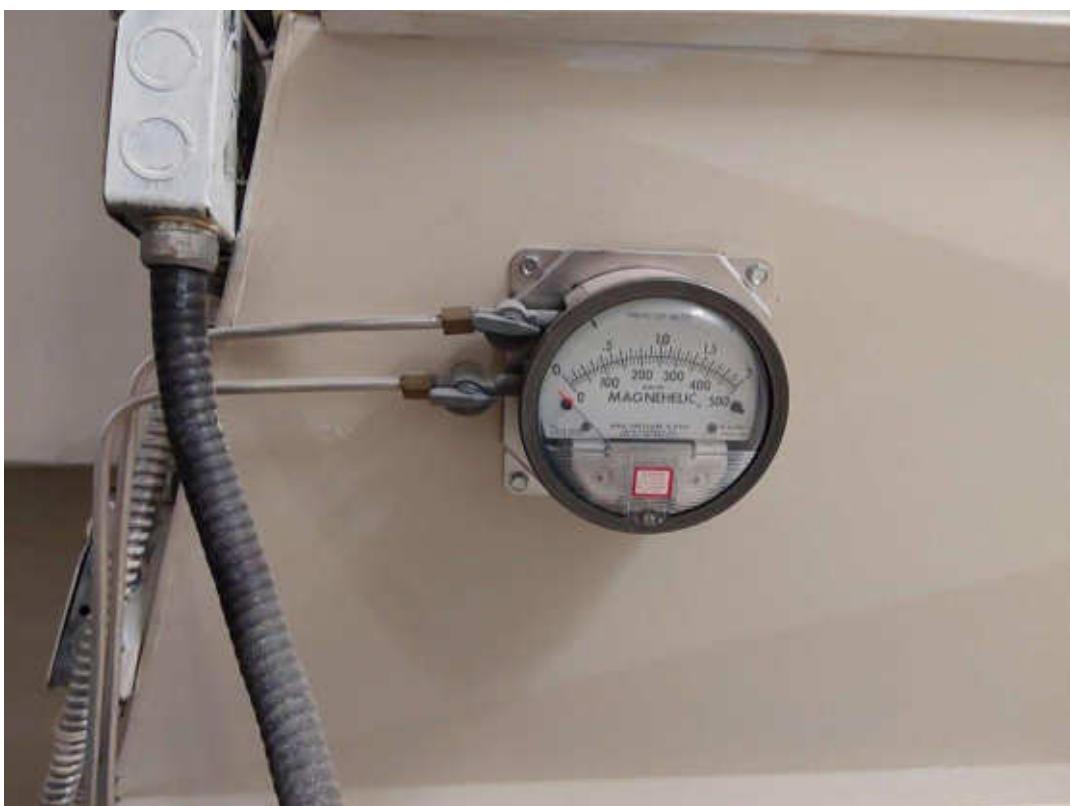
Mercury, V0000(No), MANOMETER, Non-mercury fluid, Mechanical Room (Location #: 2)
