REVISED Hazardous Building Materials Assessment (Pre-construction)

Eastside Secondary School
275 Farley Avenue, Belleville,
Ontario

July 12, 2023

Pinchin File: 200584.061

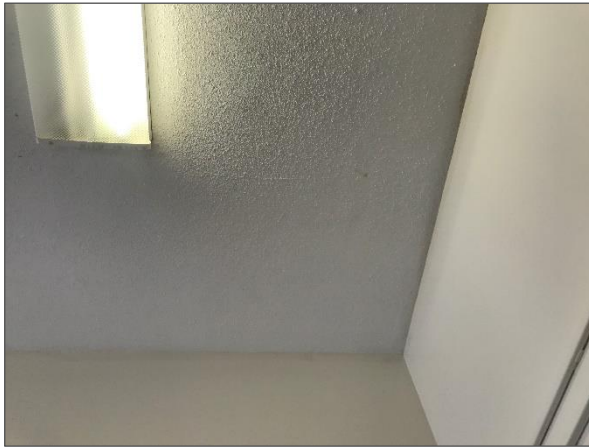
Asbestos-containing texture finish on plaster ceiling.

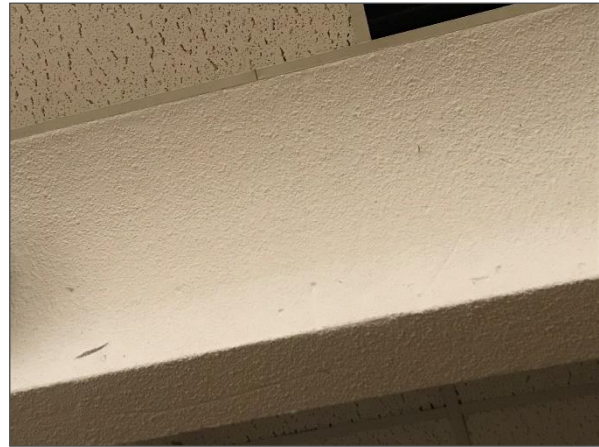
Texture finish, containing chrysotile asbestos, is present on the bulkhead in Theatre 214 (previous samples 0030A-C).

Asbestos-containing texture finish on bulkhead.

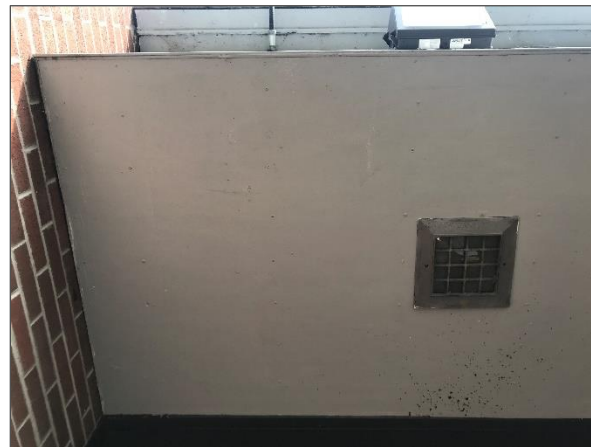
Texture finish present on the southwest exterior canopy does not contain asbestos (previous samples 0034A-C).

Non-asbestos texture finish on underside of exterior canopy.

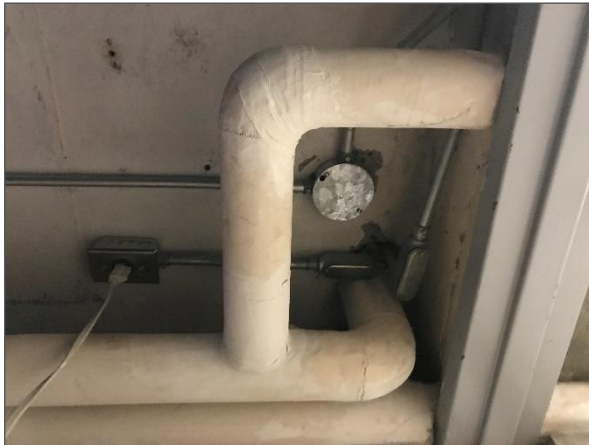
Asbestos-containing paring cement insulation on pipe elbows.

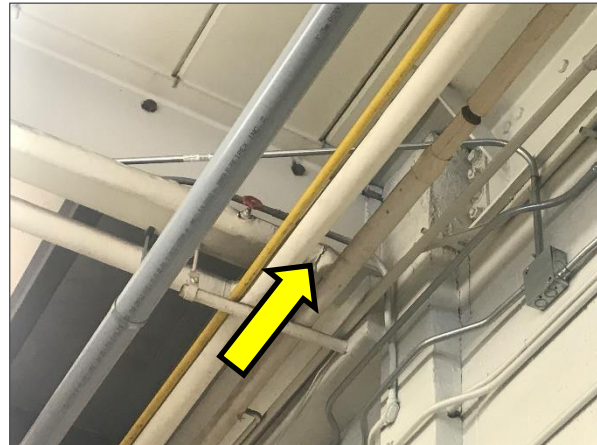
Damaged asbestos-containing paring cement insulation present on pipe elbow in Automotive Shop 153.

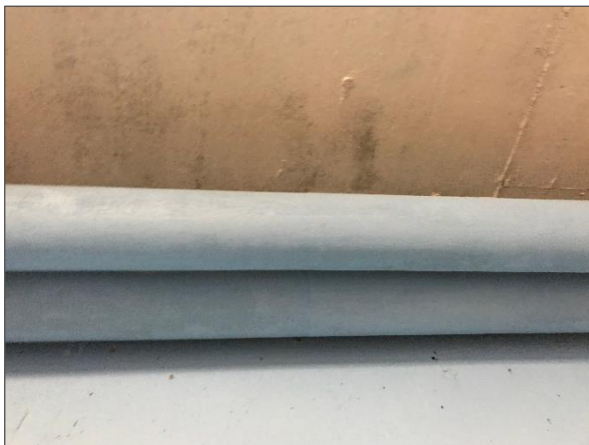
Asbestos-containing Aircell insulation on straight sections of pipes.

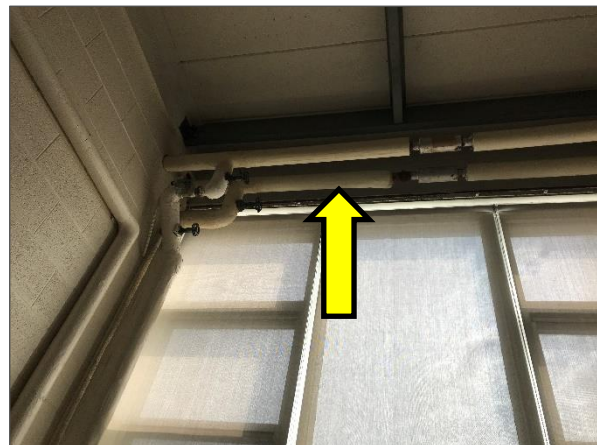
Asbestos-containing sweat wrap insulation on straight sections of pipes.

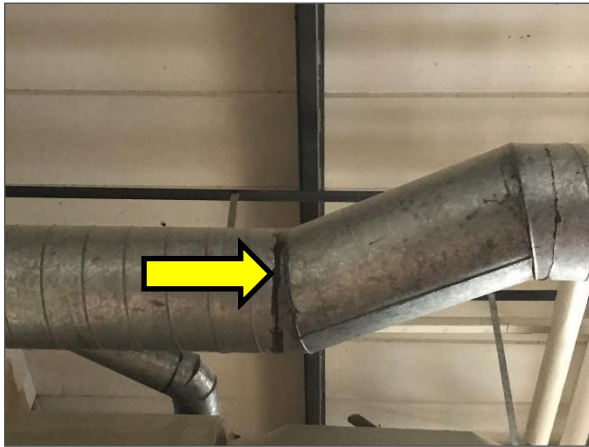
Brown mastic, present on seams of the sawdust collection system ducts within the Wood Shop 152 does not contain asbestos (previous samples 0007A-C).

Non-asbestos brown duct mastic.

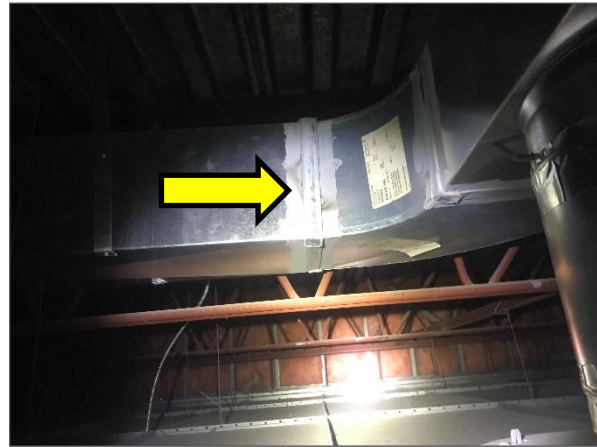
Light grey mastic present on seams/joints of ducts throughout the assessed area does not contain asbestos (samples S0046A-C).

Non-asbestos light grey duct mastic.

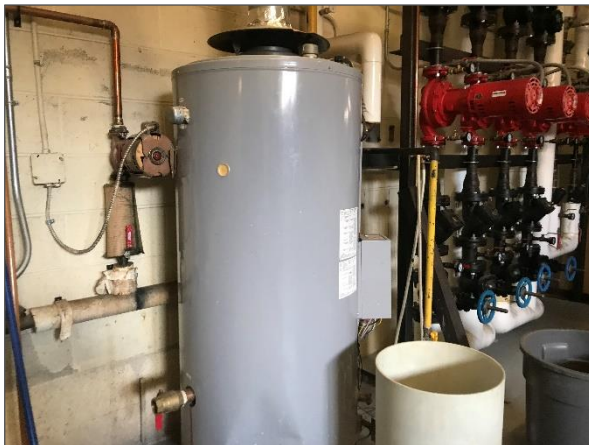
Non-asbestos fibreglass insulated hot water tank with metal jacketing.

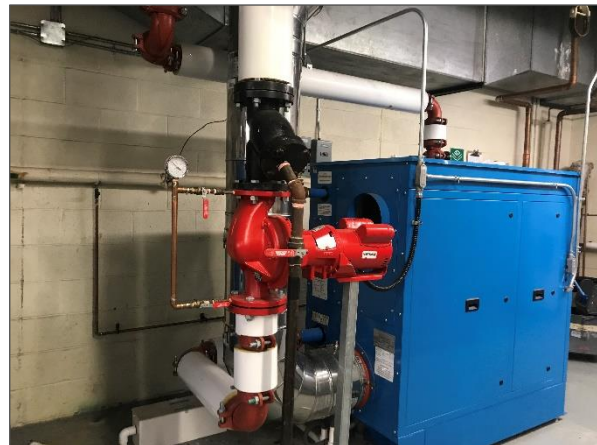
Non-asbestos fibreglass insulated boiler with metal jacketing.

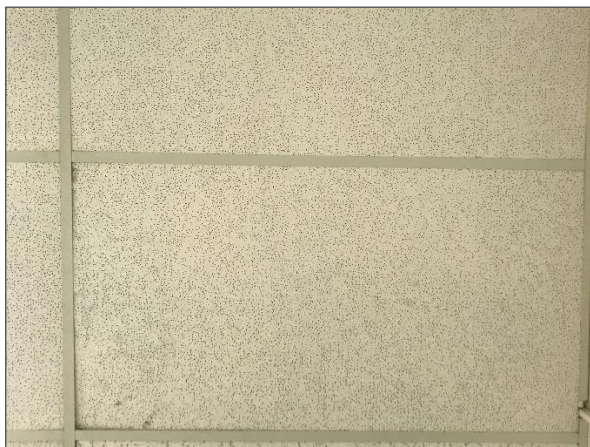
Non-asbestos 2'x4' acoustic ceiling tiles with dense small and medium pinholes.

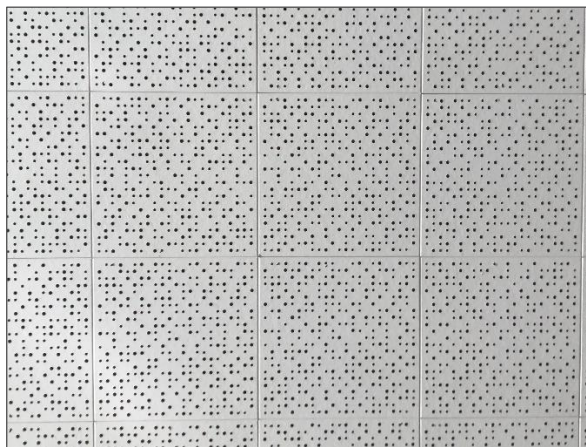
Non-asbestos 1'x1' acoustic ceiling tiles with medium and large uniform pinholes.

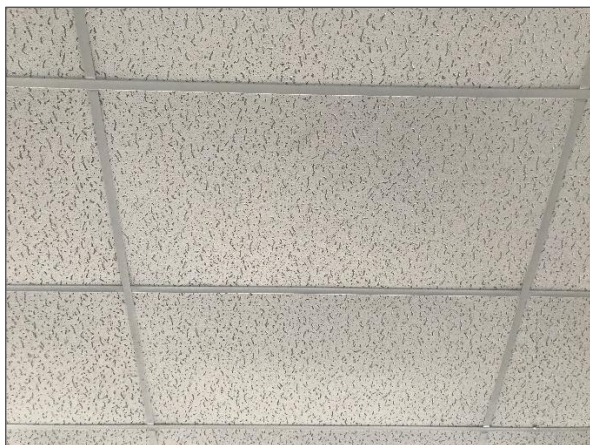
Non-asbestos 2'x4' acoustic ceiling tiles with thick widthwise fissures and pinholes.

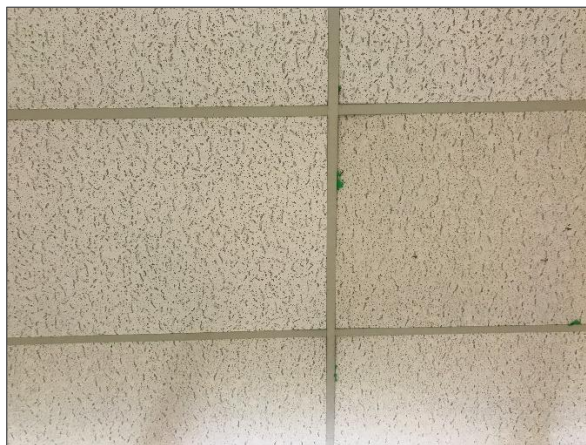
Non-asbestos 2'x4' acoustic ceiling tiles with dense short widthwise fissures.

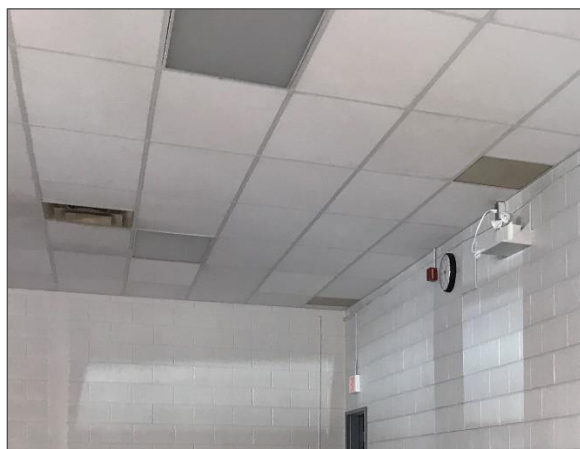
Non-asbestos 2'x4' textured acoustic ceiling tiles.

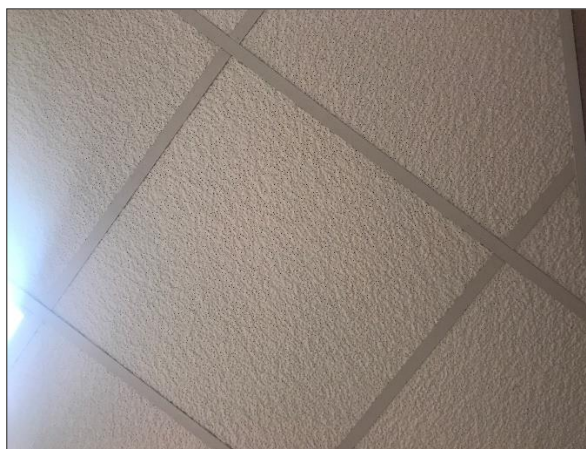
Non-asbestos 2'x2' textured acoustic ceiling tiles with pinholes.

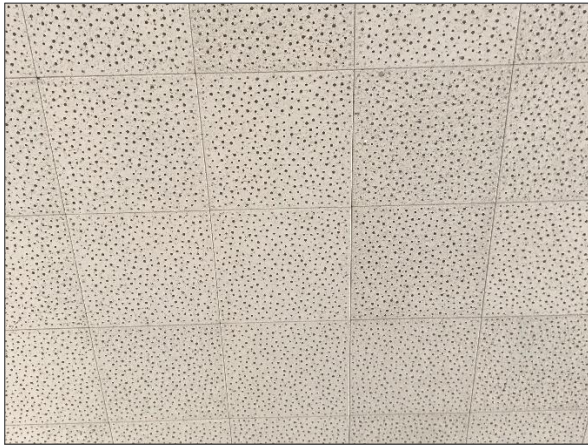
Non-asbestos 1'x1' acoustic ceiling tiles with small and large random pinholes.

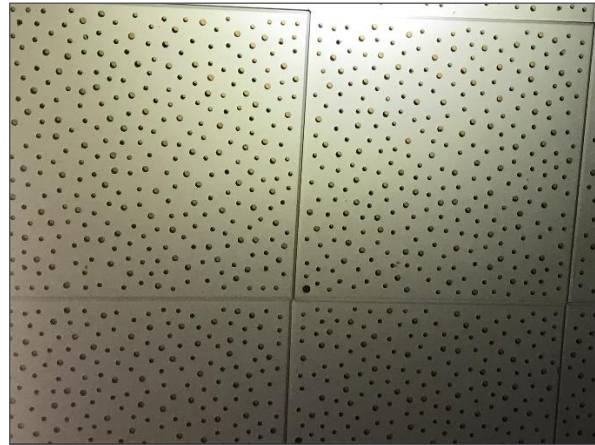
Non-asbestos 1'x1' acoustic ceiling tiles with random pinholes.

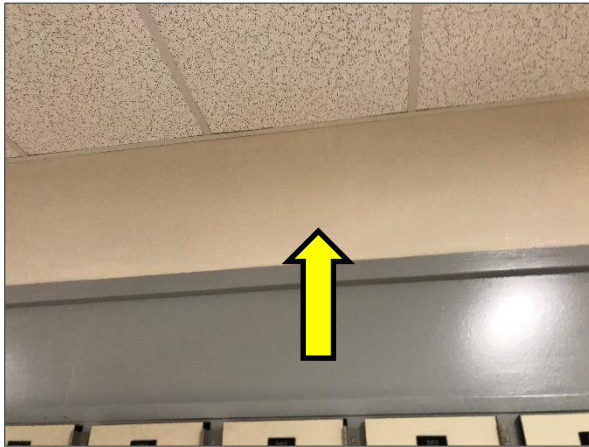
Non-asbestos smooth plaster on wall.

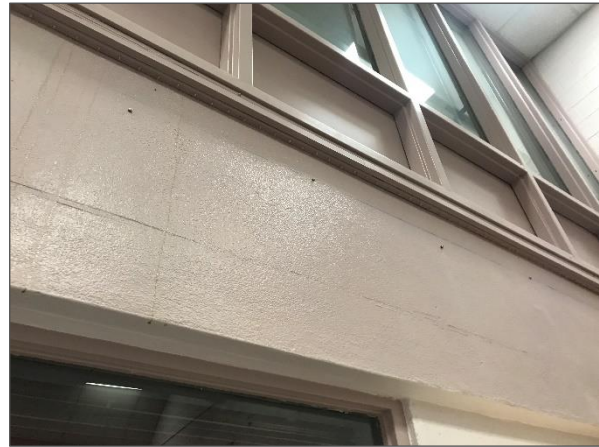
Non-asbestos textured plaster on wall.

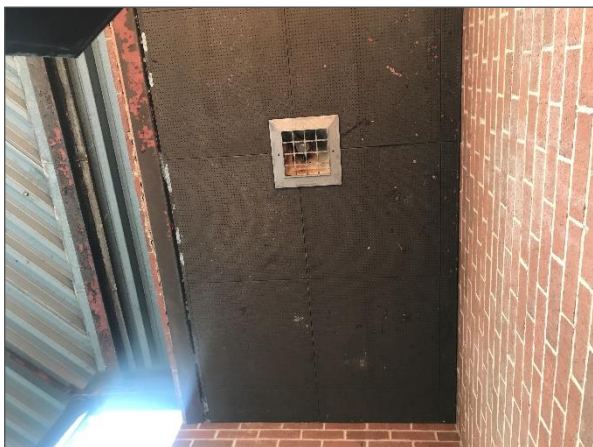
Presumed asbestos-containing Transite board present on underside of exterior canopy.

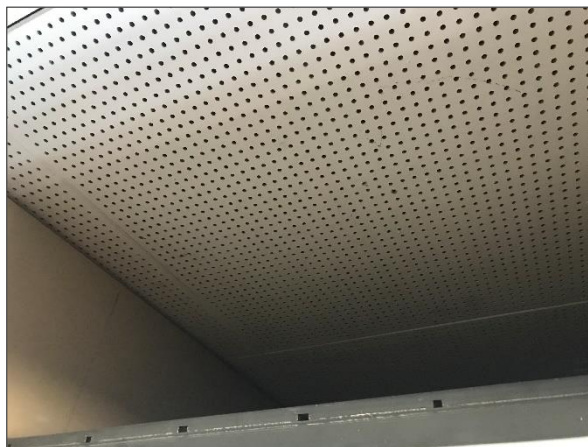
Presumed asbestos-containing Transite board present as ceiling panels.

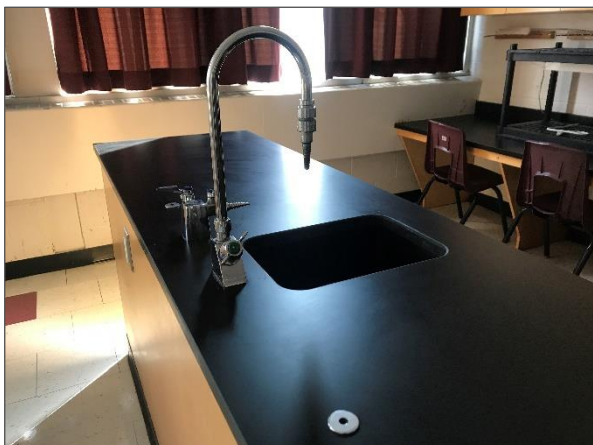
Presumed asbestos-containing Transite board present as countertops.

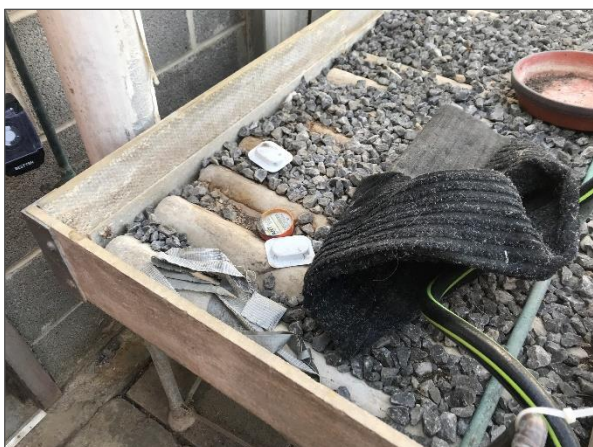
Presumed asbestos-containing Transite board present as gardening table.

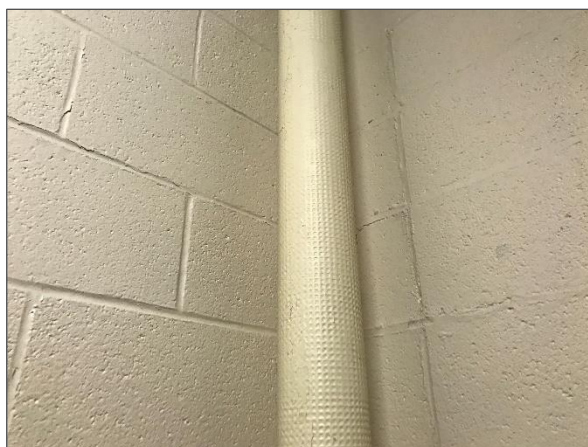
Transite pipe, presumed to contain asbestos based on visual observation, is present as rainwater leaders in the assessed area. Additional transite pipe is presumed to be concealed above solid ceilings and in vertical chases, walls and columns.

Presumed asbestos-containing Transite pipe.

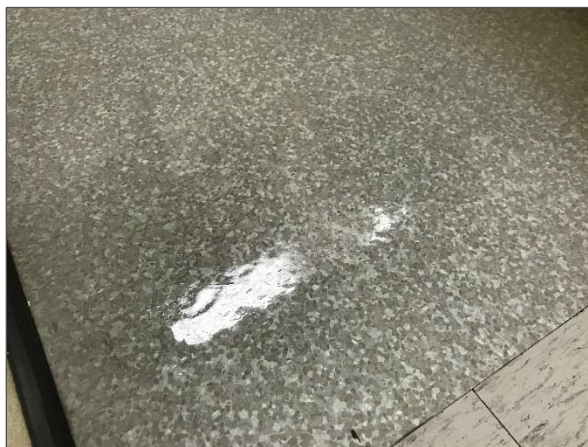
Beige/grey vinyl sheet flooring with a pebbled pattern present in Change Room 131 does not contain asbestos (previous samples 0028A-C).

Non-asbestos beige/grey vinyl sheet flooring with a pebbled pattern.

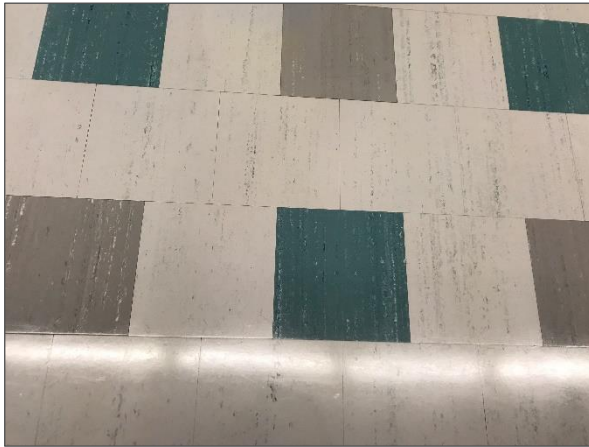
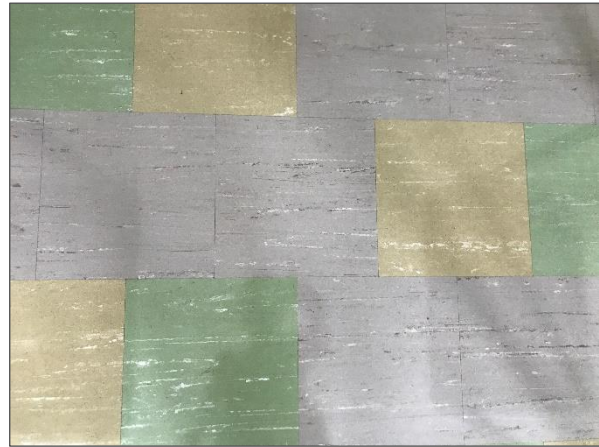
Asbestos-containing 9"x9" vinyl floor tiles of various colours.

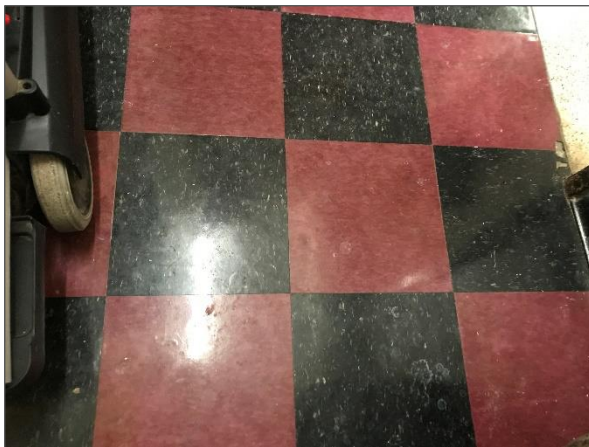
Non-asbestos 12"x12" red and black vinyl floor tiles in a checkered pattern.

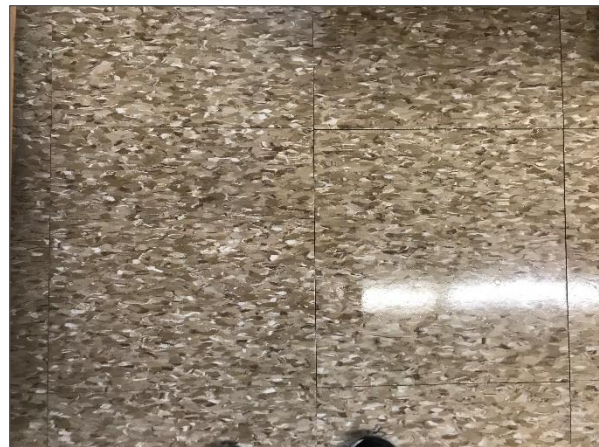
Non-asbestos 12"x12" beige vinyl floor tiles with white and beige blotches.

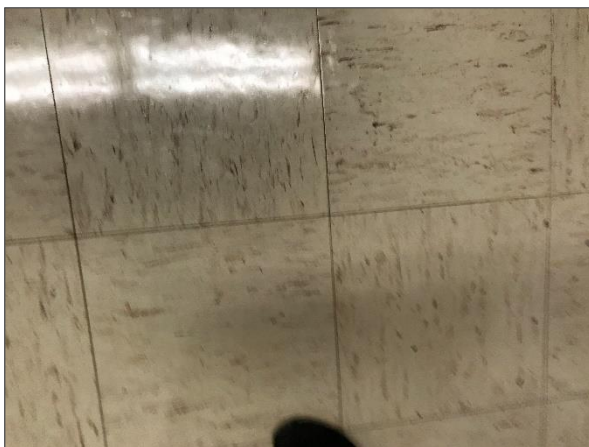
Asbestos-containing 12"x12" beige vinyl floor tiles with brown streaks.

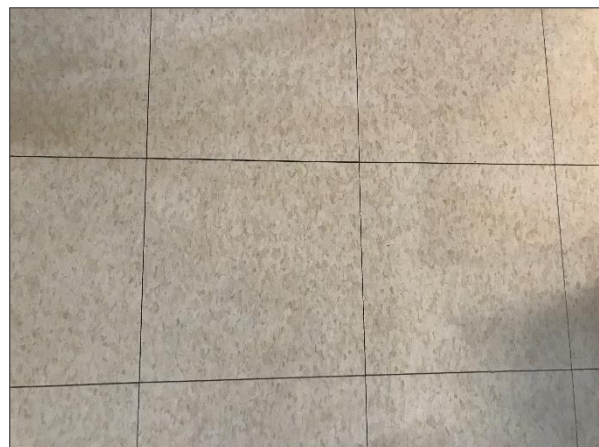
Non-asbestos 12"x12" off-white vinyl floor tiles with grey flecks.

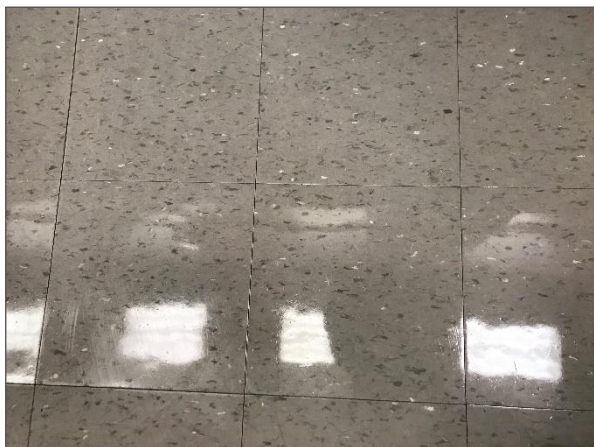
Non-asbestos 12"x12" grey vinyl floor tiles with white and grey flecks.

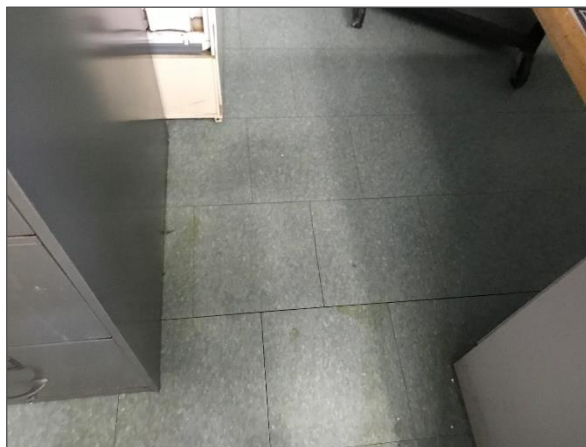
Non-asbestos 12"x12" turquoise vinyl floor tiles with white flecks.

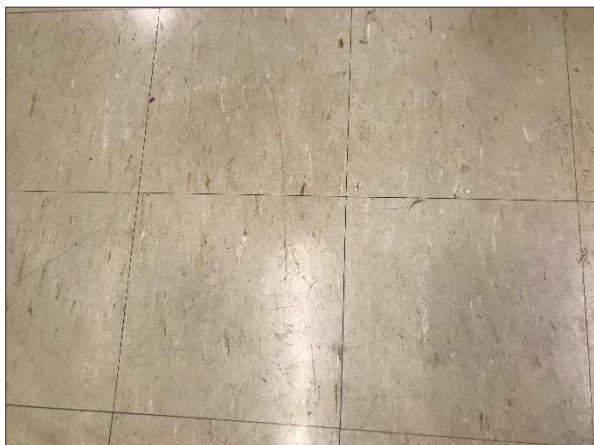
Non-asbestos 12"x12" beige vinyl floor tiles with sparse white and brown flecks.

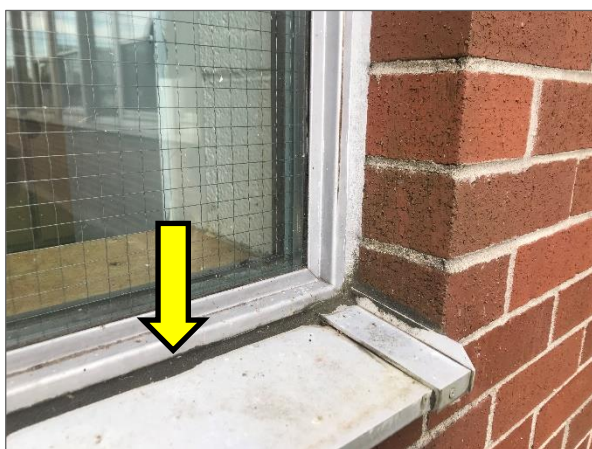
Asbestos-containing beige caulking on exterior window frame.

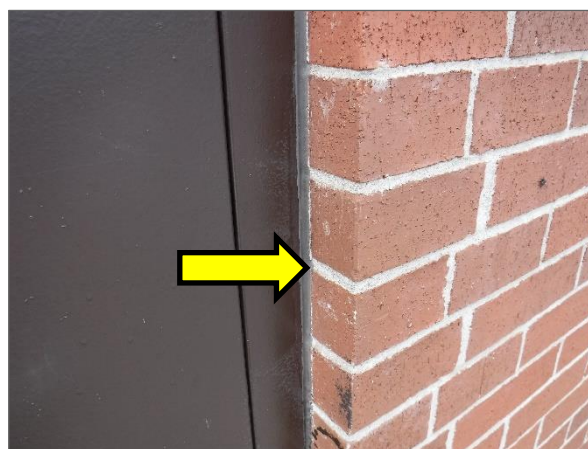
Asbestos-containing brown/grey caulking on exterior door frame.

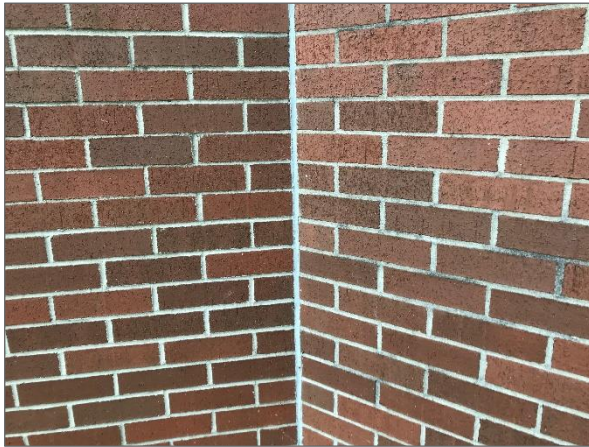
Non-asbestos grey caulking at exterior expansion joint.

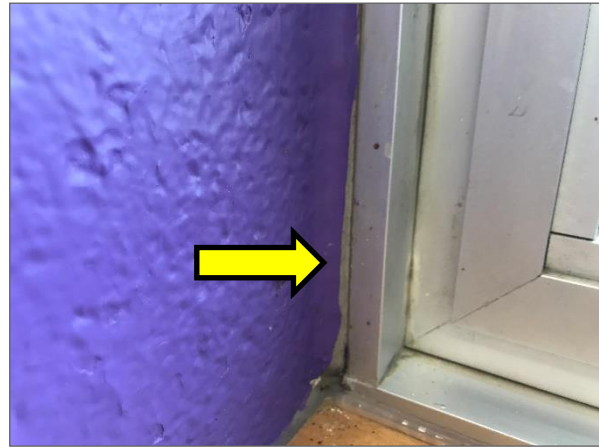
Non-asbestos firm grey caulking on interior window frame.

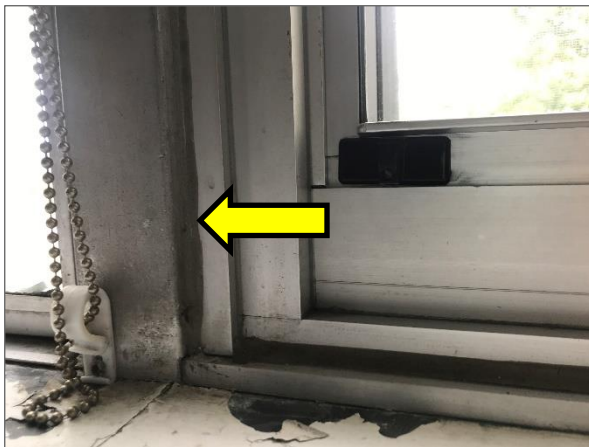
Asbestos-containing soft grey caulking on interior window frame.

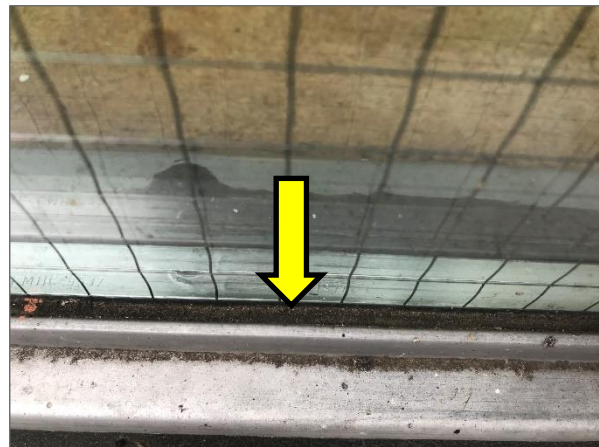
Asbestos-containing black butyl sealant on interior window.

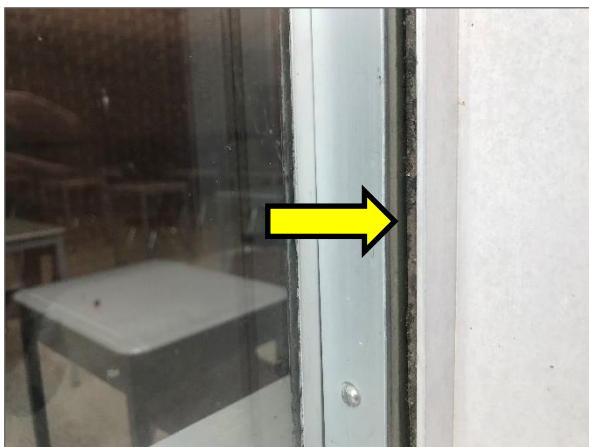
Asbestos-containing grey butyl sealant on exterior window.

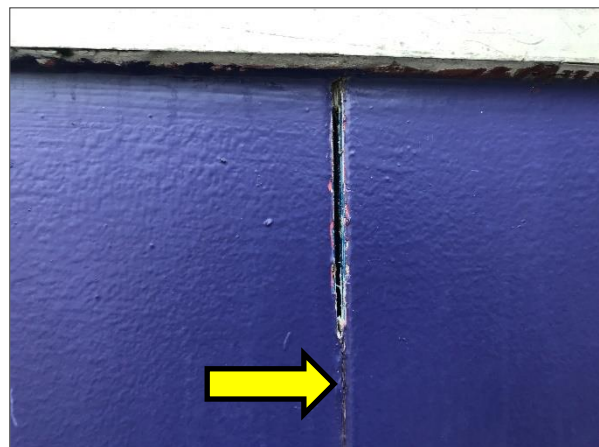
Non-asbestos grey caulking between metal panels.

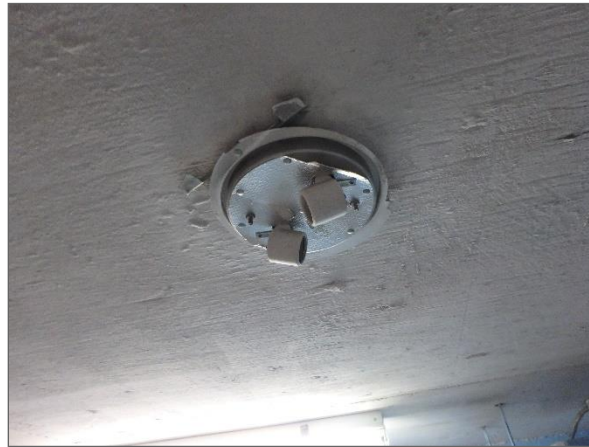
A paper heat shield, containing chrysotile asbestos, is present within an incandescent light fixture in Basement Room 002 (previous samples 0017A-C).

Asbestos-containing heat shield.

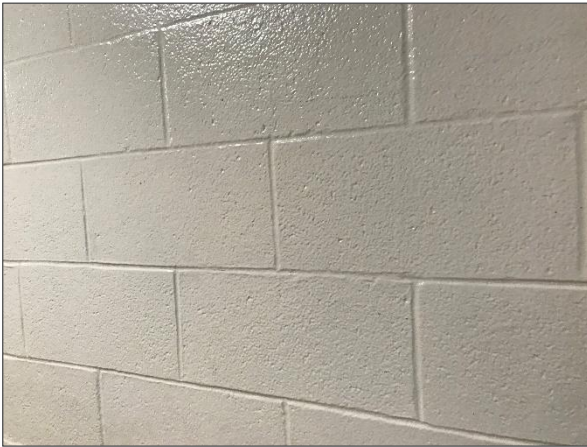
Asbestos-containing paint present on concrete block wall.

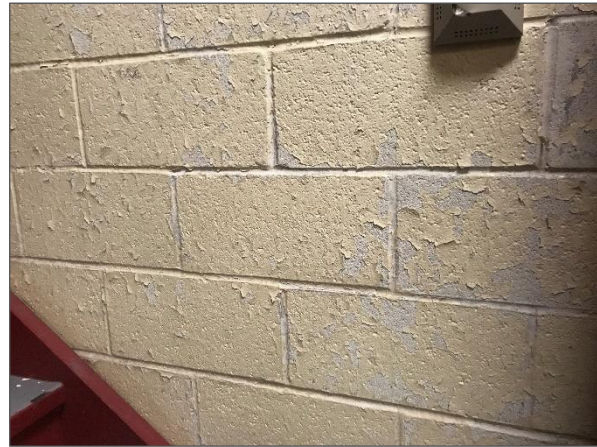
Damaged asbestos-containing paint on concrete block wall in Storage Room 139.

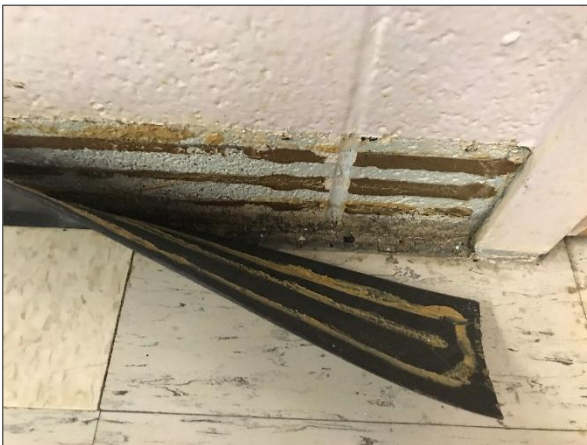
Non-asbestos adhesive present behind rubber baseboard.

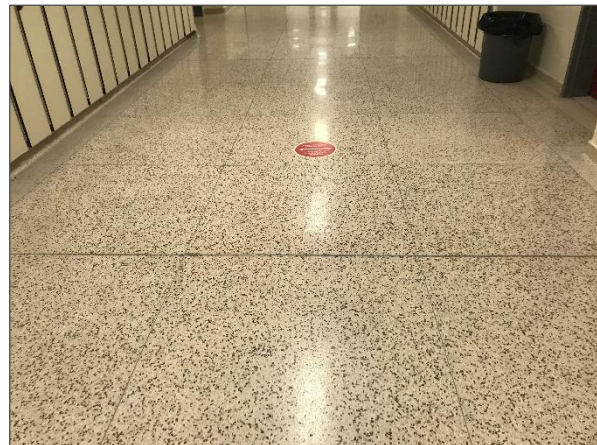
Non-asbestos terrazzo floor.

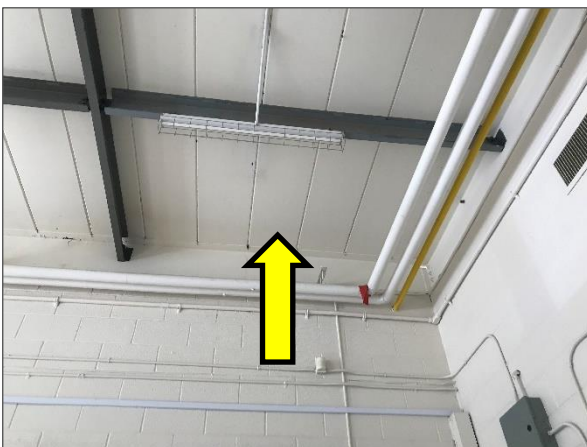
Non-asbestos off-white paint on concrete structure.

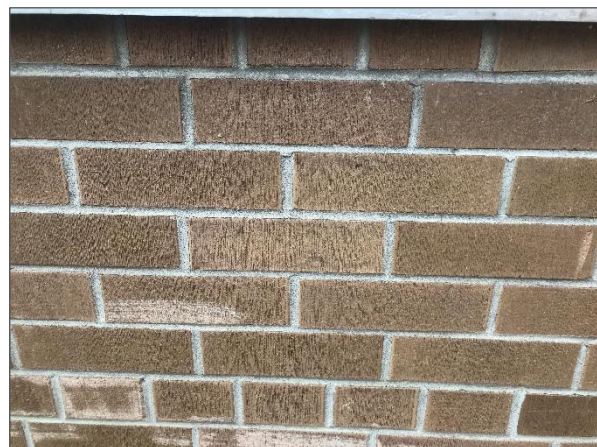
Mortar present between joints of exterior brick cladding does not contain asbestos (samples S0052A-G).

Non-asbestos mortar present between joints of exterior brick cladding.

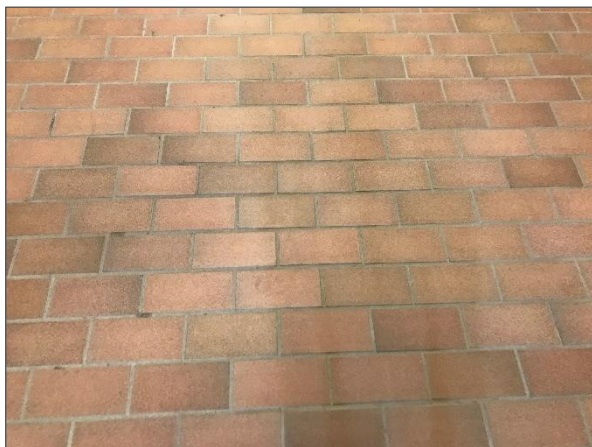
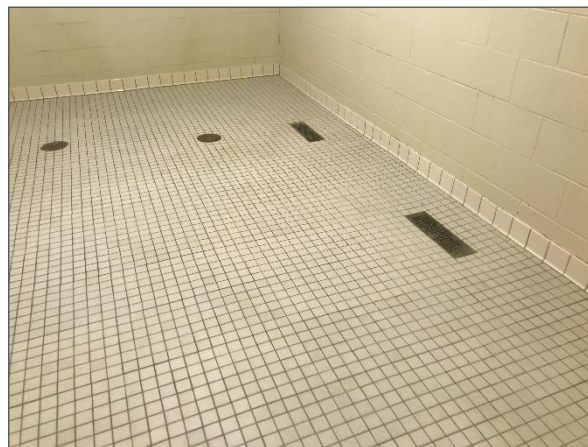
Thinset, presumed to contain asbestos, is present under various styles of ceramic tiles in isolated locations throughout the building. Due to the destructive nature of sampling, sampling of thinsets was not performed. Ceramic tiles and thinset are not anticipated to be disturbed as part of the planned renovations.

Presumed asbestos-containing thinset present behind ceramic tiles on floor.

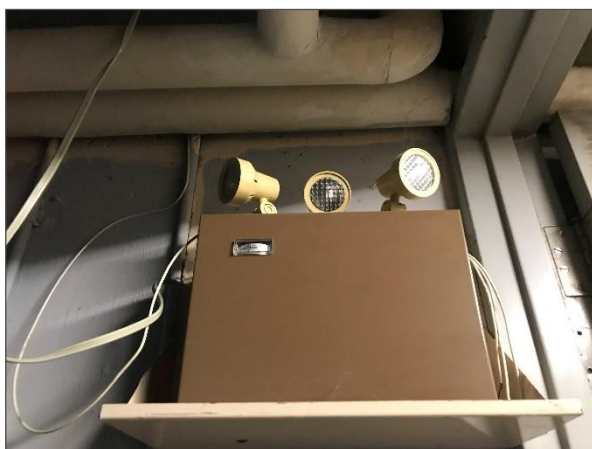
Lead-acid batteries are present in emergency lights.

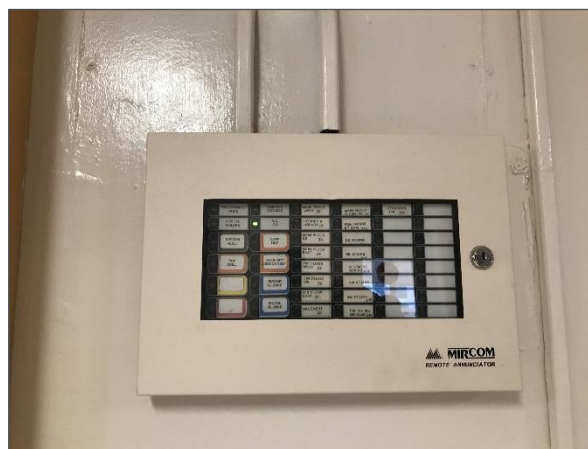
Lead-acid batteries are present in fire alarm control panels.

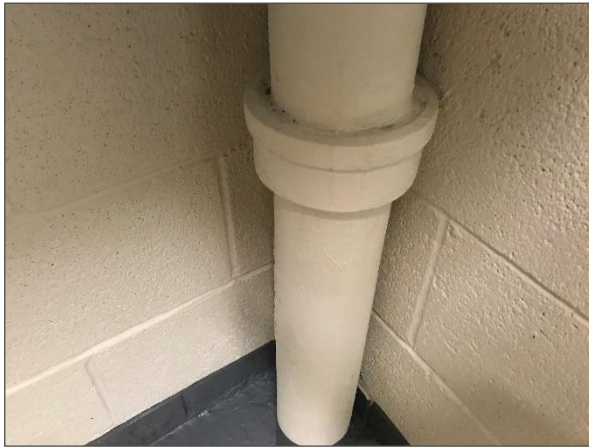
Lead caulking is present in bell and spigot fittings on cast iron pipes.

Lead caulking is present in fittings of bell and spigot fittings of cast iron pipes.

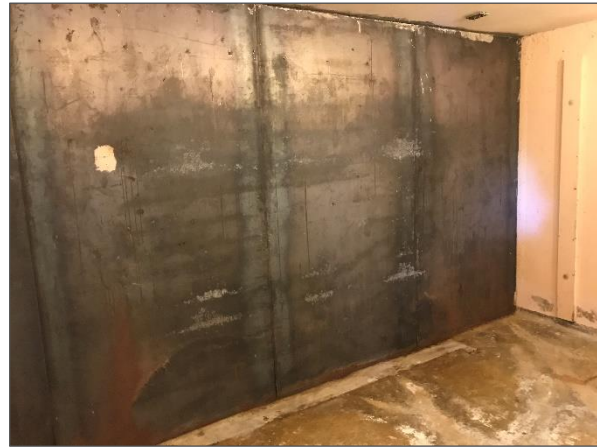
Lead sheeting is present on a wall in Basement Room 002.

Lead sheeting present on wall.

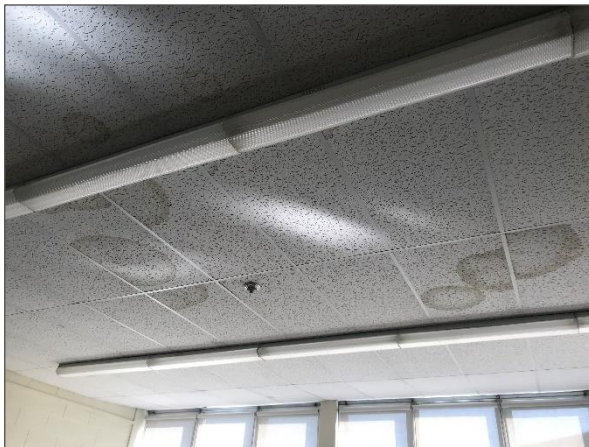
Water stained lay-in acoustic ceiling tiles in Classroom 112.

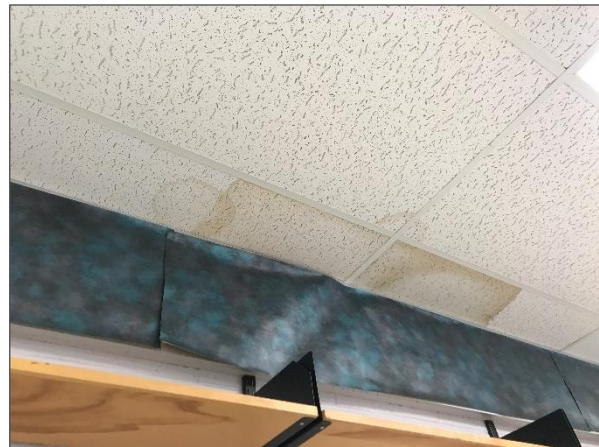
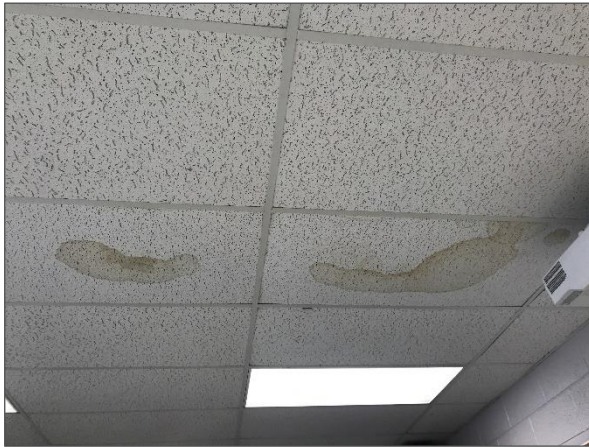
Water stained lay-in acoustic ceiling tiles in Classroom 225.

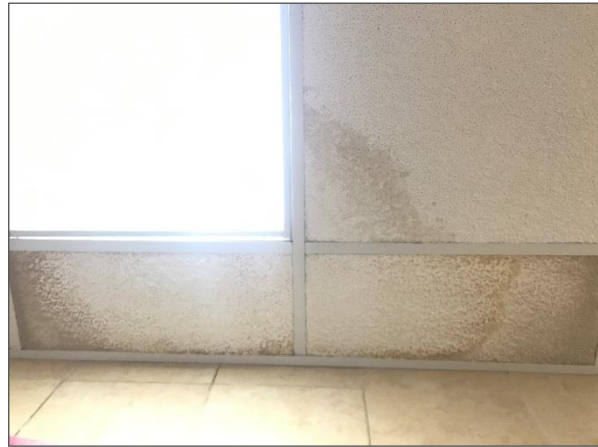
Water stained lay-in acoustic ceiling tiles in Washroom 128.

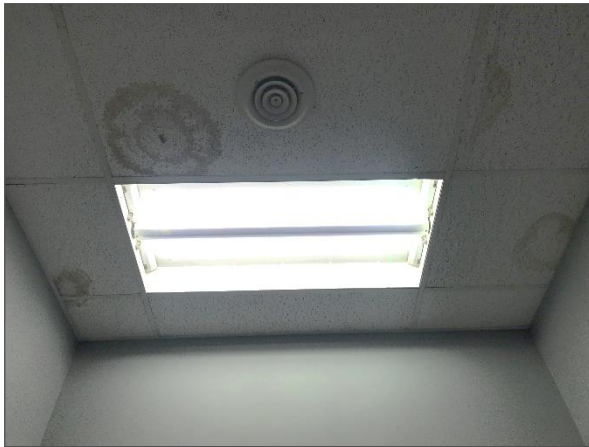
Water stained lay-in acoustic ceiling tiles in Office 129A.

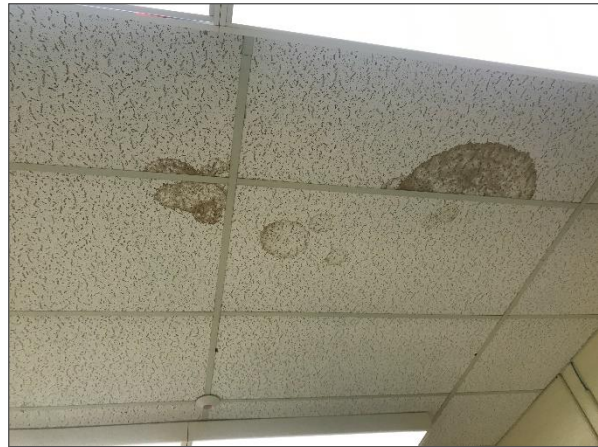
Water stained lay-in acoustic ceiling tiles in Classroom 212.

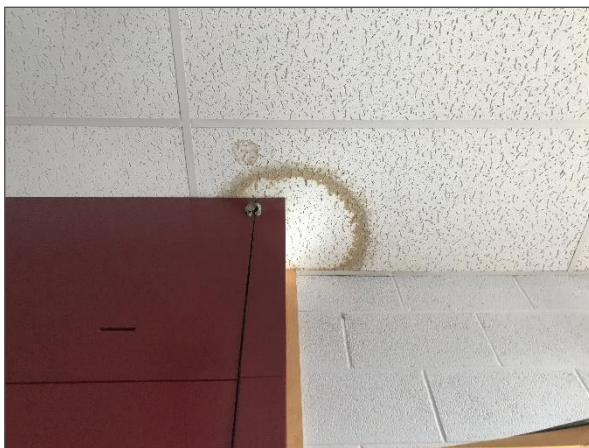
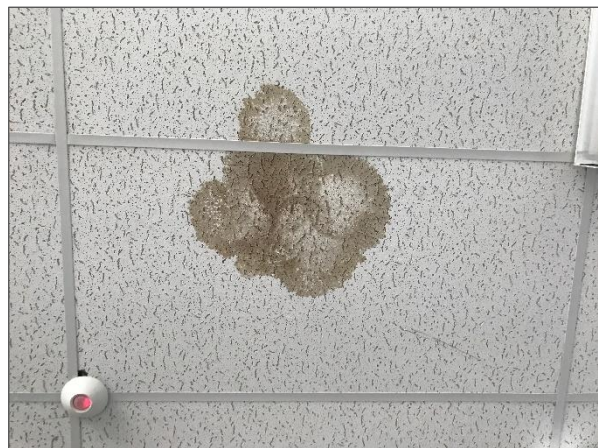
Water stained lay-in acoustic ceiling tiles in Classroom 217.

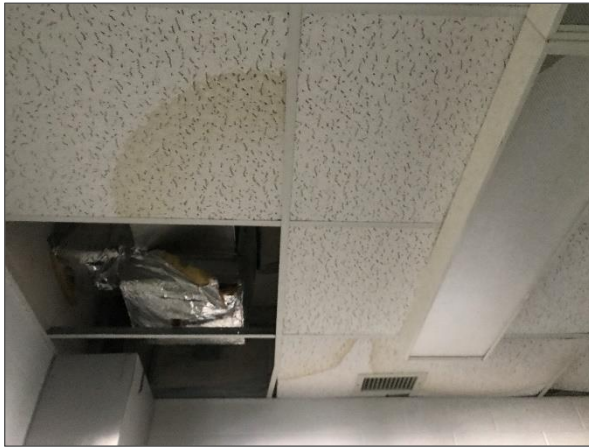
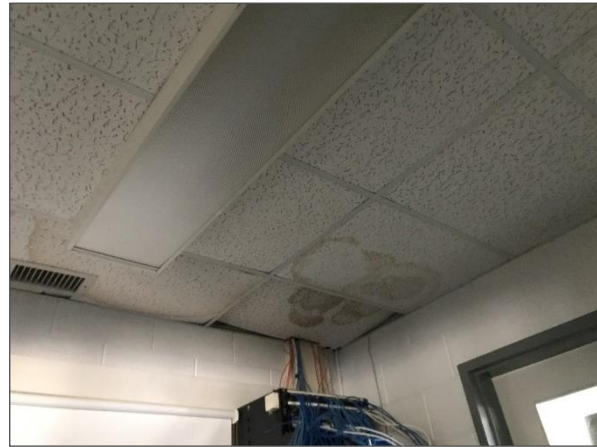
Water stained lay-in acoustic ceiling tiles in Storage 227.
