Designated Substances Survey

**St. Mary Catholic
Elementary School**

**35 Centre Street,
Campbellford, Ontario**

January 21, 2026

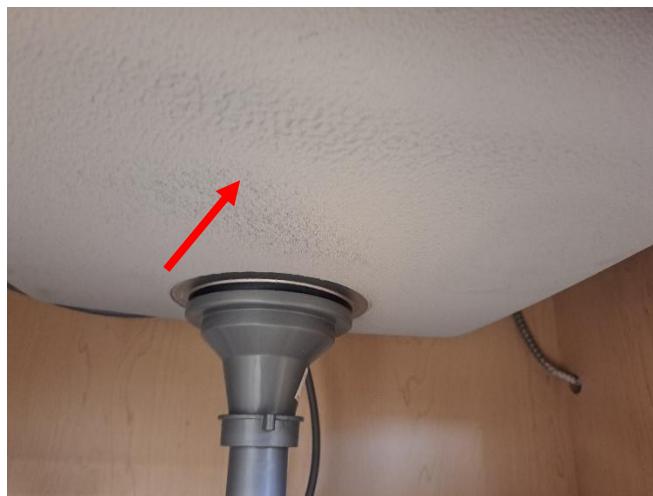
Photo 1: View of the non-asbestos containing white sink coating (see arrow) observed within Classroom 227.

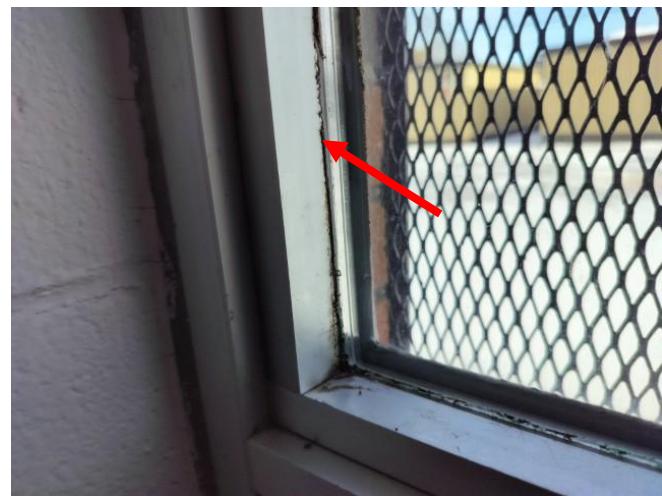
Hazardous Material	Findings
Asbestos	Grey Window Glaze was sampled from the interior windows dated from 1984 within the Subject Building (Sample Nos. 1984-GLZ-01a to 1984-GLZ-01c) and Sample No. 1984-GLZ-01b was identified to contain 6% Chrysotile asbestos by laboratory analysis. Based on the result, all grey window glaze on interior windows dated from 1984 within the Subject Building should be considered asbestos containing. At the time of site visit, approximately 500 linear feet of the asbestos containing grey window glaze was observed to be in good condition.
	Plaster previously collected throughout the Subject Building was identified to contain 0.75% Chrysotile asbestos by laboratory analysis (Jaques Whitford, 2008). Based on this homogenous grouping, all plaster finishes within the Subject Building are considered to be asbestos containing. At the time of site visit the asbestos containing plaster was observed to be in good condition throughout the Subject Building except for 0.5 ft ² observed to be in fair condition within Classroom 310A.

Photo 2: View of the asbestos containing grey glaze (see arrow) observed to be in good condition on the interior windows dated from 1984.

- Grey window glaze; and
 - Gold sink coating.
- 2) S2S recommends that the following asbestos containing materials identified in Table 2 be managed in place or removed following Type 2 asbestos abatement procedures in accordance with O. Reg 278/05:

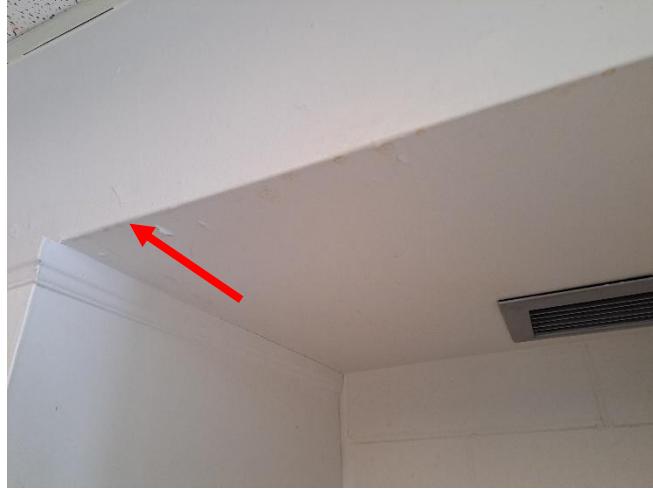
Photo 3: View of the drywall finishes (see arrow) associated with non-asbestos containing drywall joint compound observed on the bulkhead in the corridor near Room 203.

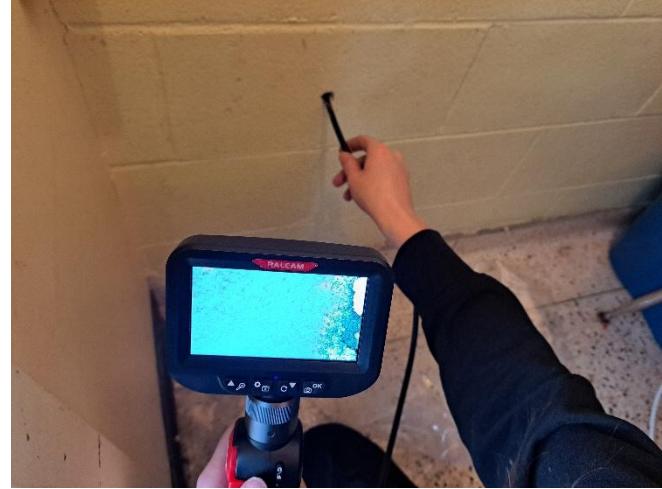
Photo 4: View of the concrete block wall during the vermiculite investigation and drilling activities near Classroom 103. No vermiculite was noted to be present in the wall cavities.

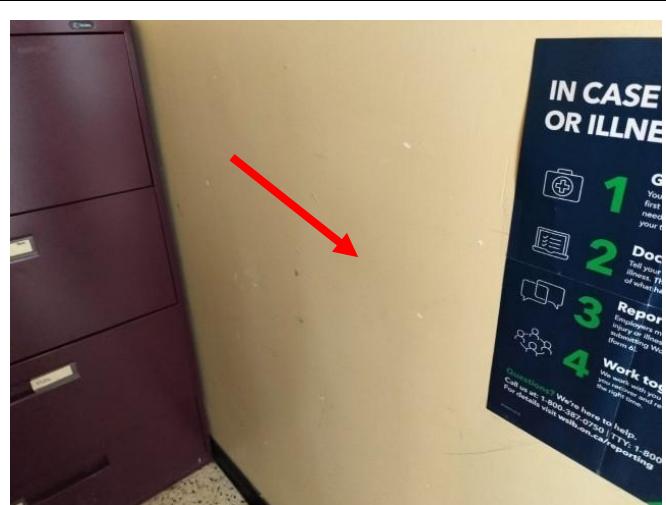
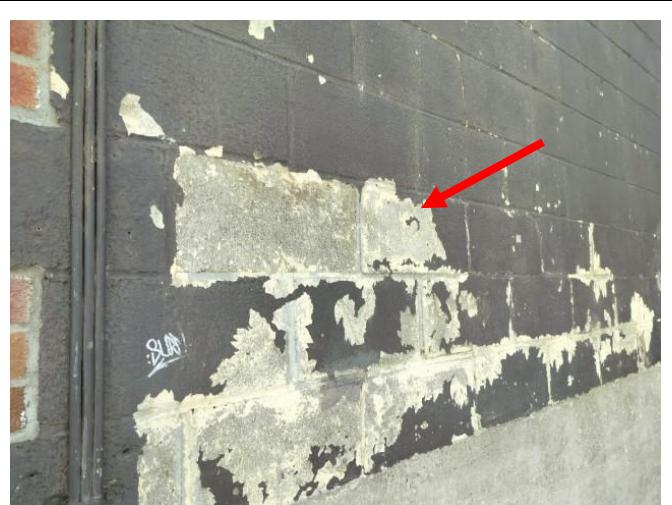
Hazardous Material	Findings
	observed to be in good condition, except for approximately 50 ft ² that was observed to be in poor condition on the exterior concrete walls.
	White paint (WSP, 2016) observed on the walls of the Subject Building was previously found to contain 0.0084% lead by dry weight. At the time of the current site visit, the lead containing white paint was observed to be in good condition.
	Beige paint (WSP, 2016) observed on the walls of the Subject Building was previously found to contain 0.088% lead by dry weight. At the time of the current site visit, the lead containing beige paint was observed to be in good condition.
	Light blue paint (WSP, 2016) observed on the doors and door frames of the Subject Building was previously found to contain 0.0095% lead by dry weight. At the time of the current site visit, the lead containing light blue paint was observed to be in good condition.

<p>Photo 7: View of the lead containing pale yellow paint (see arrow) observed in good condition on wall of Room 111.</p>	<p>Photo 8: View of the lead containing brown paint (see arrow) observed in poor condition on the exterior concrete walls of the Subject Building.</p>

- 4) Paints identified in Table 2 above were found to contain detectable concentrations of lead. Based on visual observations during the DSS, the identified lead containing paints noted in Table 2 were observed to be in good condition, with the exception of the brown paint on the exterior concrete walls observed to be in poor condition. Paints with similar texture and appearance that are present throughout the Subject Building should be presumed to contain similar concentrations of lead. It is recommended that the poor condition paint be stabilized with fresh paint using appropriate worker protection.

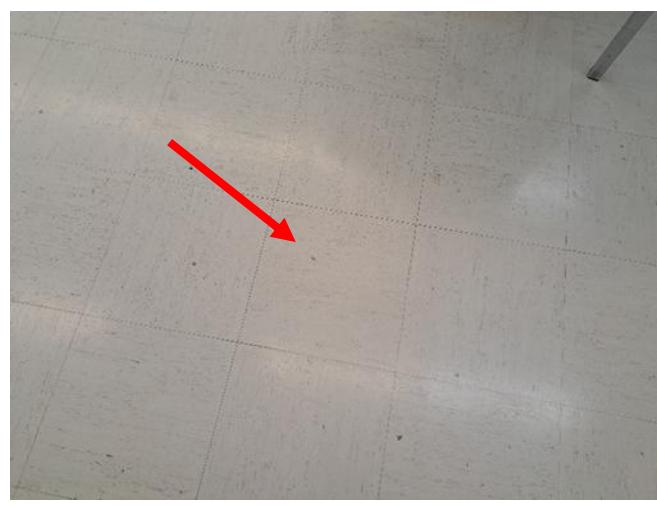
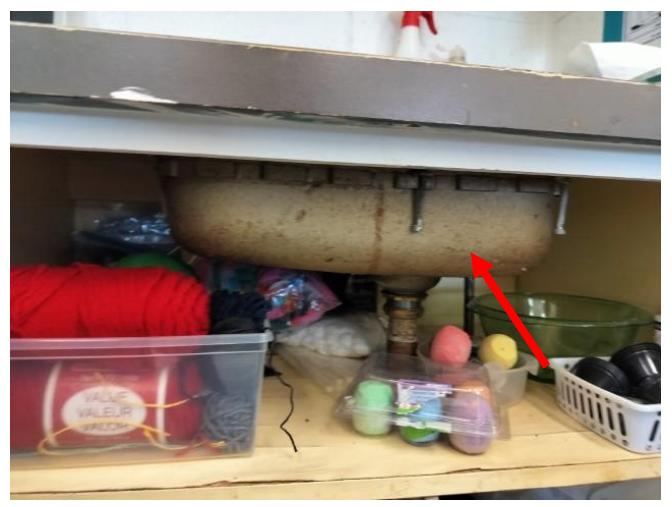
Hazardous Material	Findings
	<p>Vinyl Floor Tiles - 12"x12", off-white with dark streaks (WSP, 2016) previously collected within Classroom 310A were identified to contain 3.3% Chrysotile asbestos by laboratory analysis. At the time of site visit approximately 1,500 ft² of the asbestos containing off-white with dark streaks vinyl floor tiles were observed to be in good condition.</p>
	<p>Black floor tile mastic (WSP, 2016) previously collected within Classrooms 103, 203 310A, and 200 were identified to contain 2.1% Chrysotile asbestos by laboratory analysis. At the time of site visit approximately 1,500 ft² of the asbestos containing black floor tile mastic was observed to be in good condition and 1.5 ft² was observed to be in fair condition within Classroom 200.</p>
	<p>Vinyl Floor Tiles - 12"x12", dark green with white streaks (WSP, 2016) previously collected within the Office Washroom 219 were identified to contain 5.5% Chrysotile asbestos by laboratory analysis. At the time of site visit approximately 50 ft² of the asbestos containing dark green with white streaks vinyl floor tiles were observed to be in good condition.</p>

<p>Photo 9: View of the asbestos-containing 12"x12" off-white with dark streaks vinyl floor tiles observed to be in good condition within Room 203.</p>	<p>Photo 10: View of asbestos containing gold sink coating (see arrow) observed to be in good condition within Room 203</p>
