Designated Substances Survey

**St. Paul Catholic
Elementary School**

**1101 Hilliard Street,
Peterborough, Ontario**

January 22, 2026

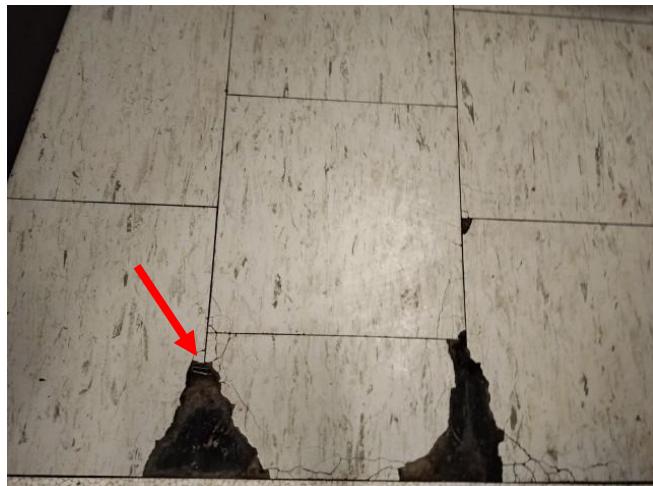
Hazardous Material	Findings
	<p>12"x12" beige vinyl floor tiles with grey streaks (WSP, 2016) previously collected from various Classrooms and the Library Storage Room was identified to contain 1.1% Chrysotile asbestos by laboratory analysis. At the time of site visit approximately 5,000 ft² of the asbestos containing beige vinyl floor tiles with grey streaks were observed to be in good condition within the following locations:</p> <ul style="list-style-type: none"> • Storage 24A; • Storage 104 and 105; • Reception Room 113; • North Storage/Electrical Room; and • Rooms 117, 118, 203, 204, 205, 206, 207, 208, and 209. <p>Additionally, the asbestos containing beige vinyl floor tiles with grey streaks were noted to be in fair condition within the following locations: 1 ft² in Staffroom 203, 1 ft² in Classroom 117, and 2 ft² in Custodial Room 206.</p>
	<p>White textured coating (WSP, 2016) previously collected from Classrooms 106, 12, 13, Staff Room, and Health Room was identified to contain 1.5% Chrysotile asbestos by laboratory analysis. Based on this homogenous grouping, all white textured coating within the Subject Building is considered to be asbestos containing. At the time of site visit approximately 2,400 ft² of the asbestos containing white textured coating was observed to be in good condition and 2 ft² was noted to be in fair condition within the Boiler Room.</p>

Photo 1: View of the asbestos-containing 12"x12" beige vinyl floor tiles with grey streaks (see arrow) observed to be in fair condition within Custodian Room 206.

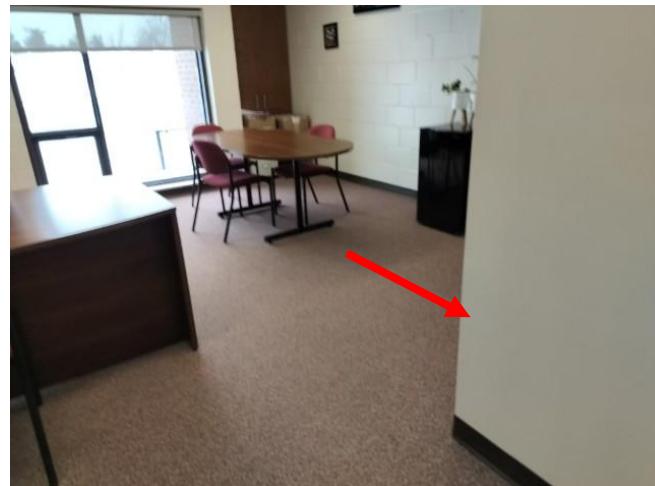
Drywall joint compound (WSP, 2016) previously collected throughout the Subject Building was identified to contain 1.2% Chrysotile asbestos by laboratory analysis. Based on this homogenous grouping, all drywall joint compound and associated drywall finish within the Subject Building are considered to be asbestos containing. At the time of site visit the asbestos containing drywall joint compound and associated drywall finishes was observed to be in good condition throughout the Subject Building except for: <ul style="list-style-type: none"> • Approximately 0.5 square feet in fair condition within Washroom 14; and • Approximately 2 square feet in fair condition within Washroom 20.

Photo 2: View of the drywall finishes with associated asbestos containing drywall joint compound (see arrow) observed to be in good condition within the Principal Room.

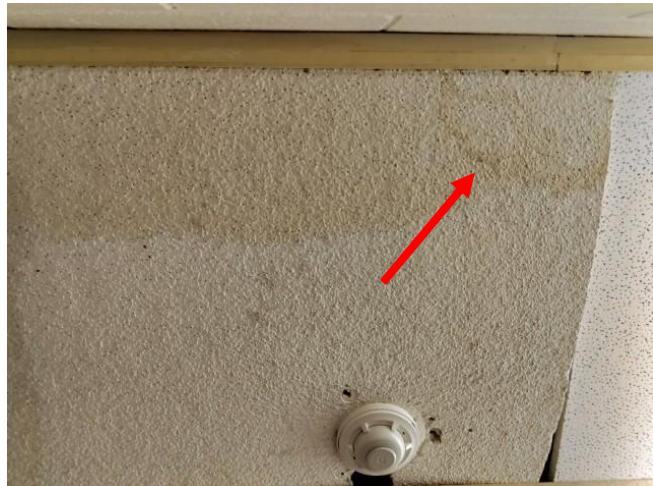
Hazardous Material	Findings
Asbestos	2' x 4' white textured ceiling tiles (Sample Nos. ACT-01a to ACT-01c) collected within the Custodian Storage Room 115 were identified to contain 5% Amosite asbestos by laboratory analysis. At the time of site visit approximately 40 ft ² the asbestos containing textured ceiling tiles were observed to be in good condition within the Custodian Storage Room 115 and 203 and 10 ft ² were observed to be in fair condition within the Custodian Storage Room 115 and 203 due to water staining.
	Insulating ceiling panels (Jacques Whitford, 2008) previously collected on light fixtures in Room 210 was identified to contain 8% Chrysotile asbestos by laboratory analysis. At the time of site visit asbestos containing insulating ceiling panels were observed to be in good condition throughout Room 210 and are presumed to be located above the drop ceiling elsewhere throughout the Subject Building.

Photo 3: View of the asbestos containing 2' x 4' white textured ceiling tiles (see arrow) observed to be in fair condition in the Custodian Storage Room 115.

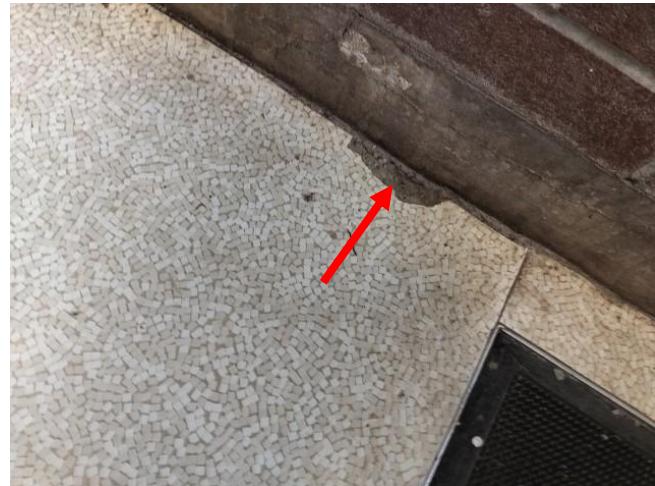
Photo 4: View of the asbestos containing beige vinyl sheet flooring (see arrow) observed in fair condition within the Corridor 110 near the Main Entrance.

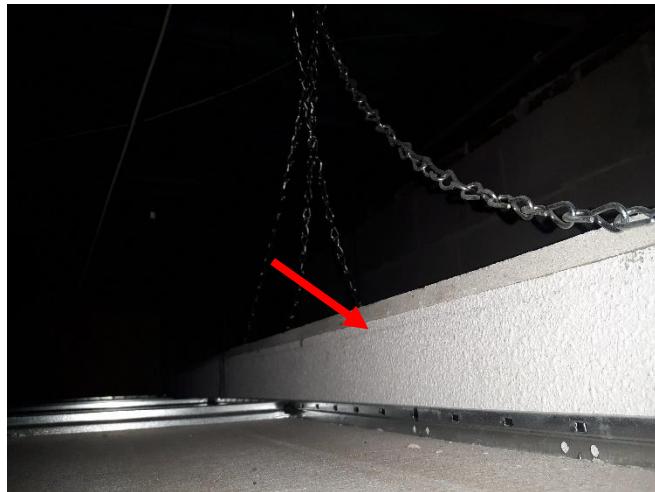
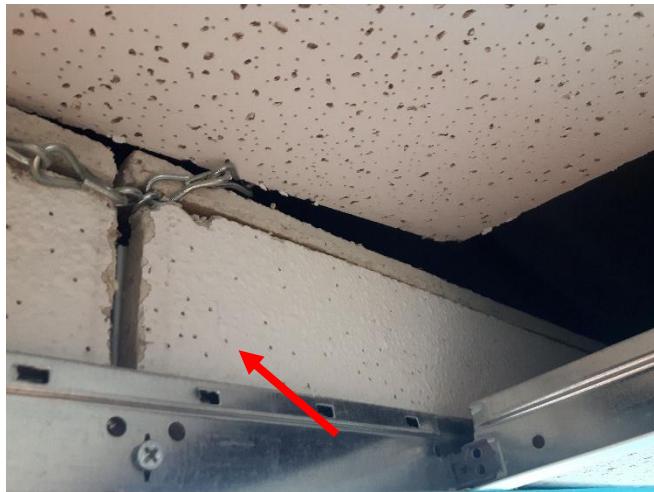
Photo 5: View of the asbestos containing insulation ceiling panels (see arrow) observed to be in good condition around the light fixtures and above the drop ceiling within Room 210.

Photo 6: Additional view of the asbestos containing insulation ceiling panels (see arrow) observed to be in good condition around the light fixtures and above the drop ceiling within Room 210.

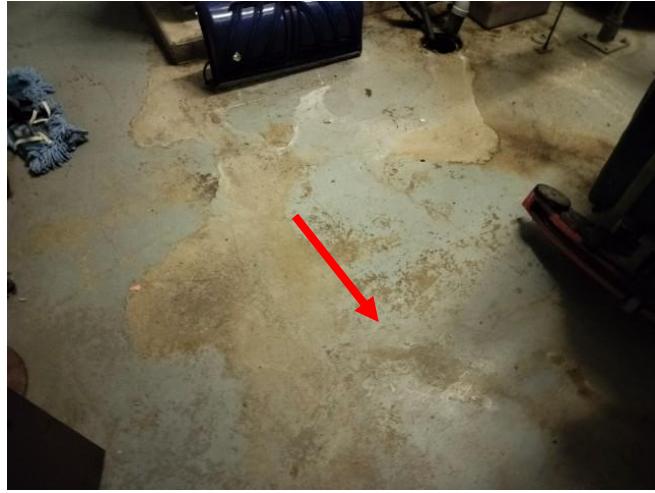
Hazardous Material	Findings
Lead	During the site visit, wall cavities were investigated throughout representative locations within the 1966 section of the Subject Building to determine the presence or absence of vermiculite. Drill holes, where required, were made to provide visual access with a borescope. Upon completion of the investigation, it was determined that no evidence of vermiculite materials was observed or are presumed to be present within the Subject Building.
	Although not observed during the inspection, additional ACMs may be present in visually inaccessible areas of the Subject Building. Refer to Appendix D for the S2S Annual ACMs Inspection Summary Table and Appendix E for the previous asbestos bulk sample locations and results.
	Grey paint (WSP, 2016) observed on the Boiler Room floor was previously identified to contain 0.010% lead content by dry weight. At the time of the current site visit the low-level lead containing grey paint was observed to be in fair condition.

Photo 7: View of the low-level lead containing grey paint (see arrow) observed to be in fair condition on the floor within the Boiler Room.

4) Based on visual observations, the previously identified lead containing paints observed during the site visit were identified to be in good condition with the exception of the low-level lead containing grey paint on the floor in the Boiler Room in fair condition and the lead containing brown paint on the exterior doors throughout the Subject Building in fair condition. Paints with similar texture and appearance that are present in other areas of the Subject Building should be presumed to contain similar concentrations of lead. Lead may also be present in paints not sampled, electronic components (e.g., wiring connections, wire bundles, etc.), plumbing solder, roof flashing, noise baffles, emergency lighting batteries, and cast-iron piping gaskets (i.e., bell & spigots). Where present within the Subject Building, they are presumed to be lead-containing. Refer to Appendix E for the previous lead paint bulk sampling locations, results, and current condition.

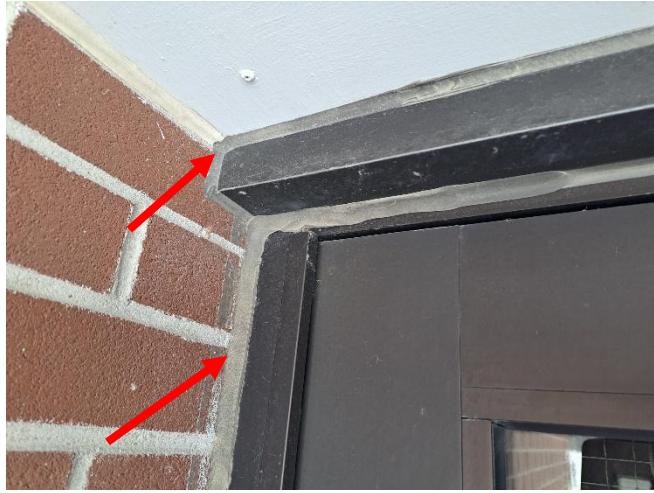
Photo 8: View of the non-asbestos containing exterior grey caulking (see right arrow) and brick mortar (see left arrow) observed to be in good condition throughout the Subject Building.

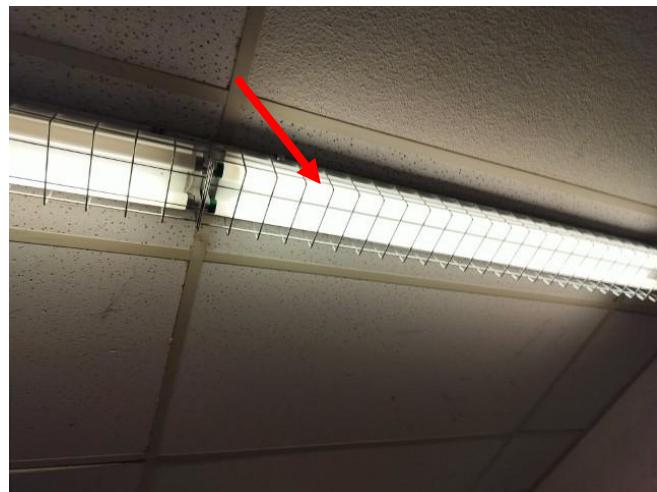
Photo 9: View of the mercury containing fluorescent light tubes (see arrow) observed to be in good condition throughout the Subject Building.

- 5) Mercury in the form of vapour was observed to be present within the fluorescent light tubes observed throughout the Subject Building. Liquid mercury is also suspected to be present within the thermostats observed throughout the Subject Building. At the time of the site visit, all visually observed fluorescent light tubes and thermostats, where accessible, were noted to be intact and in good condition. It is recommended that disposal of out-of-service fluorescent light tubes, thermostats, or any other mercury containing materials or equipment be completed in accordance with O. Reg. 490/09 and O. Reg. 347.

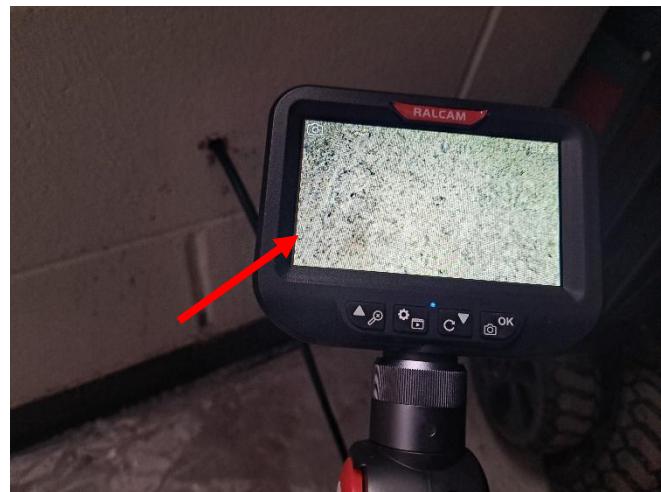
Photo 10: View of the concrete block wall during the vermiculite investigation and drilling activities (see arrow) within the library.
