April 29, 2024

Re: Hazardous Building Materials Assessment (Preconstruction)

Eastside Secondary School, Auto Shop HVAC upgrades, 275 Farley Avenue, Belleville, ON
Pinchin File: 200584.087

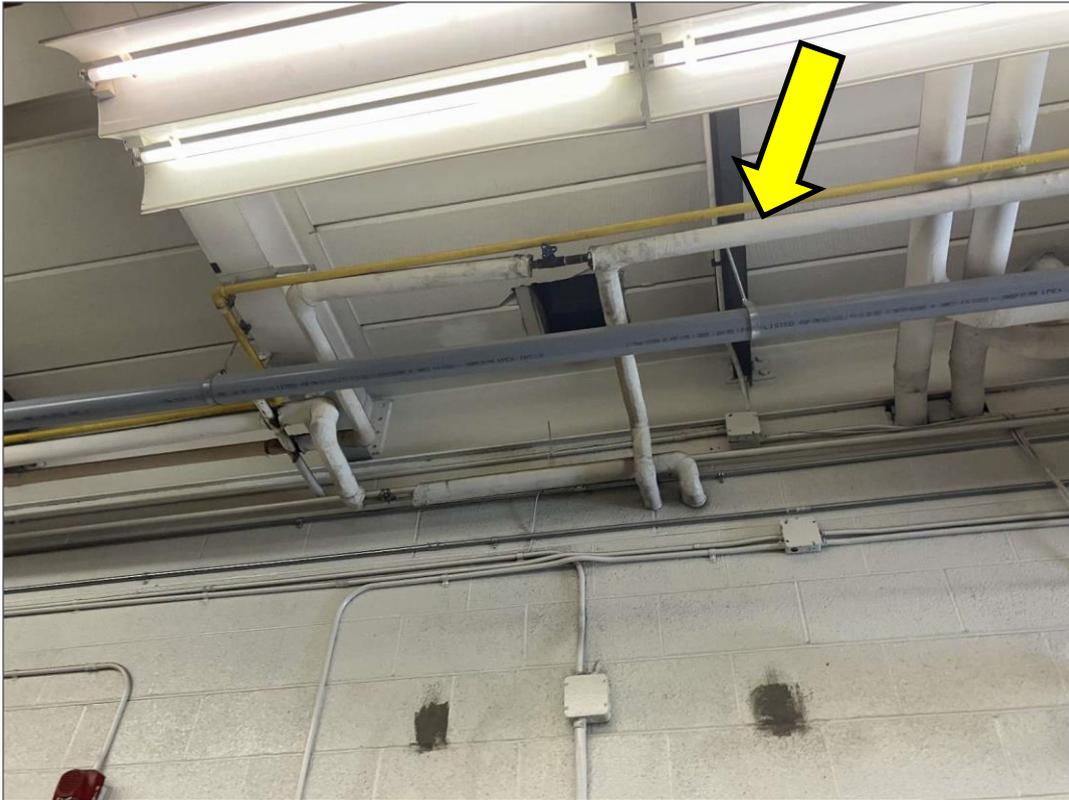
V0001 (Confirmed Asbestos), Piping, Aircell, Autoshop (Location #: 153).

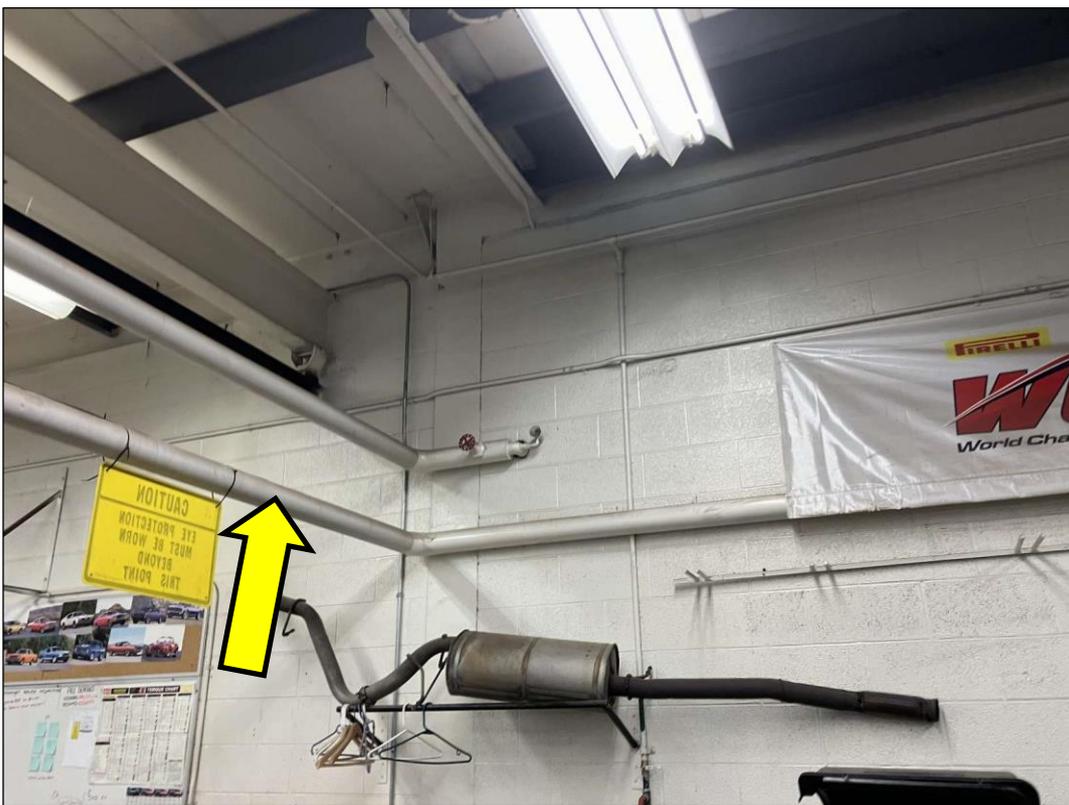
V0002 (Confirmed Asbestos), Piping, Sweatwrap, Autoshop (Location #: 153).

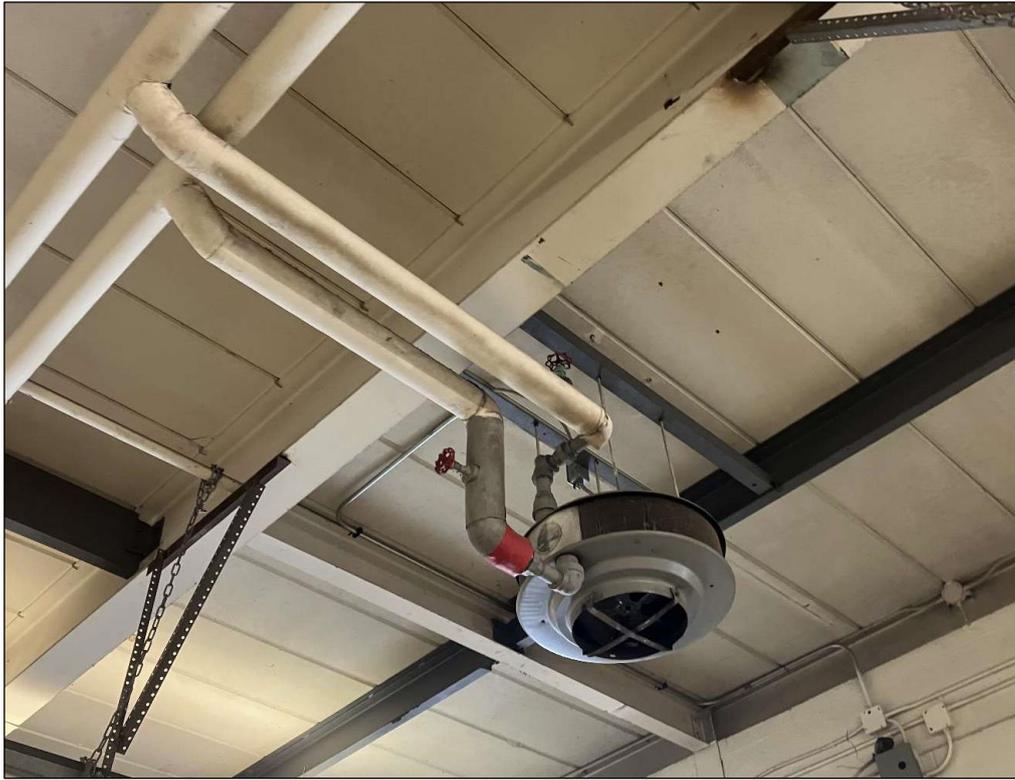
Hazard: System	Material Description	Quantities per Condition		Location Name, (Location No.)	Recommended Procedure
		Fair	Poor		
ASB: Piping	Elbow, Parging Cement	1 EA		Autoshop (Loc. 153)	Remove or repair in accordance with O.reg 278/05 Type 2 or Glove Bag Asbestos Abatement Procedures

S0008A (Confirmed Asbestos), 1 Elbow, Poor condition, Piping, All, Parging Cement, Autoshop (Location #: 153).

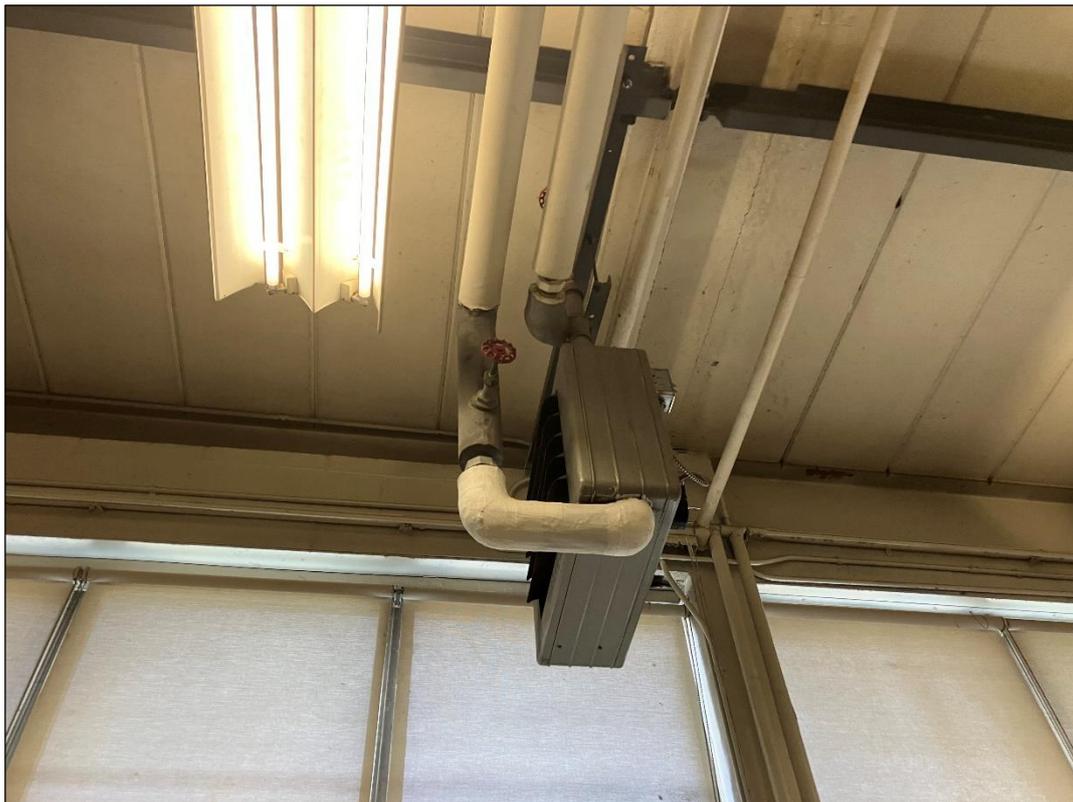
S0008A (Confirmed Asbestos), Piping, All, Parging Cement, Autoshop (Location #: 153).

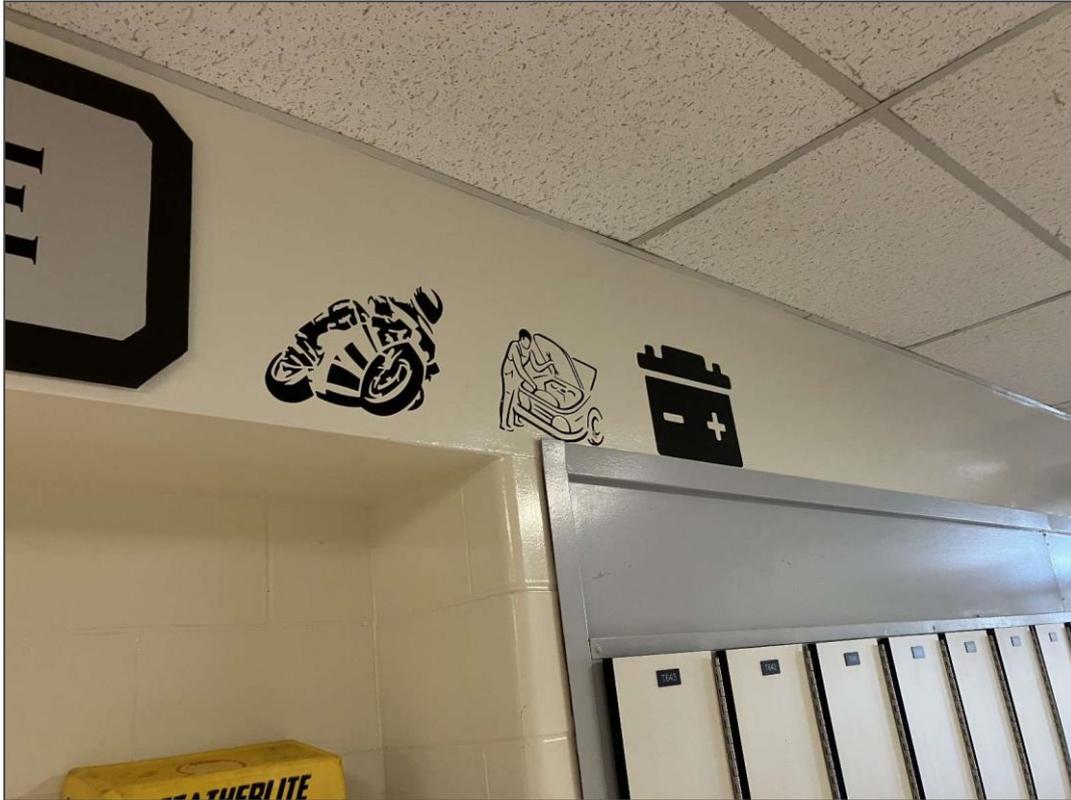
S0016A (None), Wall, Plaster, Above lockers, Corridor (Location #: 194).

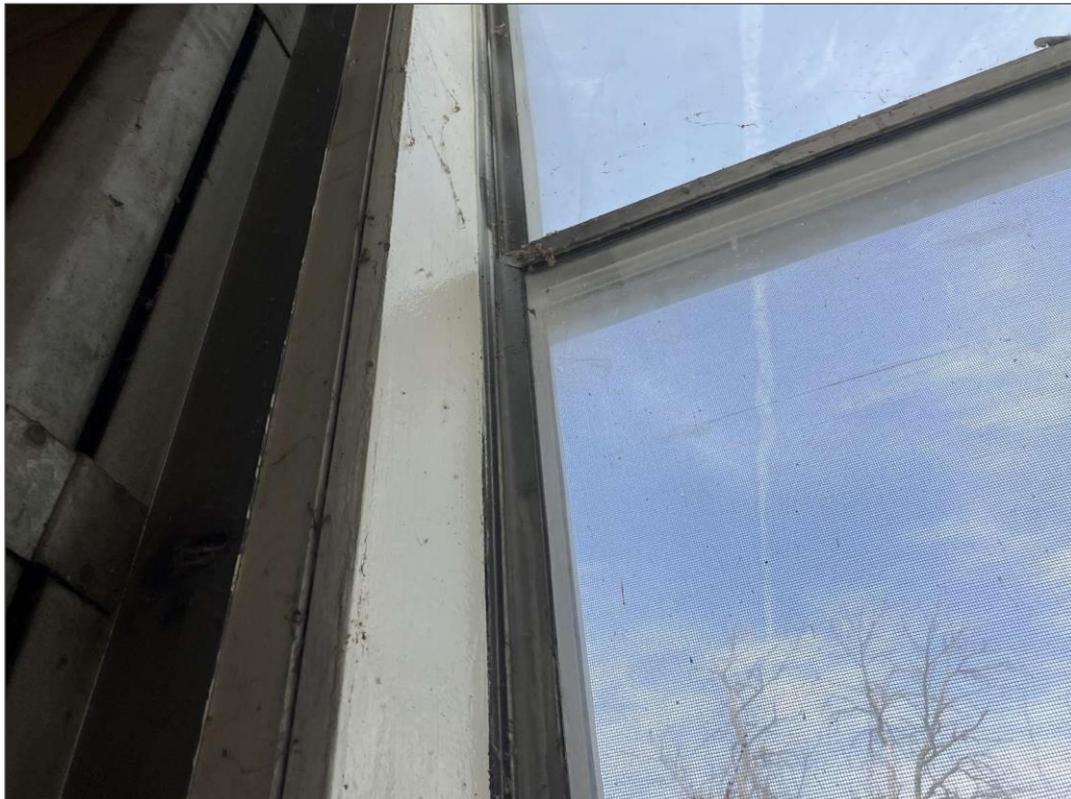
V0041 (Confirmed Asbestos), Wall, Window, Caulking, Soft grey, Autoshop (Location #: 153).

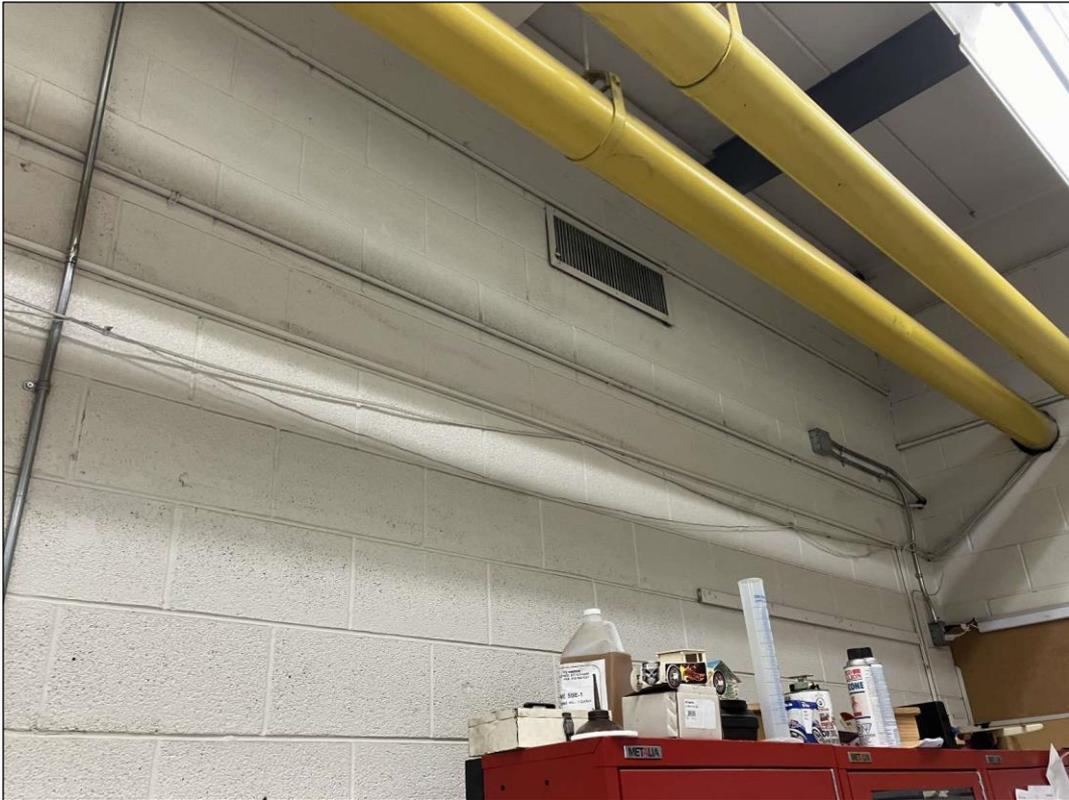
V0062 (Confirmed Asbestos), Wall, Paint On concrete block, Autoshop (Location #: 153).

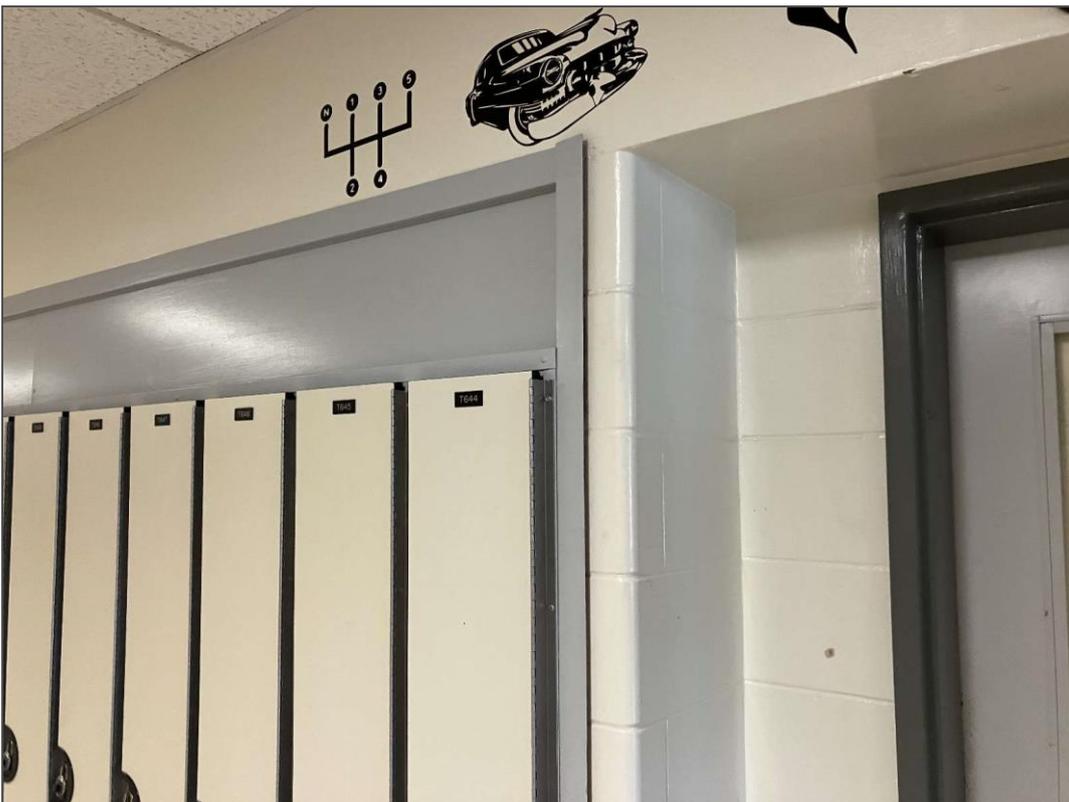
S0063D (Confirmed Asbestos), Wall, Paint, On concrete block, Corridor (Location #: 194).

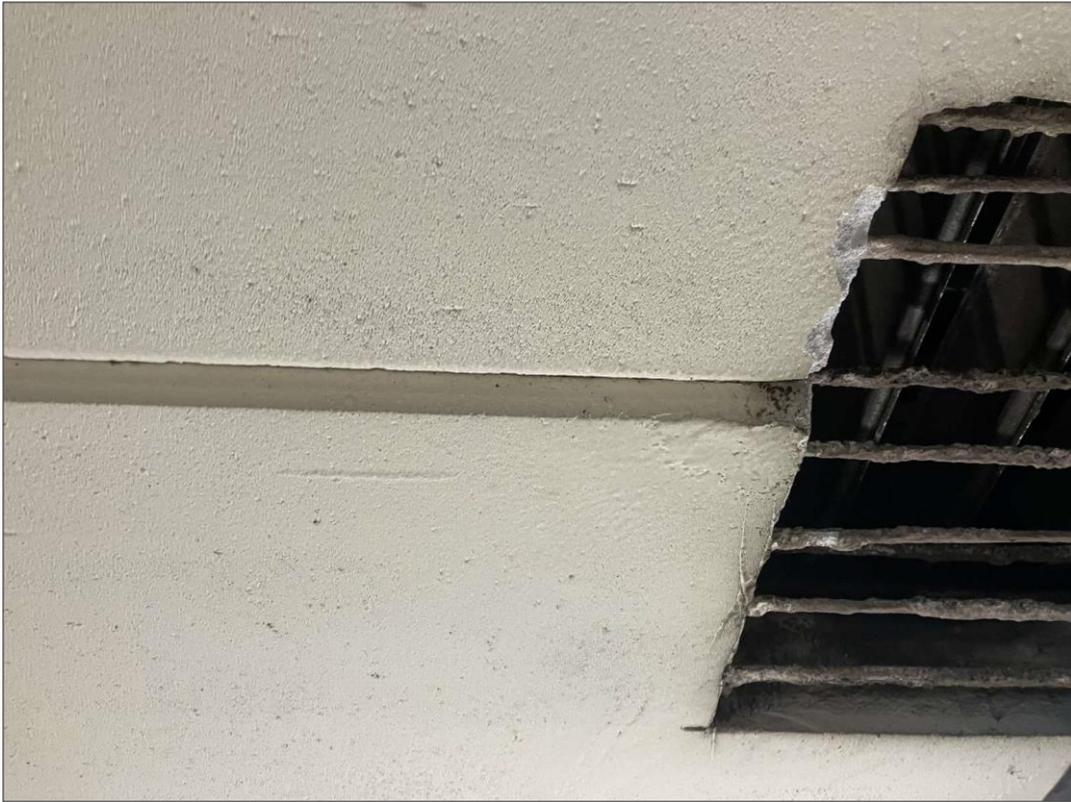
b) Homogeneous, green, yellow, black, and white, coating material.	Chrysotile	0.5-5% Vermiculite 10-25% Other Non-Fibrous > 75%
			Non-Fibrous Material > 75%

S0070A (Confirmed Asbestos), , Cement Product, Coating Material on Siporex Structure, Autoshop (Location #: 153).

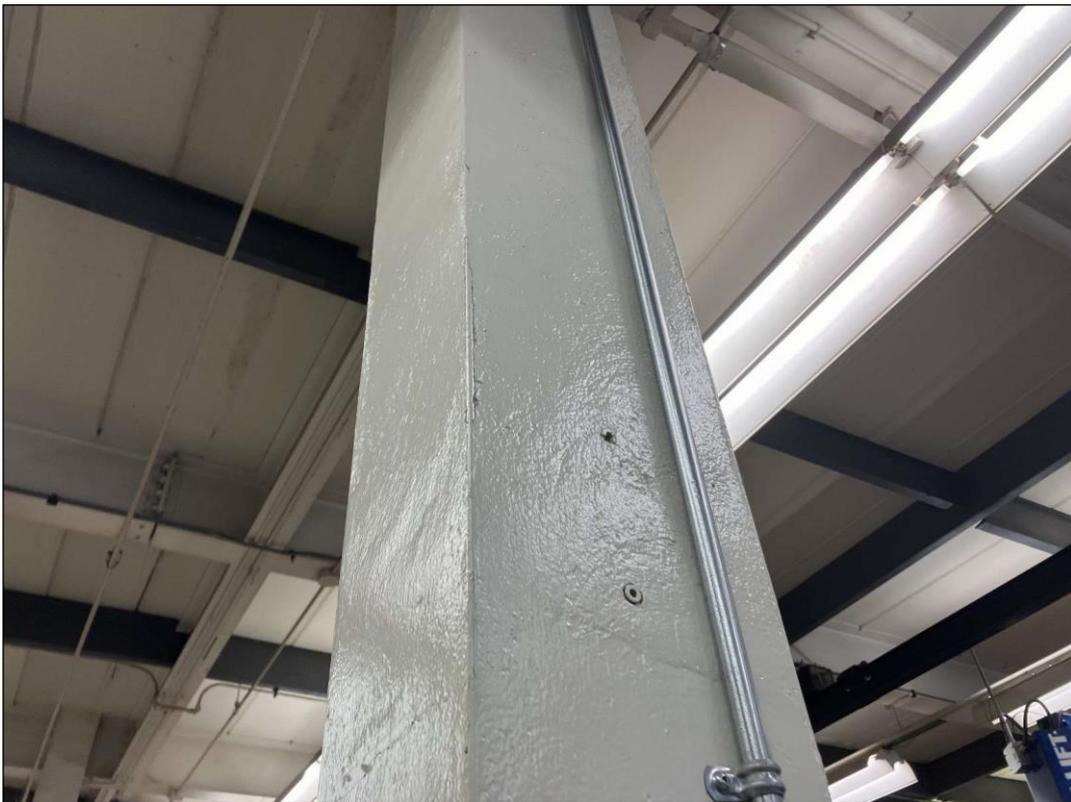
S0071A (Confirmed Asbestos), Other, Column, Coating Material on Plaster, Autoshop (Location #: 153).

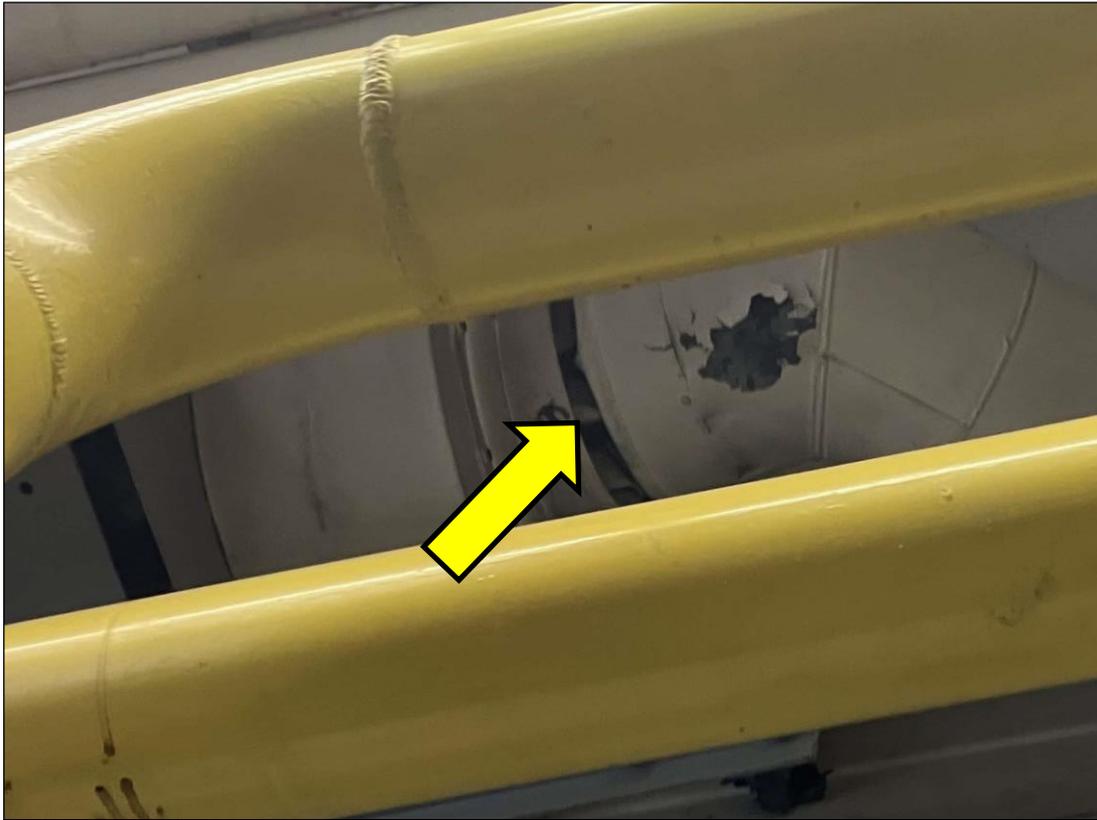
V9500 (Presumed Asbestos), Duct, Textile, Vibration damper, Autosshop (Location #: 153).

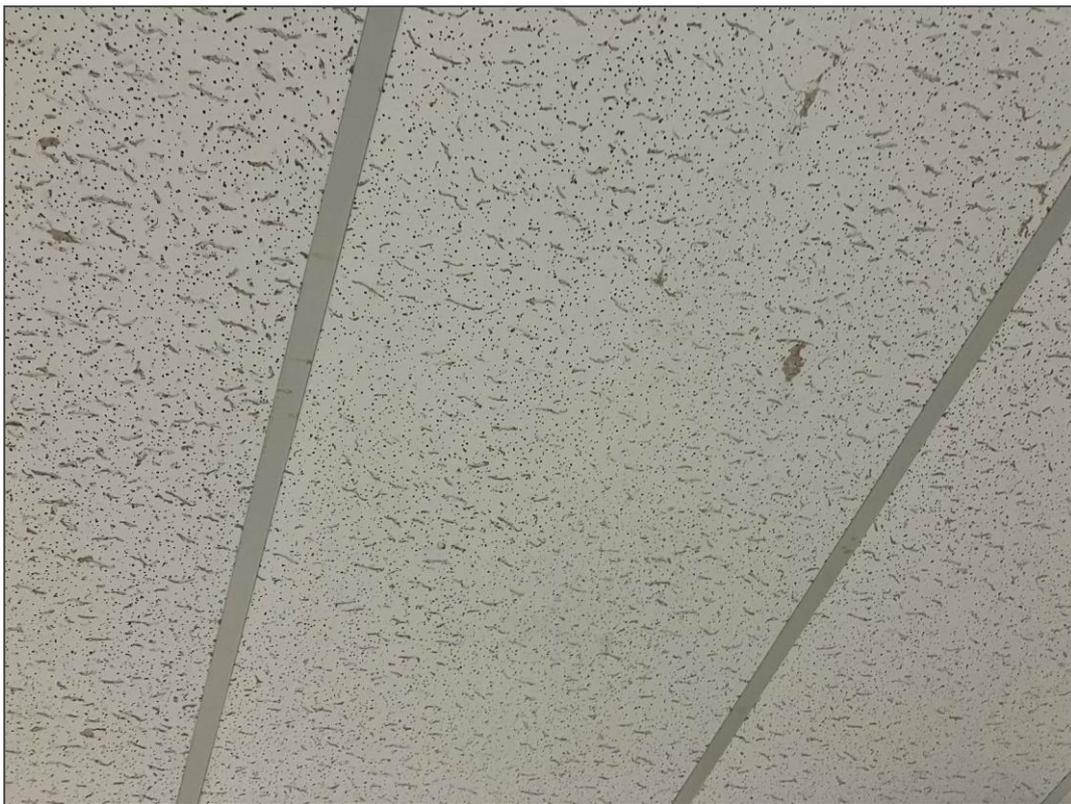
V0000 (None), Ceiling, All, Ceiling Tiles (lay-in), 2x4 dense short widthwise fissures, 01/25/2008, Corridor (Location #: 194).

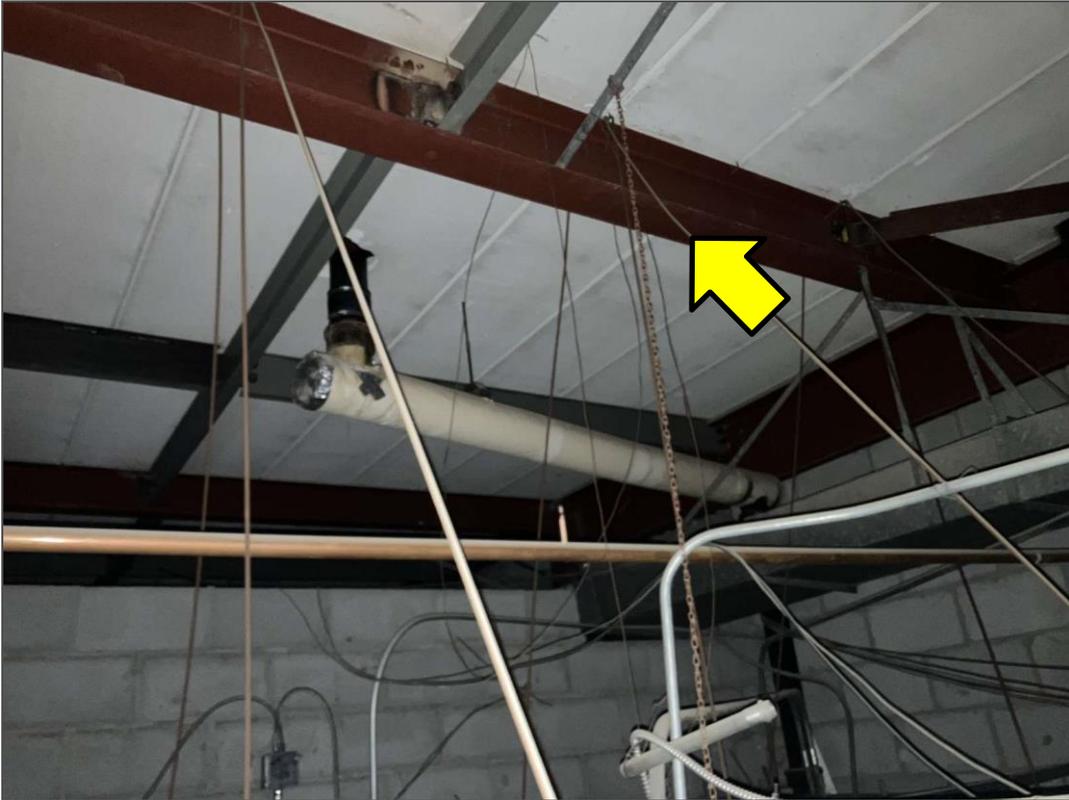
V0001(Lead, High), Red, Steel Structure, Corridor (Location #: 194).

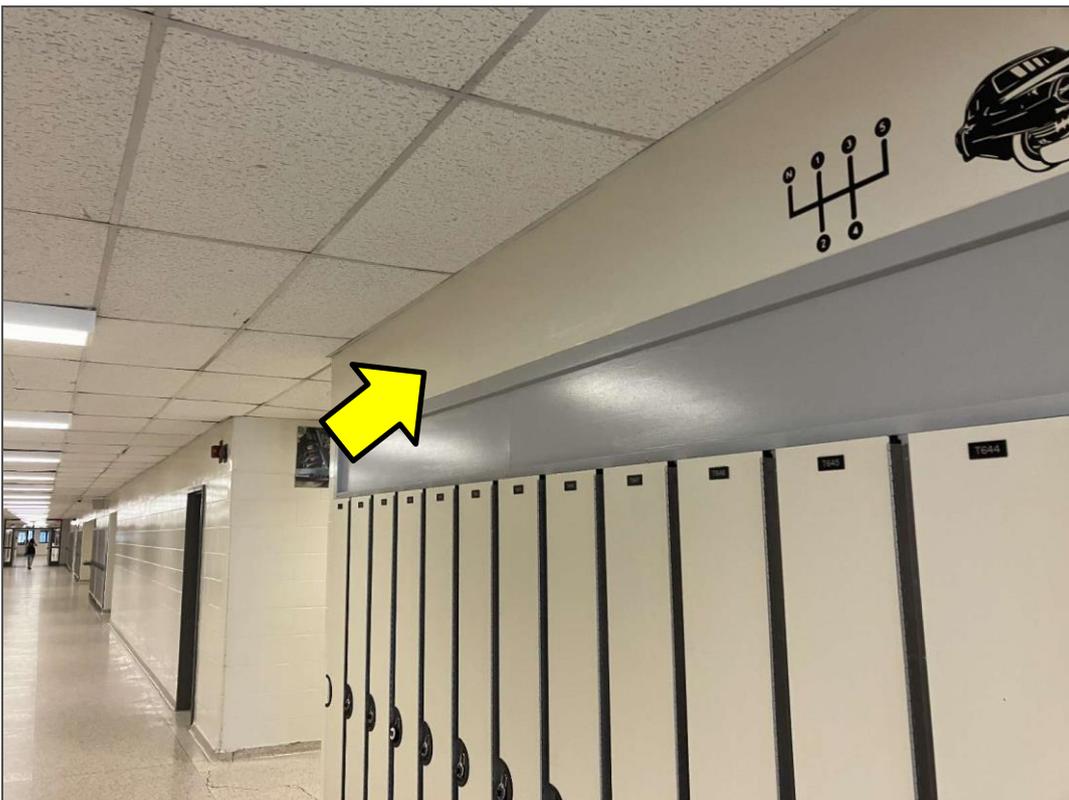
V0004(Lead, Low), Off-white, Wall, Plaster, Corridor (Location #: 194).

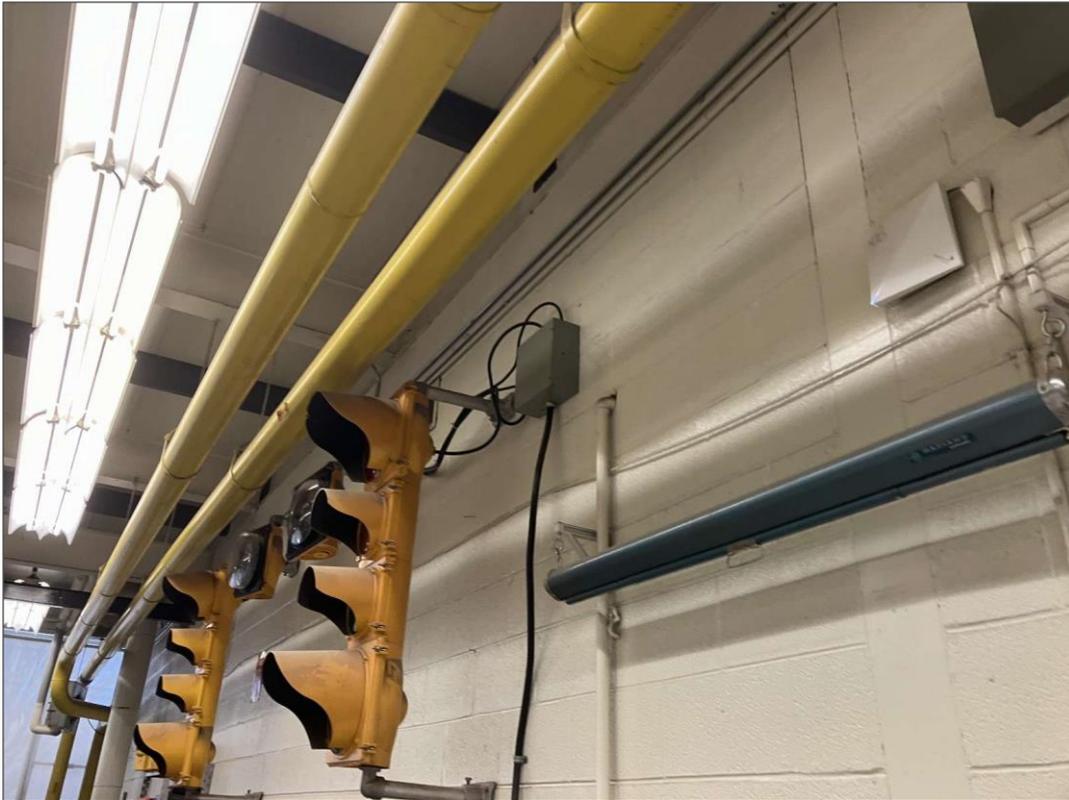
V0007(Lead, Low), Yellow, Wall, Concrete (Precast), Autoshop (Location #: 153).

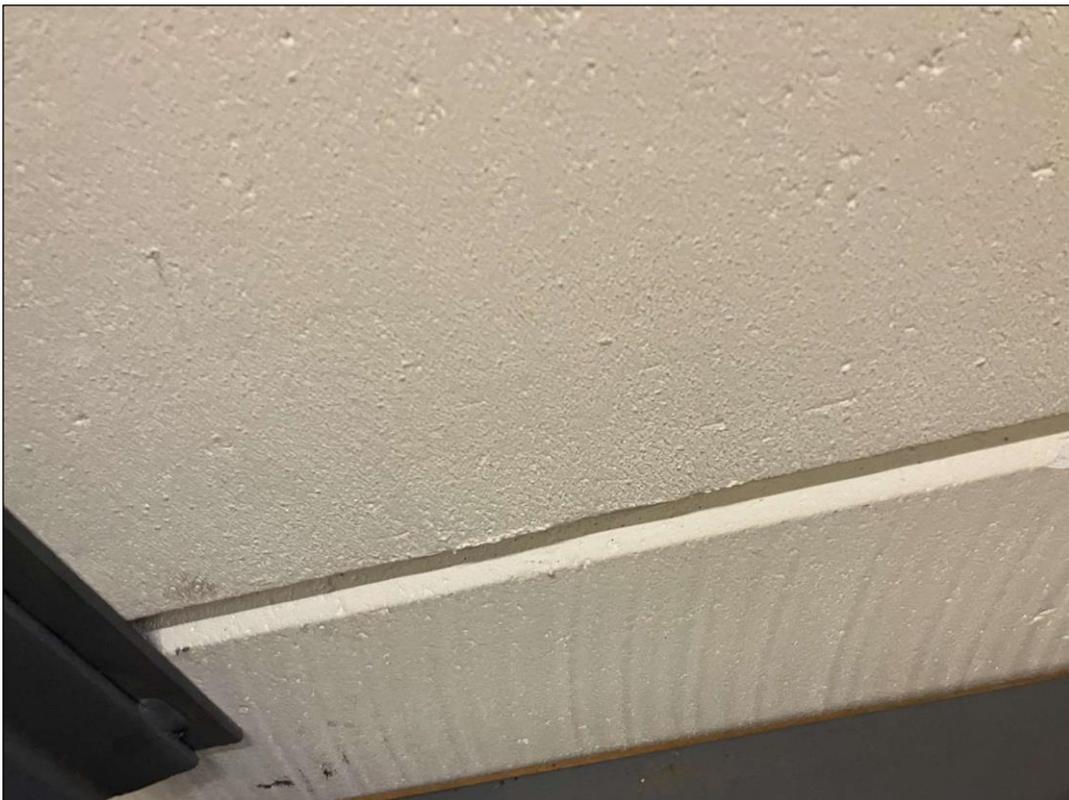
L0012(Lead, Low), Off-white, Siporex Structure, Autoshop (Location #: 153).

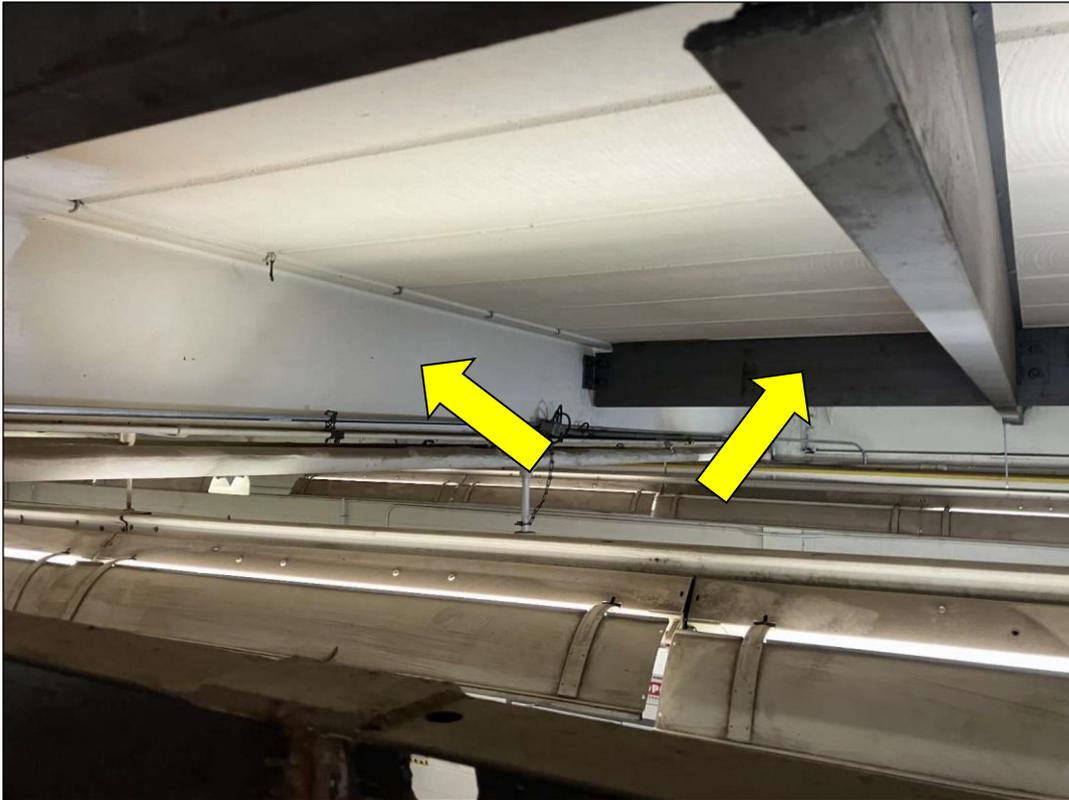
L0013(Lead, Low), Off-white/black, Steel Structure, Autoshop (Location #: 153).
