May 7, 2025

Re: Hazardous Building Materials Assessment (Preconstruction)
Greenhouse and Windows/Doors in 1961 Addition
Eastside Secondary School, 275 Farley Avenue, Belleville, ON
Pinchin File: 200584.098

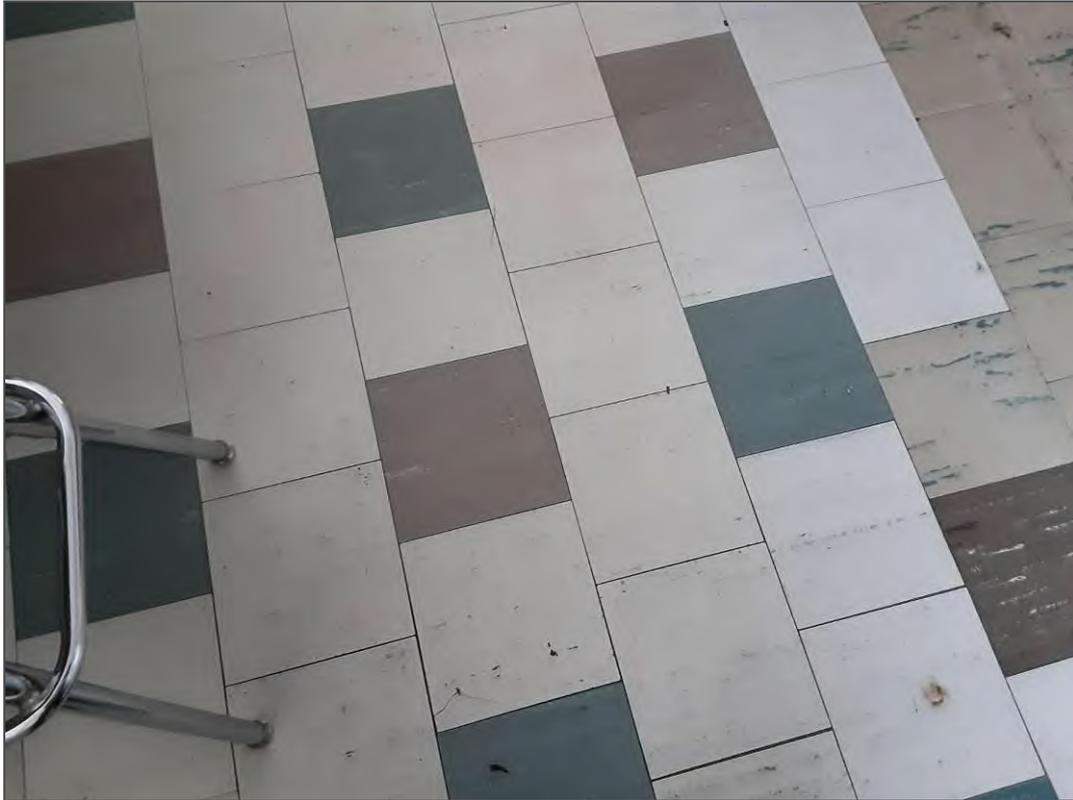
S0003D (Confirmed Asbestos), Floor, Vinyl Floor Tile and Mastic, 9x9 various colours, Classroom (Location #: 150)

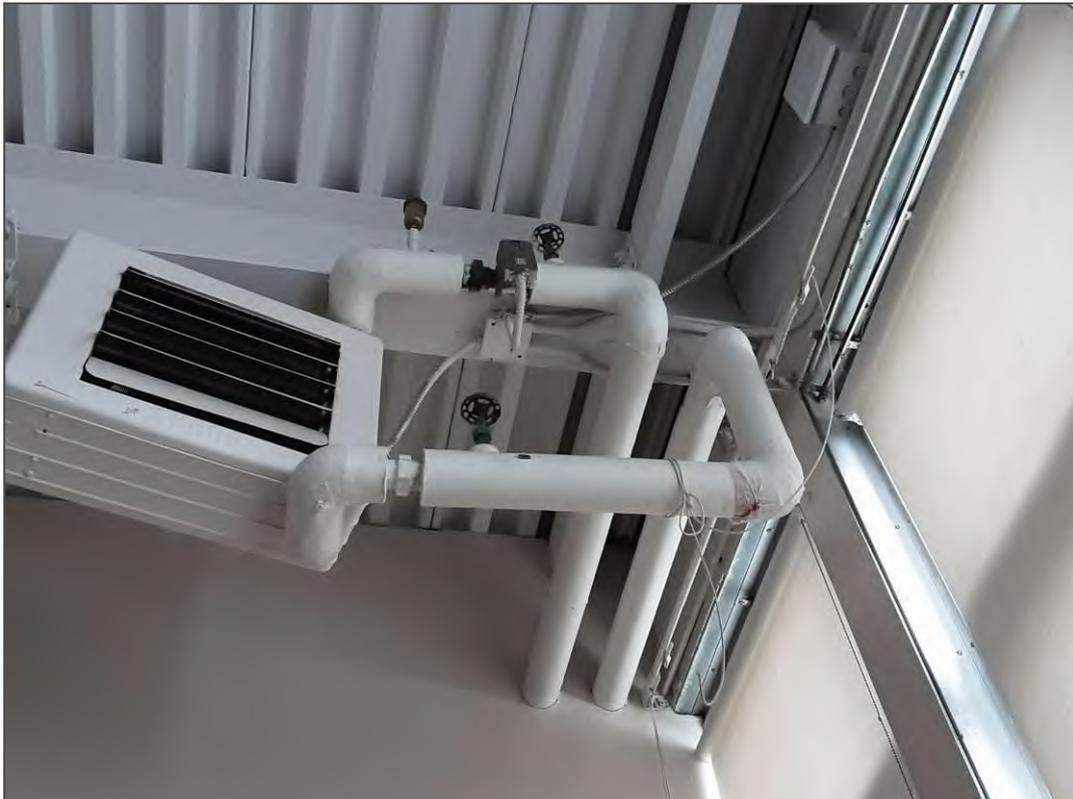
V0006 (Confirmed Asbestos), Piping, Parging Cement, Classroom (Location #: 151)

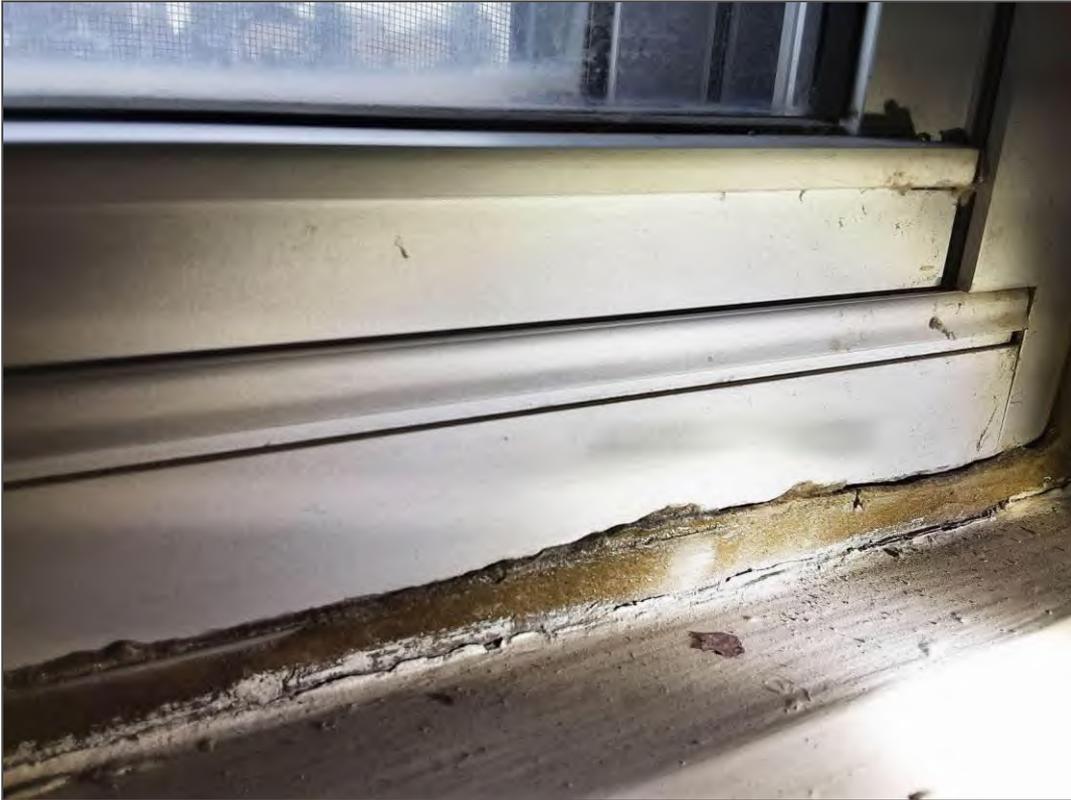
V0041 (Confirmed Asbestos), Soft grey, Wall, Window, Caulking, Classroom (Location #: 151)

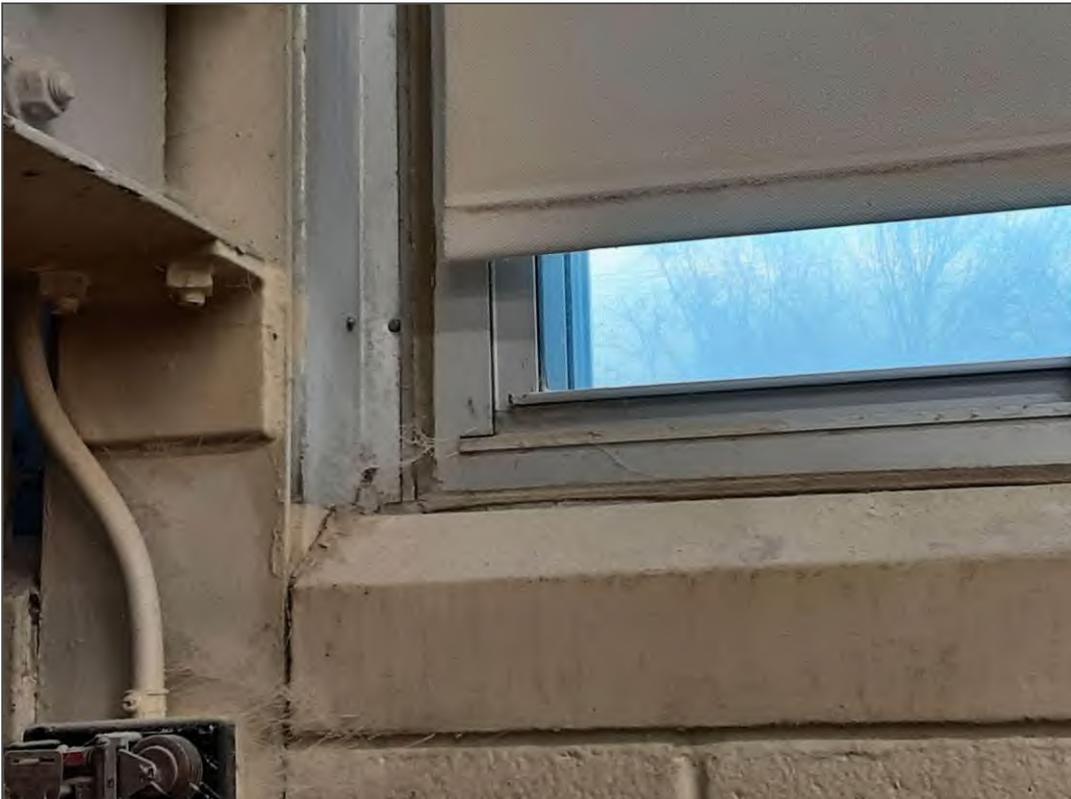
S0041B (Confirmed Asbestos), Soft grey, Wall, Window, Caulking, Wood Shop (Location #: 152)

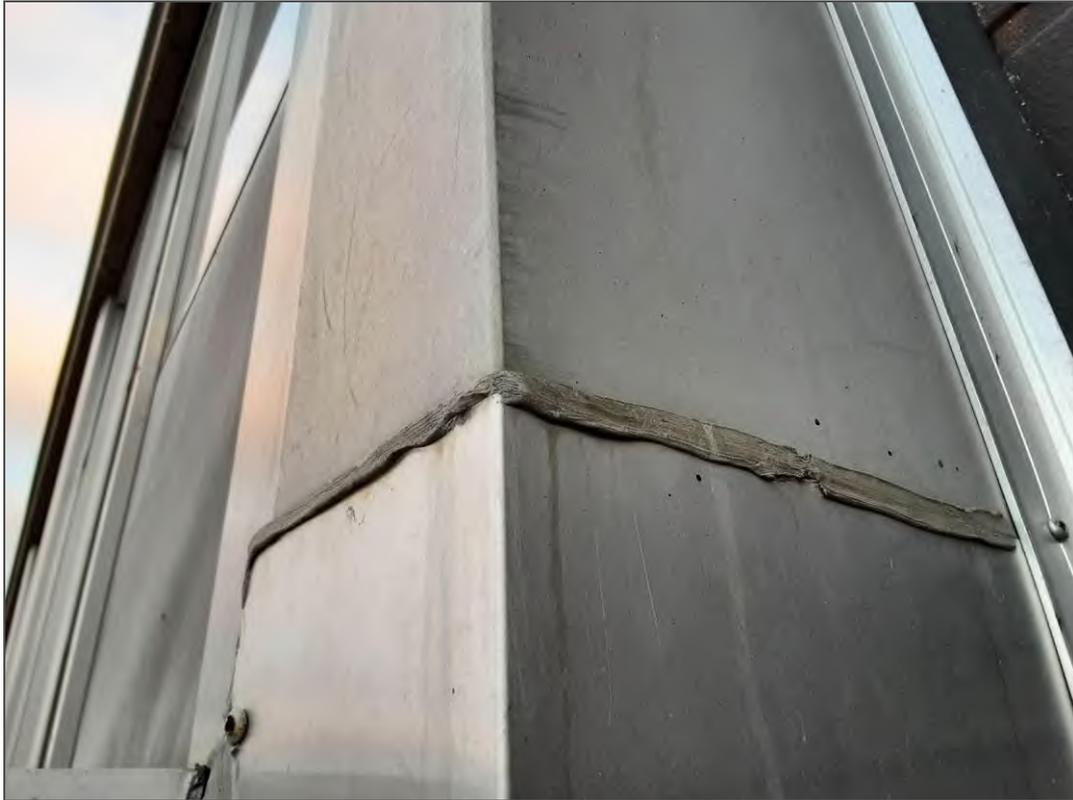
V0041 (Confirmed Asbestos), Soft, grey, Wall, Door, Caulking, Autoshop (Location #: 153)
Exterior garage door

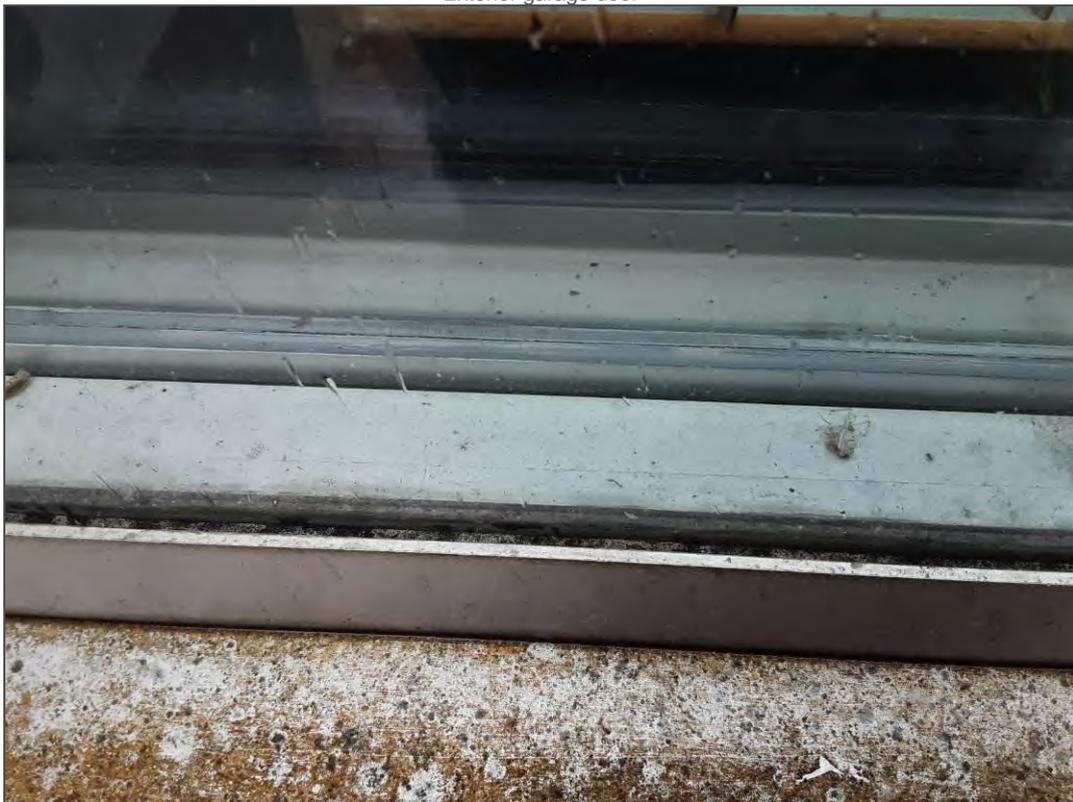
V0050 (Confirmed Asbestos), Grey, Wall, Window Liner, Sealant, Staff Room (Location #: 164)

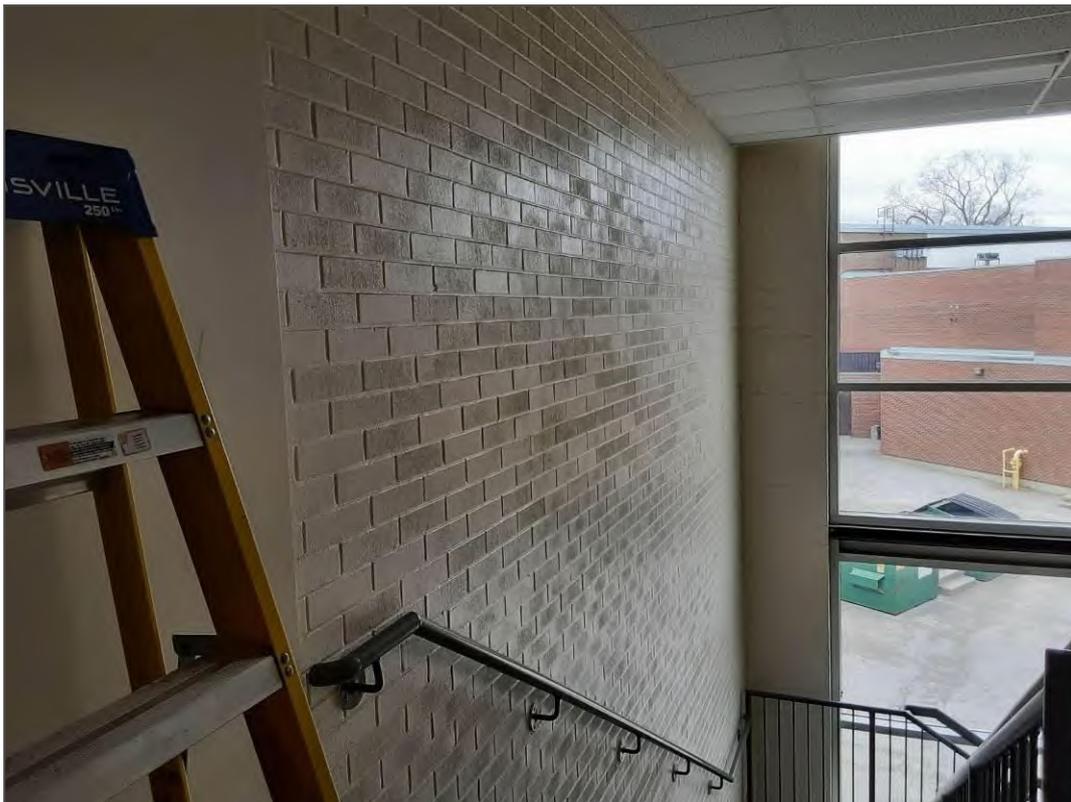
V0061 (Confirmed Asbestos), On brick and concrete block, Wall, Paint, Stairwell (Location #: 267)

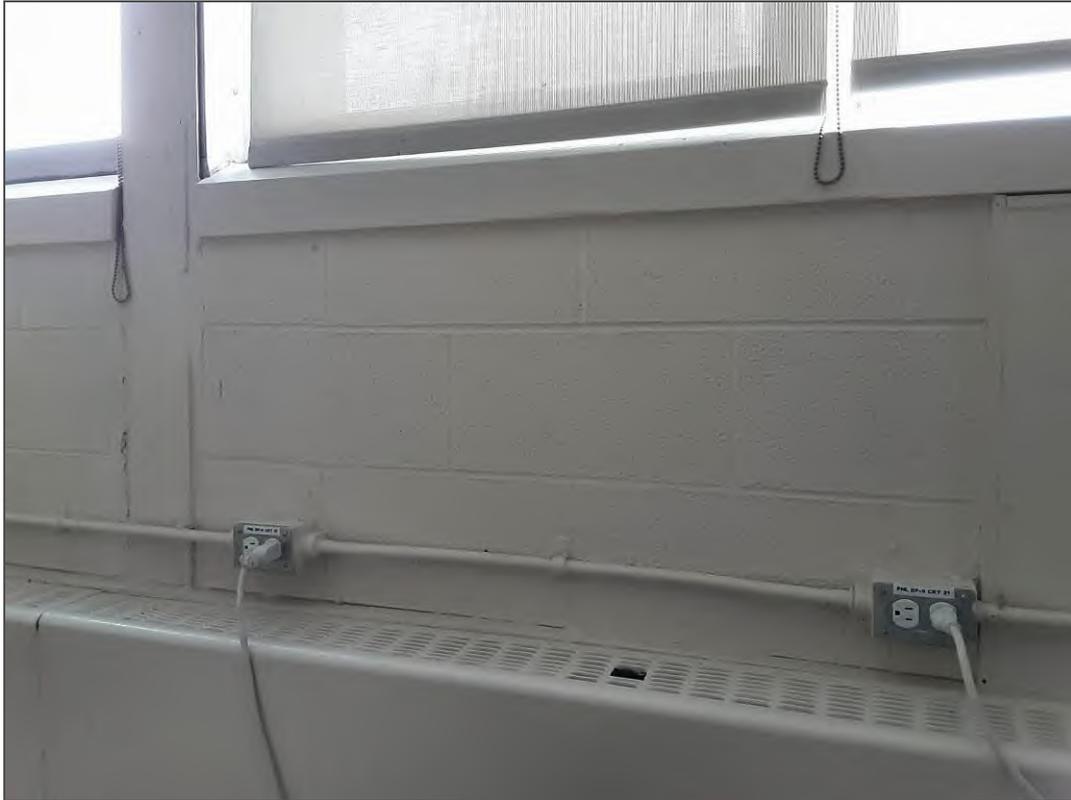
V0063 (Confirmed Asbestos), On concrete block, Wall, Paint, Classroom (Location #: 151)

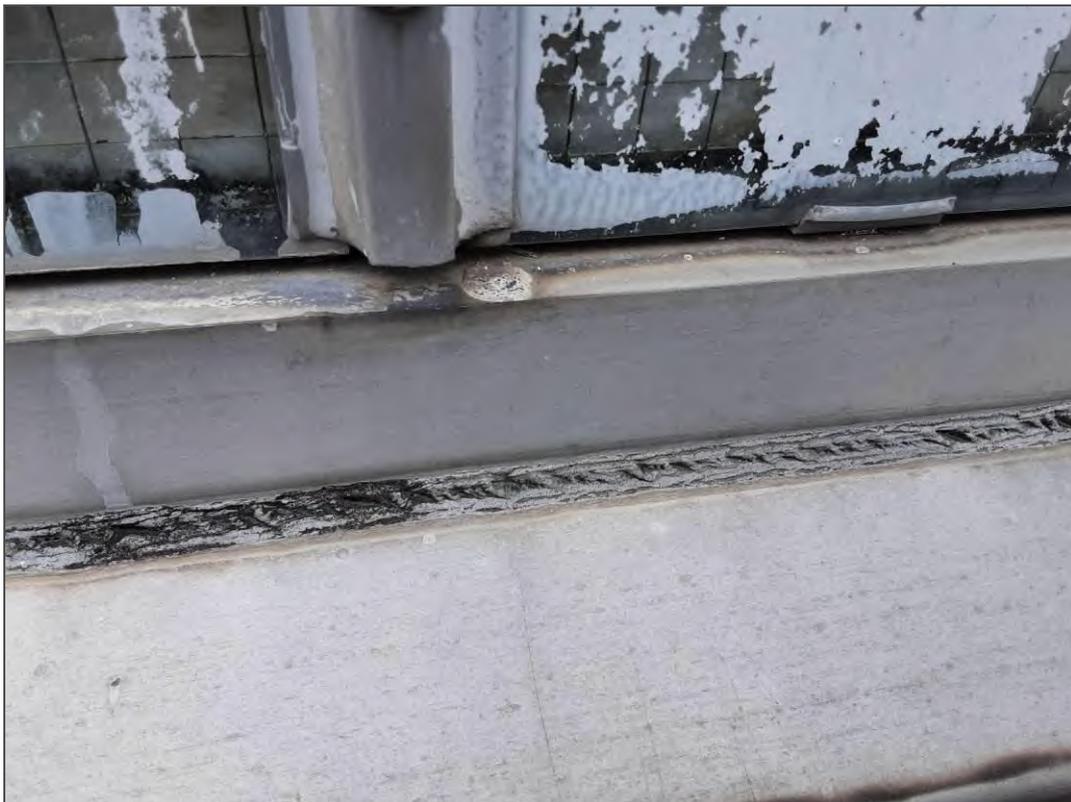
S0072C (Confirmed Asbestos), Grey, Wall, Window Frame, Caulking, Greenhouse Exterior (Location #: 1000)

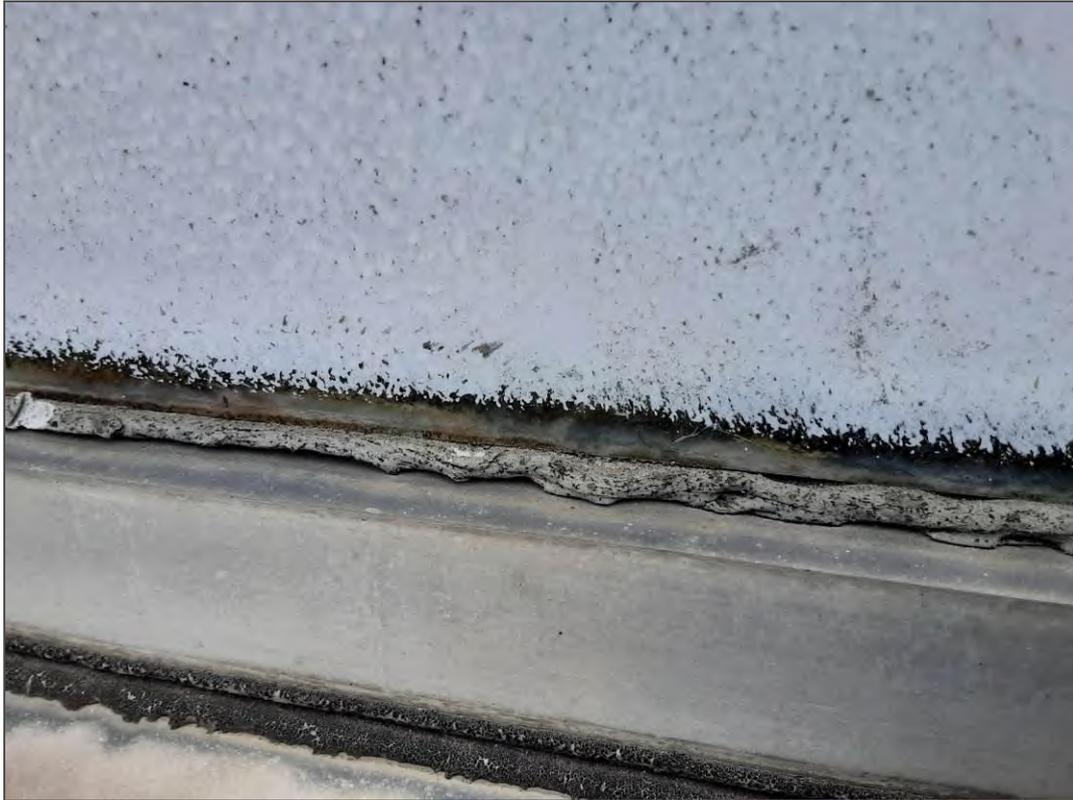
S0073A (Confirmed Asbestos), Grey, soft, Wall, Window Liner, Sealant, Greenhouse Exterior (Location #: 1000)

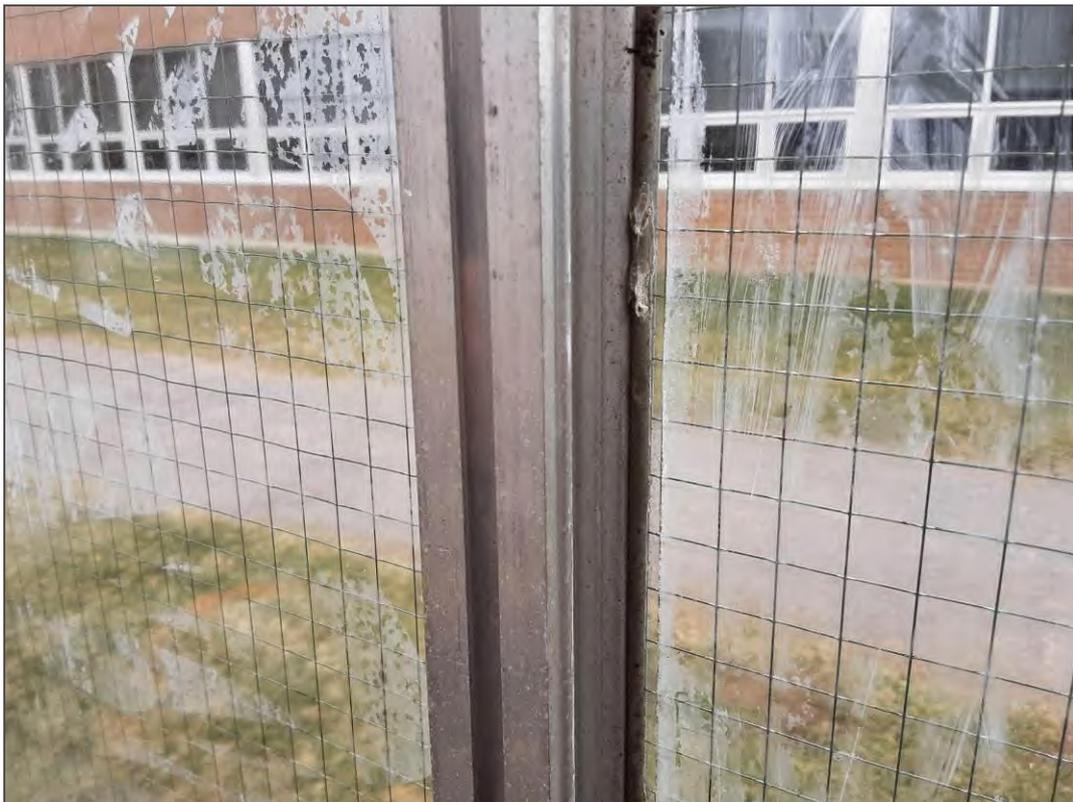
S0073C (Confirmed Asbestos), Grey, soft, Wall, Window Liner, Sealant, Greenhouse (Location #: 183)

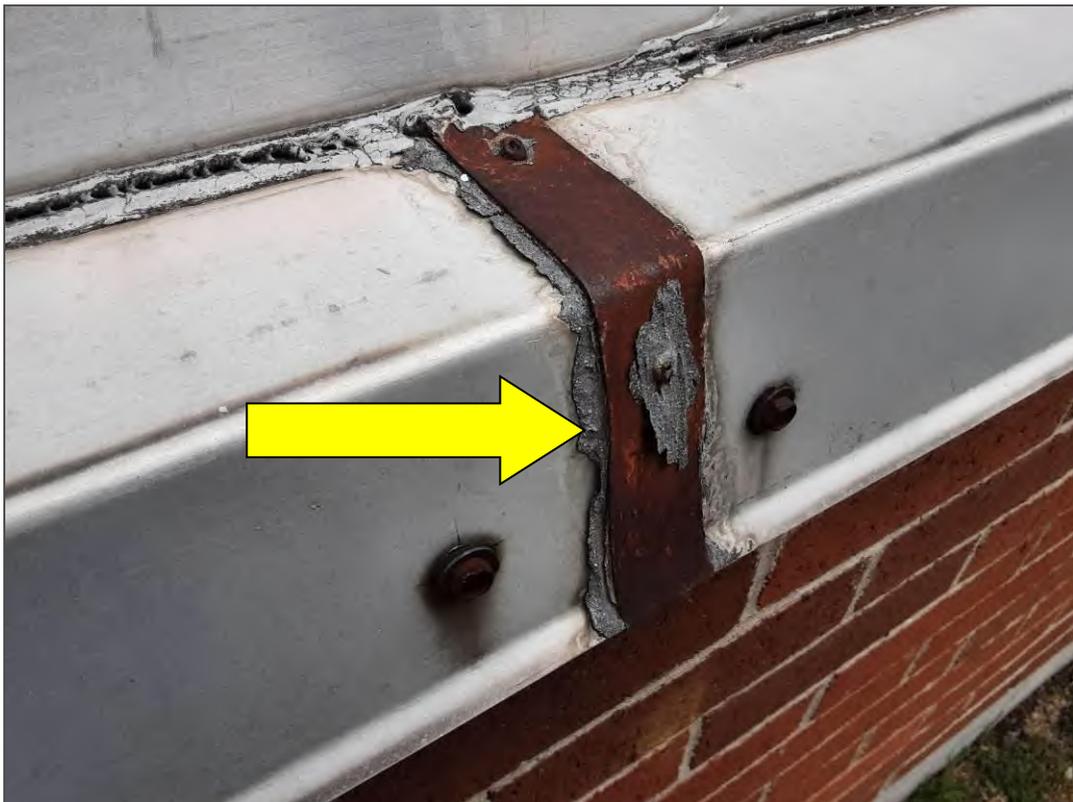
S0075C (Confirmed Asbestos), Brittle, fibrous, grey, Wall, Unidentified Material, Greenhouse Exterior (Location #: 1000)

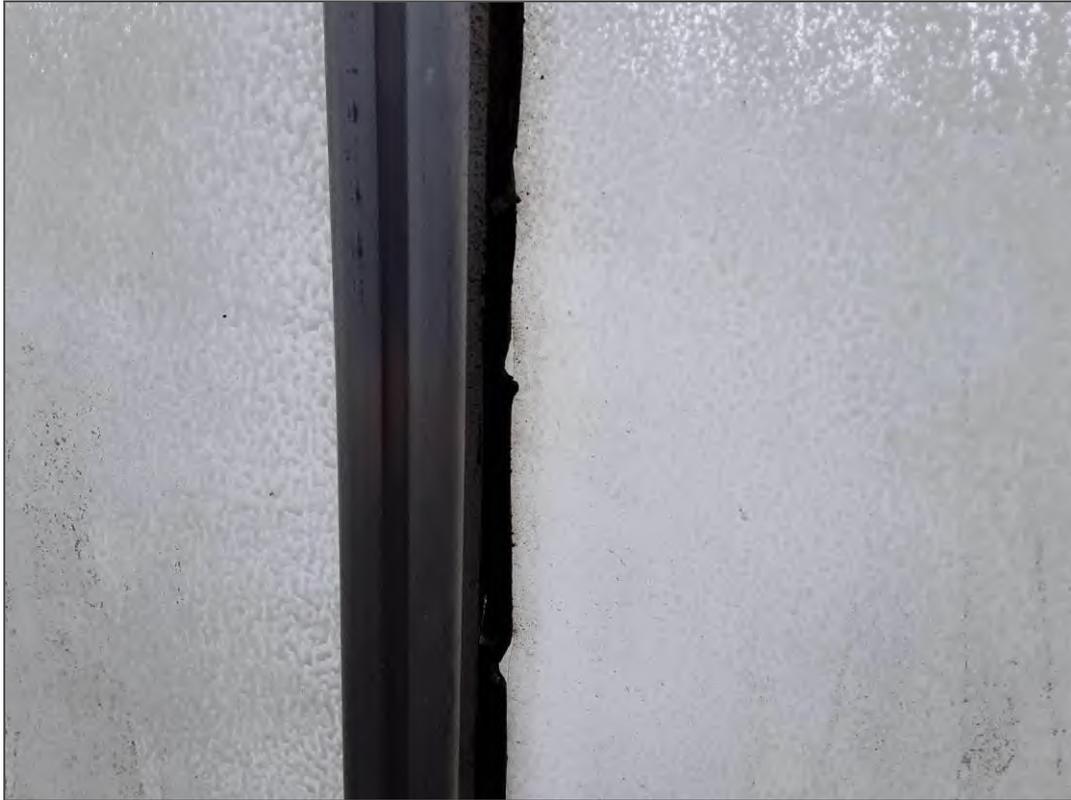
S0079C (Confirmed Asbestos), Black, Wall, Window Liner, Sealant, Greenhouse (Location #: 183)

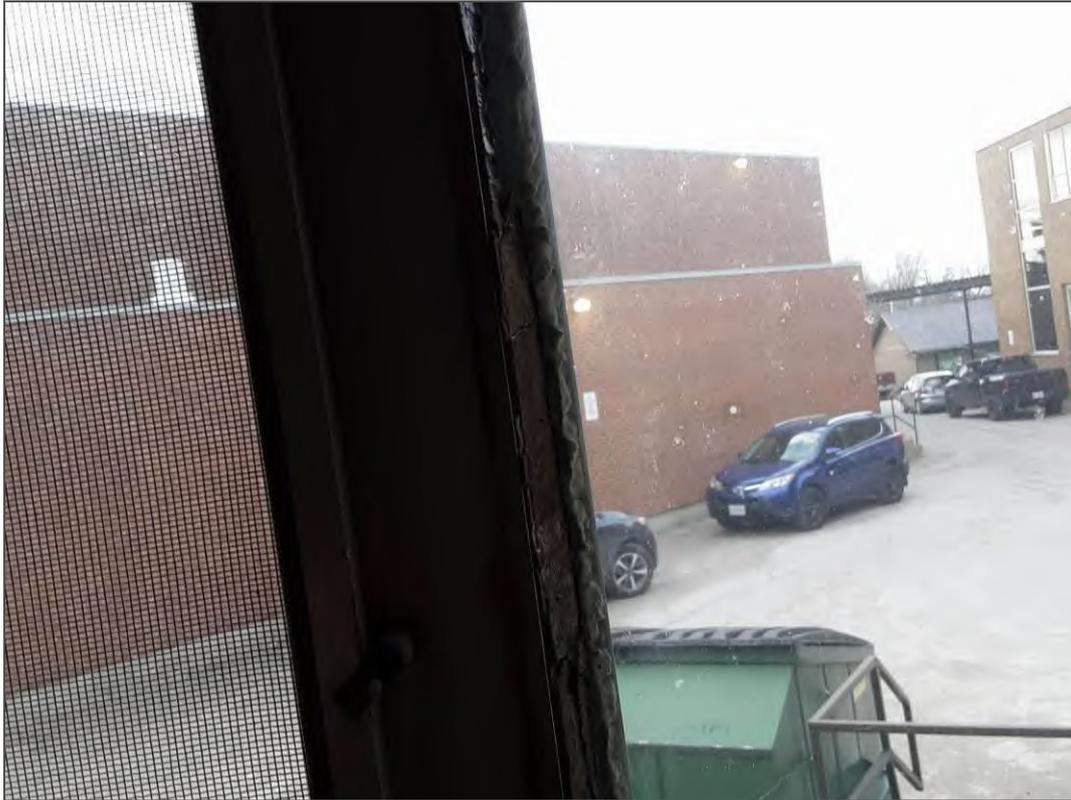
S0081C (Confirmed Asbestos), Beige, Wall, Window, Putty, Kitchen (Location #: 165)

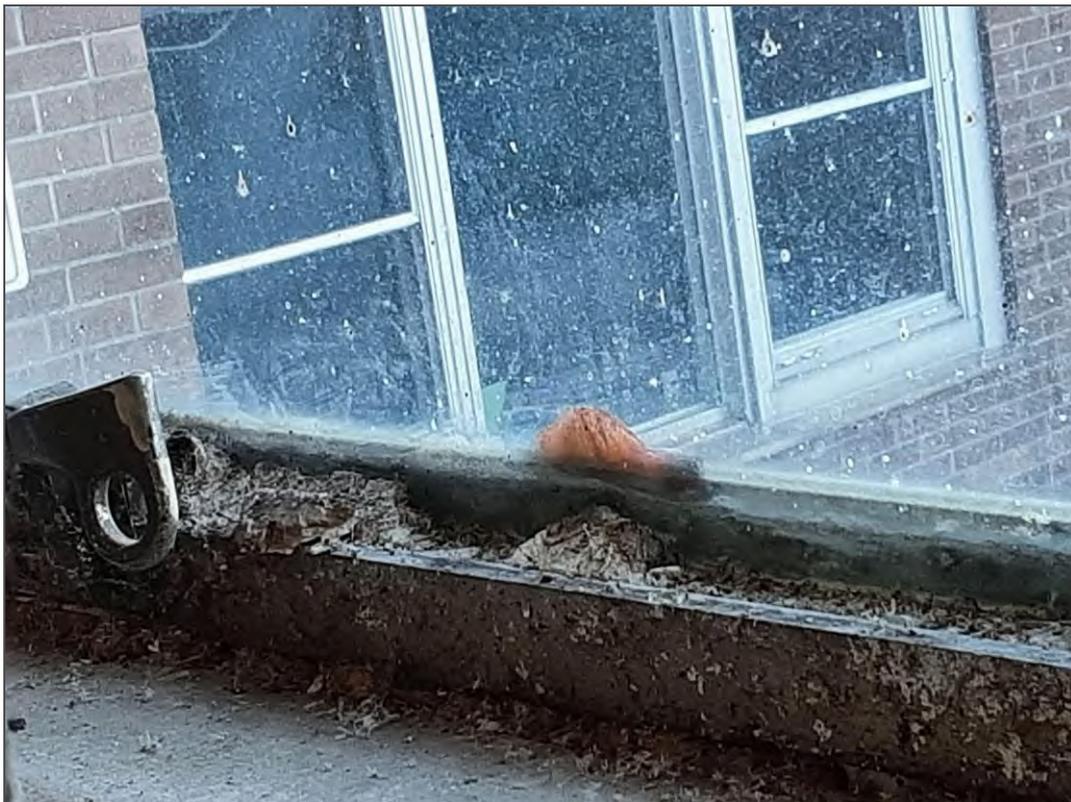
S0082A (Confirmed Asbestos), Off white, Wall, Window, Putty, Mechanical Room (Location #: 161)

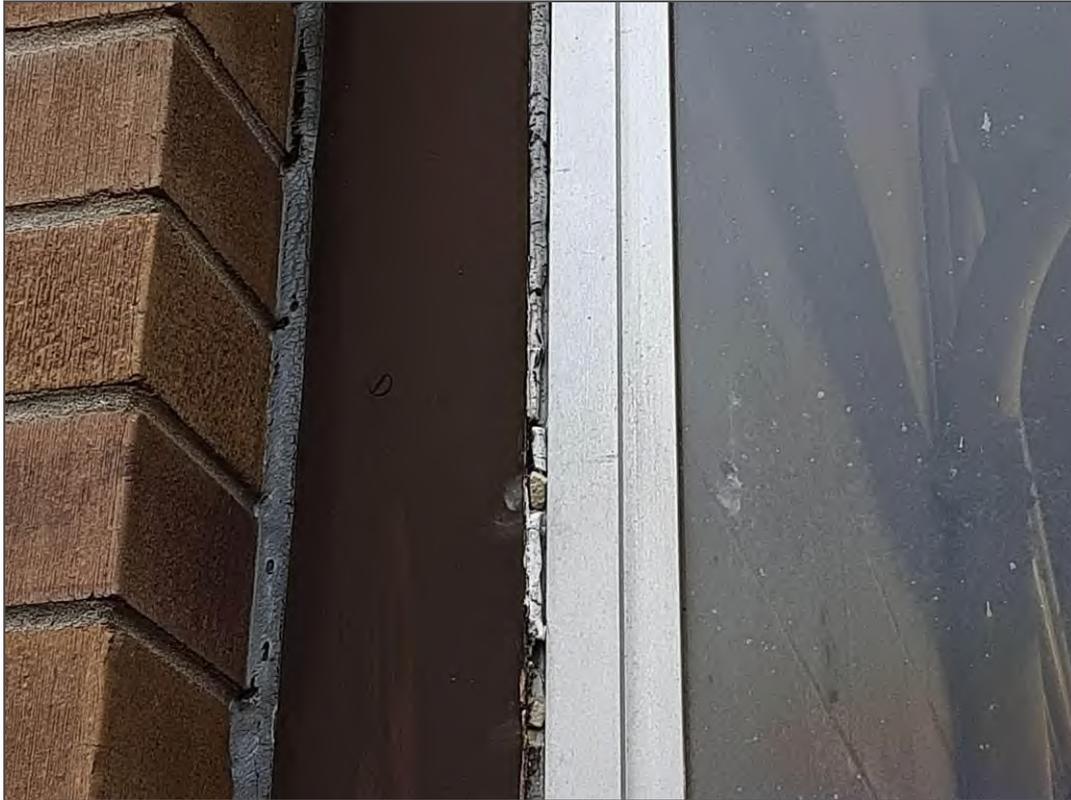
V0082 (Confirmed Asbestos), Off white, Wall, Window Liner, Putty, Mechanical Room (Location #: 161)
Exterior

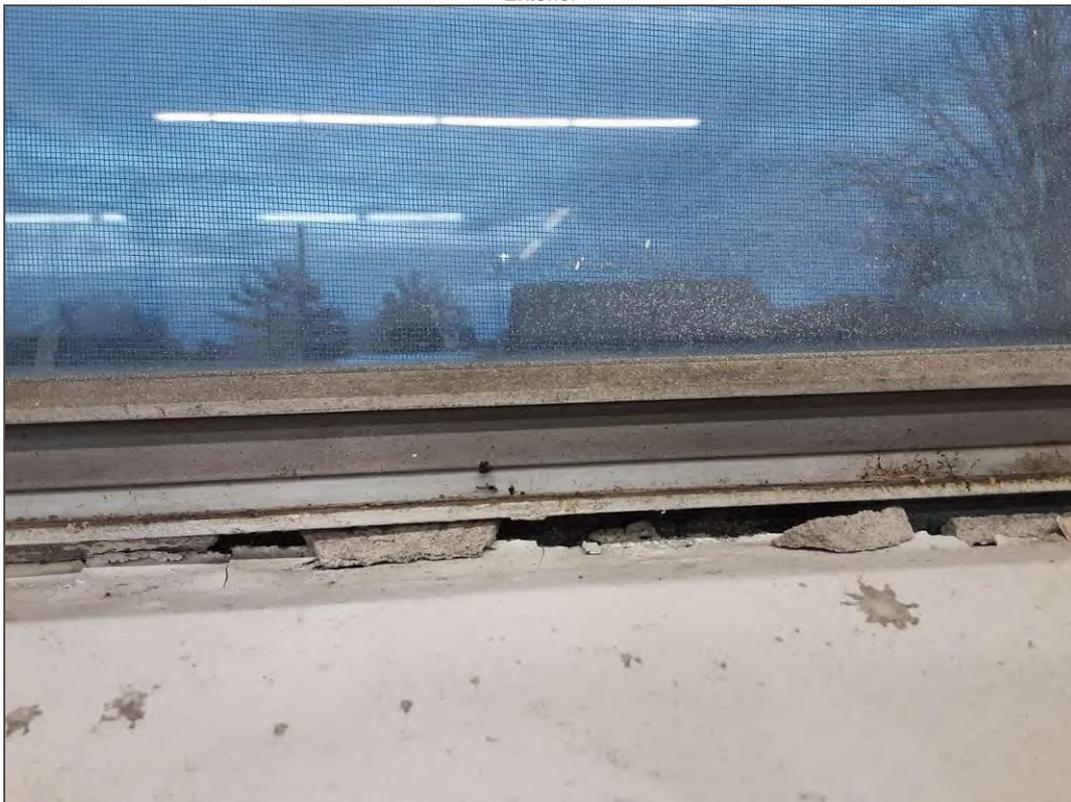
S0083B (Confirmed Asbestos), Grey, Wall, Window Frame, Putty, Manufacturing Shop (Location #: 154)

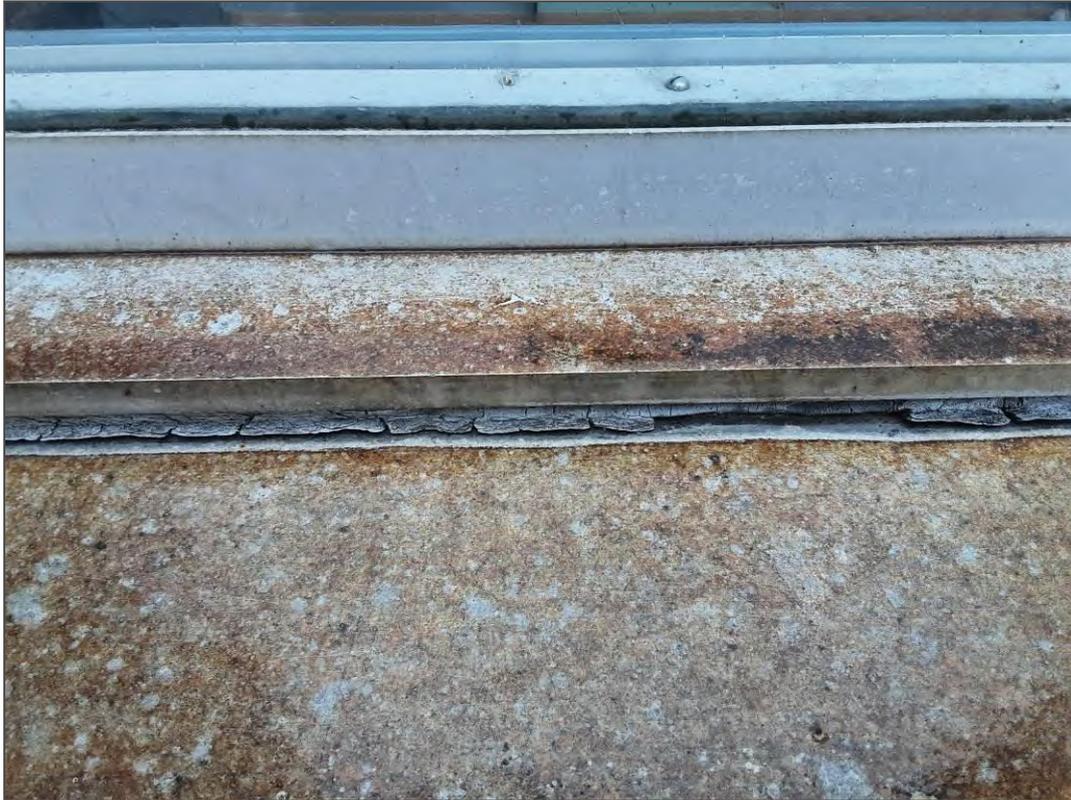
S0083C (Confirmed Asbestos), Grey, Wall, Window Frame, Putty, Staff Room (Location #: 164)
Exterior

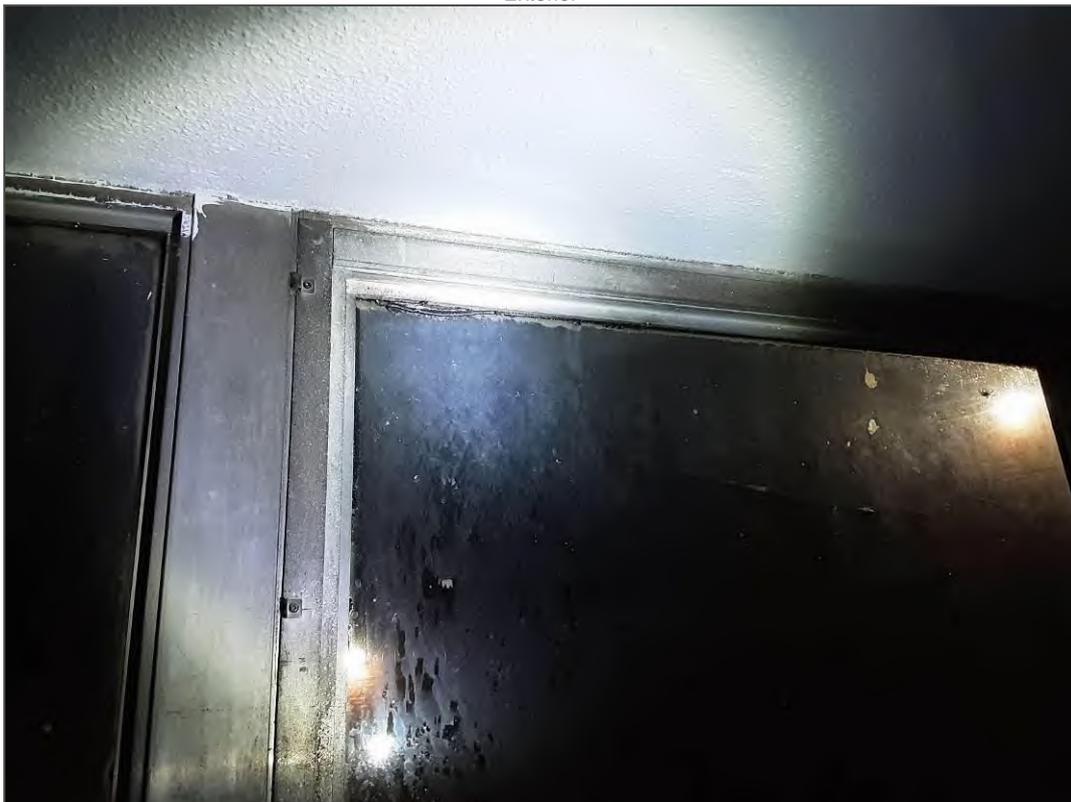
S0084C (Confirmed Asbestos), Black butyl, Wall, Window Liner, Sealant, Washroom (Location #: 159)

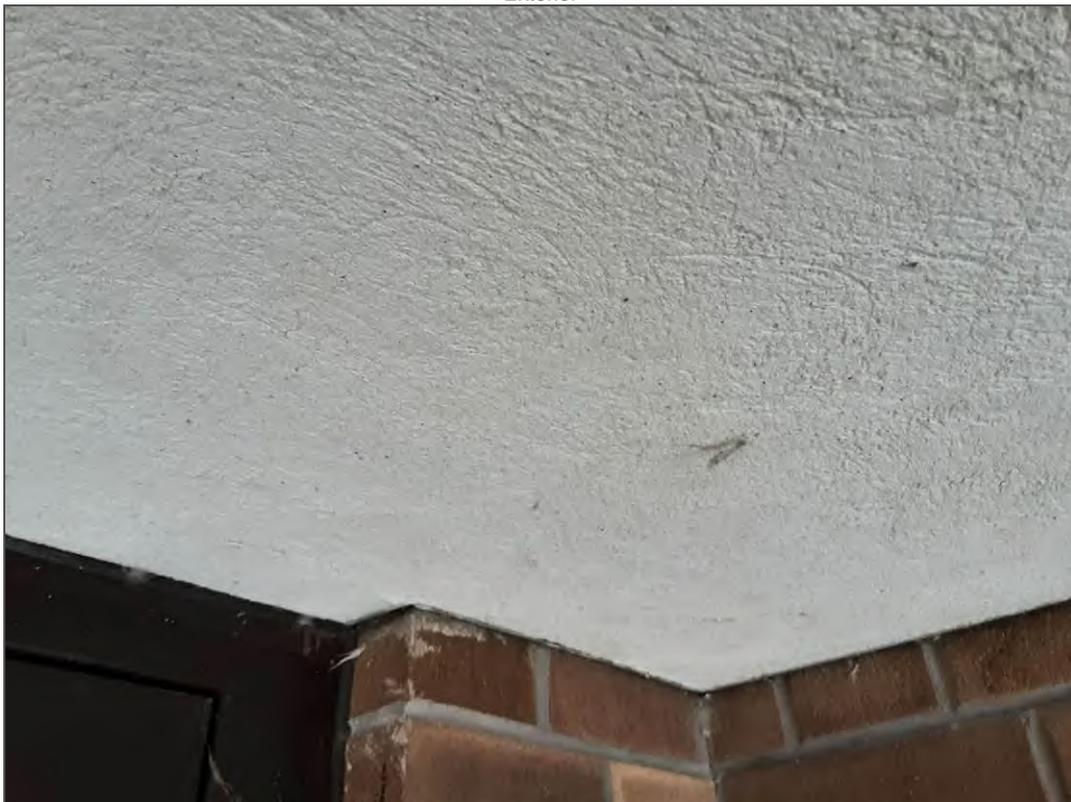
S0087C (Confirmed Asbestos), Structure, Texture Coat, Corridor (Location #: 195)
Exterior canopy

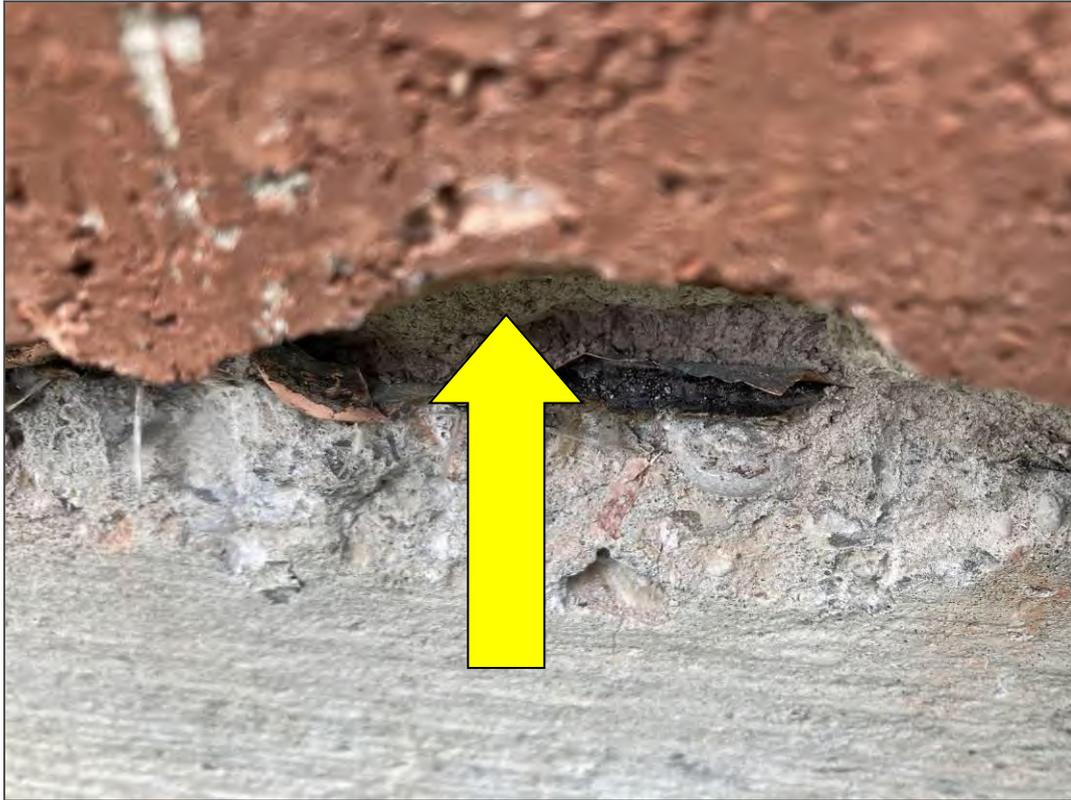
S0089A (Confirmed Asbestos), Wall, Mortar, Greenhouse Exterior (Location #: 1000)

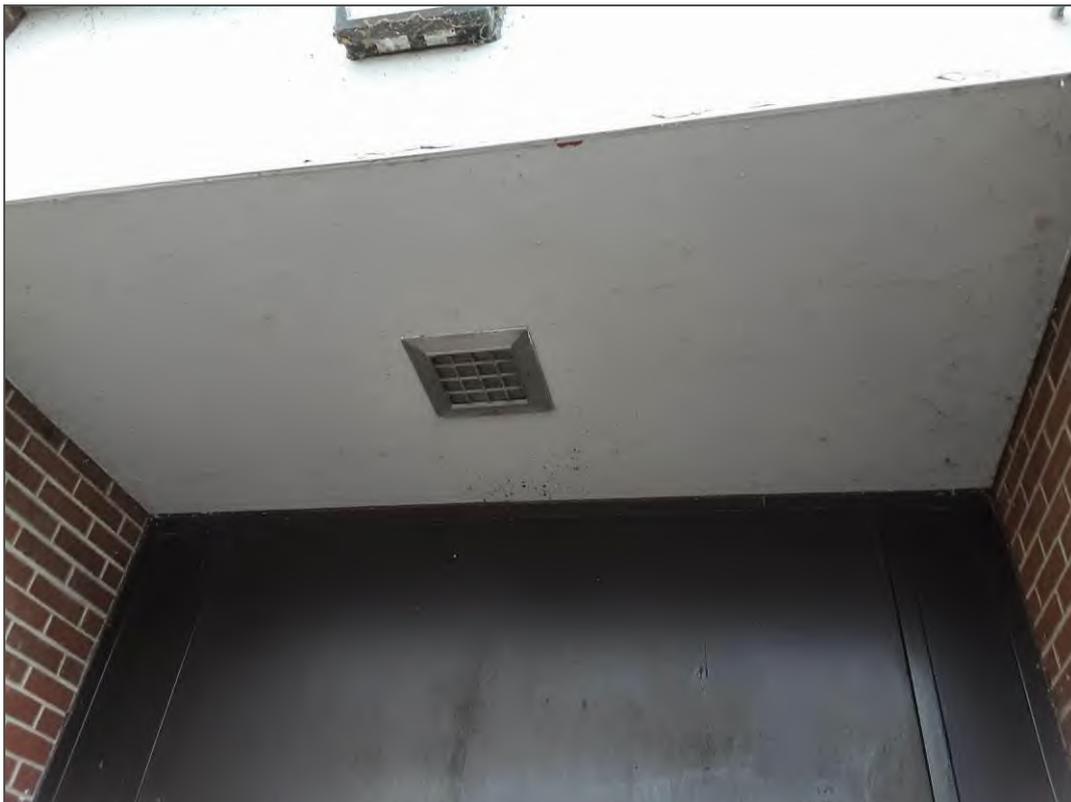
S0090A (Confirmed Asbestos), Transite, Structure, Canopy, Cement Product, Corridor (Location #: 194)
Exterior
