Re: Hazardous Building Materials Assessment (Preconstruction)
Eastside Secondary School, 275 Farley Avenue, Belleville, ON
Pinchin File: 200584.112

Hastings and Prince Edward District School Board (Client) retained Pinchin Ltd. (Pinchin) to conduct a desktop hazardous building materials assessment of Eastside Secondary School located at 275 Farley Avenue, Belleville, ON.

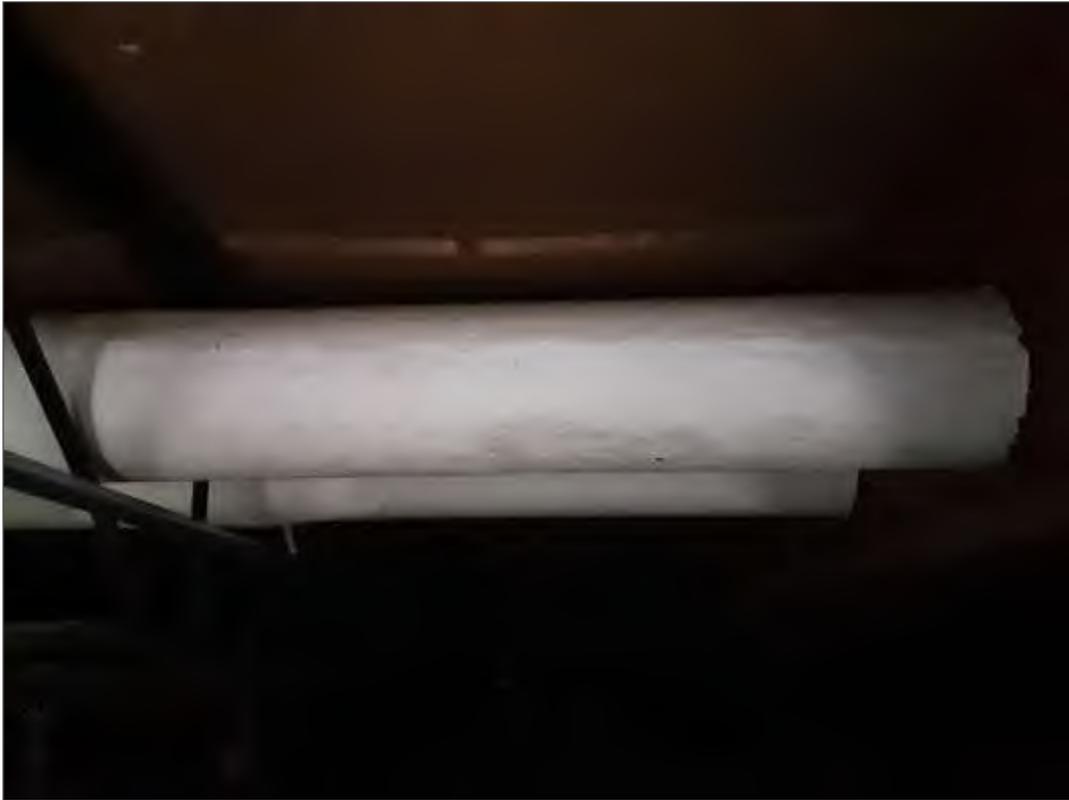
V0001 (Confirmed Asbestos), Piping, Hot Water Heating, Aircell, Classroom (Location #: 104)

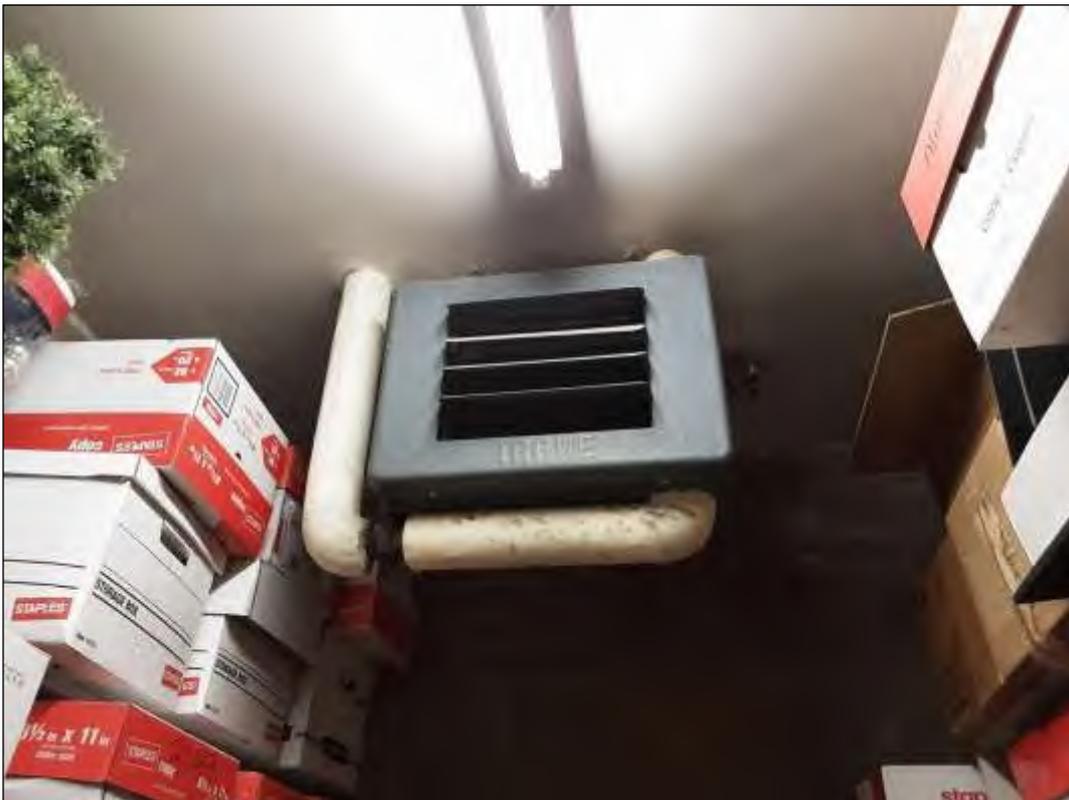
V0001 (Confirmed Asbestos), Piping, Aircell, Office (Location #: 124)

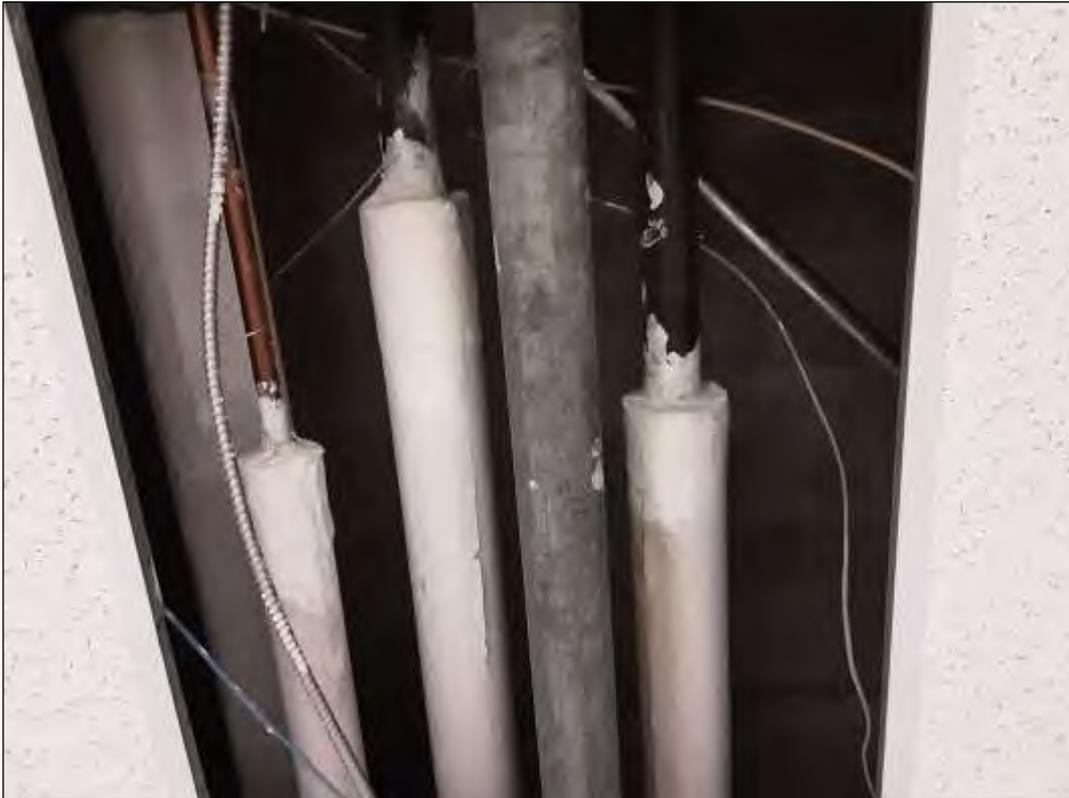
V0001 (**Confirmed Asbestos**), Piping, Aircell, Corridor (Location #: 192)

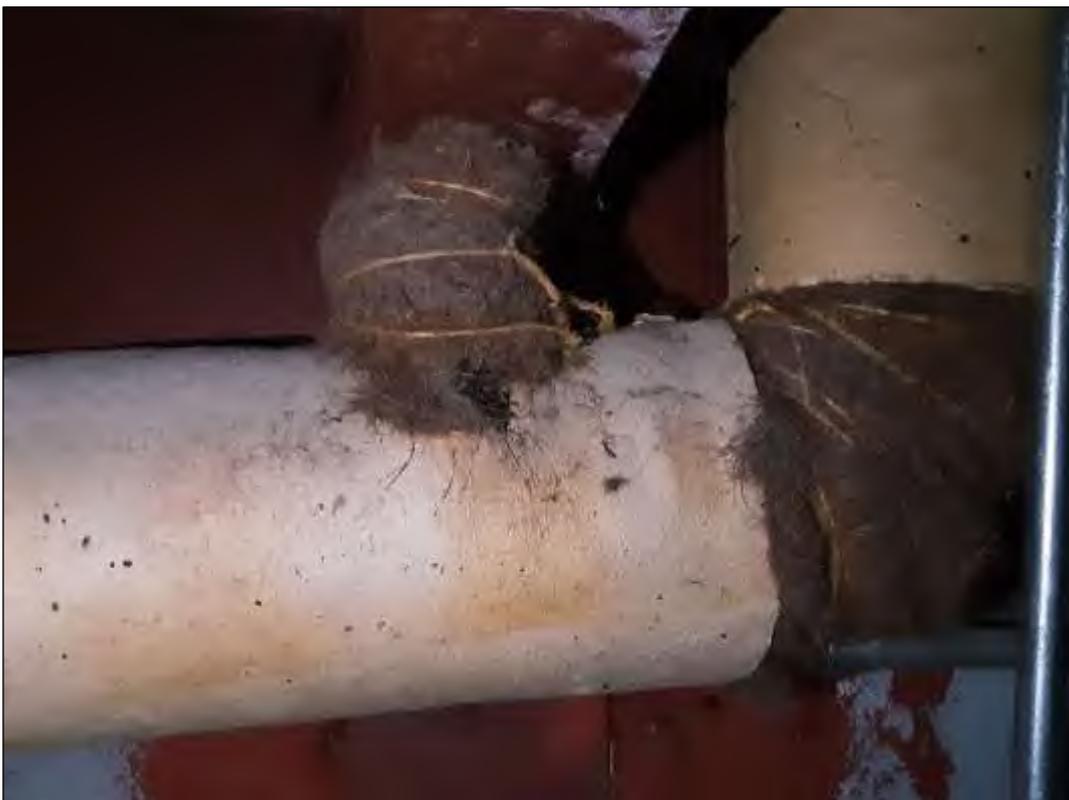
V0002 (**Confirmed Asbestos**), Piping, Rain Water Leader, Sweatwrap, Corridor (Location #: 190)

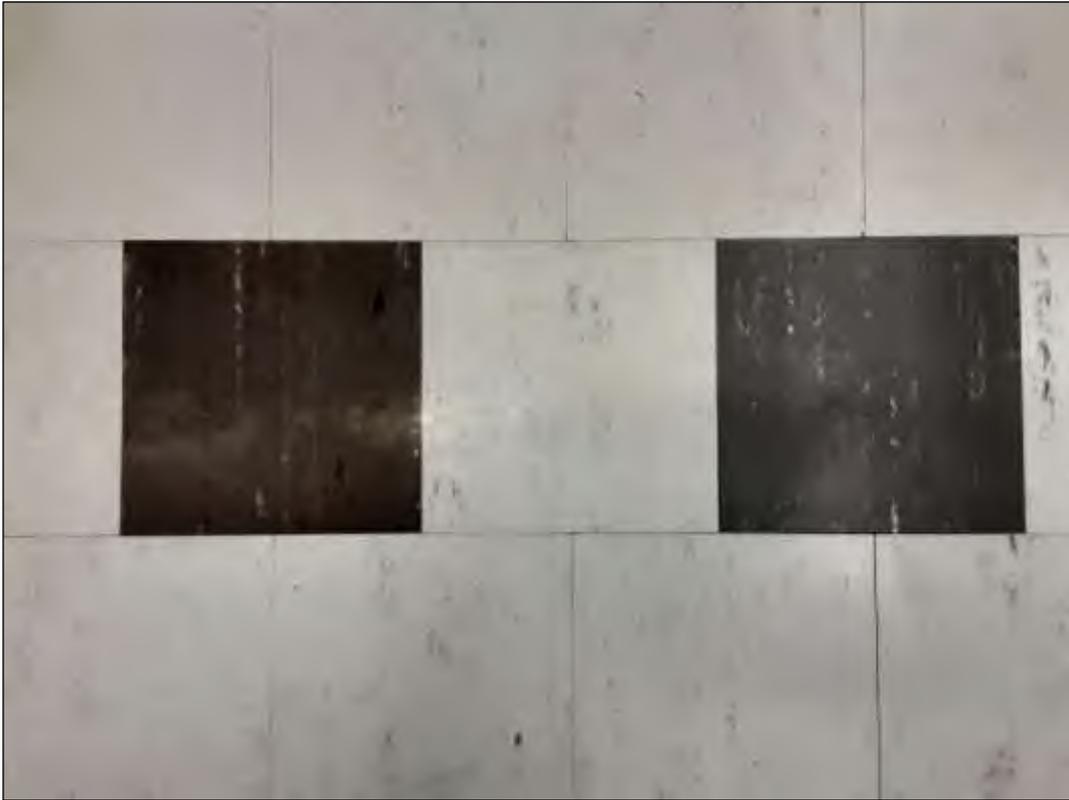
V0003 (**Confirmed Asbestos**), Floor, Vinyl Floor Tile and Mastic, 9x9 various colours, Classroom (Location #: 102)

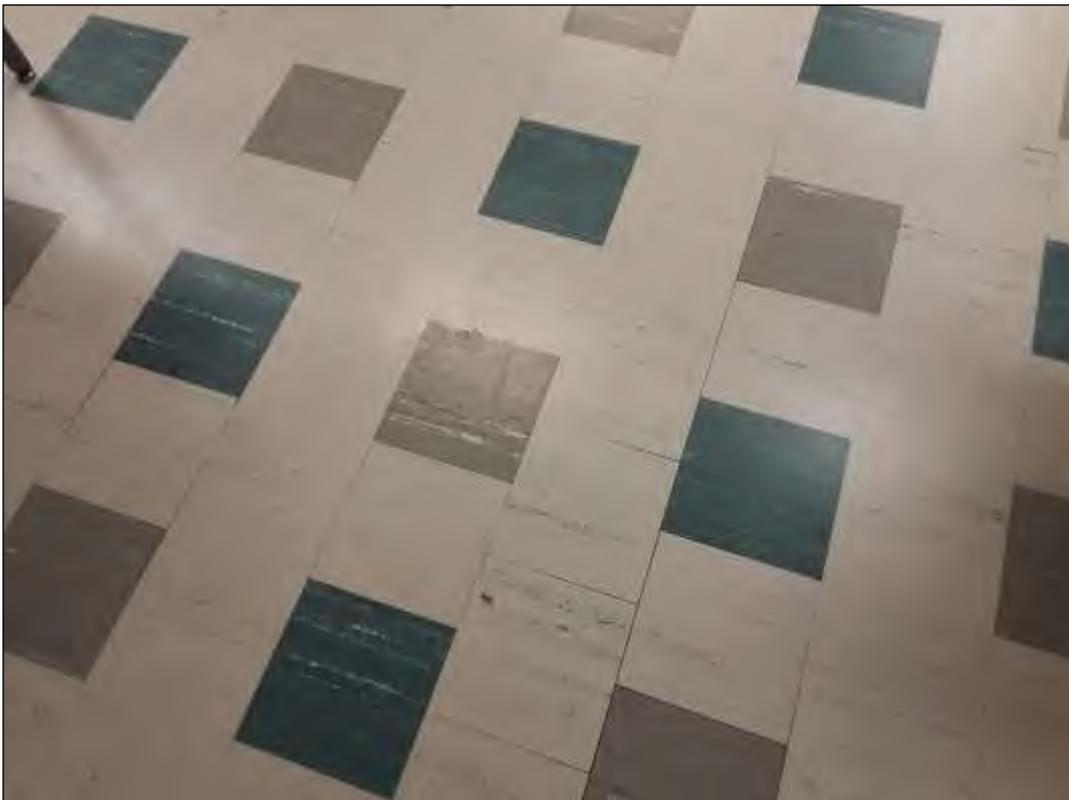
V0003 (**Confirmed Asbestos**), Floor, Vinyl Floor Tile and Mastic, 9x9 various colours, Classroom (Location #: 103)

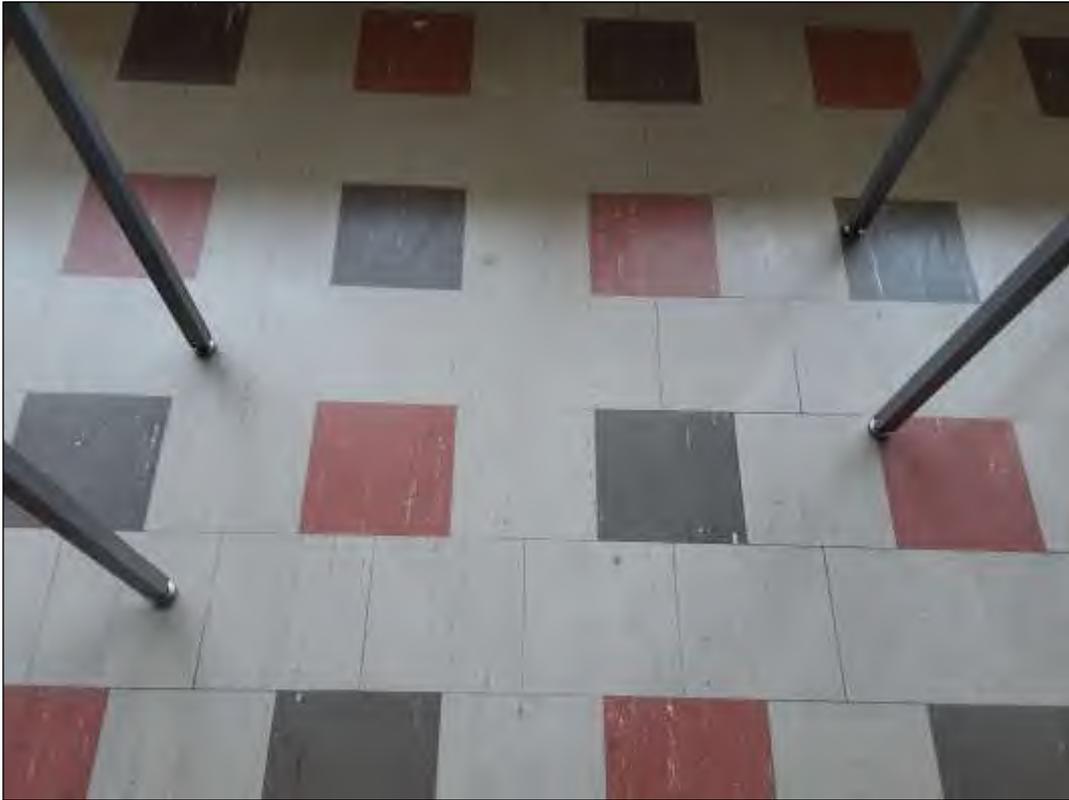
S0003B (**Confirmed Asbestos**), Floor, Vinyl Floor Tile and Mastic, 9x9 various colours, Classroom (Location #: 115)

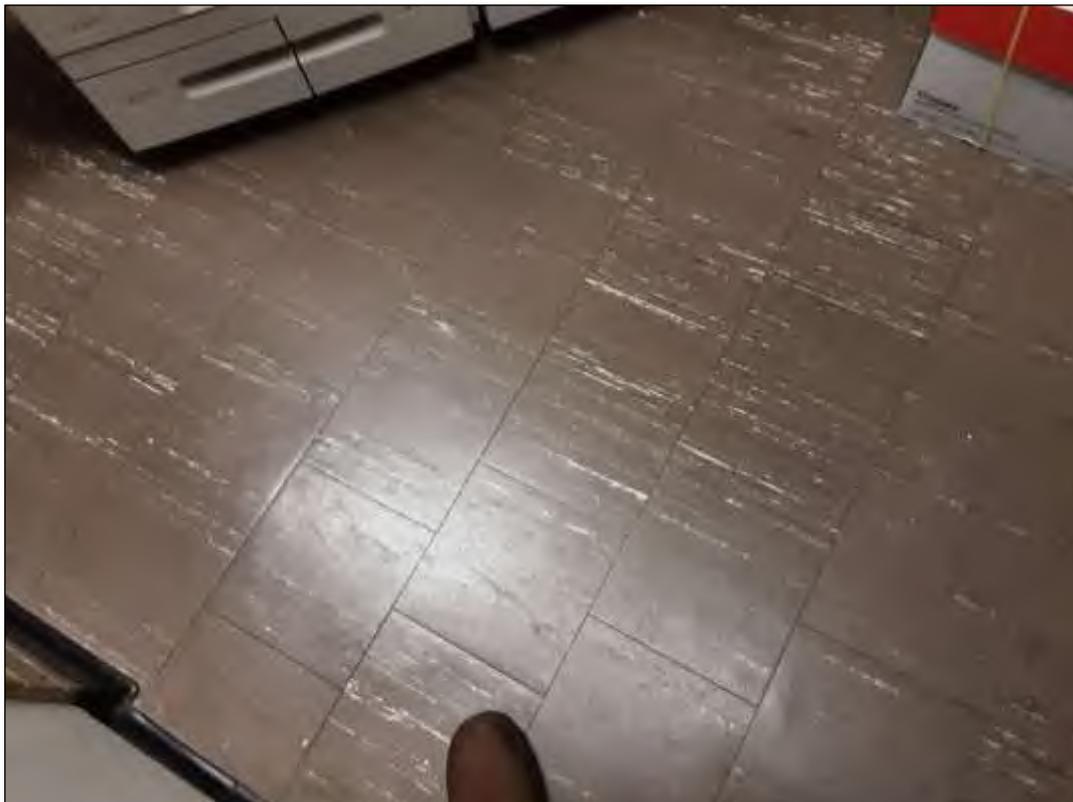
V0003 (**Confirmed Asbestos**), Floor, Vinyl Floor Tile and Mastic, 9x9 various colours, Office (Location #: 124)

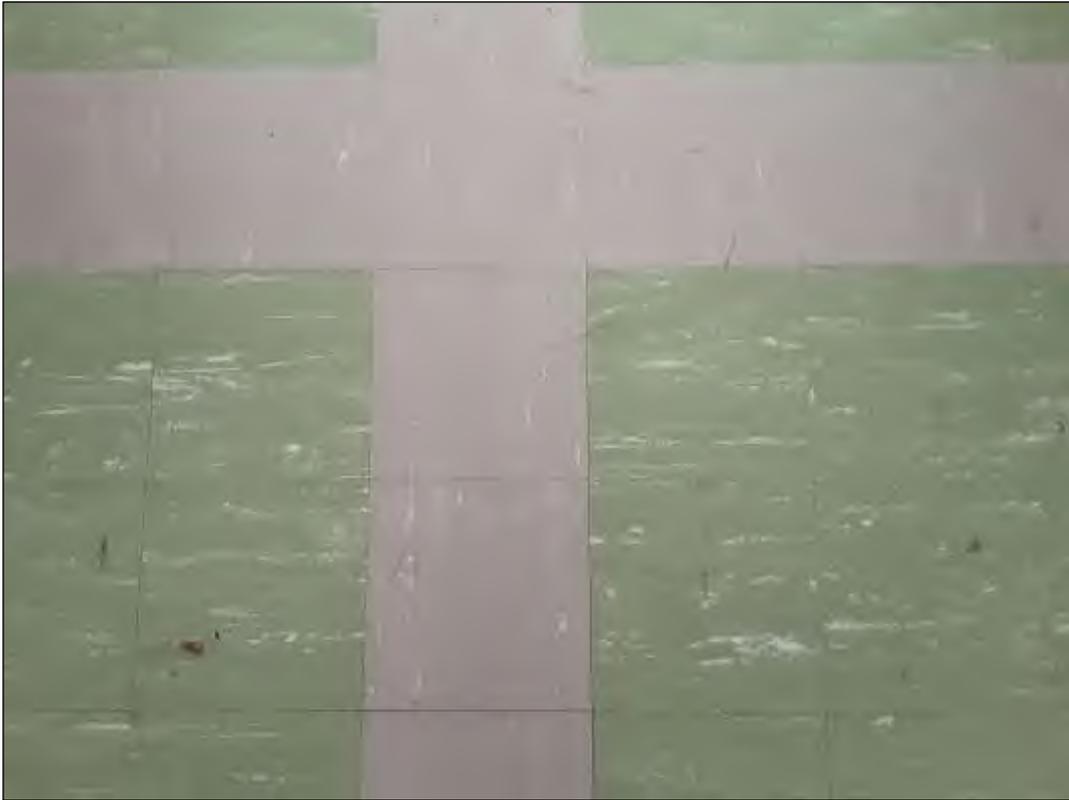
S0003C (**Confirmed Asbestos**), Floor, Vinyl Floor Tile and Mastic, 9x9 various colours, Classroom (Location #: 157)

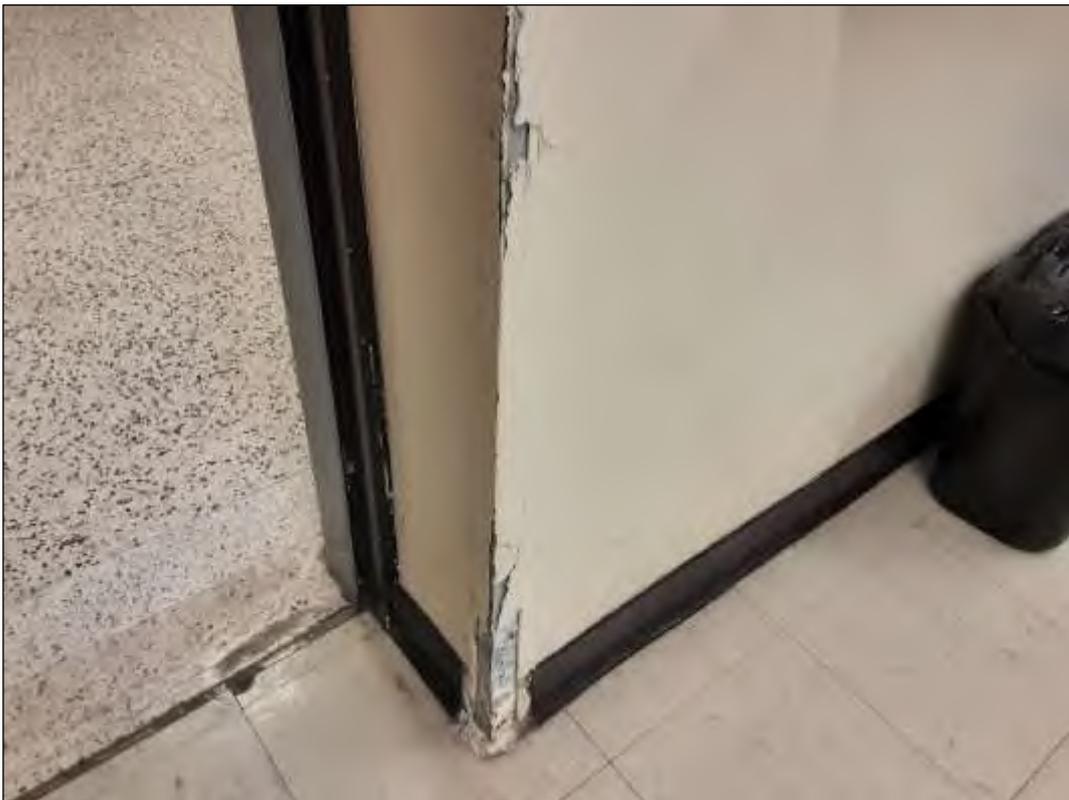
S0005E (**Confirmed Asbestos**), Wall, Drywall and joint compound, **Poor Condition**, Classroom (Location #: 212)

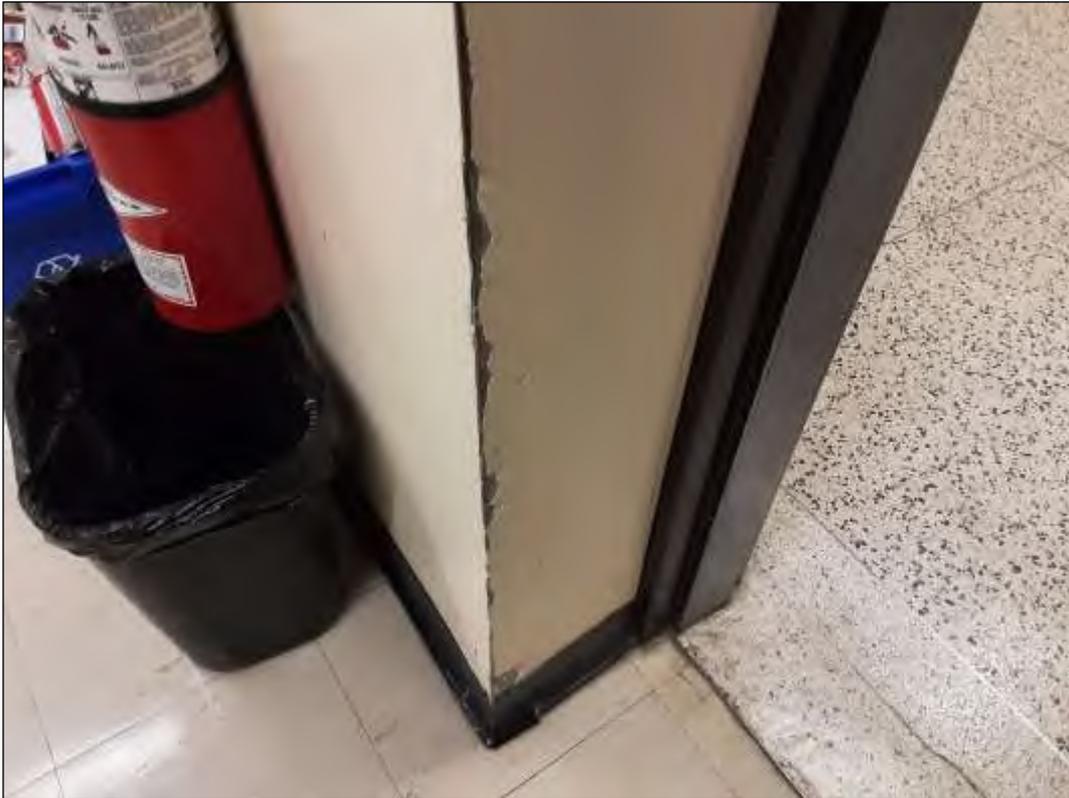
S0005G (Confirmed Asbestos), Wall, Drywall and joint compound, **Poor Condition**, Classroom (Location #: 215)

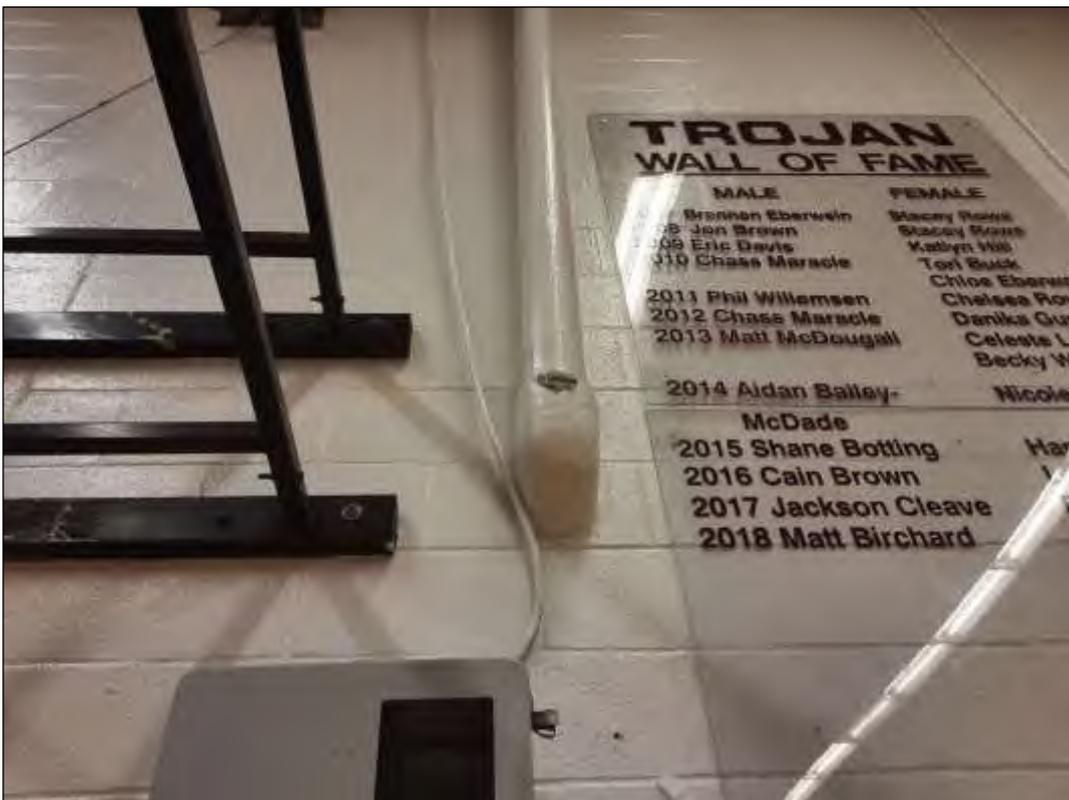
V0006 (Confirmed Asbestos), Piping, Rain Water Leader, Parging Cement, **Poor Condition**, Gym (Location #: 142)

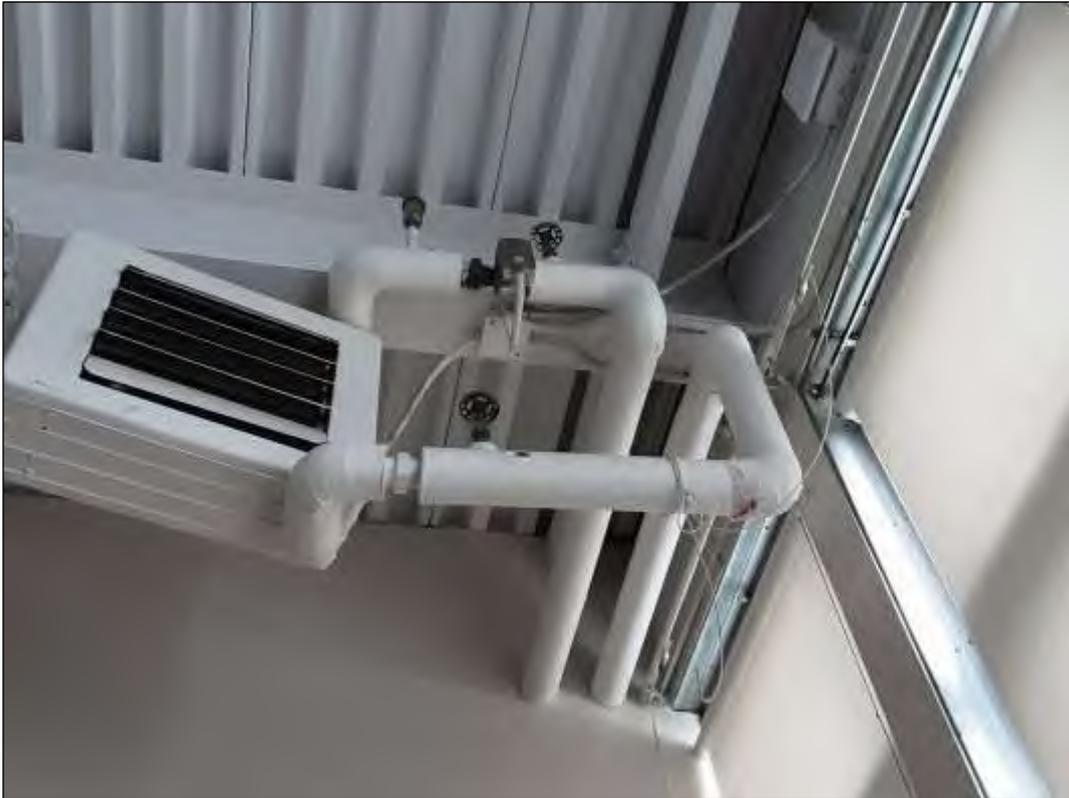
V0006 (**Confirmed Asbestos**), Piping, Parging Cement, Classroom (Location #: 151)

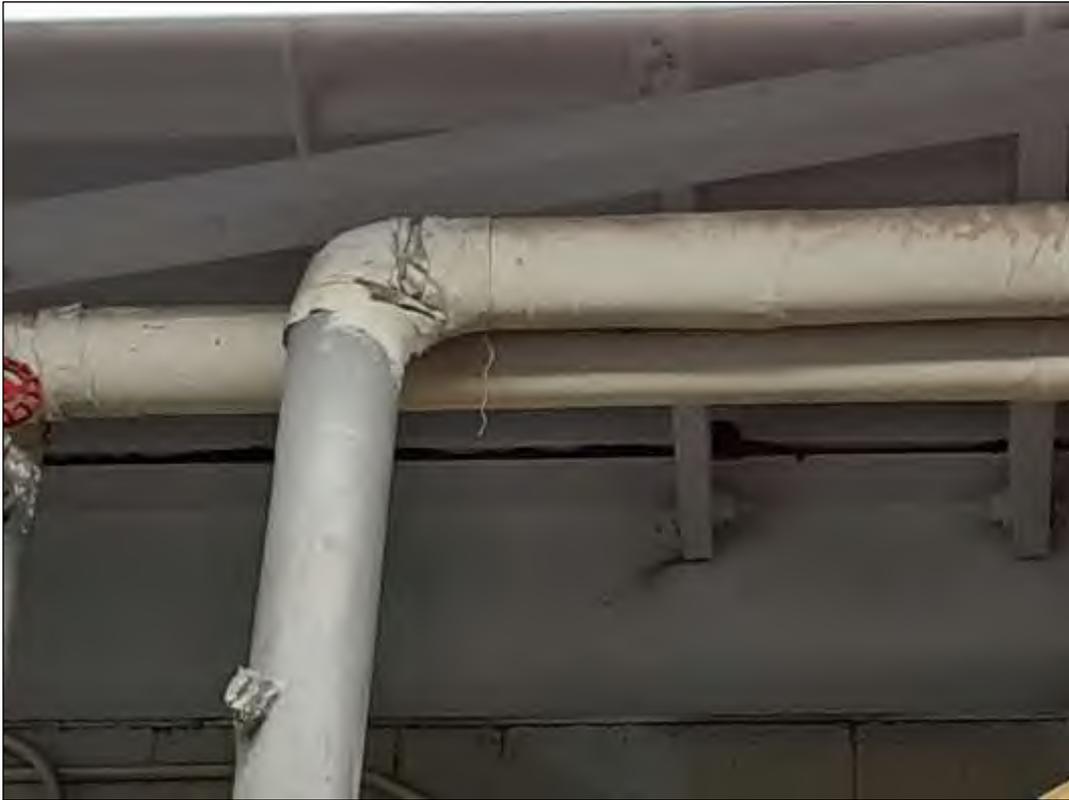
S0008A (Confirmed Asbestos), Piping, Parging Cement, **Poor Condition**, Autoshop (Location #: 153)

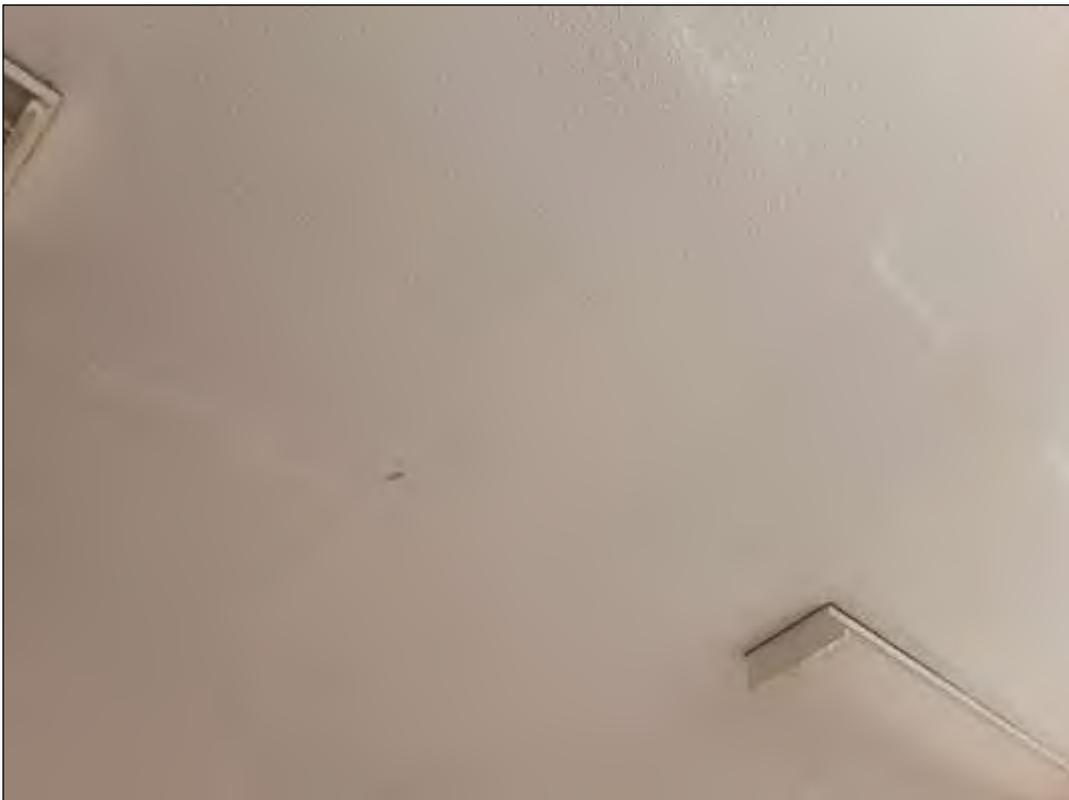
S0012A (**Confirmed Asbestos**), Ceiling, Texture Finish, Washroom (Location #: 159)

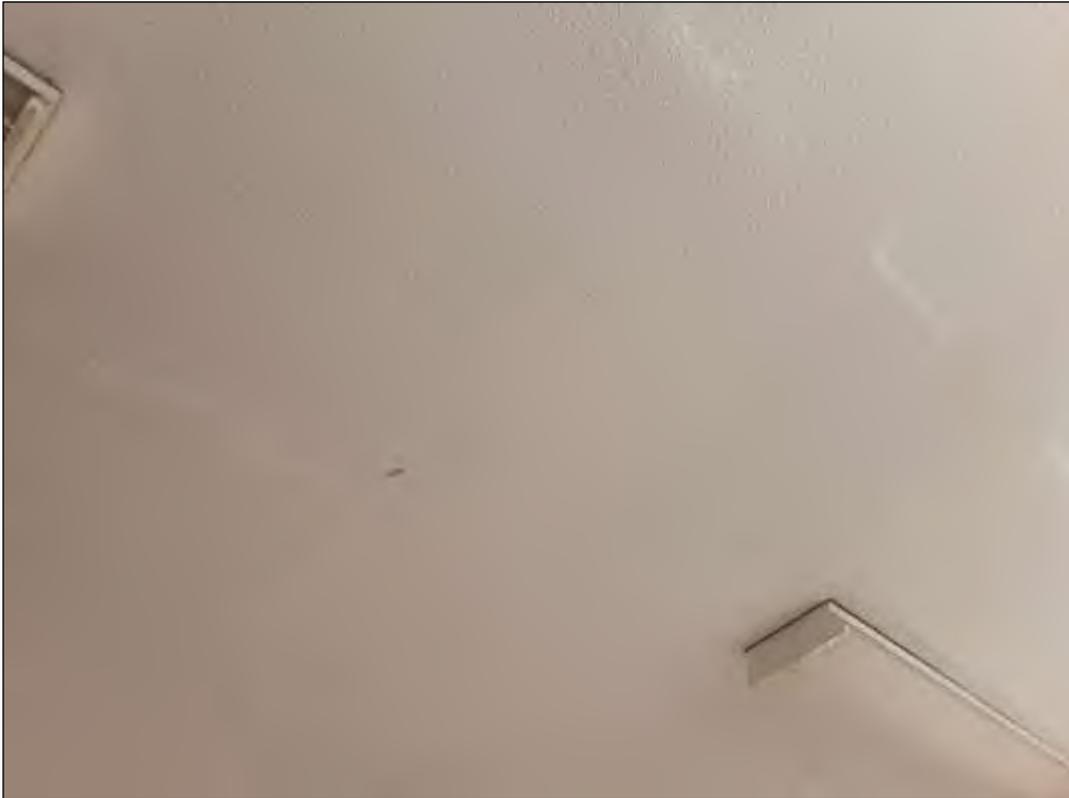
S0012A (**Confirmed Asbestos**), Ceiling, Texture Finish, Washroom (Location #: 159)

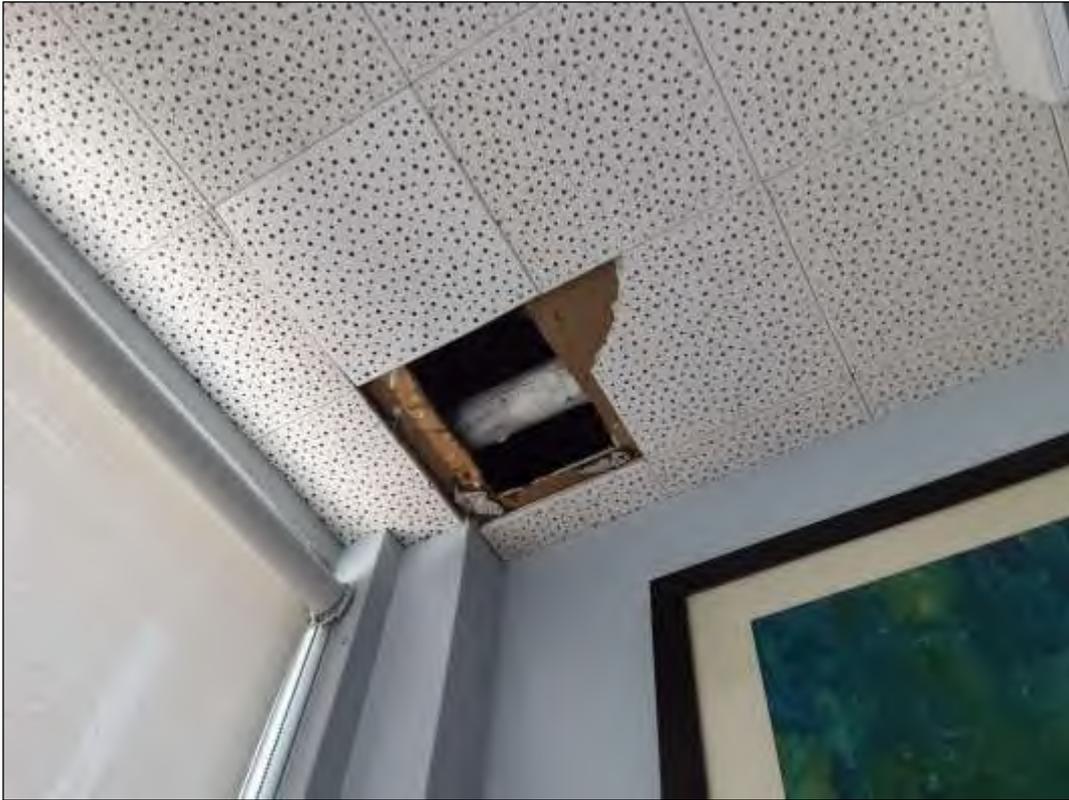
V0014 (**Confirmed Asbestos**), Piping, All, Aircell, Office (Location #: 123)

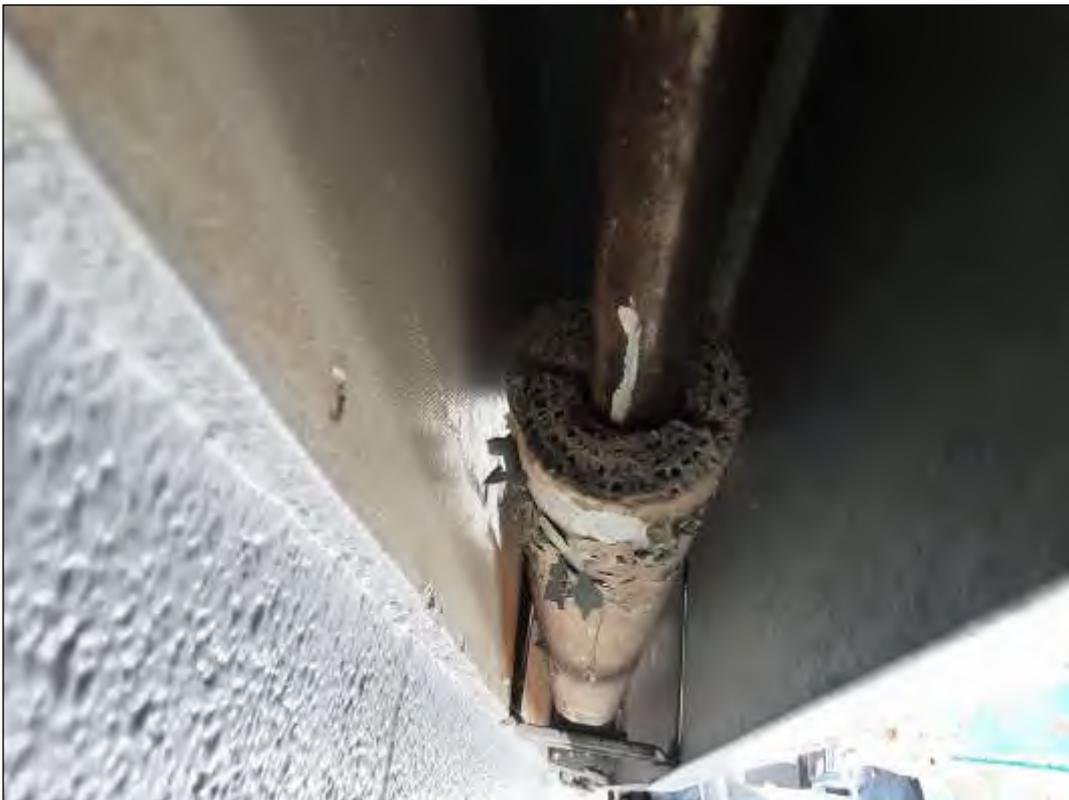
V0014 (**Confirmed Asbestos**), Piping, Aircell, Under Radiator, Classroom (Location #: 125)

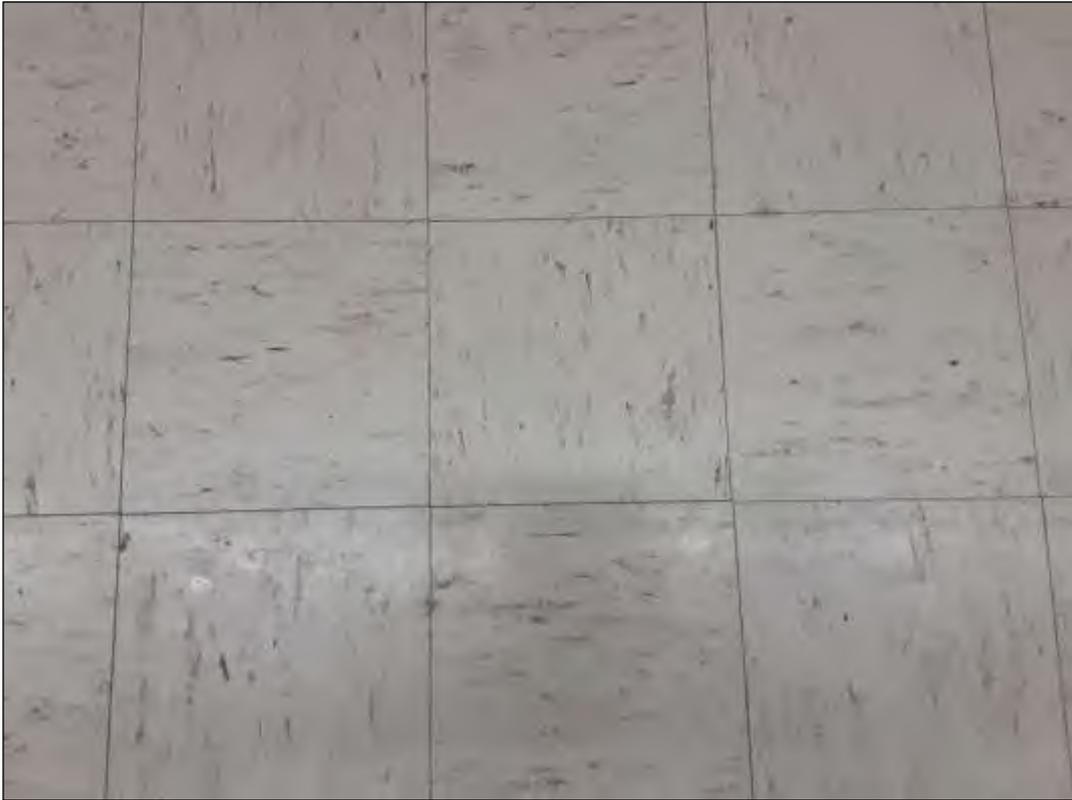
S0015A (Confirmed Asbestos), Floor, Vinyl Floor Tile, 12x12 beige with brown streaks, Boiler Room (Location #: 163)

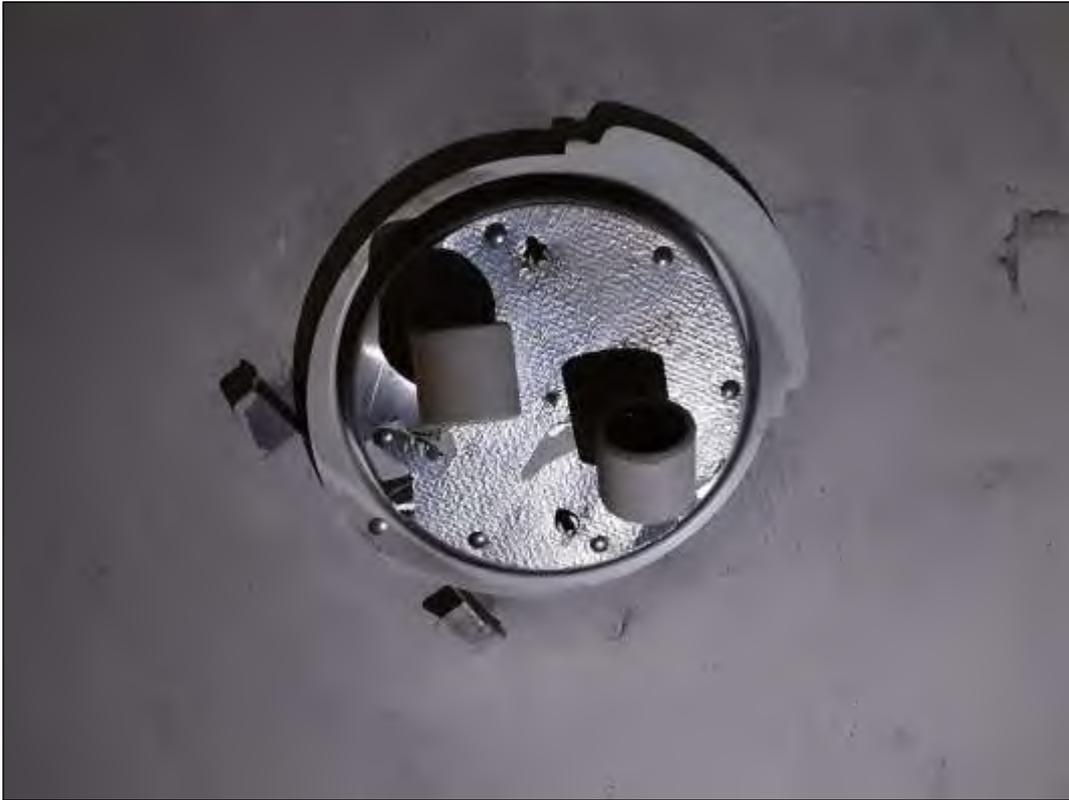
S0017A (**Confirmed Asbestos**), Structure, Light Fixture, Paper, Basement (Location #: 2)

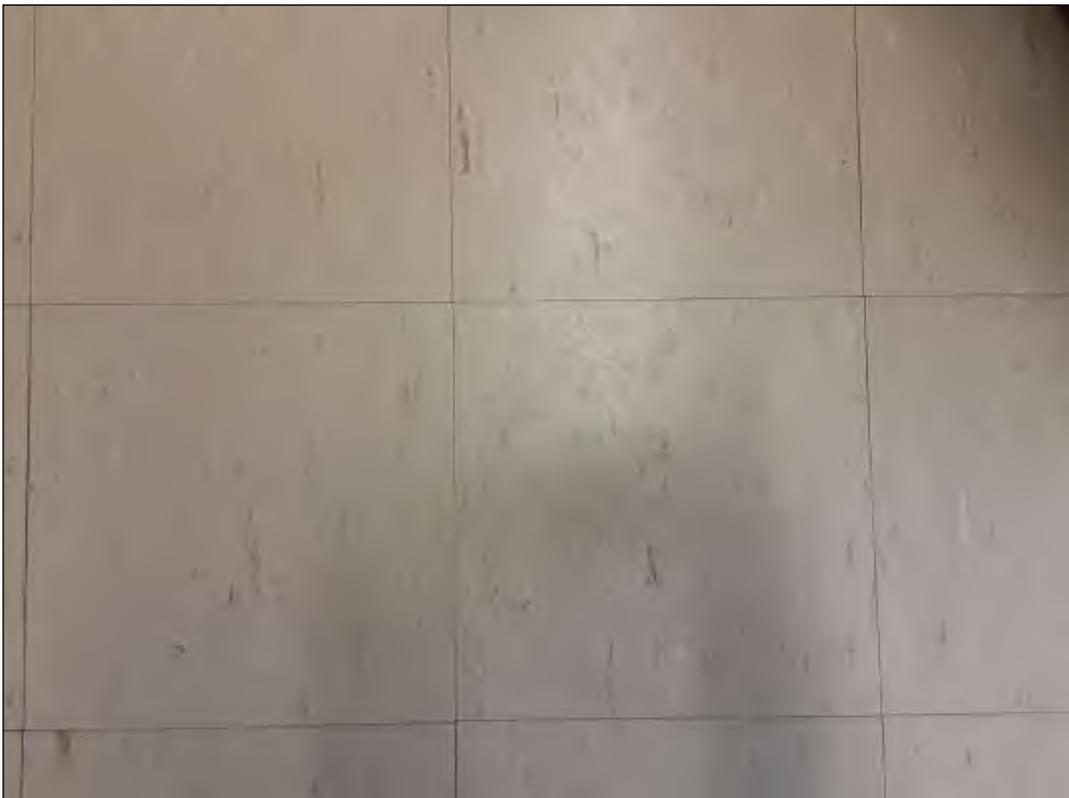
V0024 (**Confirmed Asbestos**), Floor, Vinyl Floor Tile, 12x12 beige with sparse white and brown flecks, Staff Room (Location #: 180)

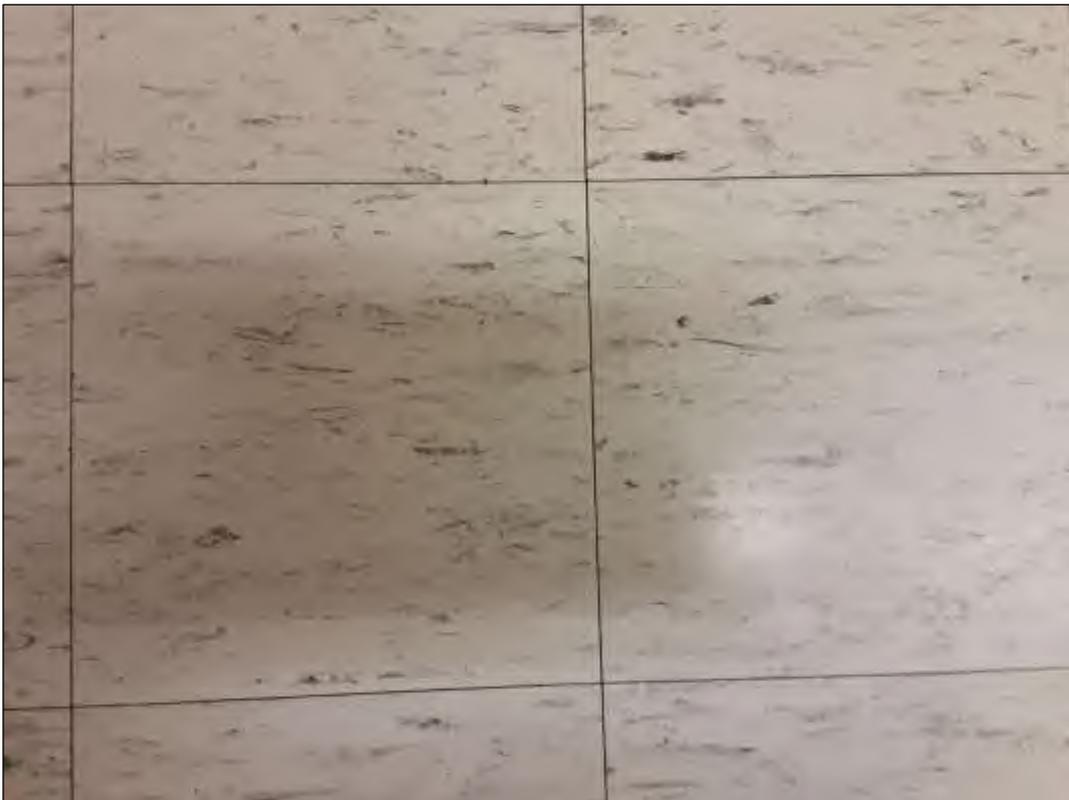
V0026 (**Confirmed Asbestos**), Floor, Vinyl Floor Tile, 12x12 off-white with black and grey streaks, Change Room (Location #: 131)

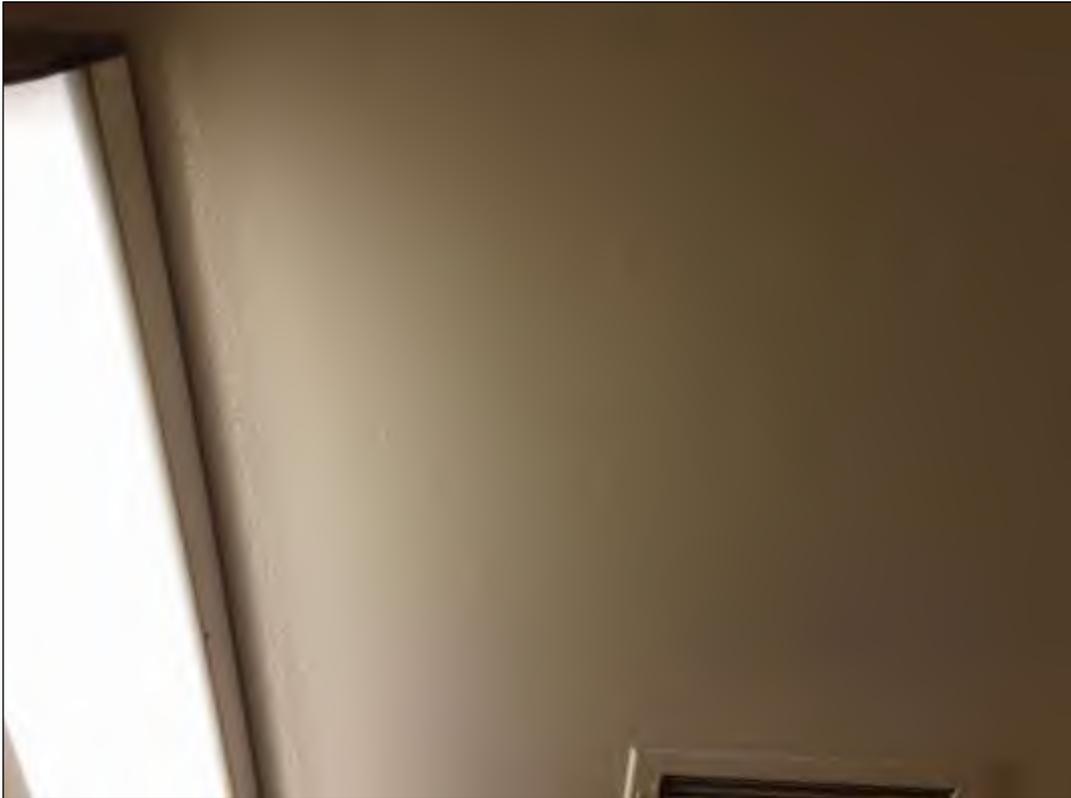
S0027B (**Confirmed Asbestos**), Ceiling, Drywall and joint compound, Change Room (Location #: 131)

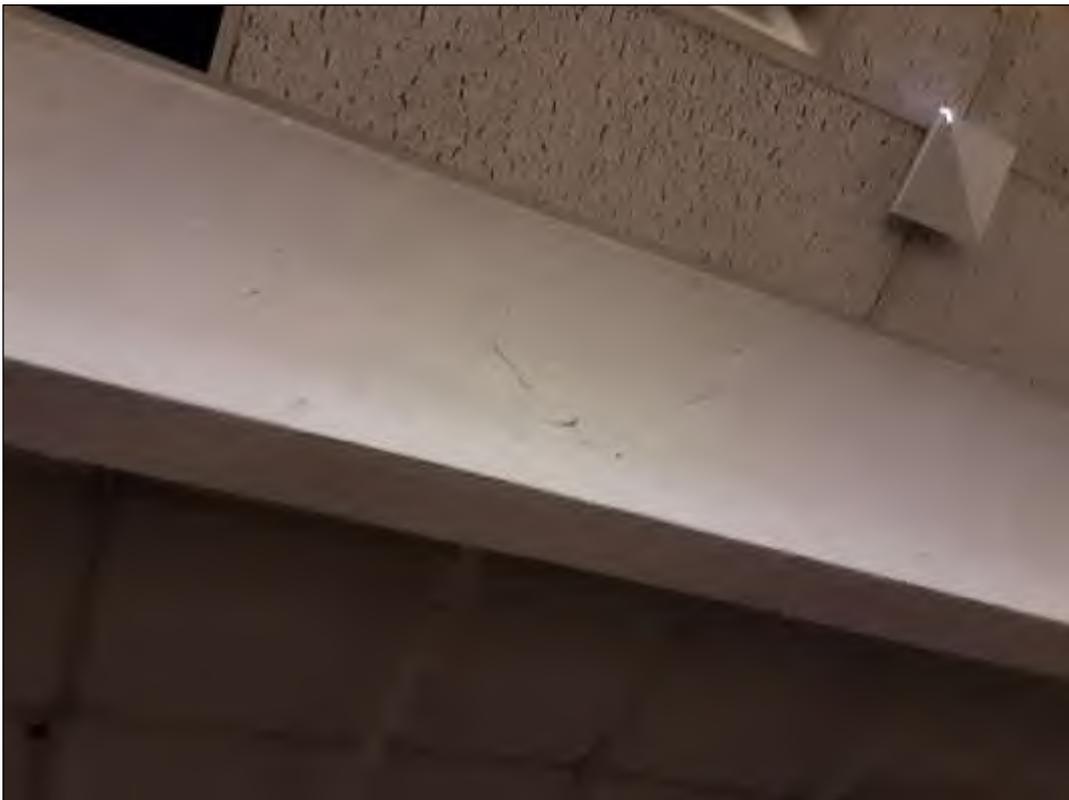
S0030A (**Confirmed Asbestos**), Ceiling, Bulkhead, Texture Finish, Theatre (Location #: 214)

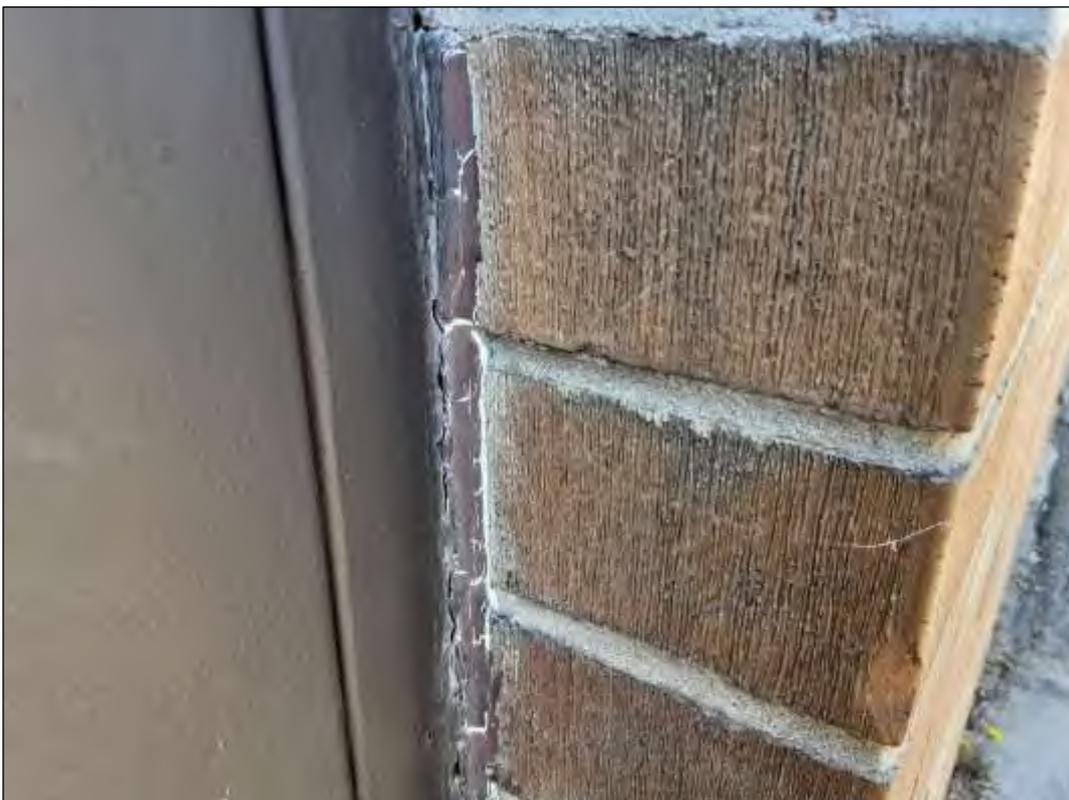
S0033B (**Confirmed Asbestos**), Wall, Door, Caulking, Brown and grey, Exterior (Location #: 3)

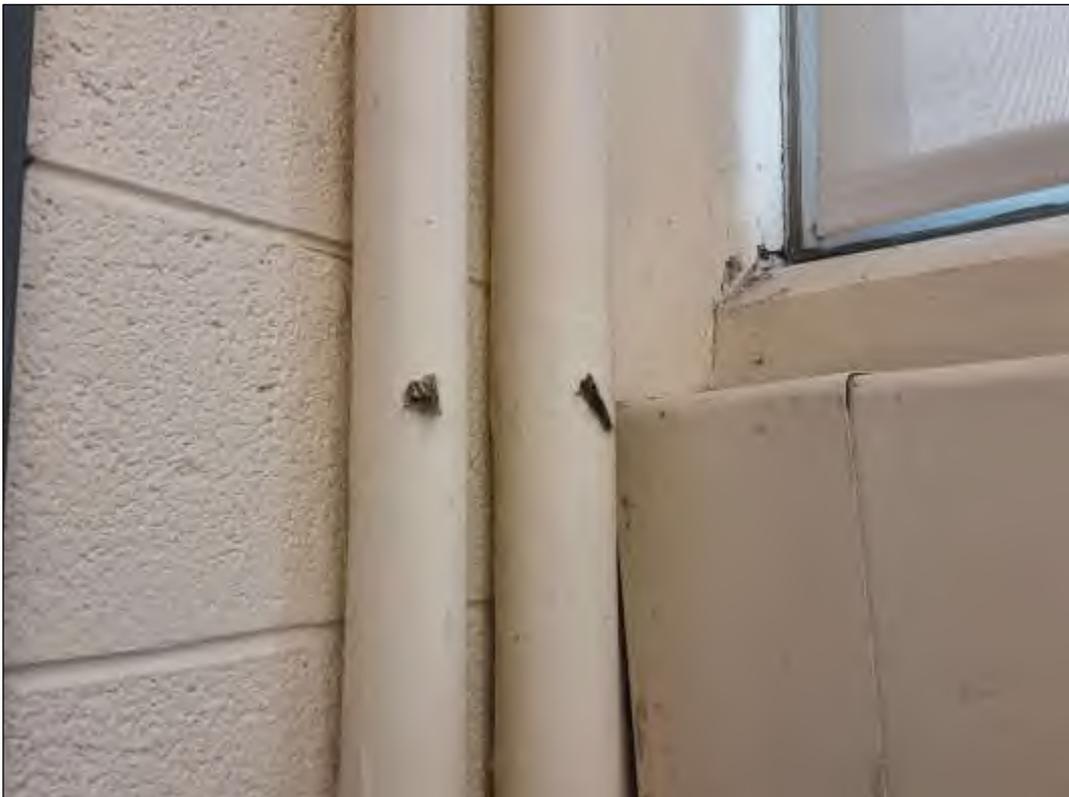
S0035A (**Confirmed Asbestos**), Piping, Sweatwrap, **Poor Condition**, Classroom (Location #: 150)
