Re: Hazardous Building Materials Assessment (Preconstruction)
Eastside Secondary School, 275 Farley Avenue, Belleville, ON
Pinchin File: 200584.112

Hastings and Prince Edward District School Board (Client) retained Pinchin Ltd. (Pinchin) to conduct a desktop hazardous building materials assessment of Eastside Secondary School located at 275 Farley Avenue, Belleville, ON.

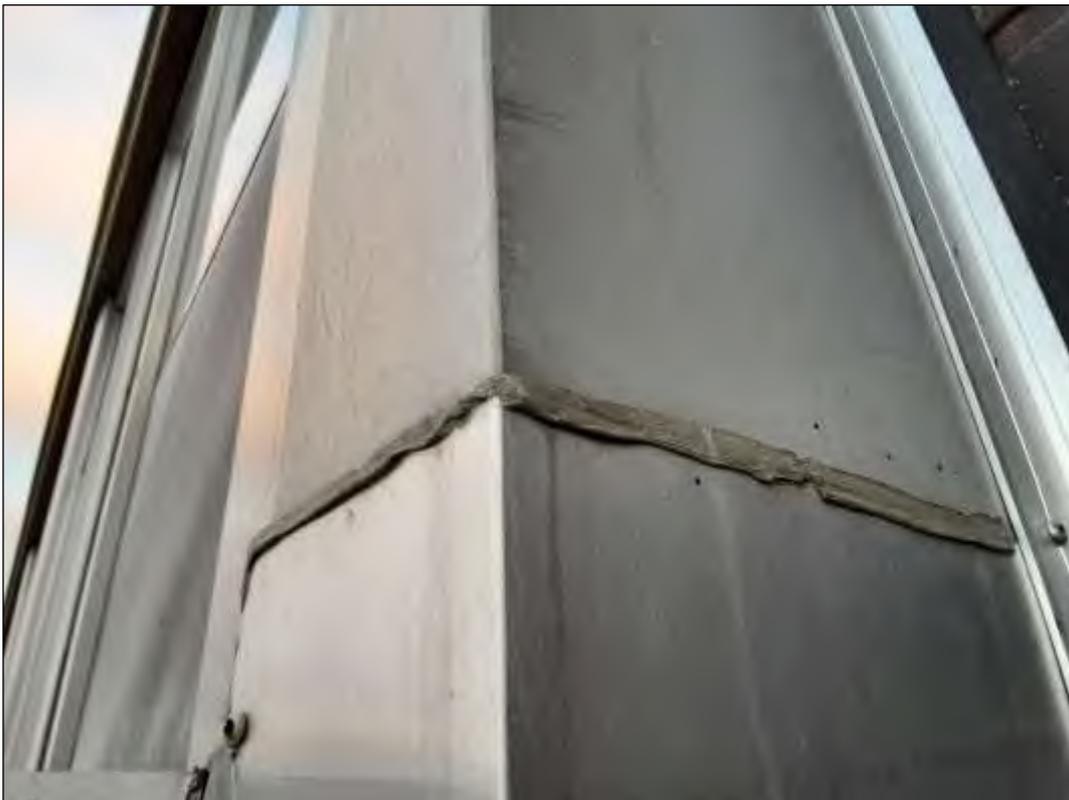
V0041 (Confirmed Asbestos), Wall, Door, Caulking, Soft, grey, Autoshop (Location #: 153)

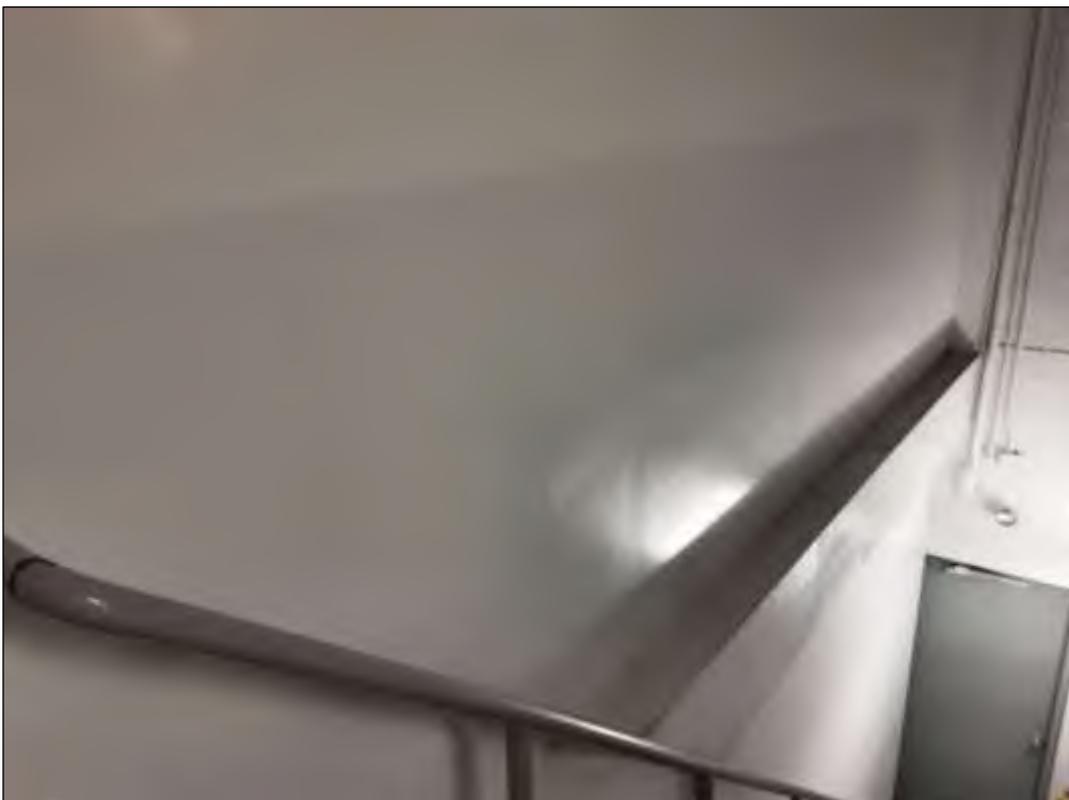
S0053F (**Confirmed Asbestos**), Wall, Drywall and joint compound, Penthouse (Location #: 280)

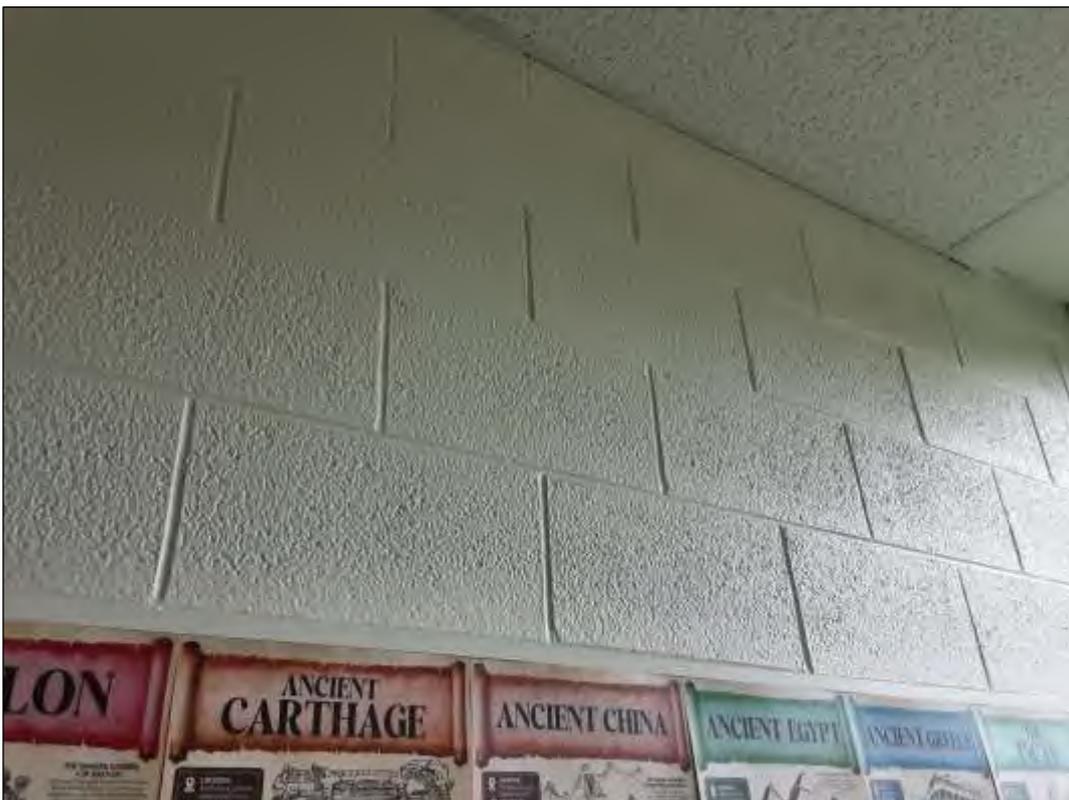
V0063 (Confirmed Asbestos), Wall, Paint, On concrete block, Classroom (Location #: 102)

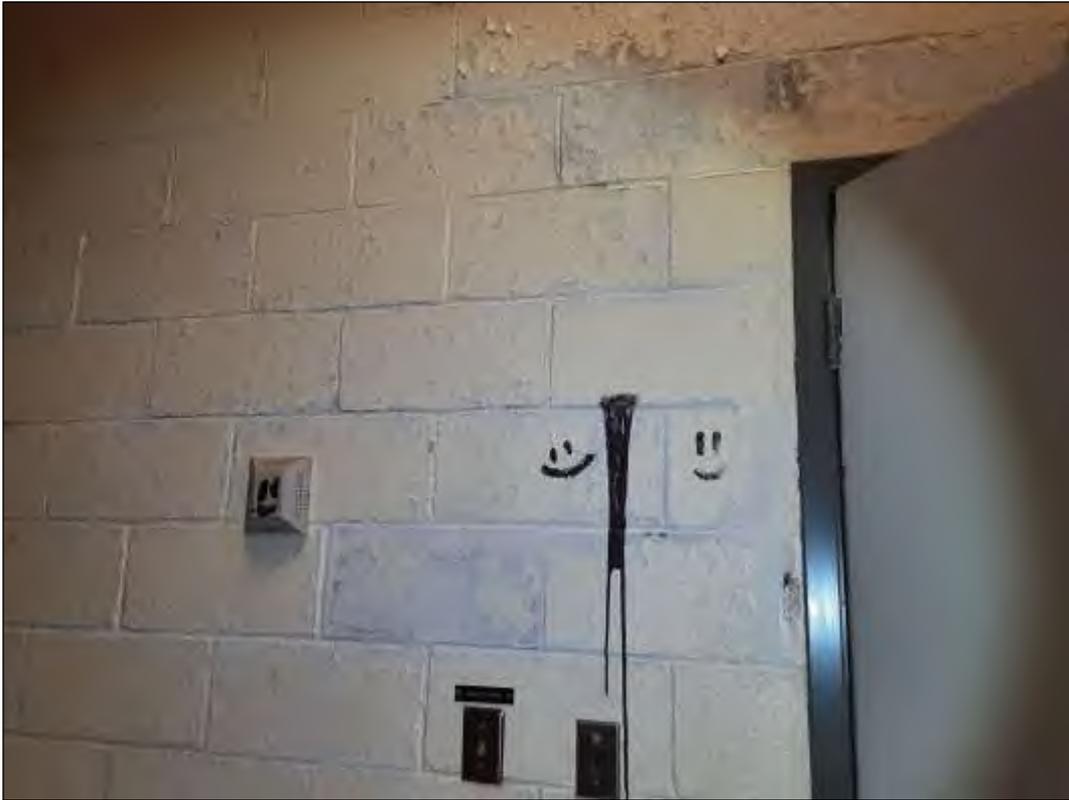
S0066A (Confirmed Asbestos), Wall, Paint, On concrete block, **Poor Condition**, Storage Room (Location #: 139)

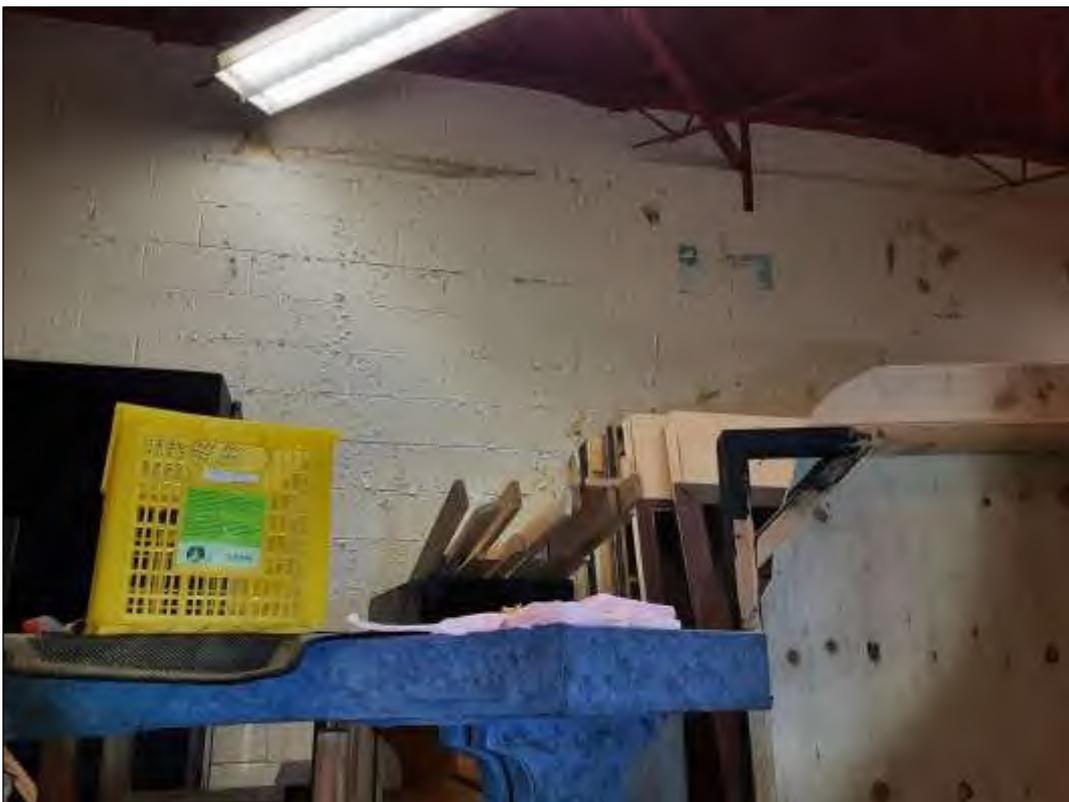
V0066 (Confirmed Asbestos), Wall, Paint, On concrete block, **Poor Condition**, Storage Room (Location #: 139)

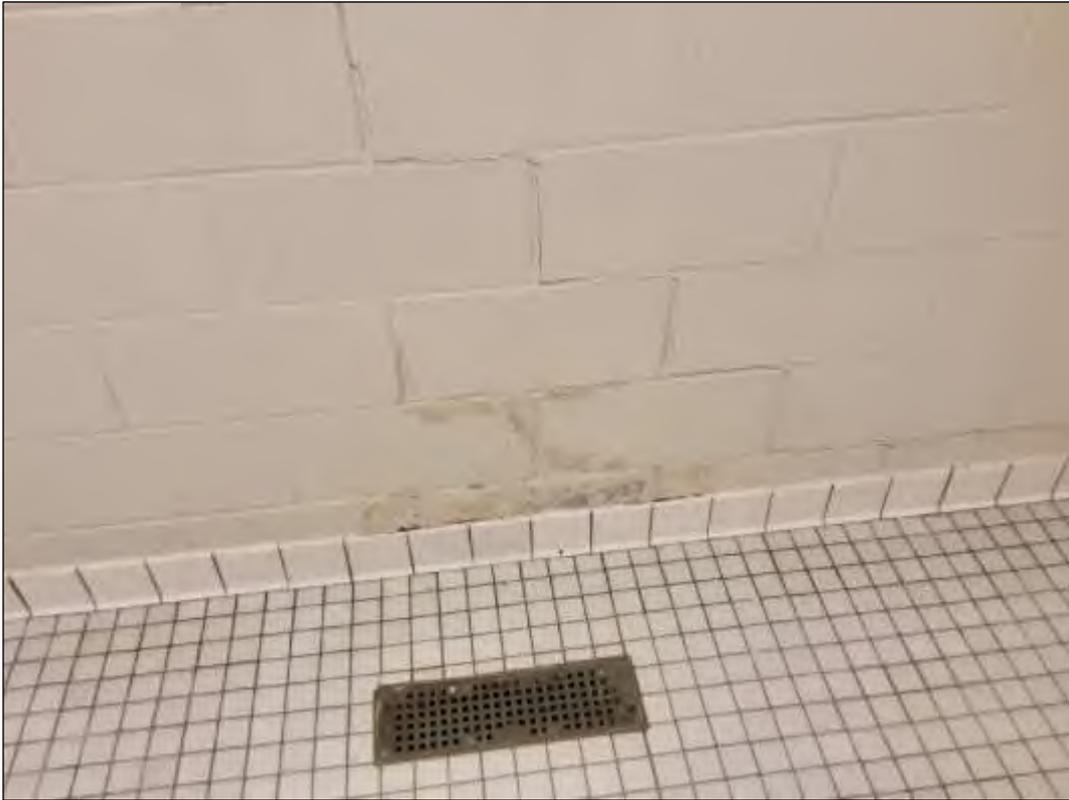
V0067 (**Confirmed Asbestos**), Wall, Paint, On concrete block, **Poor Condition**, Change Room (Location #: 135)
Room 135b

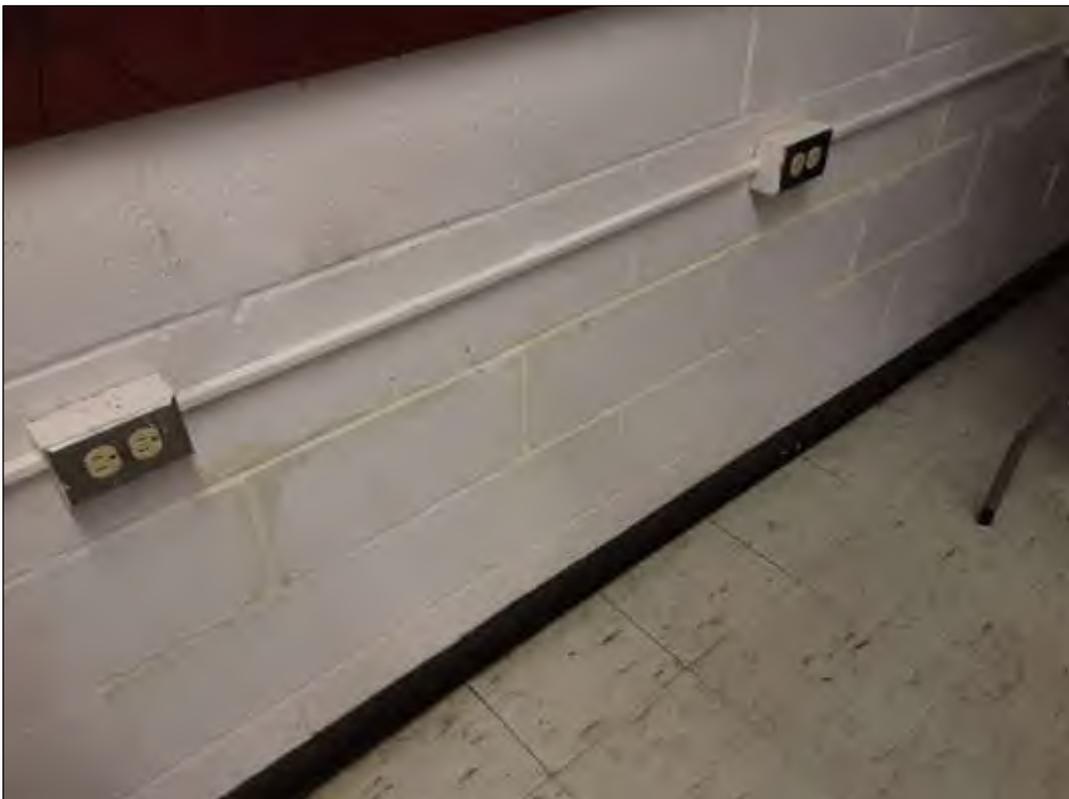
V0067 (**Confirmed Asbestos**), Wall, Paint, On concrete block, **Poor Condition**, Classroom (Location #: 187)

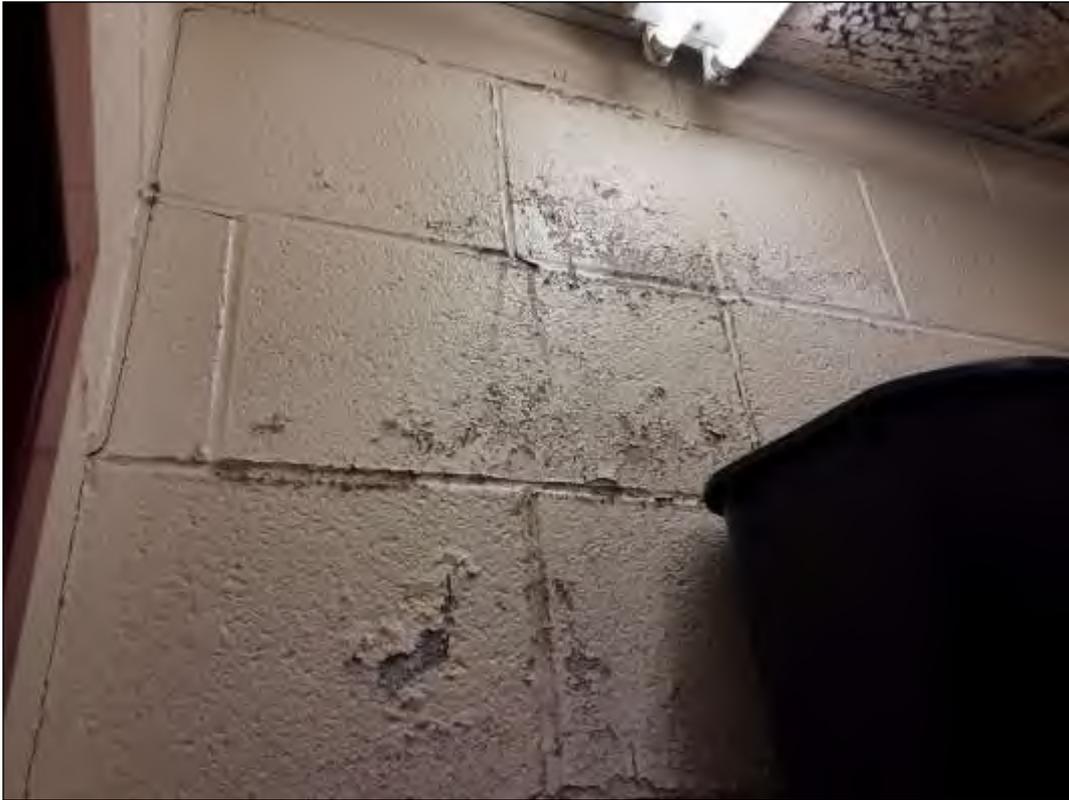
S0067B (**Confirmed Asbestos**), Wall, Paint, On concrete block, **Poor Condition**, Corridor (Location #: 191)

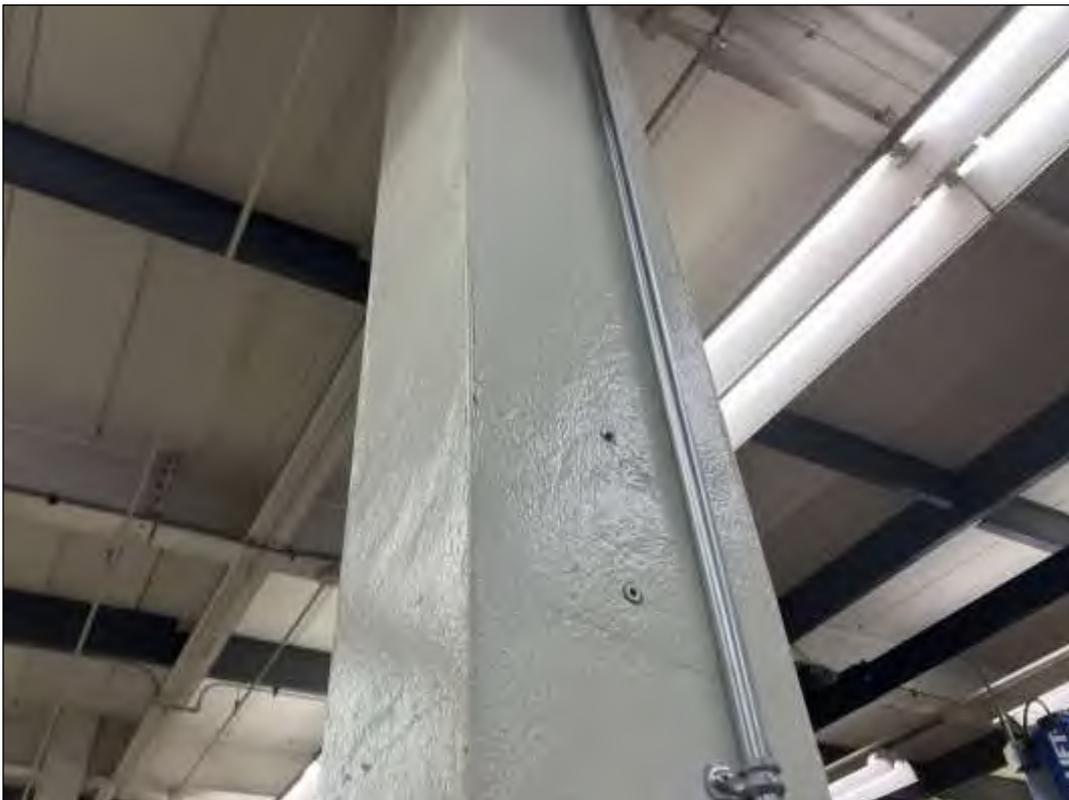
S0071A (**Confirmed Asbestos**), Other, Column, Plaster, Coating material, Autoshop (Location #: 153)

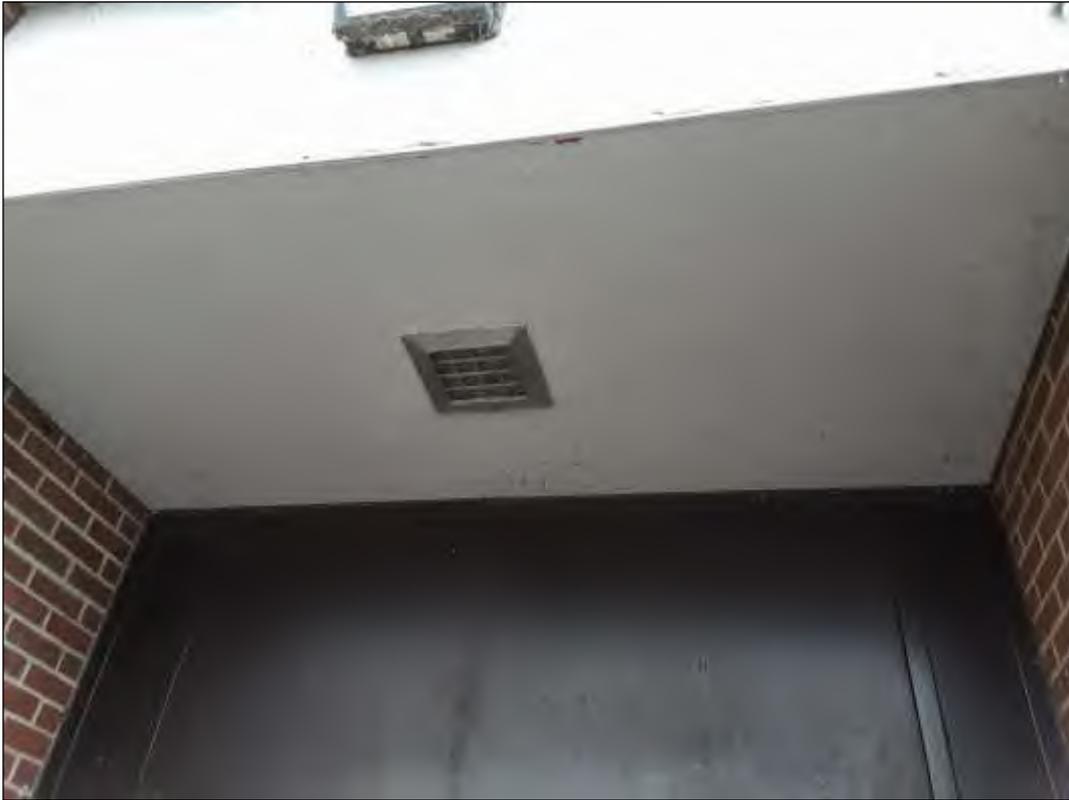
S0090A (**Confirmed Asbestos**), Structure, Canopy, Cement Product, Transite, Corridor (Location #: 194)
Exterior

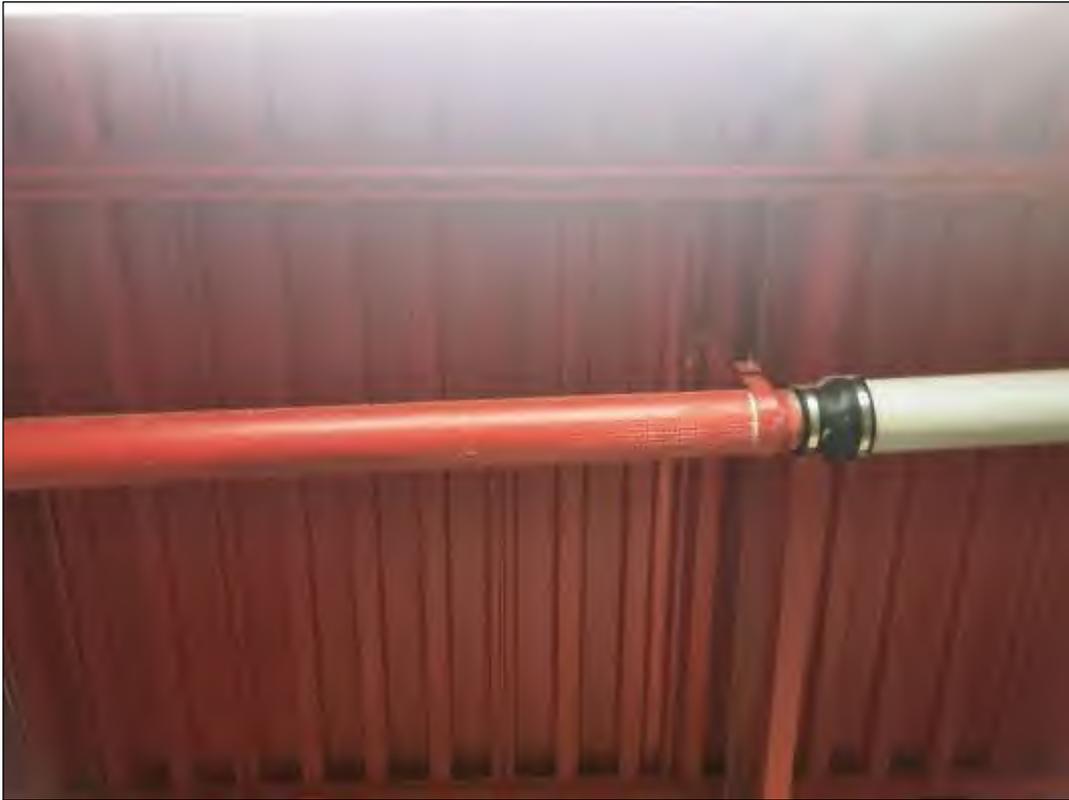
V9500 (**Presumed Asbestos**), Piping, Rain Water Leader, Cement Product, Transite, Equipment Storage (Location #: 141)

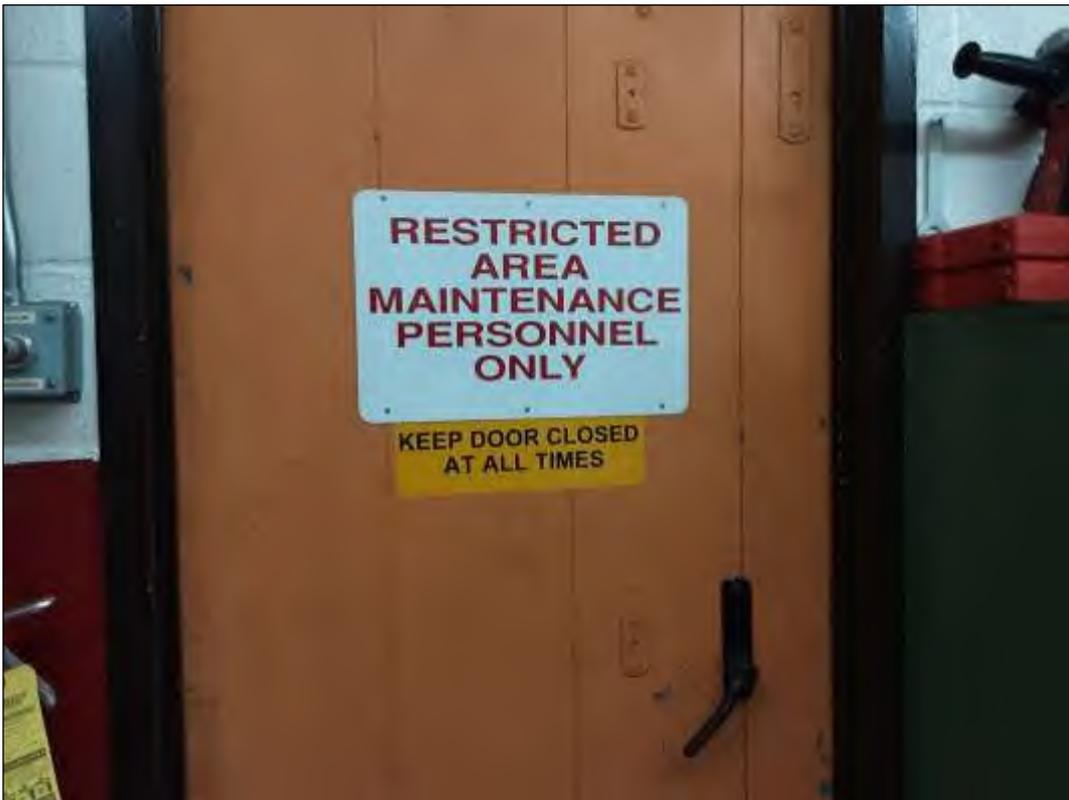
V9500 (**Presumed Asbestos**), Wall, Door, Thermal Insulation, Boiler Room (Location #: 163)

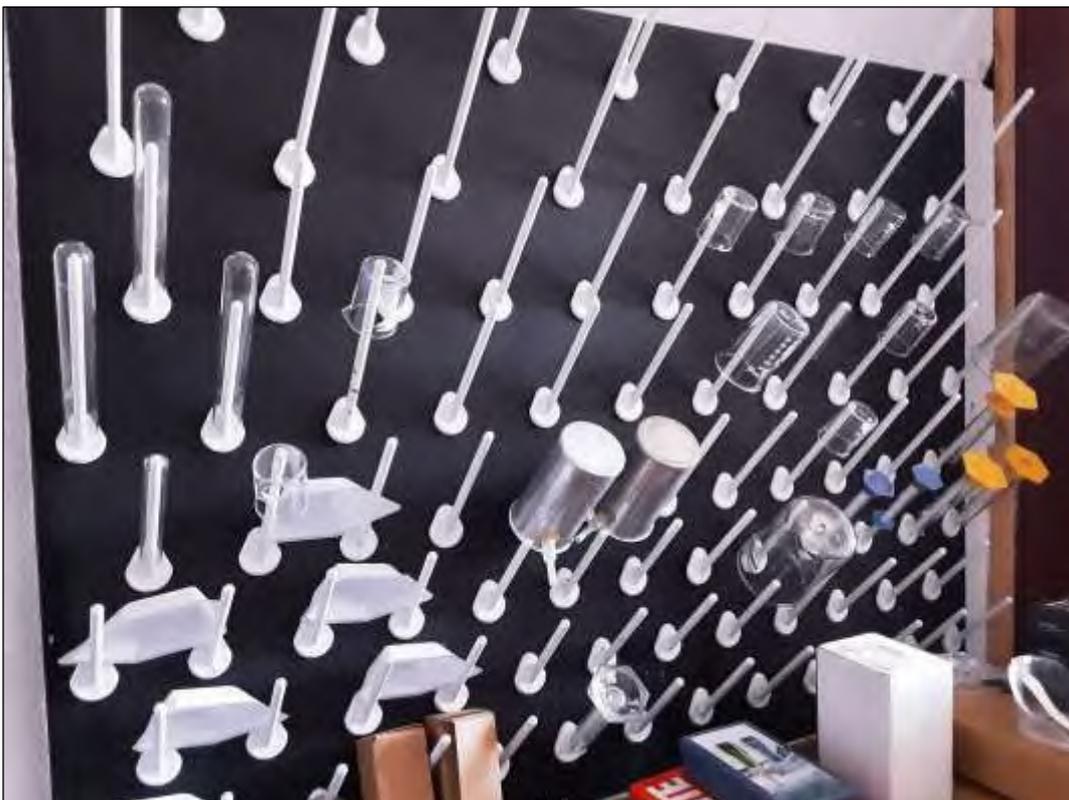
V9500 (Presumed Asbestos), Other, Cement Product, Transite drying rack, Classroom (Location #: 217)

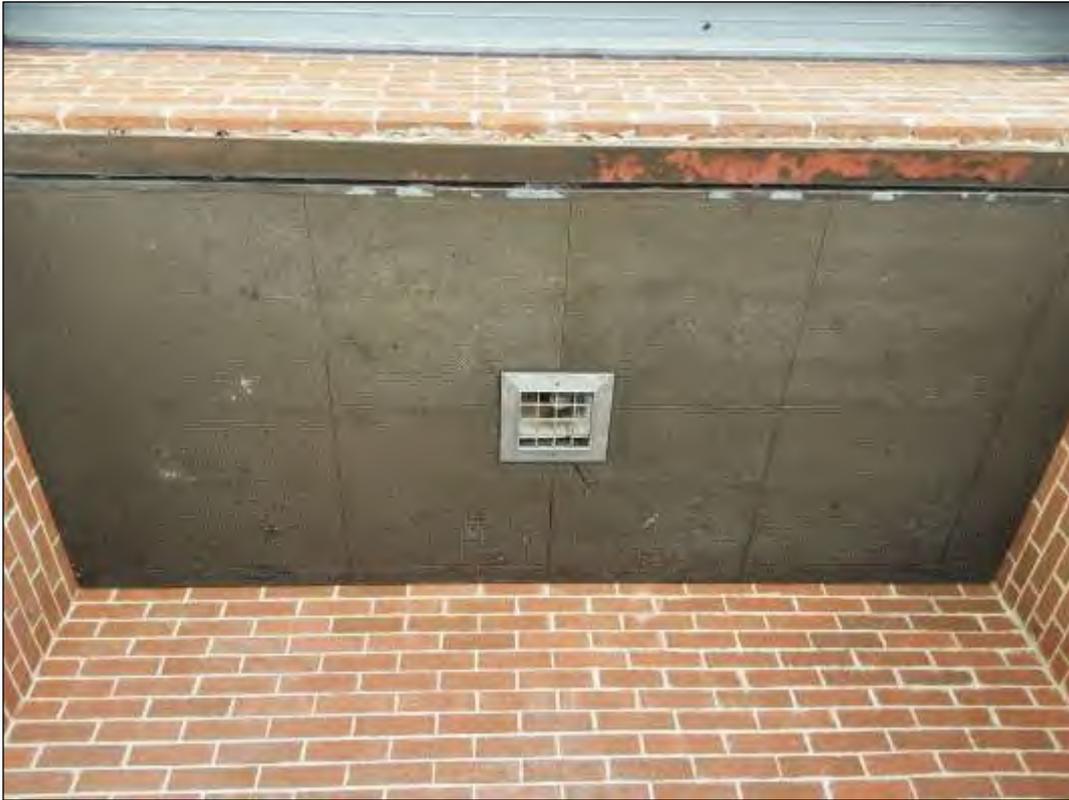
V9500 (Presumed Asbestos), Structure, Canopy, Cement Product, Transite panels, Exterior (Location #: 3)

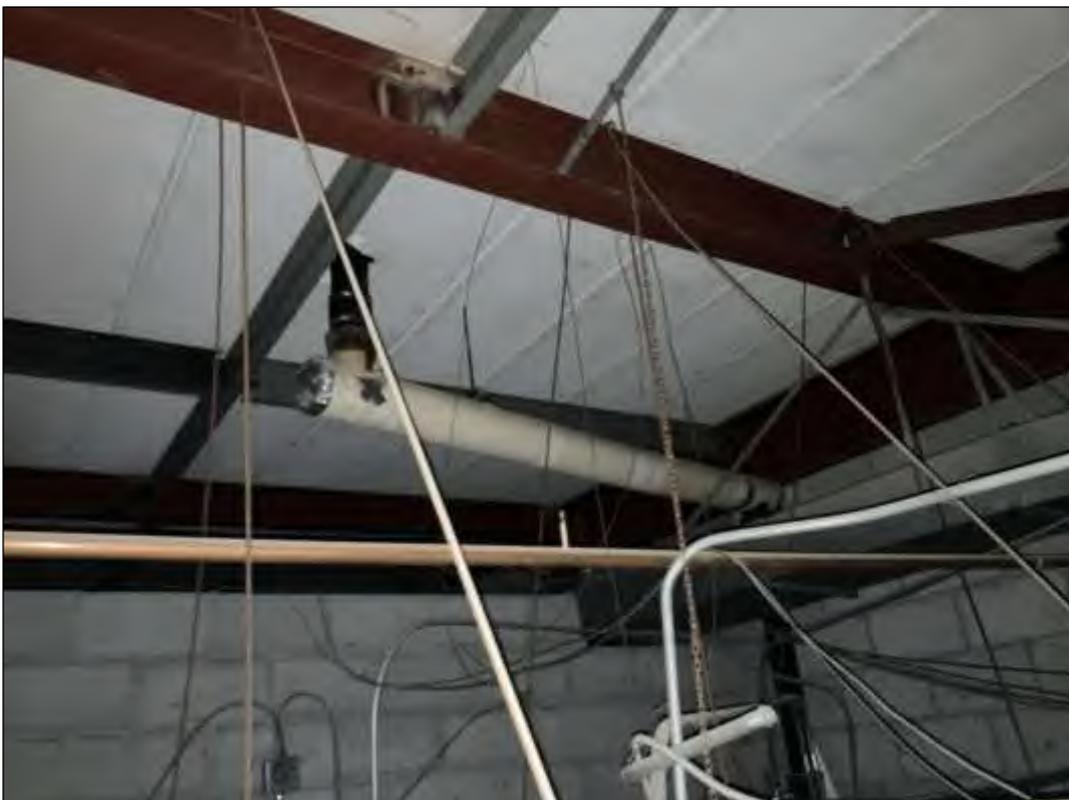
V0001(Lead, High), Red, Structure, Metal, Corridor (Location #: 194)

Items painted with paints containing elevated levels of lead may be a hazardous waste. Test lead-painted materials for leachable lead and other metals prior to disposal. Metallic components coated with lead paint do not require leachate testing and can be disposed of as non-hazardous construction and demolition (C&D) waste.

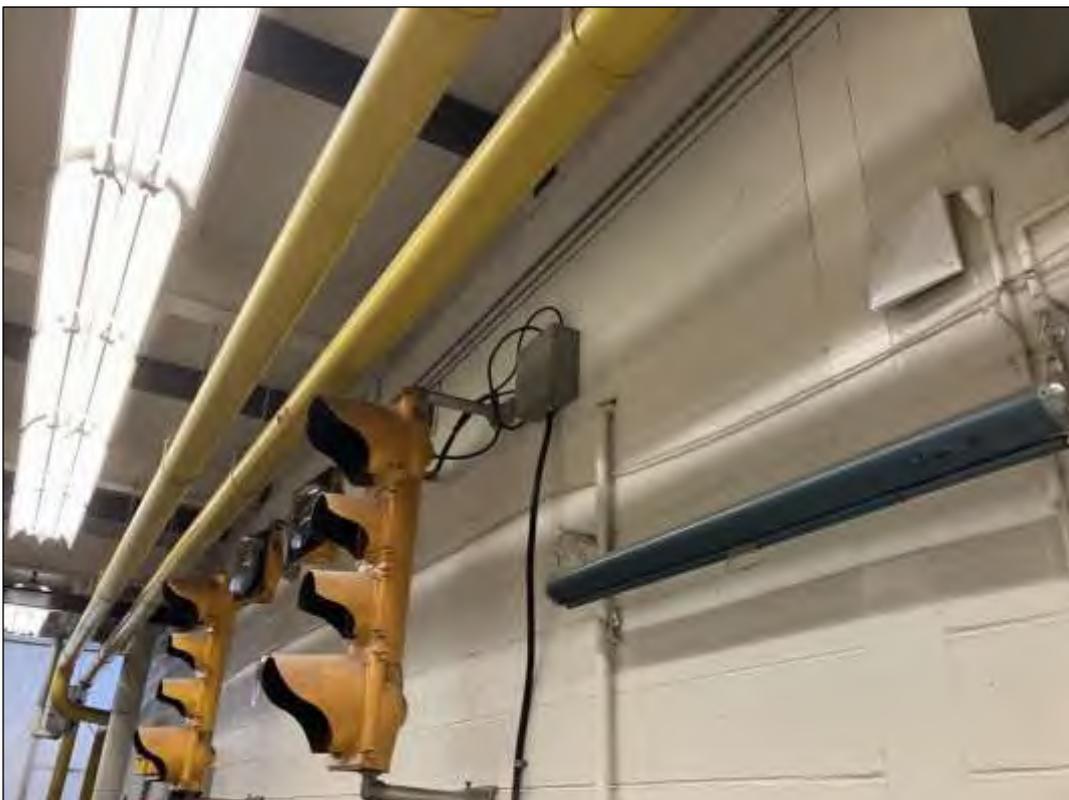
V0007(Lead, Low), Yellow, Wall, Concrete (Pre-cast), Autoshop (Location #: 153)

For paints identified as having low levels of lead (i.e., equal to or above 0.009% (90 mg/kg) but less than or equal to the EACC guideline of 0.1% (1,000 mg/kg) for lead-containing paints) special precautions are not recommended unless aggressive disturbance (grinding, blasting, torching) is planned.

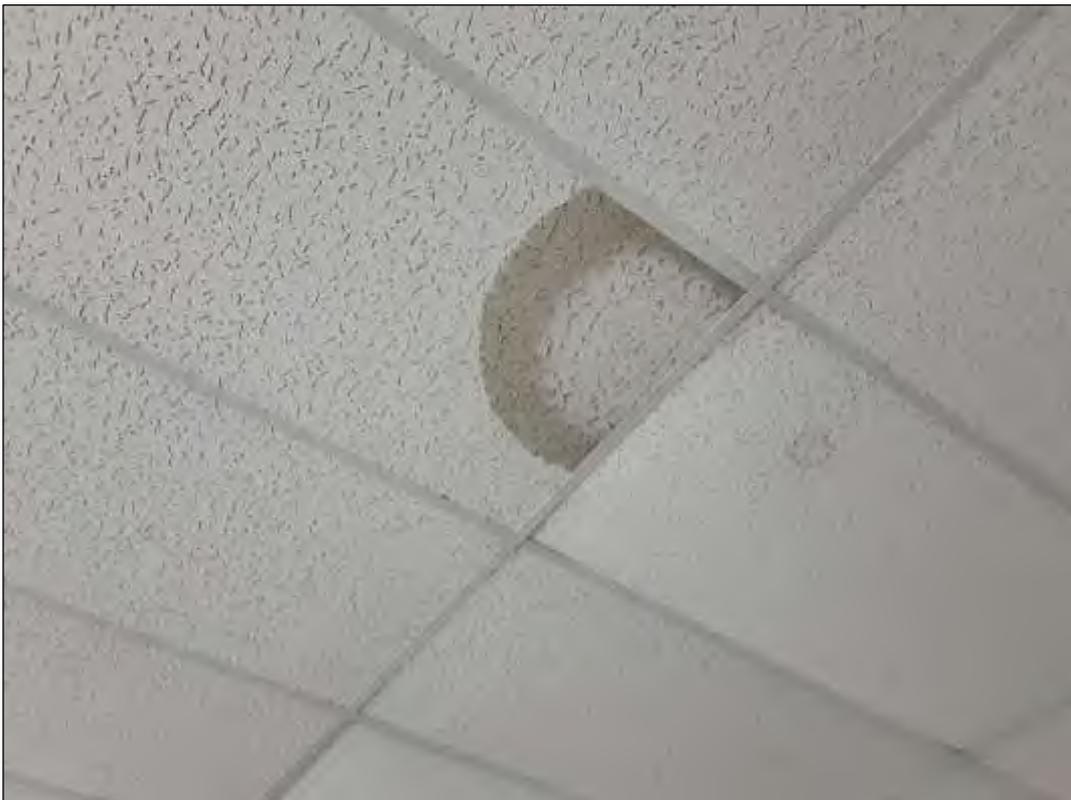
Sample Number	Material Description	Location	Confirmed Hazard	Total Quantity Present	Material Specific Notes
V9500	Ceiling Tiles (lay-in)	115, 124, 125, 128	Yes	56 SF	Water stained ceiling tiles

Mould, (Water Damage), Ceiling, Ceiling Tiles (lay-in), Classroom (Location #: 115)

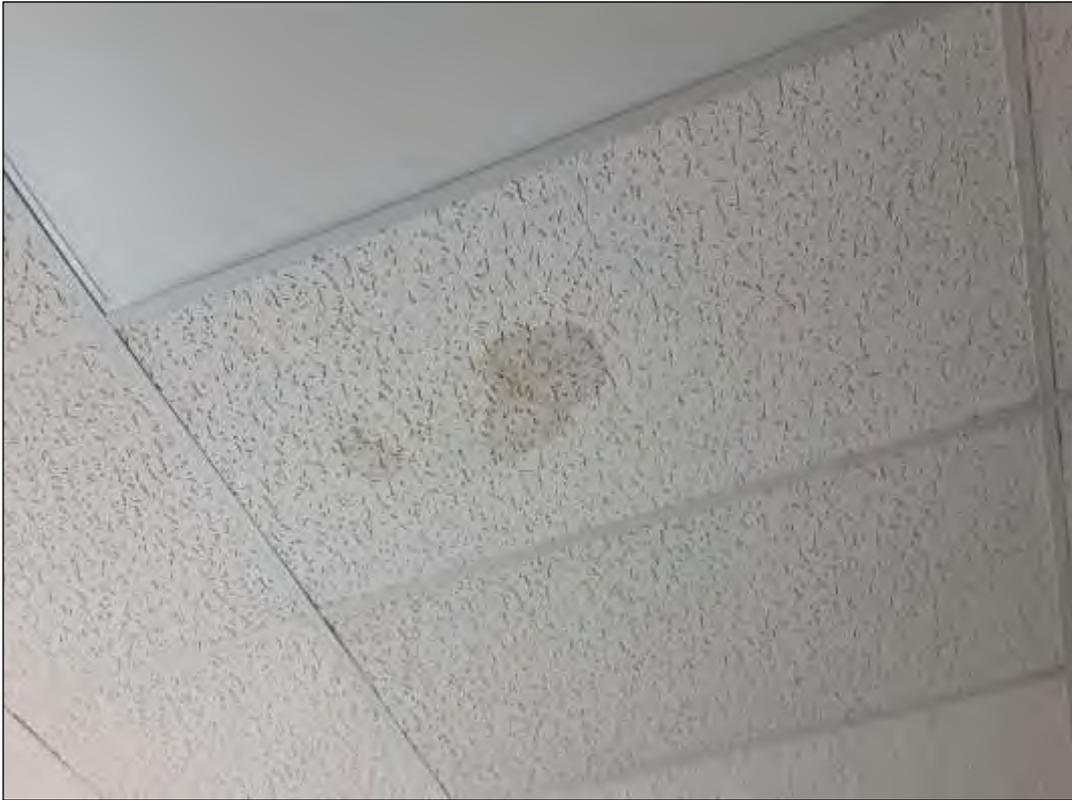
Mould, (Water Damage), Ceiling, Ceiling Tiles (lay-in), Classroom (Location #: 115)

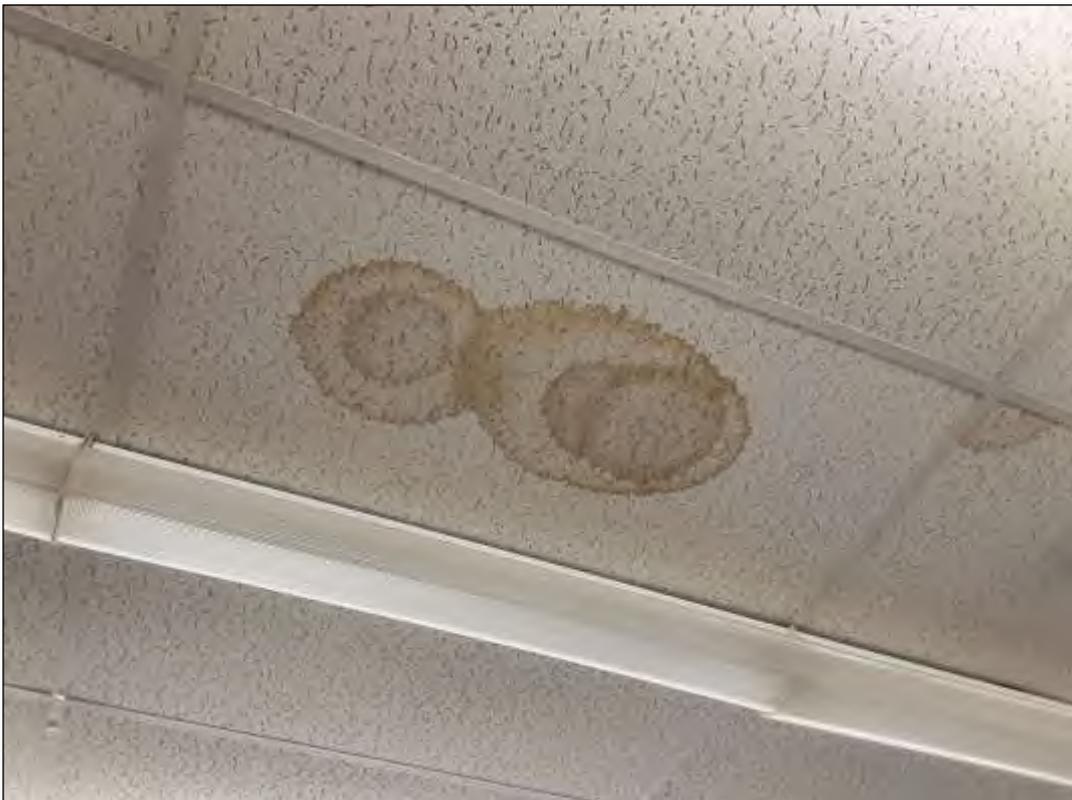
Mould, (Water Damage), Ceiling, Ceiling Tiles (lay-in), Office (Location #: 124)

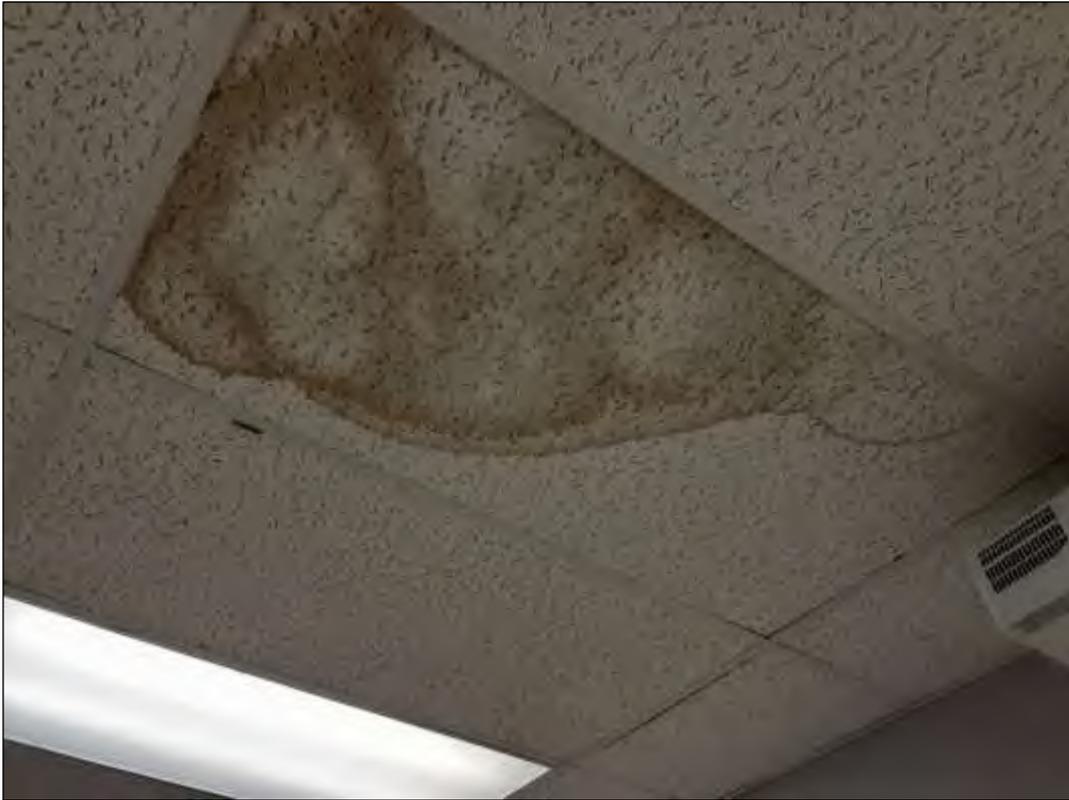
Mould, (Water Damage), Ceiling, Ceiling Tiles (lay-in), Classroom (Location #: 125)

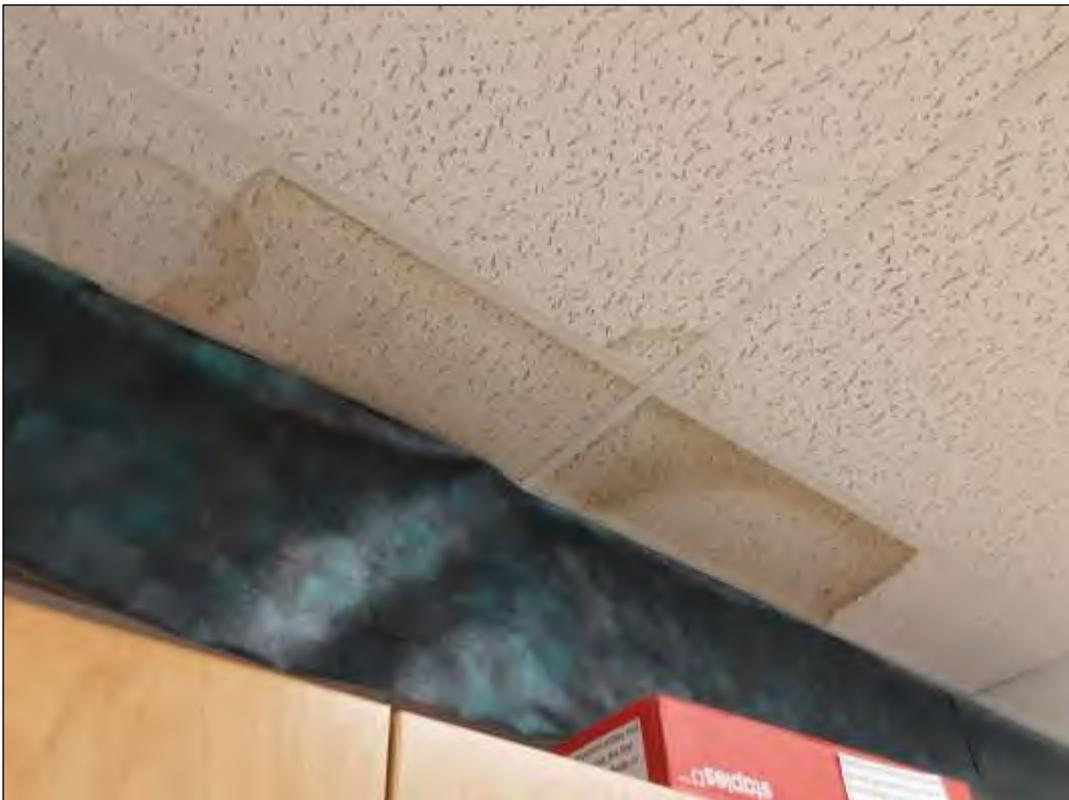
Mould, (Water Damage), Ceiling, Ceiling Tiles (lay-in), Classroom (Location #: 125)

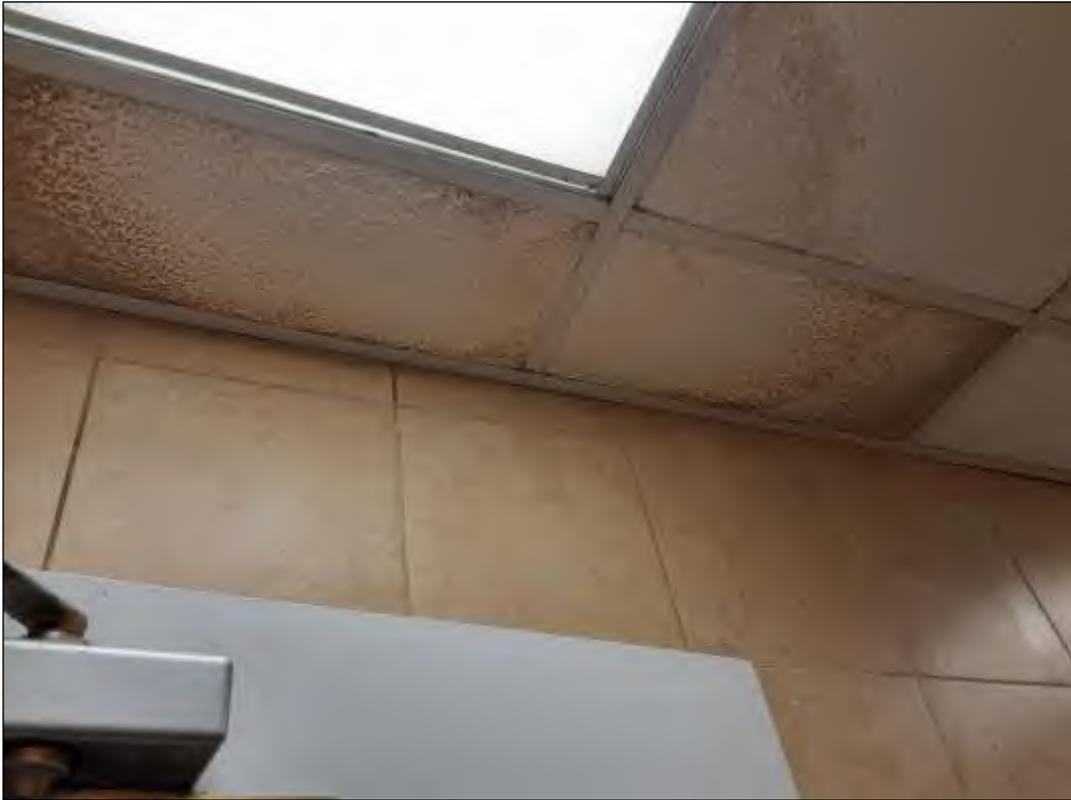
Mould, (Water Damage), Ceiling, Ceiling Tiles (lay-in), Washroom (Location #: 128)
