# Limited Designated Substance Survey Report

William Dunbar Public School

1030 Glenanna Road, Pickering, Ontario

January 16, 2026  
Parasol Project No: 13357

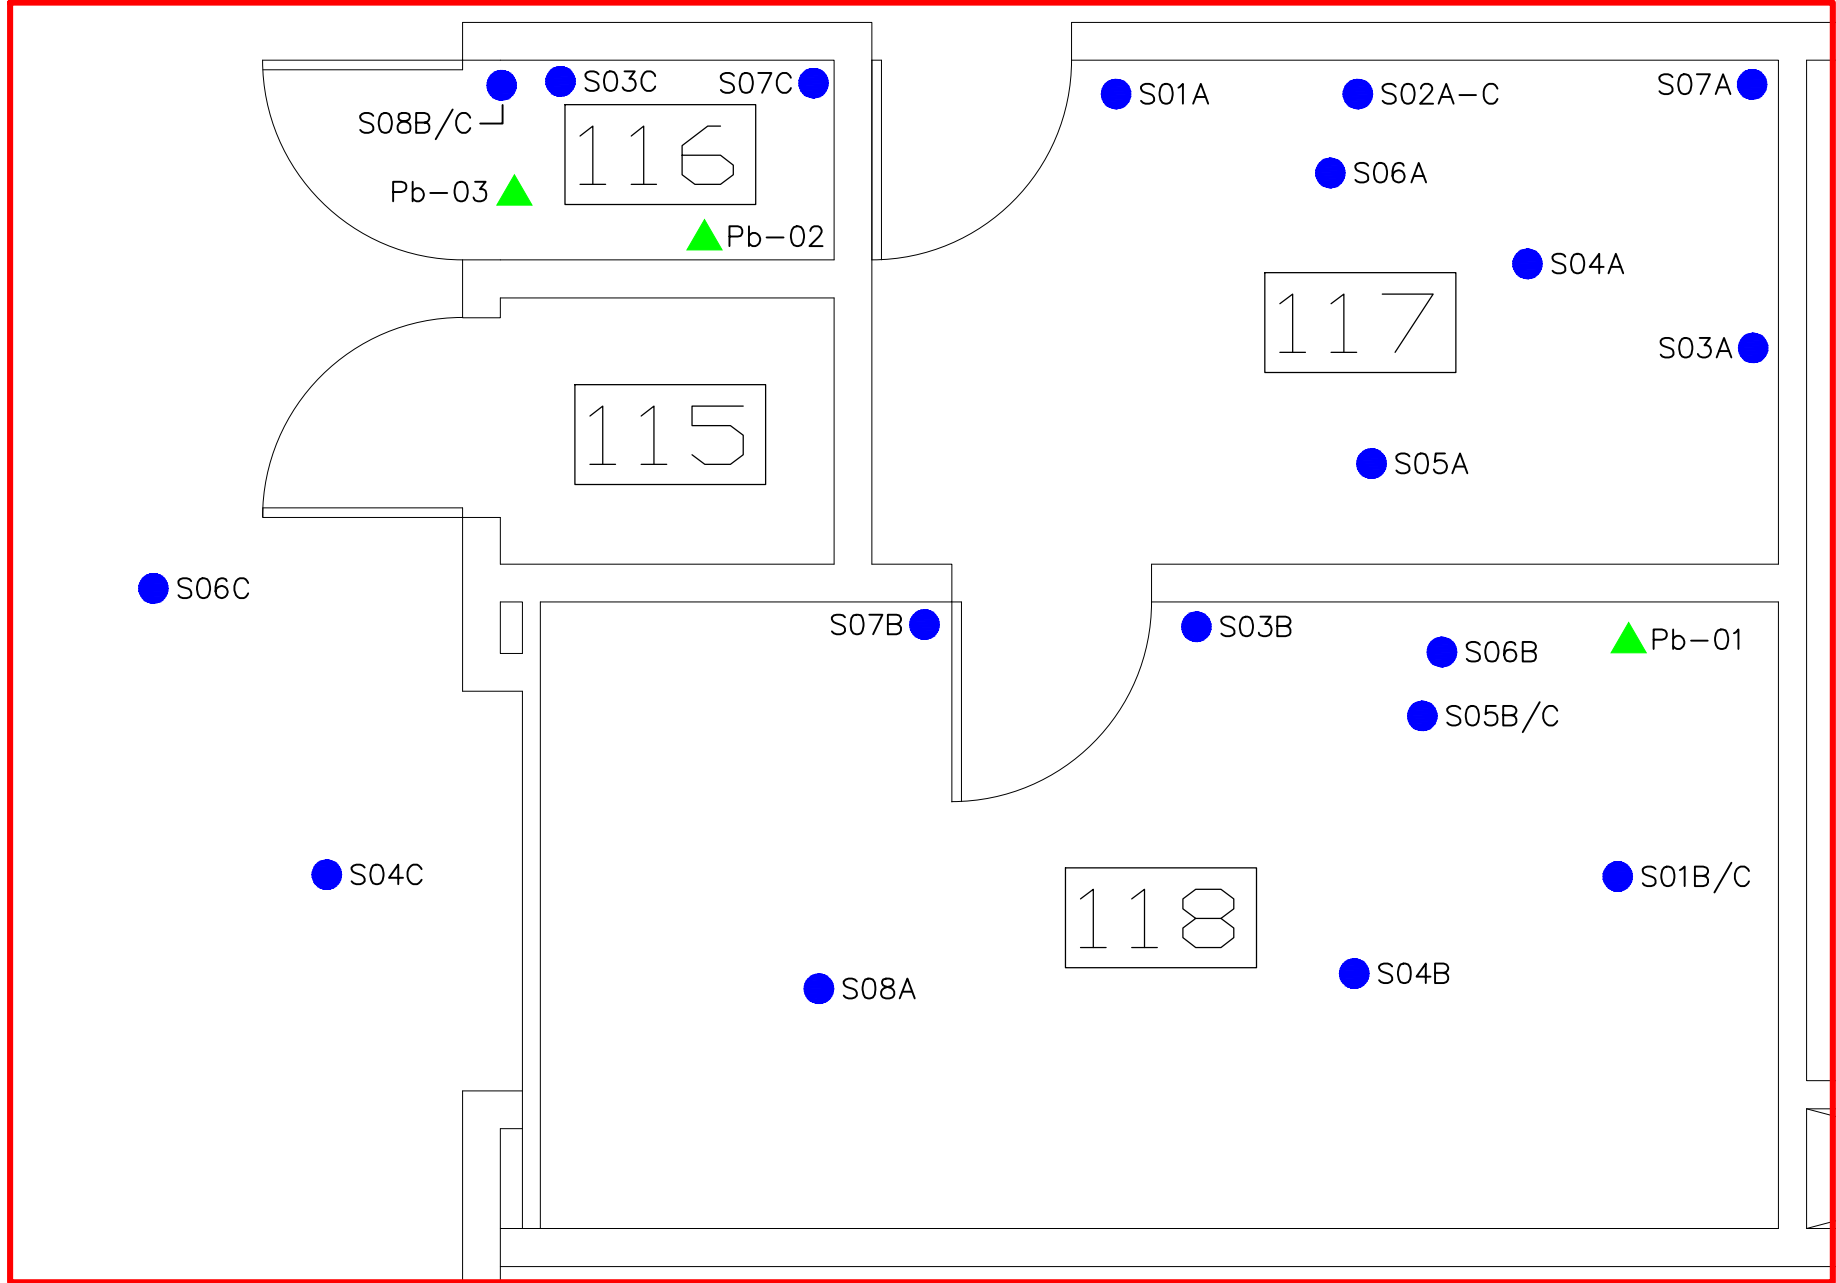
DRAWING NO	DSR-01
SCALE	NTS
DATE	January 16, 2026

TITLE	Limited Designated Substance Survey First Floor Plan
CLIENT	Durham District School Board
LOCATION	William Dunbar Public School 1030 Glenanna Road Pickering, Ontario

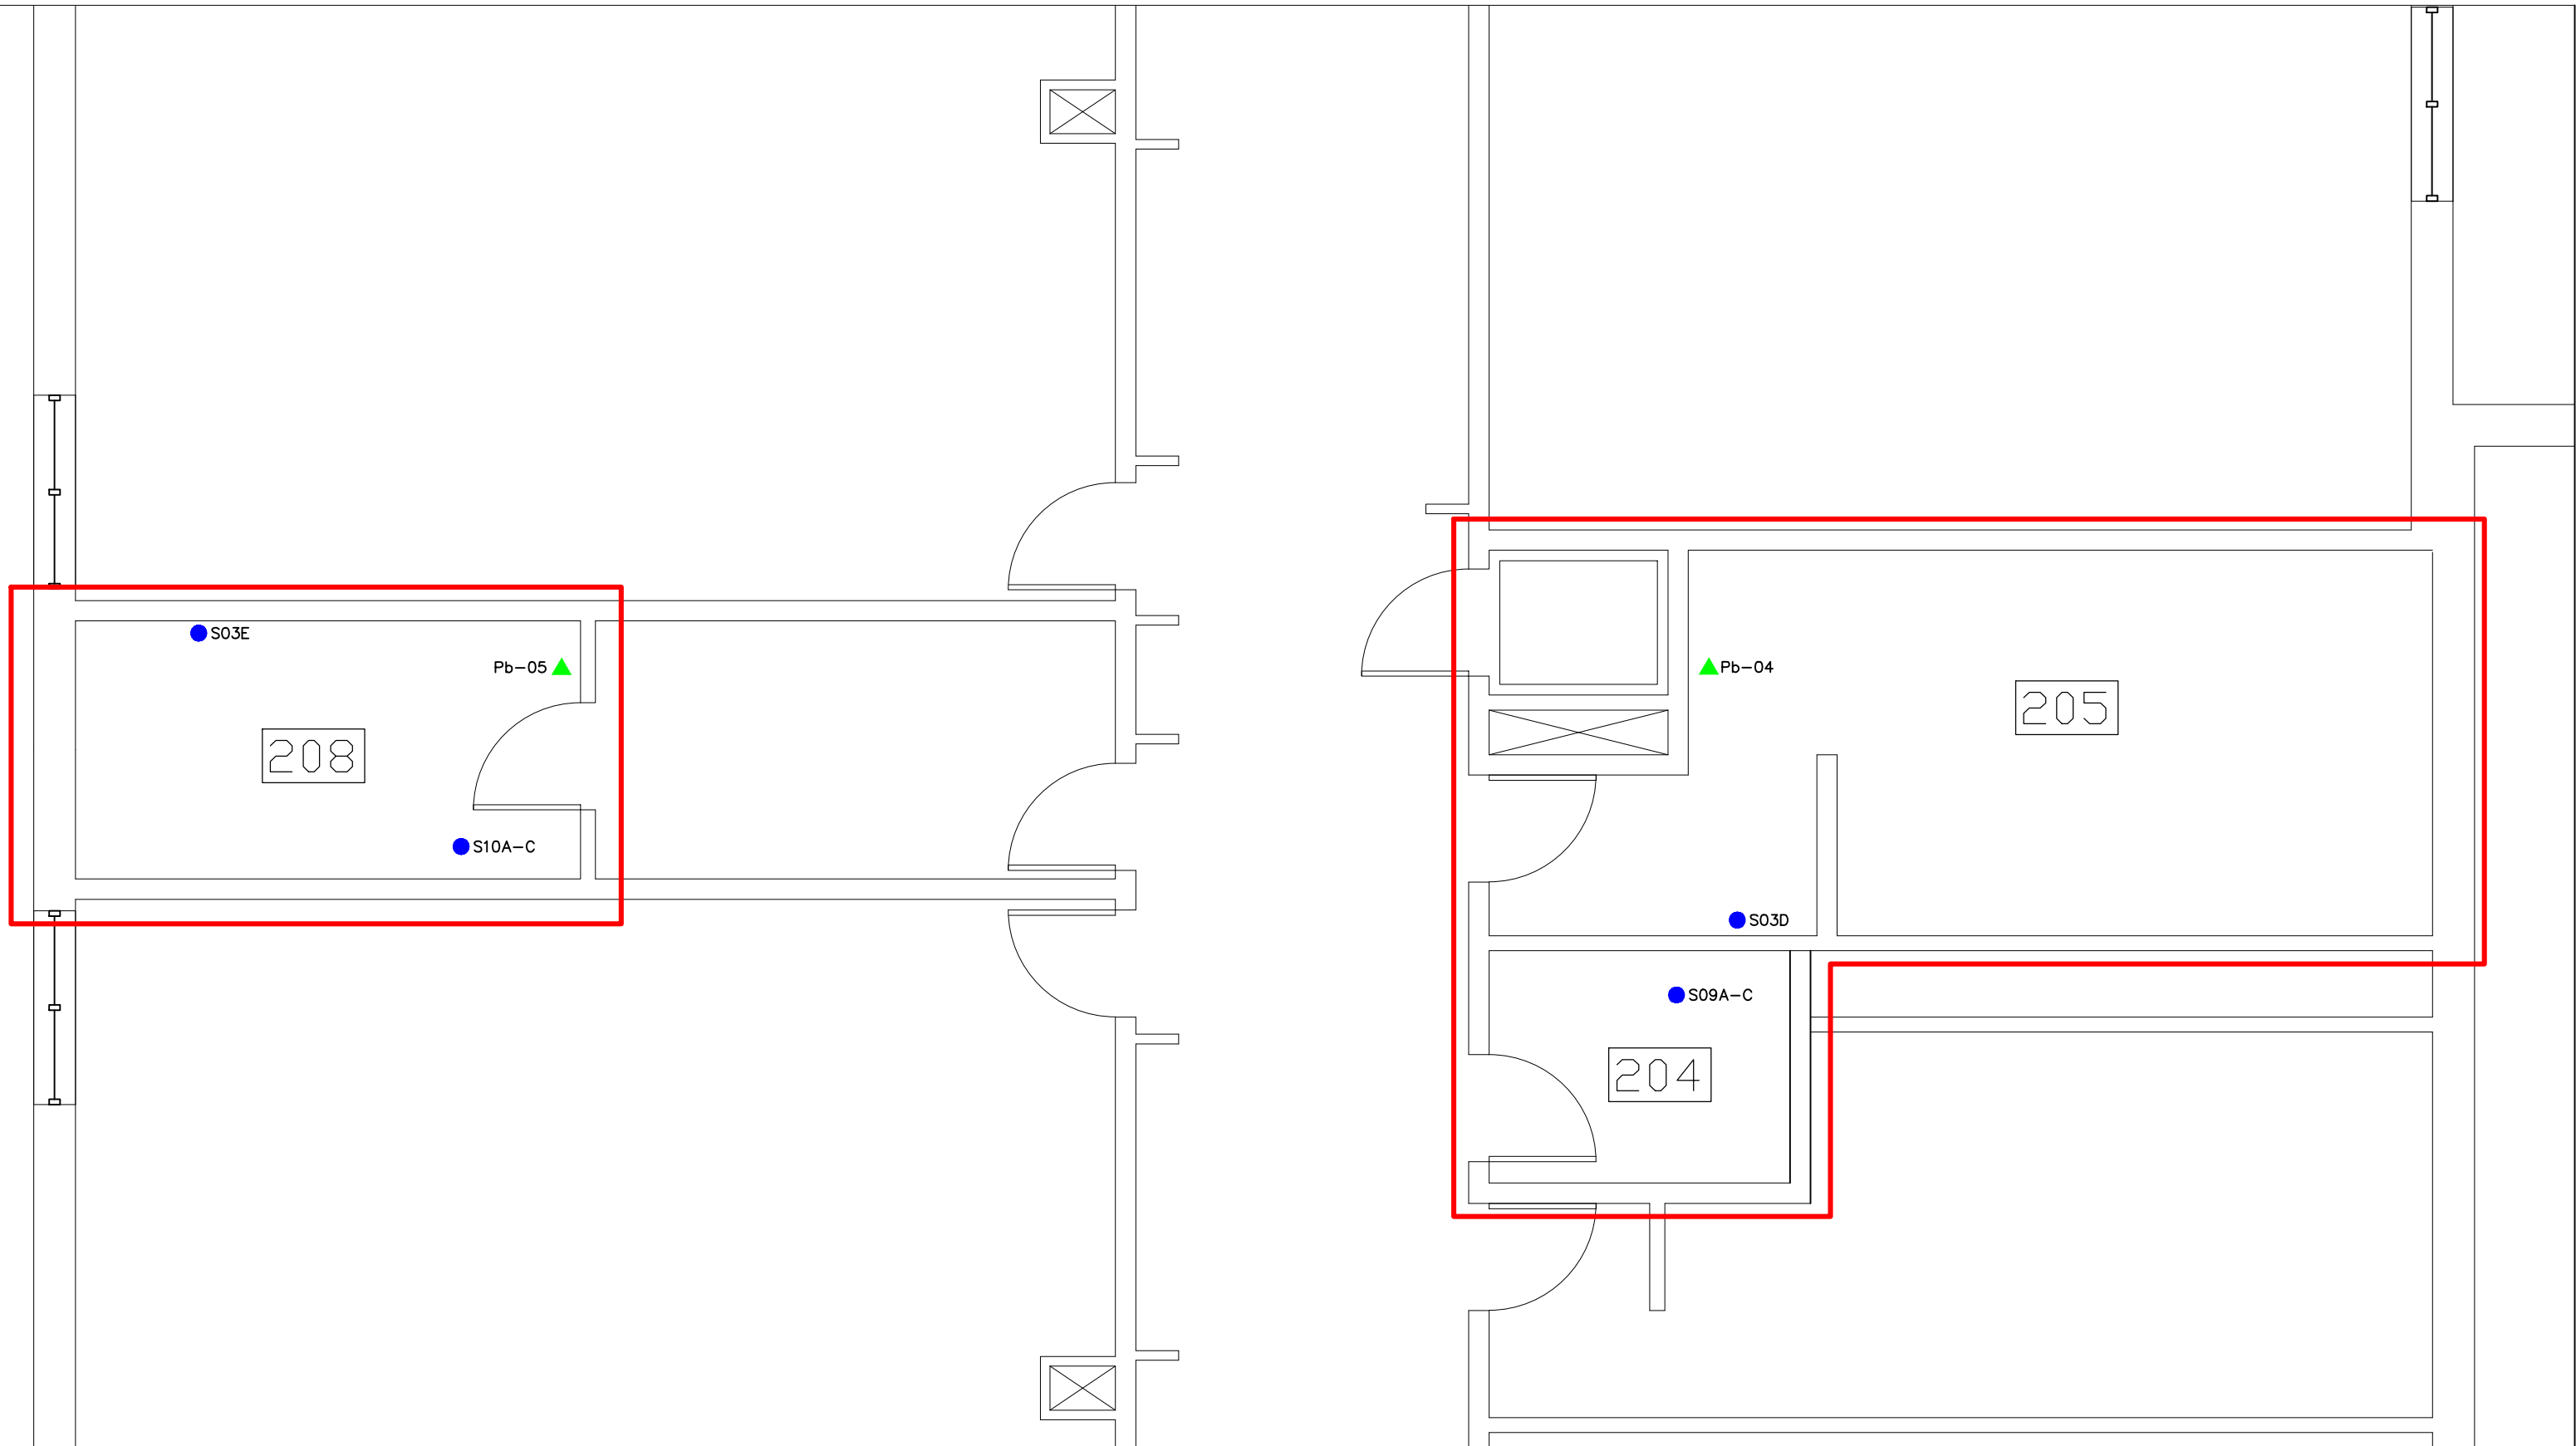
DRAWING NO	DSR-02
SCALE	NTS
DATE	January 16, 2026

TITLE	Limited Designated Substance Survey Second Floor Plan
CLIENT	Durham District School Board
LOCATION	William Dunbar Public School 1030 Glenanna Road Pickering, Ontario
