# Designated Substance and Hazardous Materials Survey – Pre-Renovation

**École élémentaire Antonine-Maillet  
615 Ridgeway Avenue, Oshawa, Ontario**

February 26, 2026

Arcadis Project No. 30305984

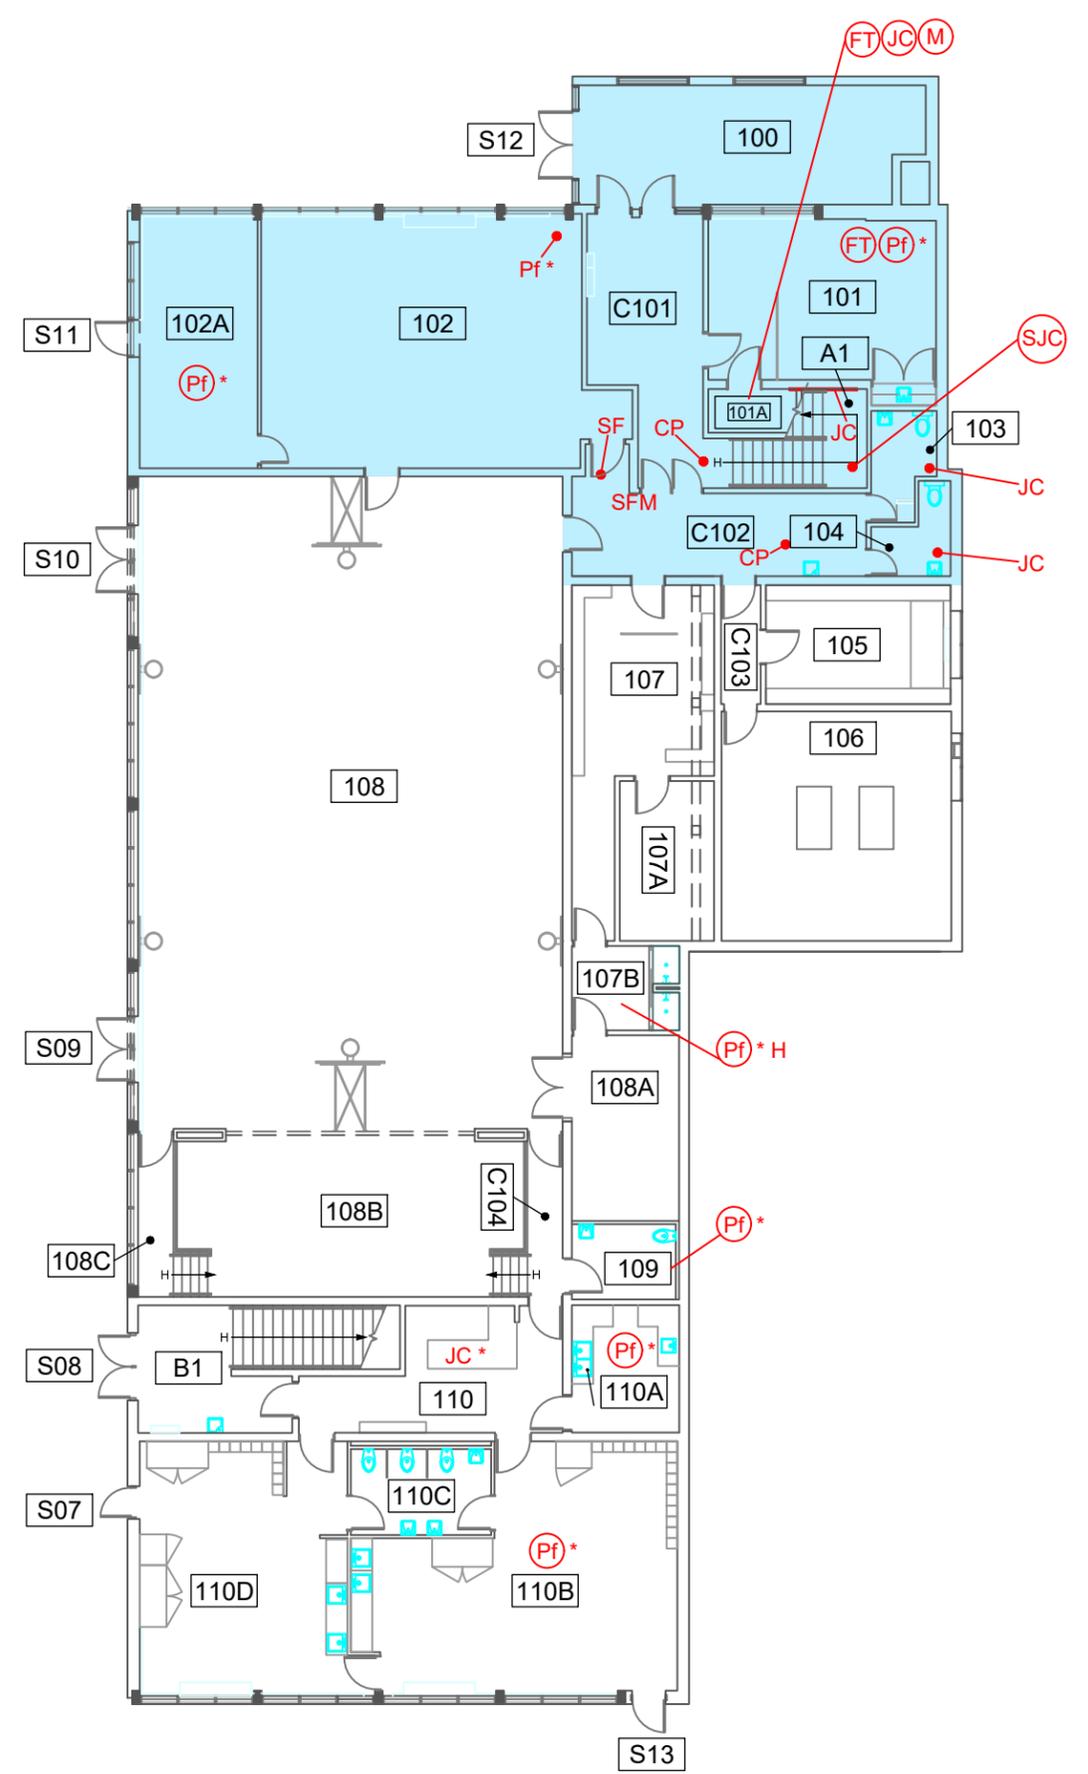
**GROUND FLOOR PLAN**

ASBESTOS PAINT IS PRESENT ON CONCRETE BLOCK WALLS THROUGHOUT THE 1961 CONSTRUCTION ERA

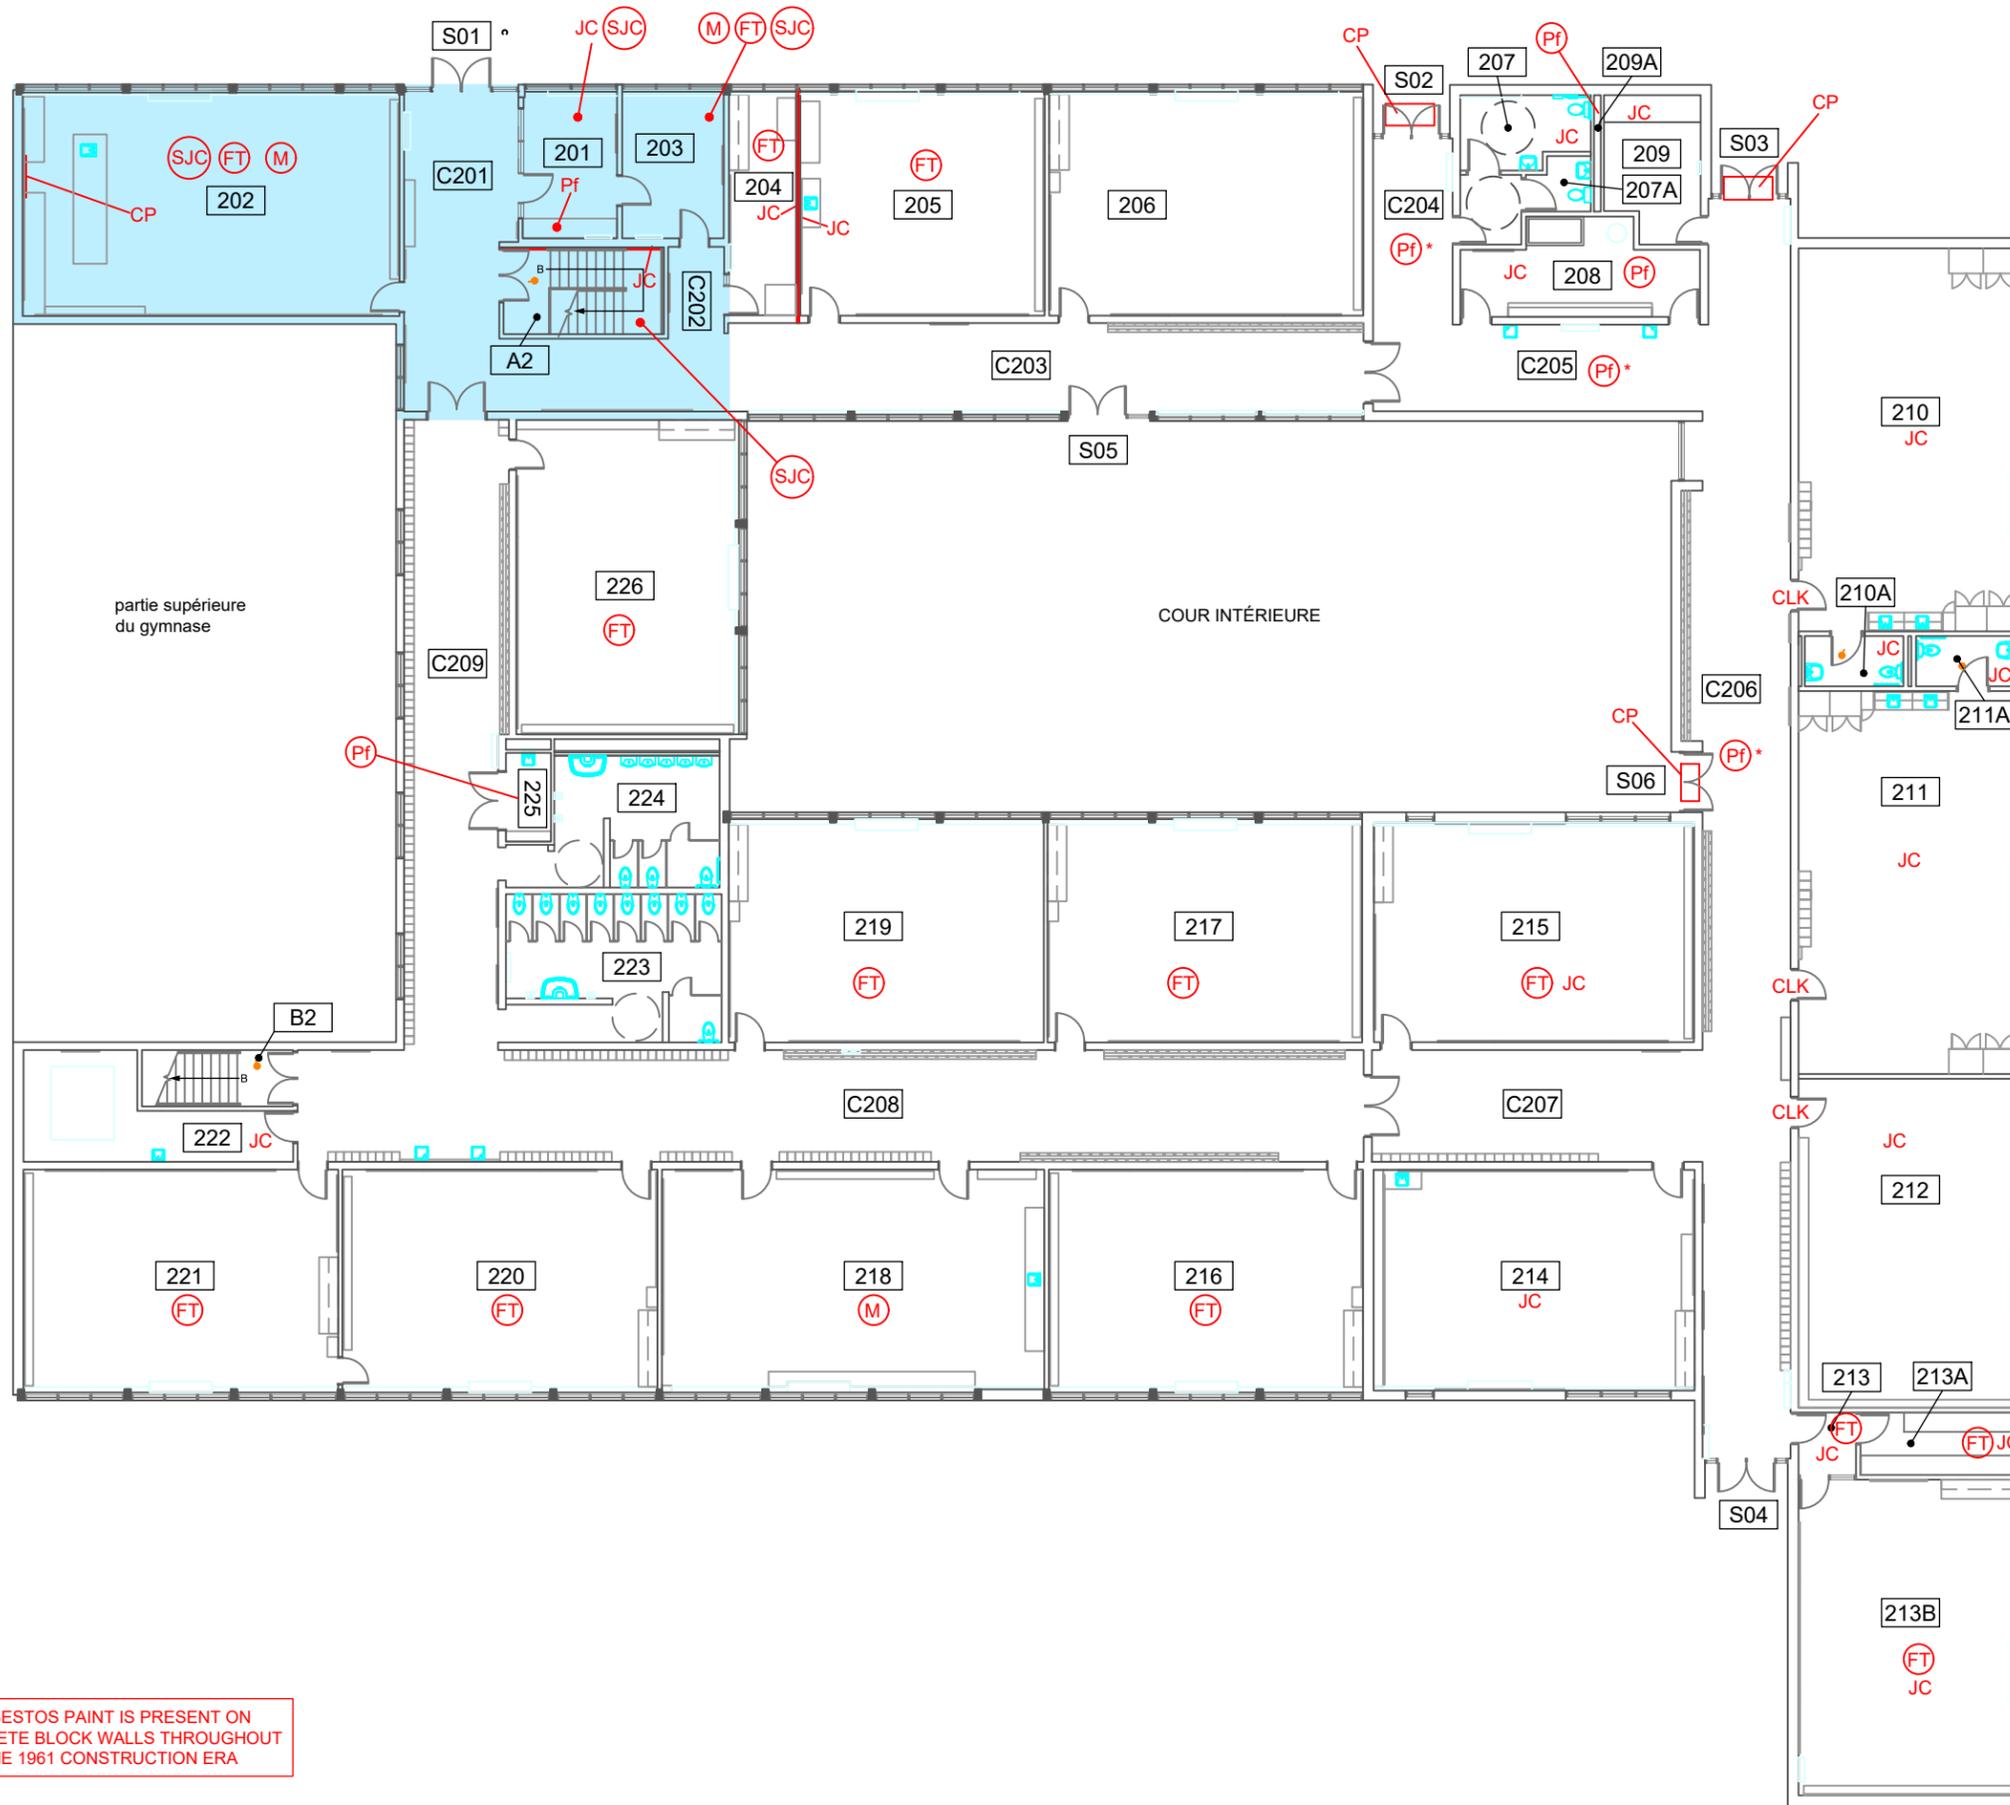
ASBESTOS PAINT IS PRESENT ON CONCRETE BLOCK WALLS THROUGHOUT THE 1961 CONSTRUCTION ERA
