DESIGNATED SUBSTANCES - SPREADSHEET OF FINDINGS
FOR PAINTING OPERATIONS
1330 Foxglove Avenue, Pickering, Ontario

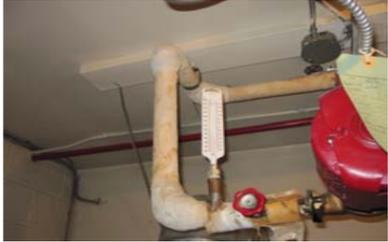
Area	Level	Location	Material & Description	Est. Qty*	Units	Condition	Friable Yes/No	Accessibility	Sample #	% Asbestos and Type	Photographs	Recommended Procedures For Painting Operations
Furnace & Elevator Mechanical Room (Note: may be present in other concealed locations throughout the Site)	Ground Level	Domestic Water Pipe Fittings (i.e. elbows, valves, tees, etc.)	Grey Parging Cement	5	Each	Good	Yes	Mod to Low	01-A	65% Chrysotile

Do not disturb the material. If disturbance is required or the material is damaged, repair following Type 2 Asbestos Procedures. If greater than 1 square metre of damage is present, removal and repair will require Type 3 Asbestos Procedures. Painting asbestos-containing pipe fitting parging in good condition requires Type 2 asbestos procedures.
Throughout	Throughout	Walls & Ceilings	Drywall Joint Compound ("DJC")	7,500	Square Meters	Good	No	High	02-A	0.75% Chrysotile

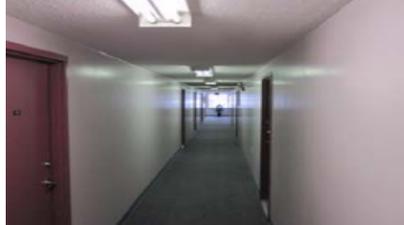
Area	Level	Location / Substrate	Colour & Description	Estimated Quantity	Condition	Accessibility	Sample #	% Lead	Photographs	Recommended Procedures For Painting Operations		
Throughout	All	Walls and Ceilings	Paint	N/A	Good	High	P-1 to P-5	All paint samples collected were found to contain low levels of lead ranging from <0.0076% to 0.34%

Light sanding of surfaces containing low levels of lead is classified as a Type 1 Lead Operation, provided the airborne concentration of lead is maintained below <0.05 mg/m ³ of air. Applying paint causes no disturbance to the lead-containing paint that is present in good condition. Lead Awareness Procedures are recommended.		
Copper pipes	Throughout	All	Solder on copper pipes	N/A	Good	Moderate	Not sampled - presumed	N/A

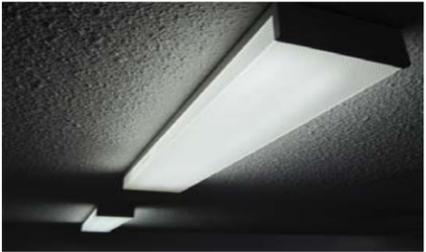
Substance	Level	Location	Estimated Quantity	Condition	Accessibility	Sample #	Photographs	Recommended Procedures For Painting Operations
Mercury - vapour	All	Fluorescent light fixtures	N/A	Good	High	Not sampled - presumed

Disturbance of this mercury-containing product is not anticipated during painting operations.
Mercury - liquid	All	Select thermostat switches and compact fluorescent bulbs	N/A	Good	High	Not sampled - presumed	Photograph Not Available	Disturbance of this mercury-containing product is not anticipated during painting operations.
Silica	ALL	Bricks and mortar	N/A	Good	High	Not Sampled - presumed
