DESIGNATED SUBSTANCES SPREADSHEET OF FINDINGS  
FOR PAINTING OPERATIONS  
20 Perry Street, Uxbridge, Ontario

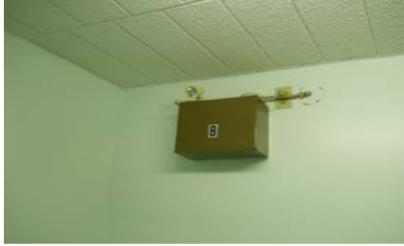
Light sanding of surfaces containing low levels of lead is classified as a Type 1 Lead Operation, provided the airborne concentration of lead is maintained below <math>0.05 \text{ mg/m}^3</math> of air. Applying paint causes no disturbance to the lead-containing paint that is present in good condition. Lead Awareness Procedures are recommended.
Stairwells/ Exit Corridors	Throughout	Battery in Exit Lights		N/A	Good	Moderate		N/A

Disturbance of this lead-containing product is not anticipated during painting operations. However, if this material is to be disturbed or is present in damaged condition, follow the appropriate procedures outlined in the Lead Guideline.

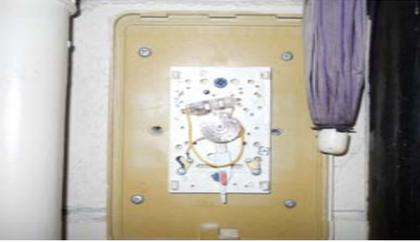
OTHER DESIGNATED SUBSTANCES										
Substance	Level	Location	Estimated Quantity	Condition	Accessibility	Sample #	Photographs	Recommended Procedures For Painting Operations		
Mercury - vapour	All	Fluorescent light fixtures	N/A	Good	Moderate	Not sampled - presumed	Photograph Unavailable	Disturbance of this mercury-containing product is not anticipated during painting operations.		
Mercury - liquid	First Floor	Elevator Room / Garbage Room	1	Good	Moderate	Not sampled - presumed

Disturbance of this mercury-containing product is not anticipated during painting operations.

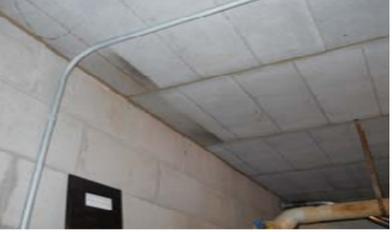
Silica	ALL	Bricks and mortar	N/A	Good	High	Not Sampled - presumed

<p>Disturbance of this silica-containing product is not anticipated during painting operations. However, if this material is to be disturbed or is present in damaged condition, follow the appropriate procedures outlined in the Silica Guideline.</p>
--------	-----	-------------------	-----	------	------	------------------------	---	--
