**ASBESTOS-CONTAINING MATERIALS**

OTHER DESIGNATED SUBSTANCES

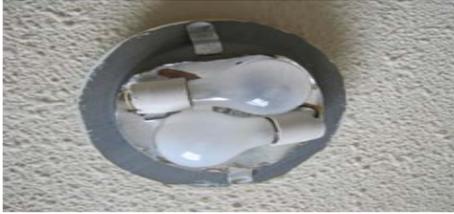
Area	Level	Location	Material & Description	Est. Qty*	Units	Condition	Friable Yes/No	Accessibility	Sample #	% Asbestos and Type	Photographs	Recommended Procedures For Painting Operations
Tenant Units - Unit 114 (also suspected to be present in the Bedrooms of additional Tenant Units)	Ground Floor	Bedroom ceiling - behind light fixture	Heat shield material	1	Each	Good	No	Moderate	01 A-C	30% Chrysotile

Do not disturb the material. If disturbance is required or the material is damaged, remove following Type 1 Asbestos Procedures.
Maintenance Areas	Ground Floor - Maintenance Office Second Floor - Storage Room (off 209) and adjacent Furnace Room	Floor	Yellow 30cm x 30cm vinyl floor tiles with white streaks	56	Square meters	Good	No	Moderate	02 A-C	1.1% Chrysotile

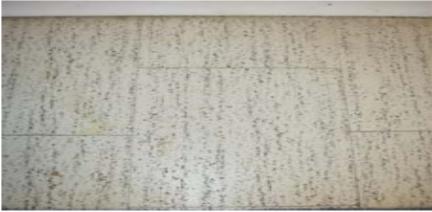
Tenant Spaces	All	Floor	Dark beige 300 mm x 300 mm vinyl floor tiles with brown spots	42	Square meters (per unit)	Good	No	High	03 A-C	0.5% Chrysotile

Do not disturb the material. If disturbance is required or the material is damaged, remove following Type 1 Asbestos Procedures.
Throughout	All	Select walls and ceilings	Drywall joint compound	4,500	Square meters	Good	No	High	06 A-C	1.7% Chrysotile asbestos

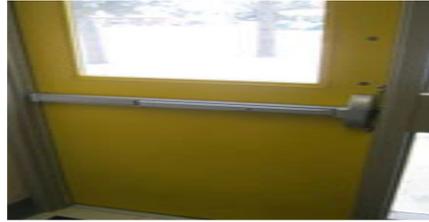
Area	Level	Location / Substrate	Colour & Description	Estimated Quantity	Condition	Accessibility	Sample #	% Lead	Photographs	Recommended Procedures For Painting Operations
Exit doors	Throughout	Metal Exit doors	Yellow paint	Unknown	Good	High	LP-01	0.75%

Light sanding of surfaces containing low levels of lead is classified as a Type 1 Lead Operation, provided the airborne concentration of lead is maintained below <math>0.05 \text{ mg/m}^3</math> of air. Applying paint causes no disturbance to the lead-containing paint that is present in good condition. Lead Awareness Procedures are recommended.
Tenant Spaces and Common Areas	Throughout	All	All	N/A	Good	High	LP-02 to LP-04	All remaining paint samples collected were found to contain low levels of lead ranging from 0.06% to <math>0.02\%</math>

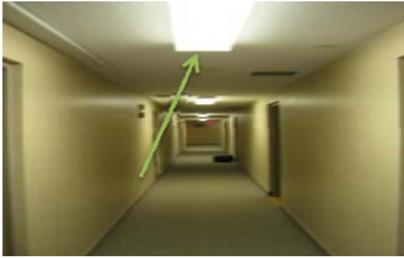
Substance	Level	Location	Estimated Quantity	Condition	Accessibility	Sample #	Photographs	Recommended Procedures For Painting Operations
Mercury Vapour	All	Fluorescent Light Fixtures	N/A	Good	Moderate	Not sampled - presumed

Disturbance of this mercury-containing product is not anticipated during painting operations.
Silica	All	Bricks and mortar	N/A	Good	High	Not Sampled - presumed
