ASBESTOS-CONTAINING MATERIALS

Area	Level	Location	Material & Description	Est. Qty*	Units	Condition	Friable Yes/No	Accessibility	Sample #	% Asbestos and Type	Photographs	Recommended Procedures For Painting Operations
Garbage Room	First and Second Floors	Floor	Pink pattern vinyl sheet flooring. Second layer beneath S05 vinyl floor tile.	40	Square meters	Good	Yes	High	S08 A - C	60% chrysotile

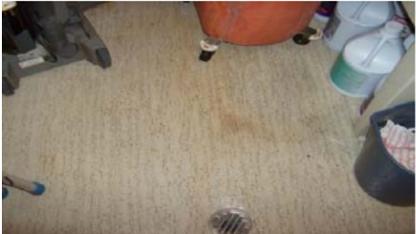
Do not disturb the material. If disturbance is required or the material is damaged, repair following Type 2 Asbestos Procedures.
Tenant Units, Janitor Room	All	Floor	300 mm x 300 mm off-white with black spot vinyl floor tile	1,400	Square meters	Good	No	High	S10 A - C	2.1% chrysotile

Do not disturb the material. If disturbance is required or the material is damaged, remove following Type 1 Asbestos Procedures.
Laundry Room	Second Floor	Floor	300 mm x 300 mm yellow with white streak vinyl floor tile. Second layer beneath S07 vinyl floor tile.	20	Square meters	Good	No	High	S06 A - C	0.75% chrysotile

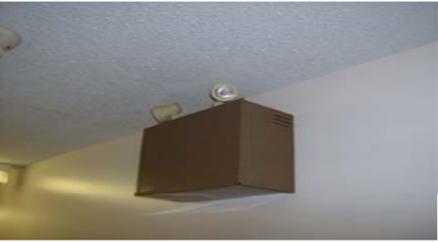
Stairwells/ Exit Doors	Throughout	Battery in Exit Lights		N/A	Good	Moderate	N/A

Disturbance of this lead-containing product is not anticipated during painting operations. However, if this material is to be disturbed or is present in damaged condition, follow the appropriate procedures outlined in the Lead Guideline.
Copper pipes	Throughout	All	Solder on copper pipes	N/A	N/A	Moderate	Not sampled - presumed	N/A

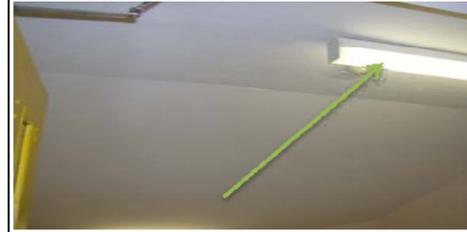
Substance	Level	Location	Estimated Quantity	Condition	Accessibility	Sample #	Photographs	Recommended Procedures For Painting Operations
Mercury Vapour	All	Fluorescent Light Fixtures	N/A	Good	Moderate	Not sampled - presumed

Disturbance of this mercury-containing product is not anticipated during painting operations.
Mercury Thermostat	Various	Corridors - Wall mounted Thermostat	N/A	Good	High	N/A	Photograph Not Available	Disturbance of this mercury-containing product is not anticipated during painting operations.
Silica	All	Bricks and mortar	N/A	Good	High	Not Sampled - presumed
