**REPORT ON
GEOTECHNICAL INVESTIGATION
51 WRIGHT STREET
RICHMOND HILL, ONTARIO**

**REPORT NO.: 6381W-23-GA
REPORT DATE: JUNE 28, 2023**

**PREPARED FOR
BARRY BRYAN ASSOCIATES (BBA)
201-250 WATER STREET
TORONTO, ONTARIO
L1H 0G5**

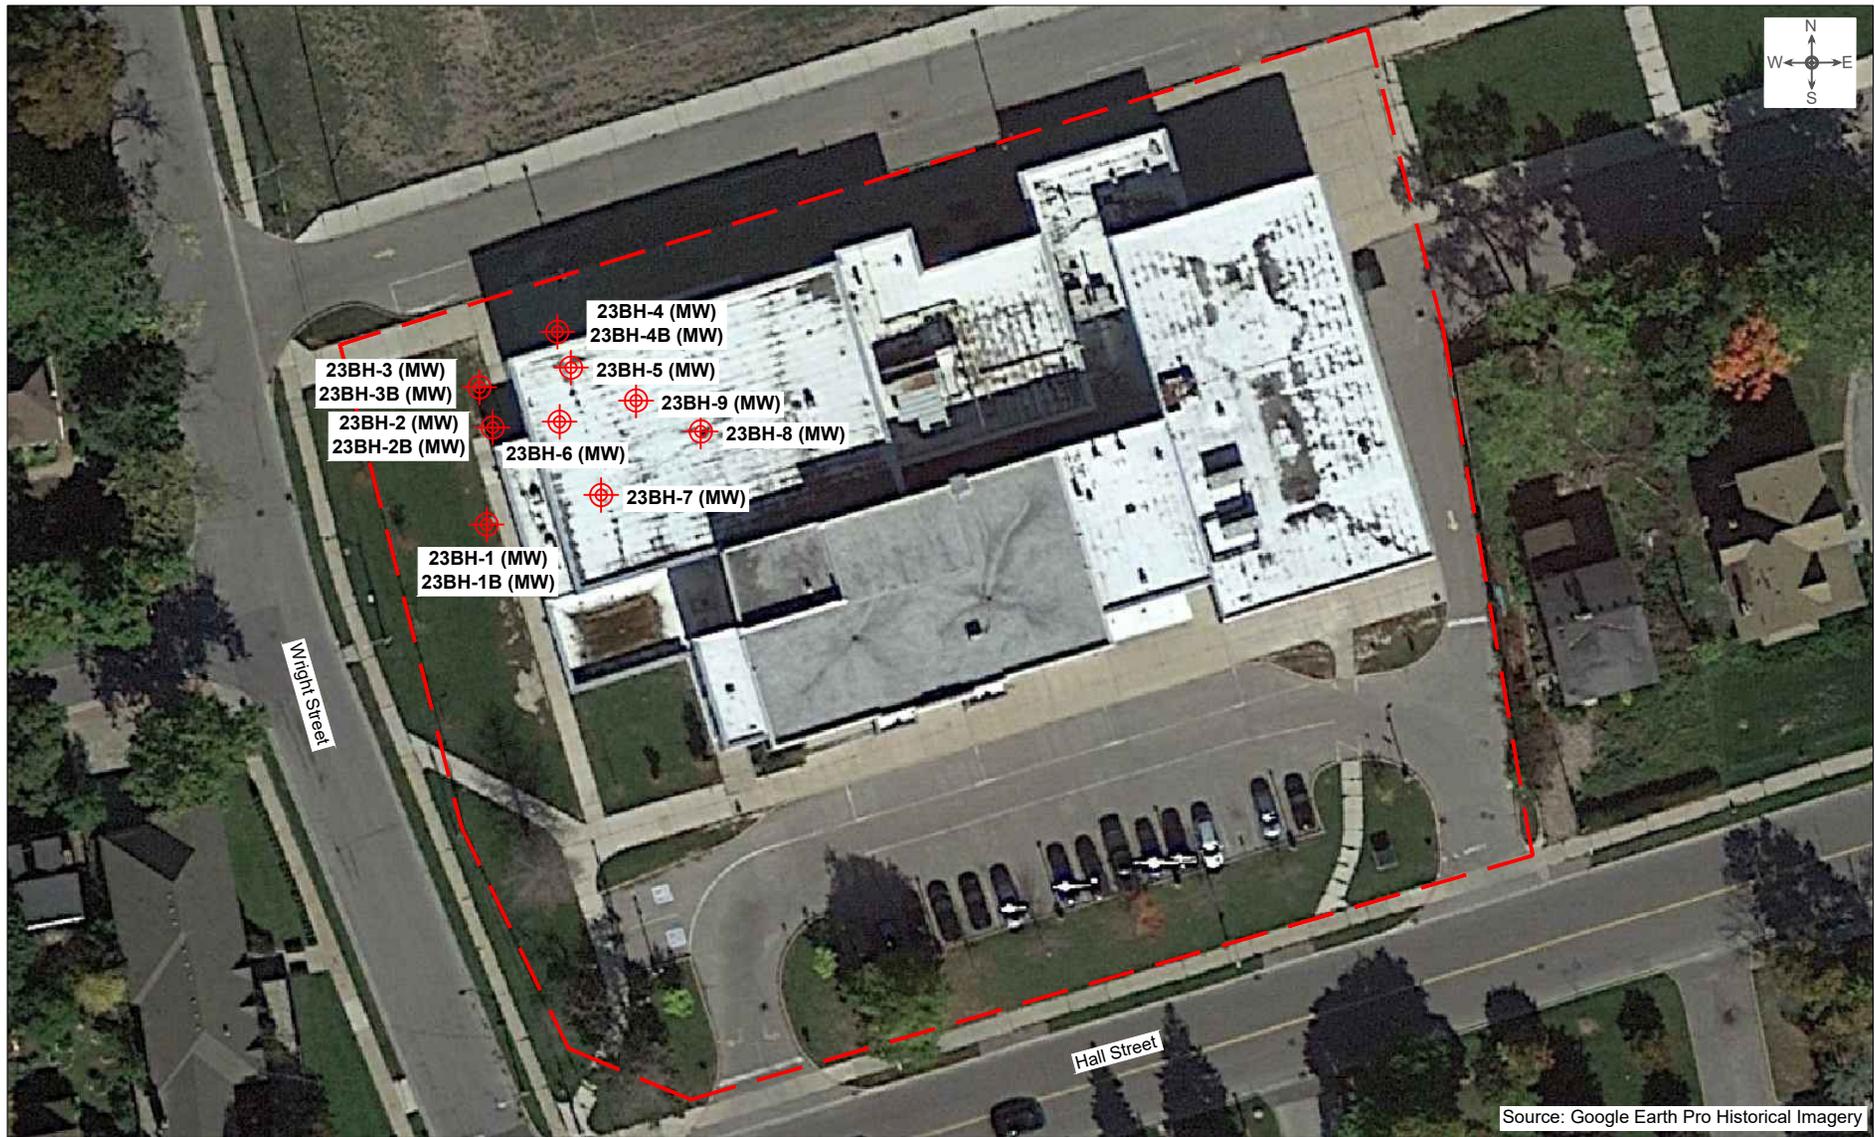
TITLE:		Borehole and Monitoring Well Location Plan	
LOCATION:		51 Wright Street, Richmond Hill, Ontario	
PROJECT NO.	6381W-23-GA	DATE :	June 2023
DRAWING NO.		1

The field work for the investigation was carried out on May 25 and 26, 2023. Four sampled boreholes (23BH-1 to 23BH-4) were drilled outside of the building, to the west and north of the Gym, extending to depths of 2.1m from grade, and five sampled boreholes (23BH-5 to 23BH-9) were drilled within the gym, extending to depths of 2.0m to 2.1m from grade. In addition, four boreholes, 23BH-1B to 23BH-4B, were drilled beside Boreholes 23BH-1 to 23BH-4, respectively, without sampling until depths of 2.1m from grade, extending to depths of 3.4m to 3.7m from grade, and were completed as monitoring wells. These borehole locations are shown in the appended Borehole Location Plan, Drawing No. 1.

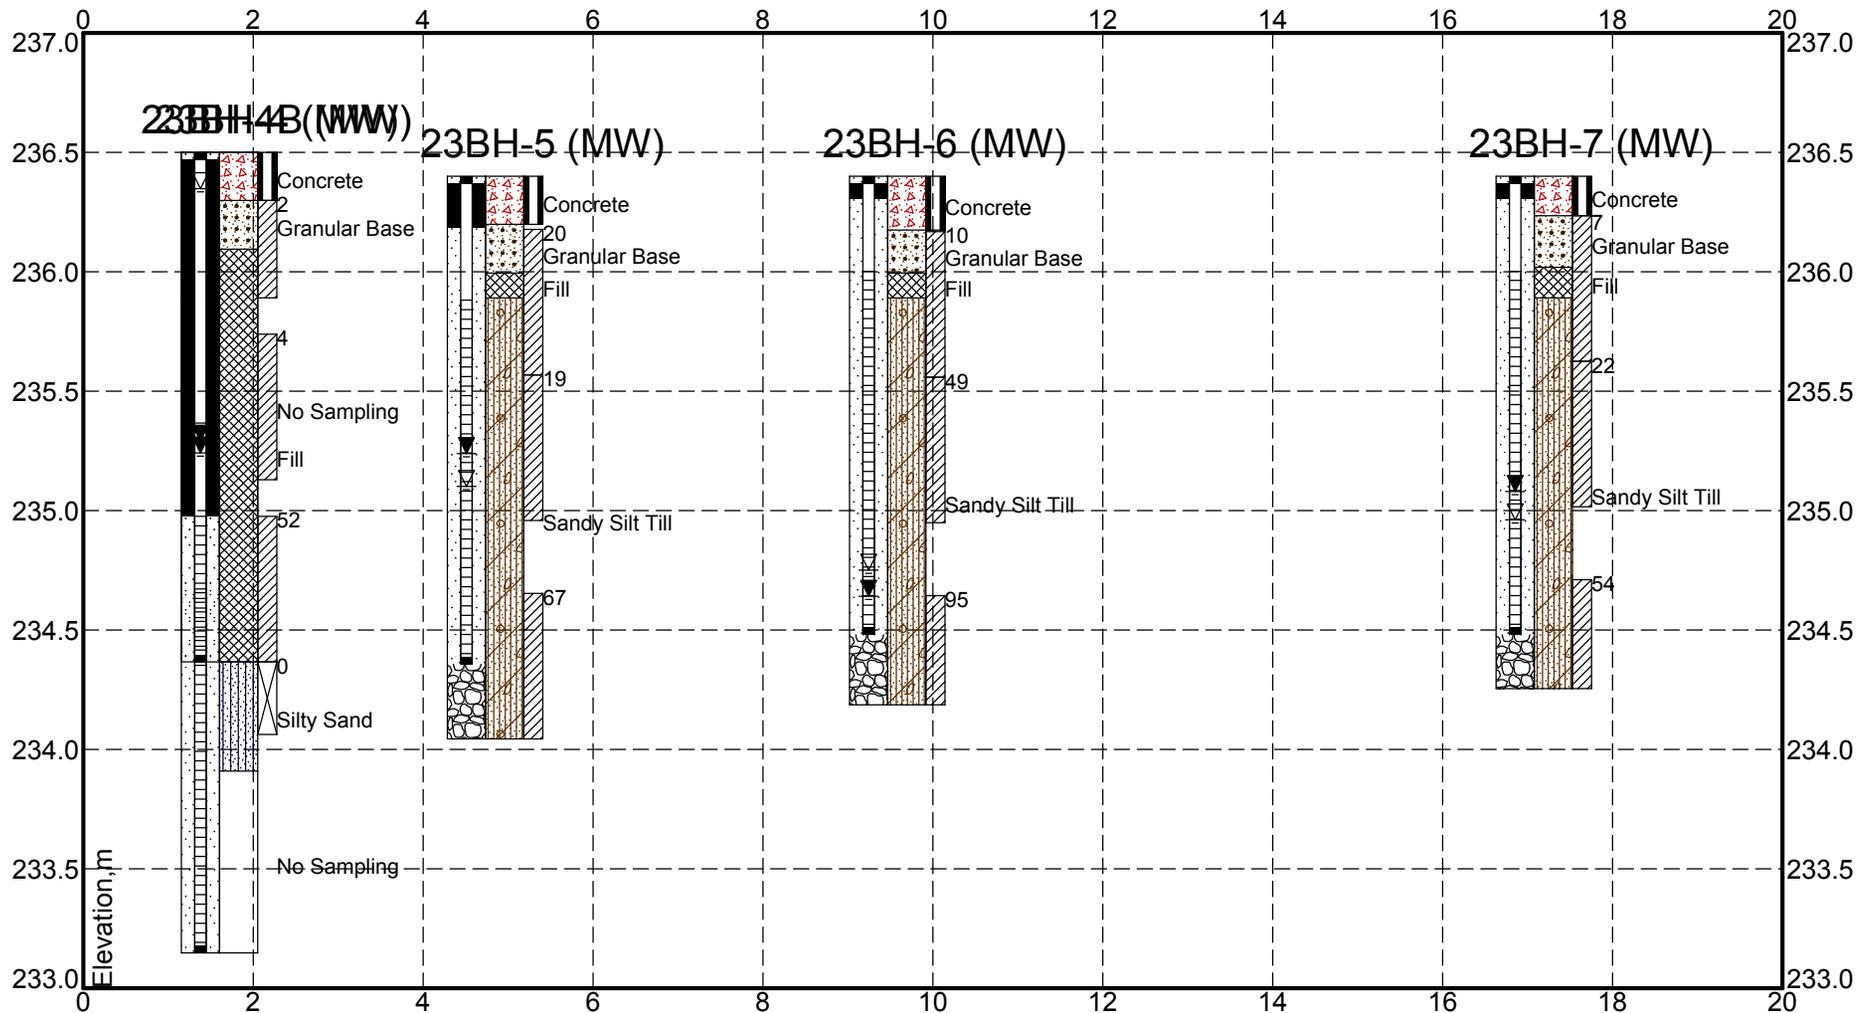
SUBSURFACE STRATIGRAPHY		
Section 1		
Geotechnical Investigation		
51 Wright Street, Richmond Hill, Ontario		
PROJECT #	DATE	DRAWING
6381W-23-GA	Jun 23	15

2. The heaving of the concrete slab of the walkway, to the north of the door of the gym, could be due to the freeze-thaw effects to the wet and saturated granular base and silty sand fill under the concrete slab, revealed at Boreholes 23BH-4/4B locations.

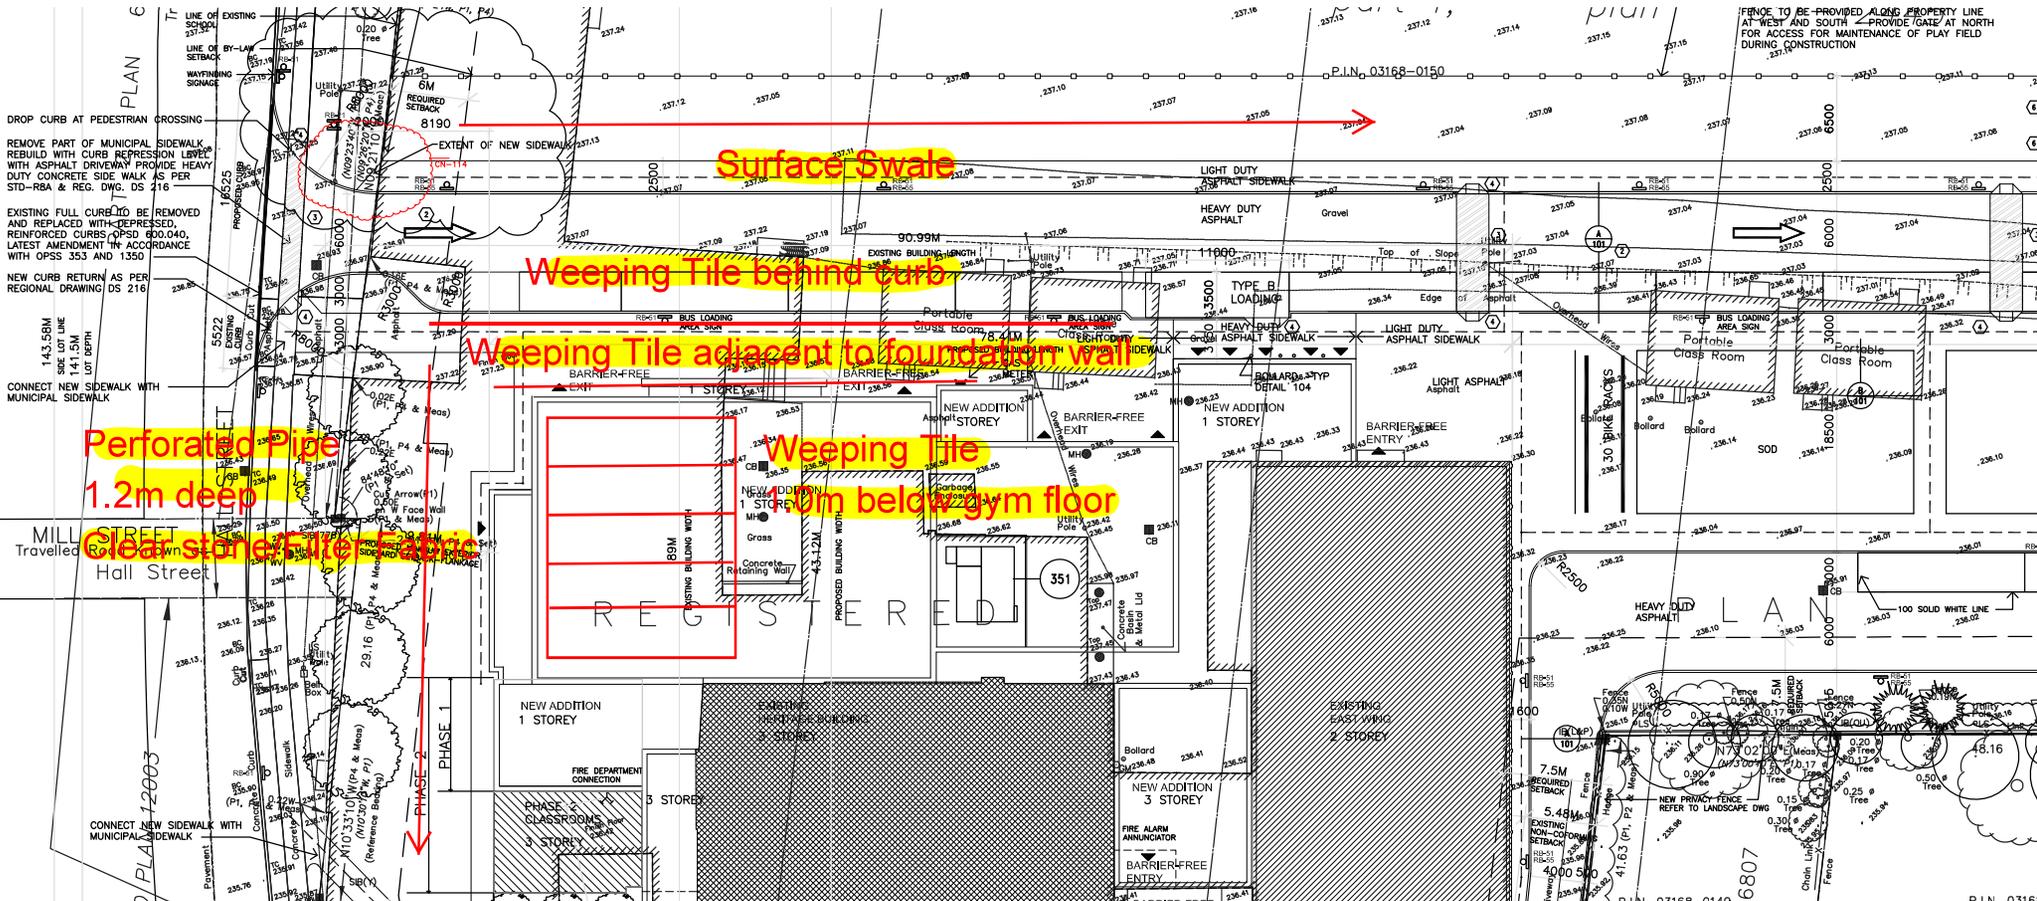
1. The existing ground level in the landscaped area to the west and concrete walkway to the north of the gym, at Boreholes 23BH-2 to 23BH-4 locations, is slightly higher than the concrete floor level of the gym. Water from rain or snow melting may flow towards the gym, particularly into the door of the gym from the concrete walkway. The play field, higher than the driveway and the walkway, may bring some surface water to the south portion of the Site.

- A surface drainage or weeping tiles be installed in the landscaped area along the west of the building/gym and along the south boundary of the play field to catch most of the surface water.
- Weeping tiles be installed along the south curb of the driveway and adjacent to the foundation wall below the concrete walkway, for the water to drain out of and not collect in the granular base courses. The subdrains should be at least 800mm below the road pavement or concrete walkway level, and installed on a positive gradient to allow for a free flow of water.
- A subfloor drainage system will be necessary to keep the groundwater level at least 1.0m below the concrete floor in the gym. The recommended permanent perimeter drainage system is shown in Figure No. 2, Item 11.
